Sustaining Performance of ASR-Affected Pavements: Effective Practices and Insights

Fatih Bektas, Principal Investigator
Department of Mechanical and Civil Engineering
Minnesota State University - Mankato

June 2025

Research Project
Final Report 2025-29

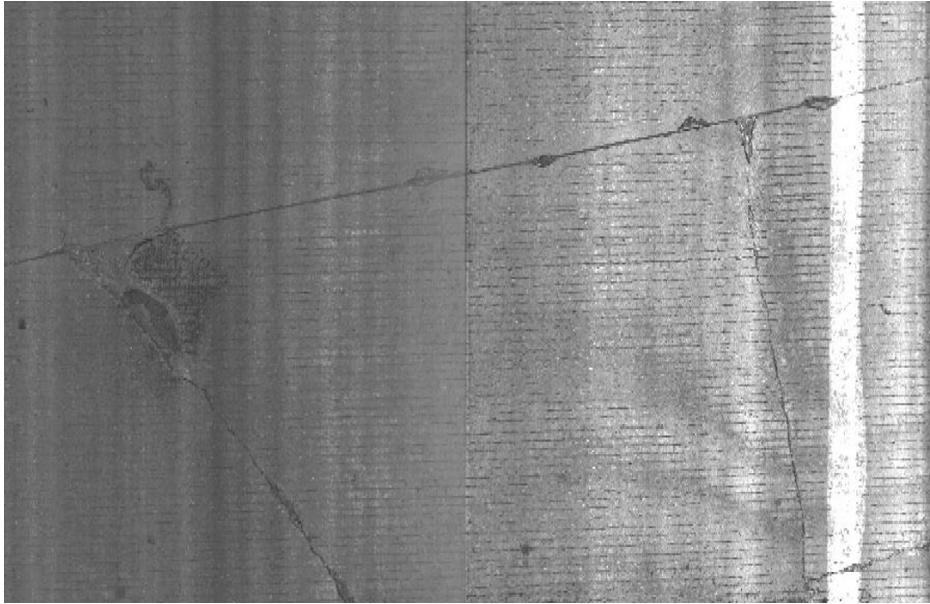
ASR manifests itself as map cracking on the surface and initially it is in the form of fine cracking. The process requires moisture; therefore, it is often concentrated around the joints, possibly co-existing with freeze-thaw cracking. The Pathweb image resolution is not sufficient to identify fine cracking (Figure 3.15). MnDOT collects D-cracking (Figure 3.16) and localized distress and incorporates it to its SR. Therefore, SR might be a better ASR indicator, hence, can be used to determine effective strategies.

Figure 3.15 Pathweb image from US 169-WVC (Mile post 20.505).

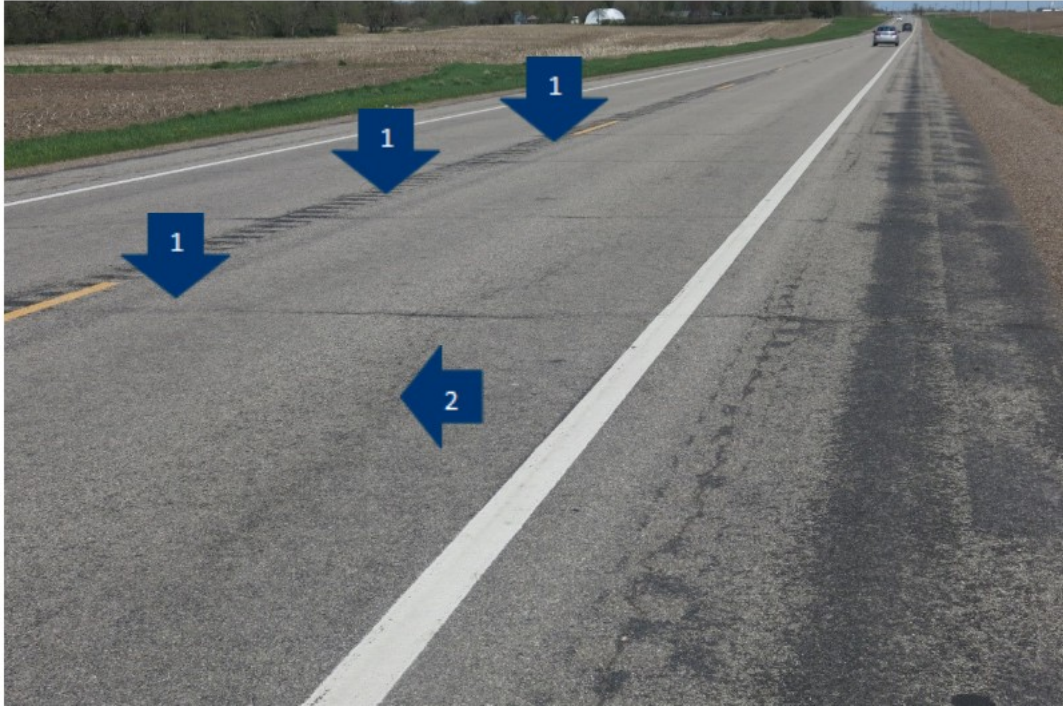
The reflective cracking on the transverse joints of the underlying concrete pavement are prominent (Figure 4.2). These reflective cracks often extend to the shoulder edge. Some low severity cracking on wheelpath started to develop (Figure 4.2). There is also cracking on the centerline (Figure 4.3) some probably reflecting from the longitudinal concrete pavement joint underneath and some due to separation of the seams between the bituminous lanes. Furthermore, longitudinal reflective cracking on the shoulder along the edges of the original pavement is present (Figure 4.4). Randomly oriented transverse cracking also exists in small number of locations (Figure 4.5). In one of these locations, Figure 4.6, the cracking is in advanced stage. This might be associated with a problem related to the underlying concrete. Overall, this section is in good shape.

Figure 4.2 Reflective cracking (1) and wheelpath cracking (2).

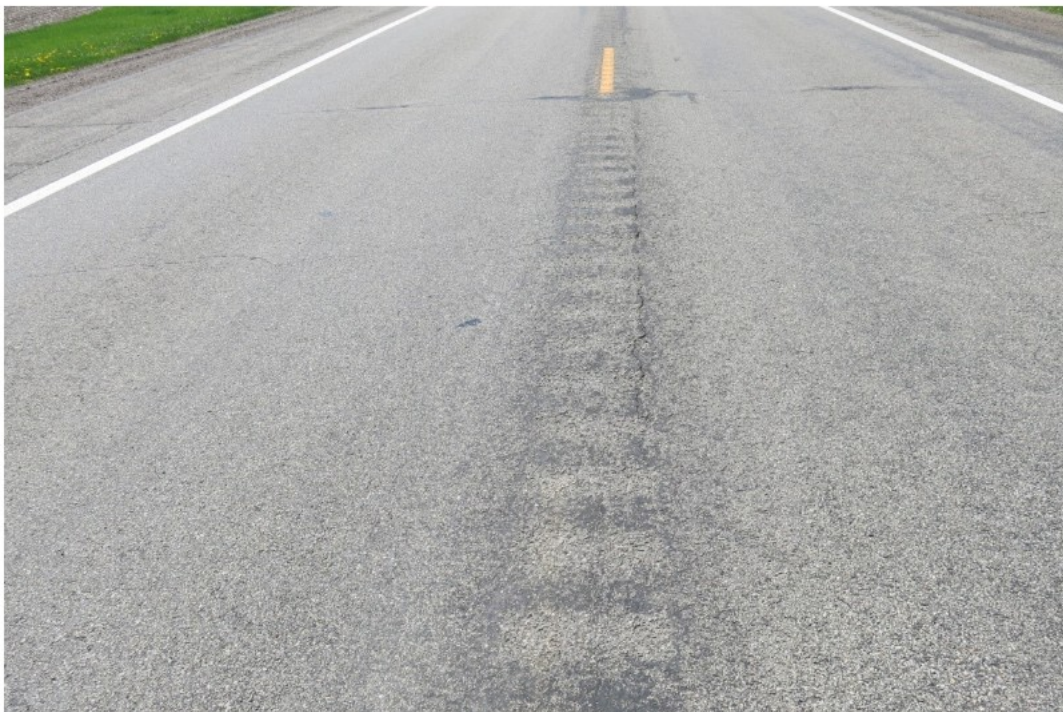
Figure 4.3 Reflective cracking on the centerline.

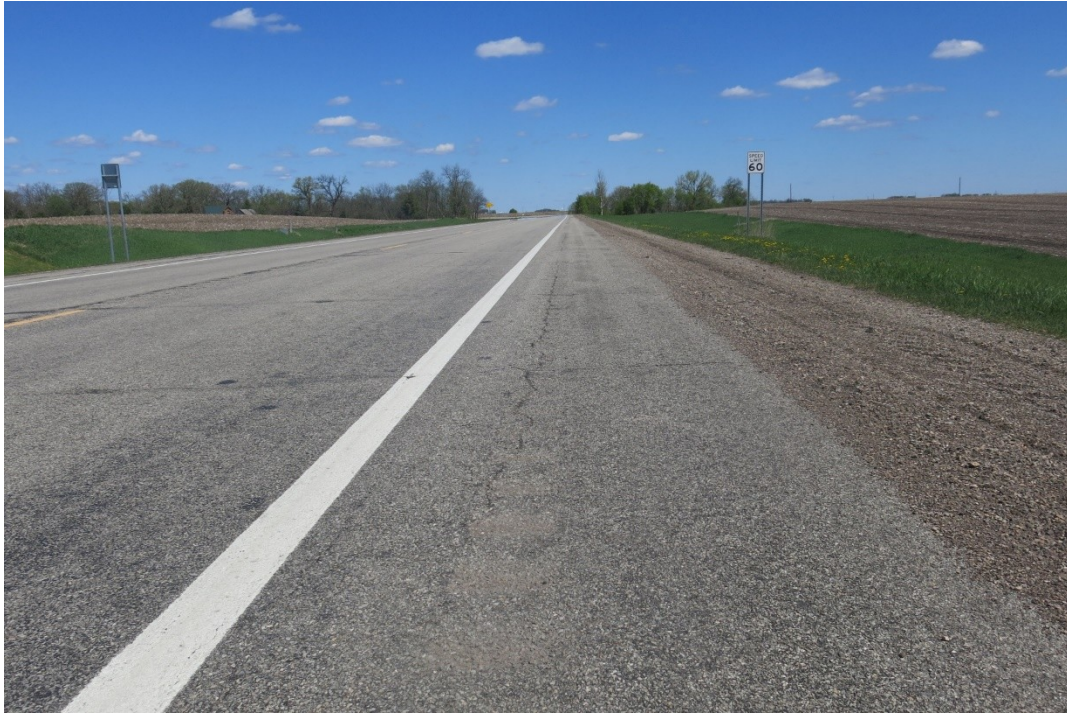
Figure 4.4 Longitudinal cracking on shoulder along the original pavement edge.

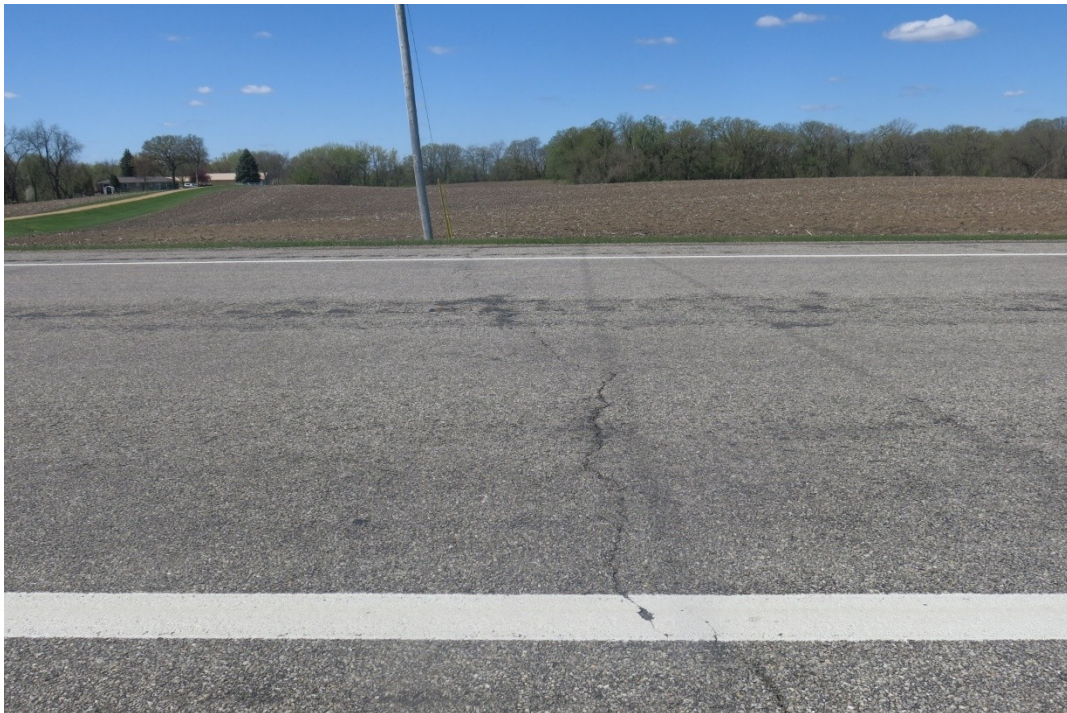
Figure 4.5 Randomly oriented transverse cracking.

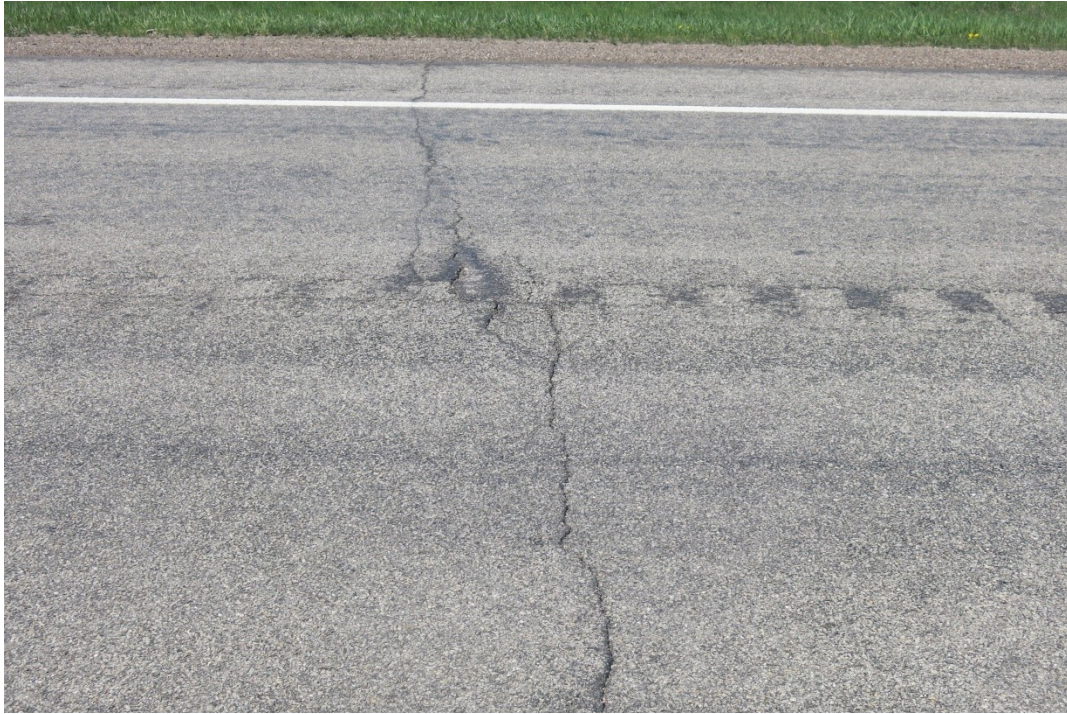
Figure 4.6 Advanced cracking at transverse joint of the original concrete layer.

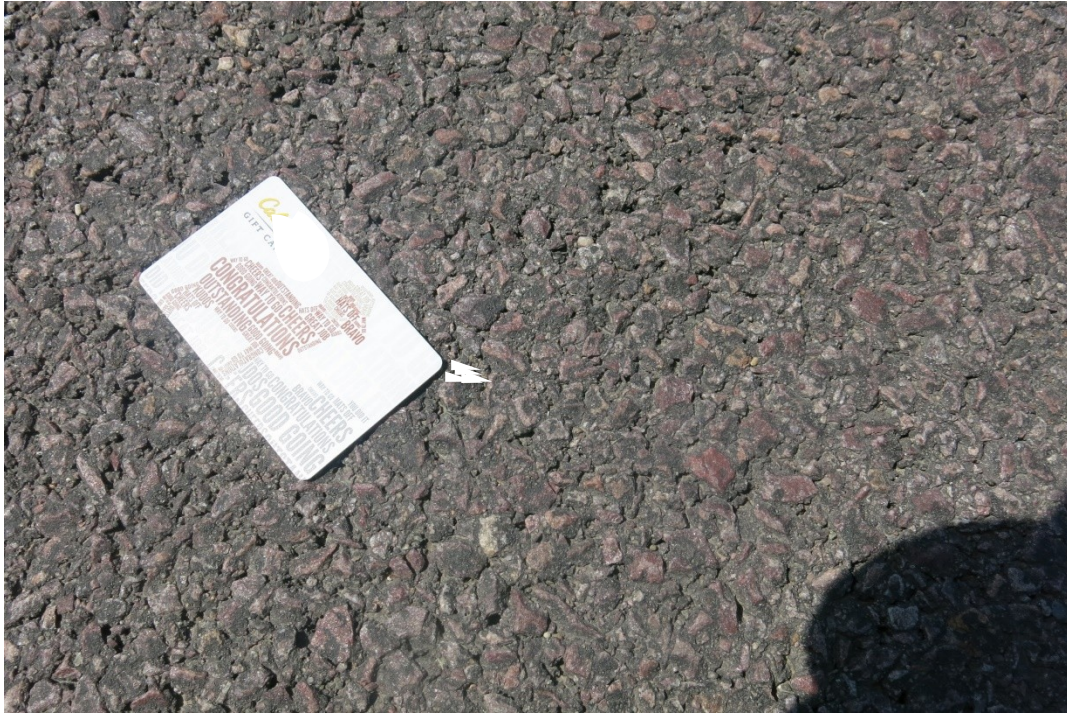
This stretch of US 169 was overlaid a few years after the previous project site. Similar observations are valid. The asphalt mix for this site seem different, somewhat rough (Figure 4.8). Reflective transverse cracking (Figures 4.9 and 10) is prominent and at locations seemed wider than the previous project site. In general, these transverse cracks do not extend to the shoulder, however, arrested by the longitudinal cracking on shoulder along the original pavement edge (Figure 4.11). No centerline cracking is observed in this section. After three years of service the surface is in good condition.

Figure 4.8 Asphalt pavement surface.

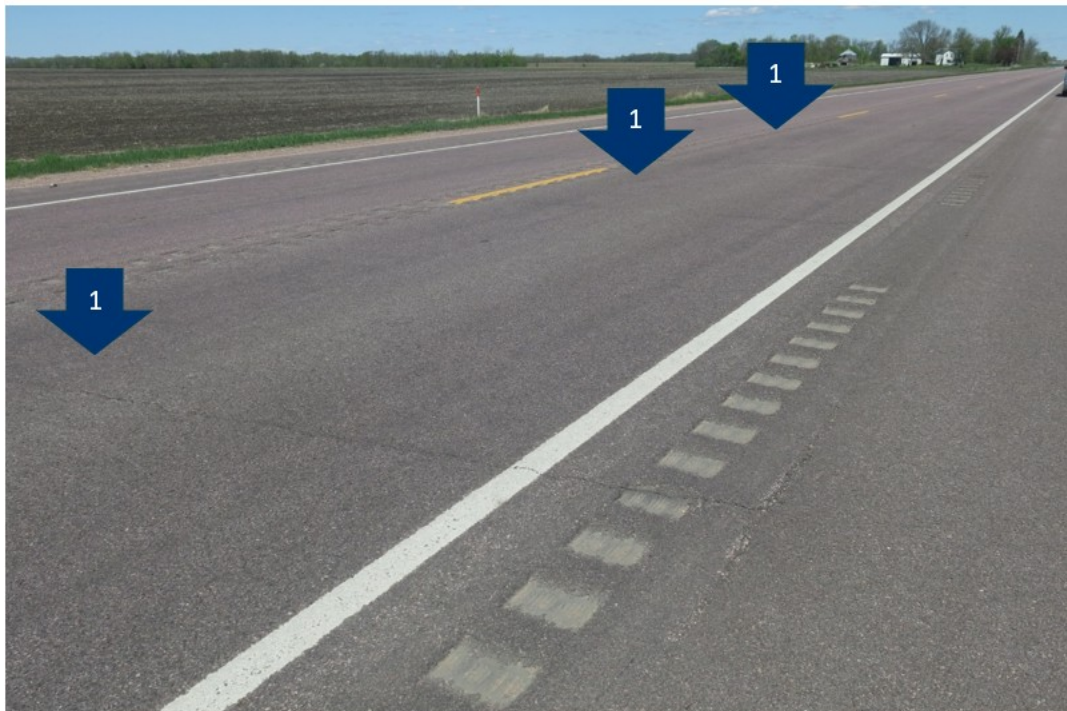
Figure 4.9 Reflective cracking over transverse joints of the underlying concrete pavement.

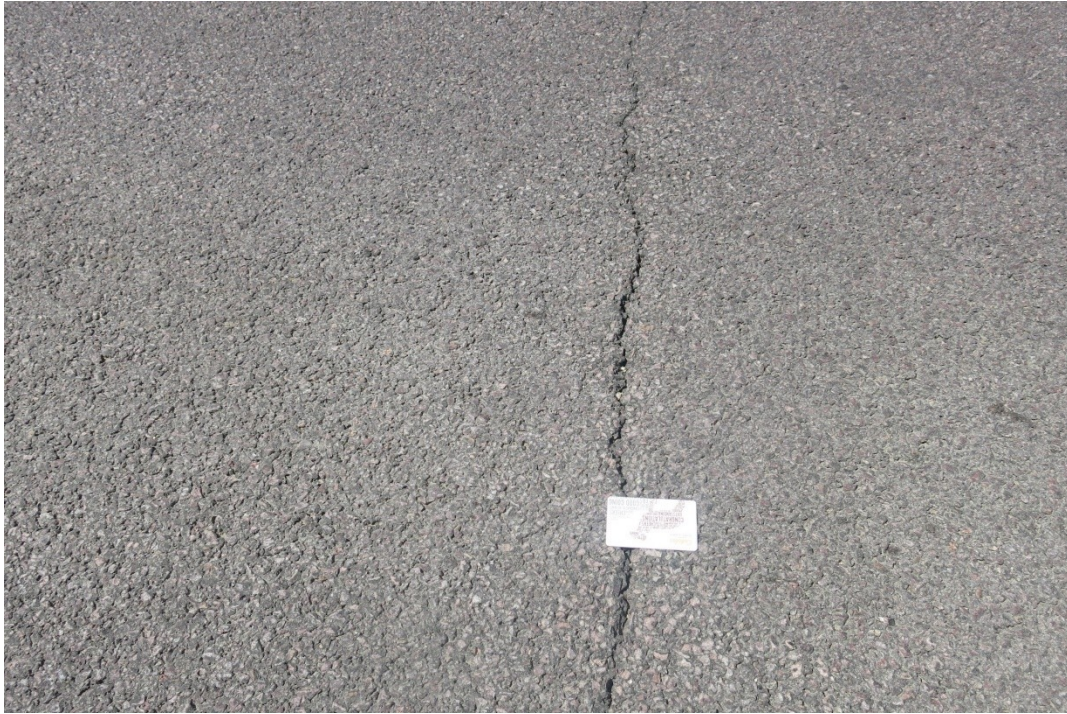
Figure 4.10 Transverse reflective cracking.

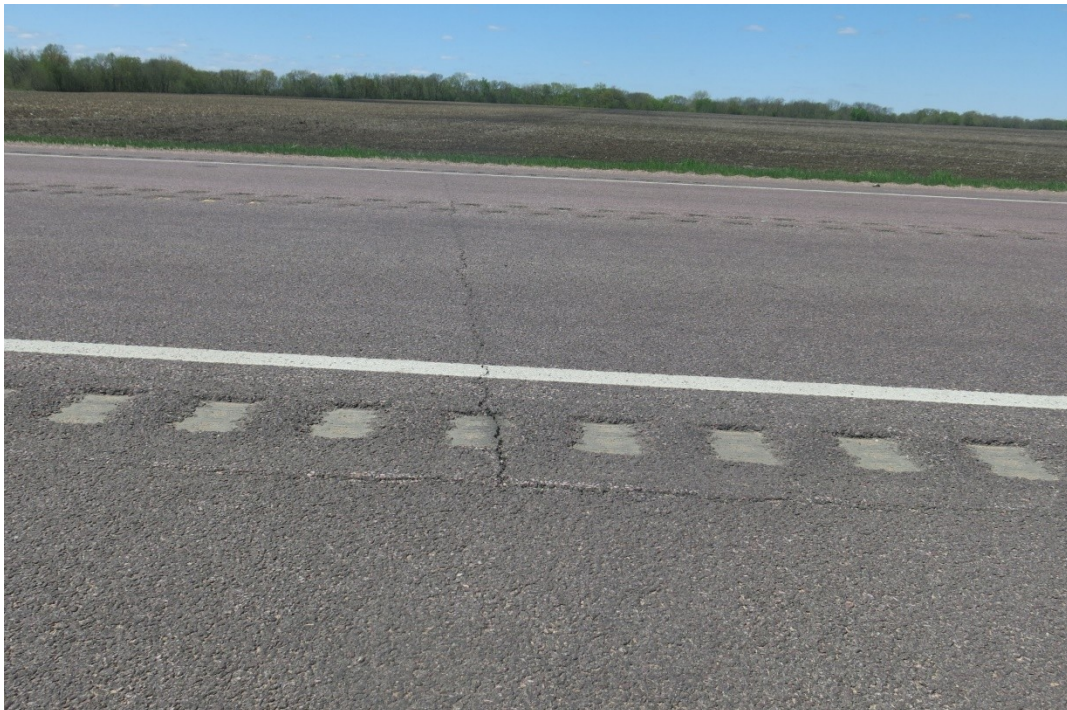
Figure 4.11 Longitudinal cracking along the original pavement edge.

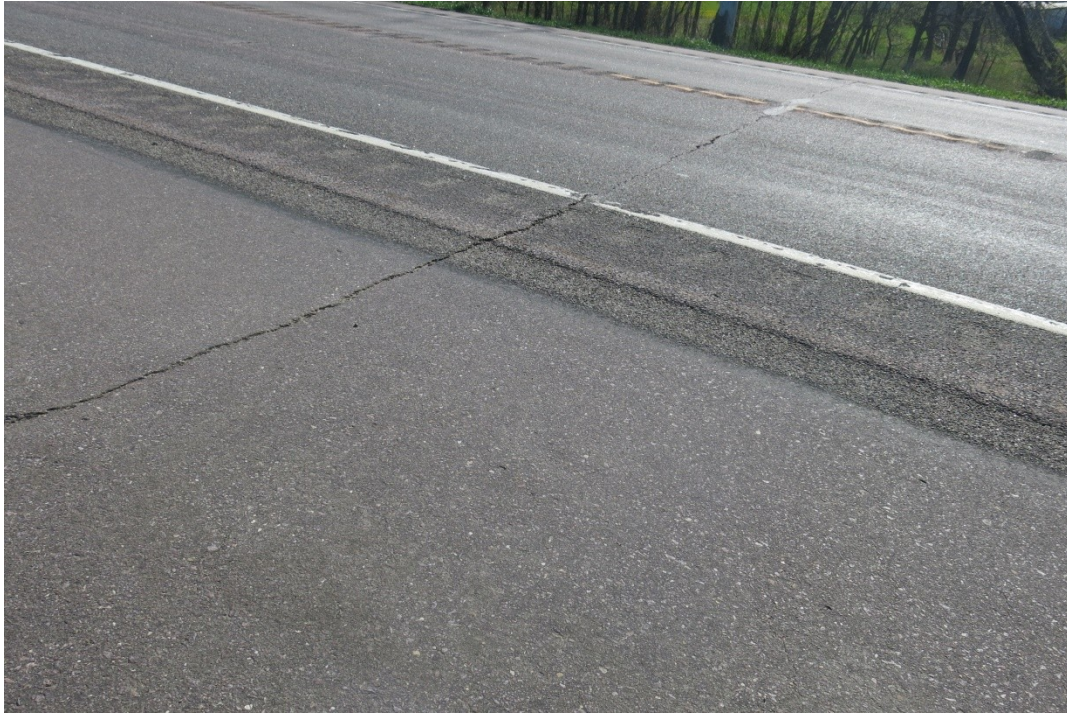
In this site, the observations are similar to the previous two sites, however, the cracking are in an advanced stage comparatively. The overlay is older than the previous two sites. Transverse reflecting cracks extend to the shoulder (Figure 4.13). The longitudinal cracking is prominent (Figure 4.14): the cracks are severe, and material loss is seen frequently (Figure 4.15). There are also a few sites that show advanced deterioration other than cracking (Figure 4.16). Crack sealing has been observed on this site (Figure 14.17)

Figure 4.13 Reflective transverse cracking.

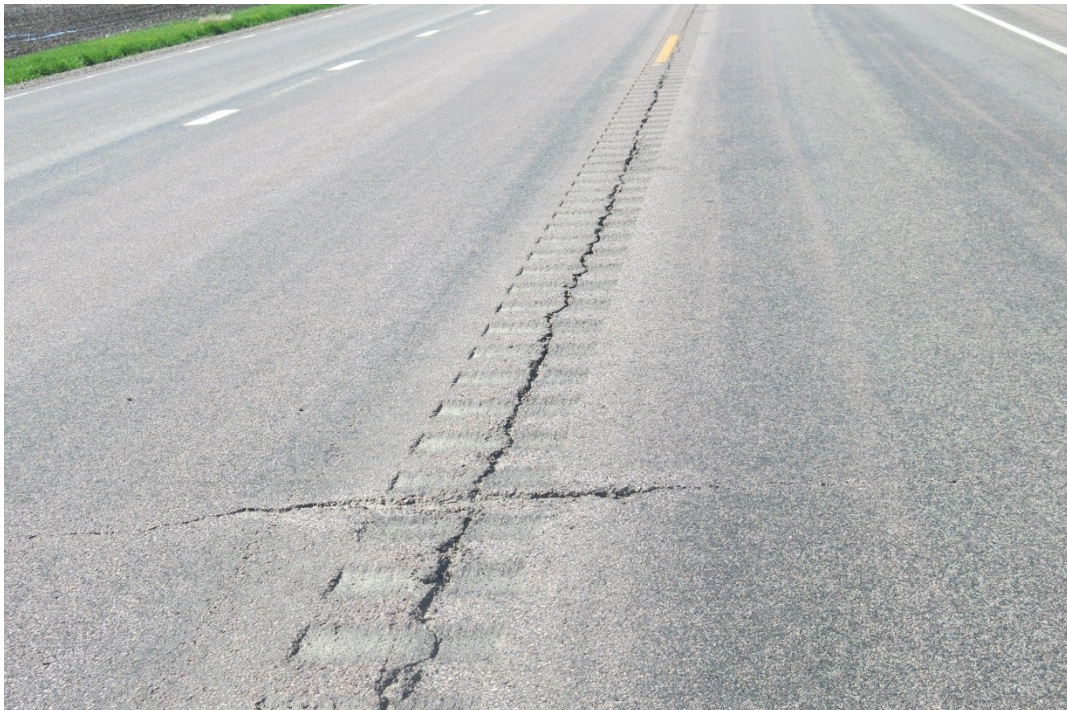
Figure 4.14 Longitudinal cracking on the centerline.

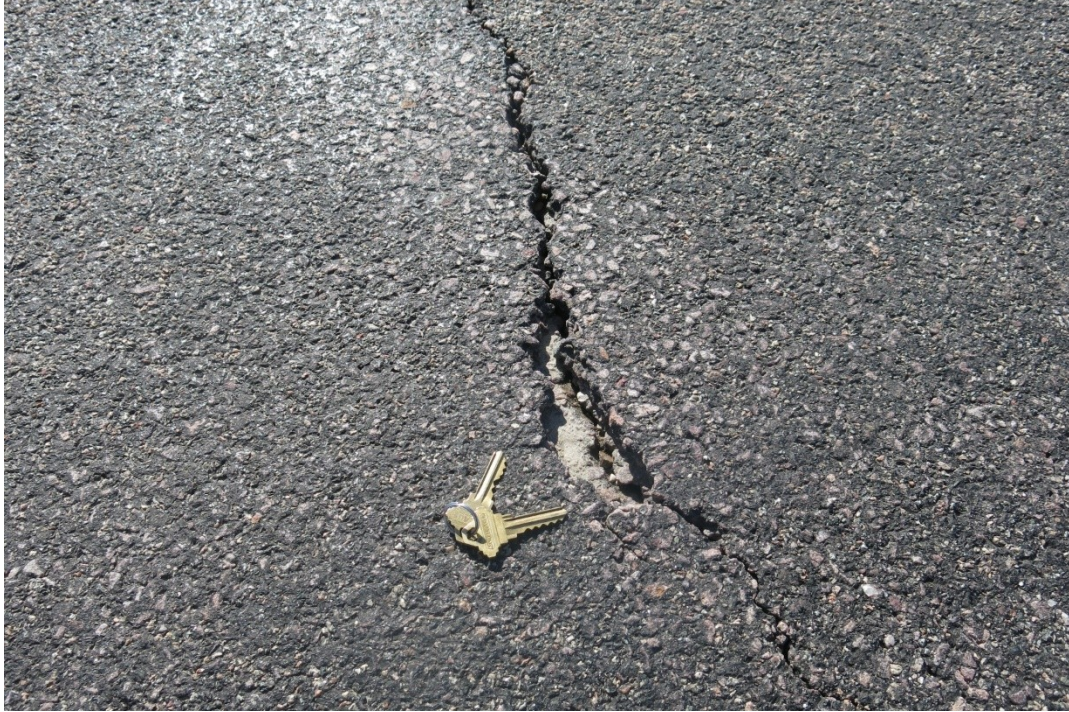
Figure 4.15 Material loss in cracks.

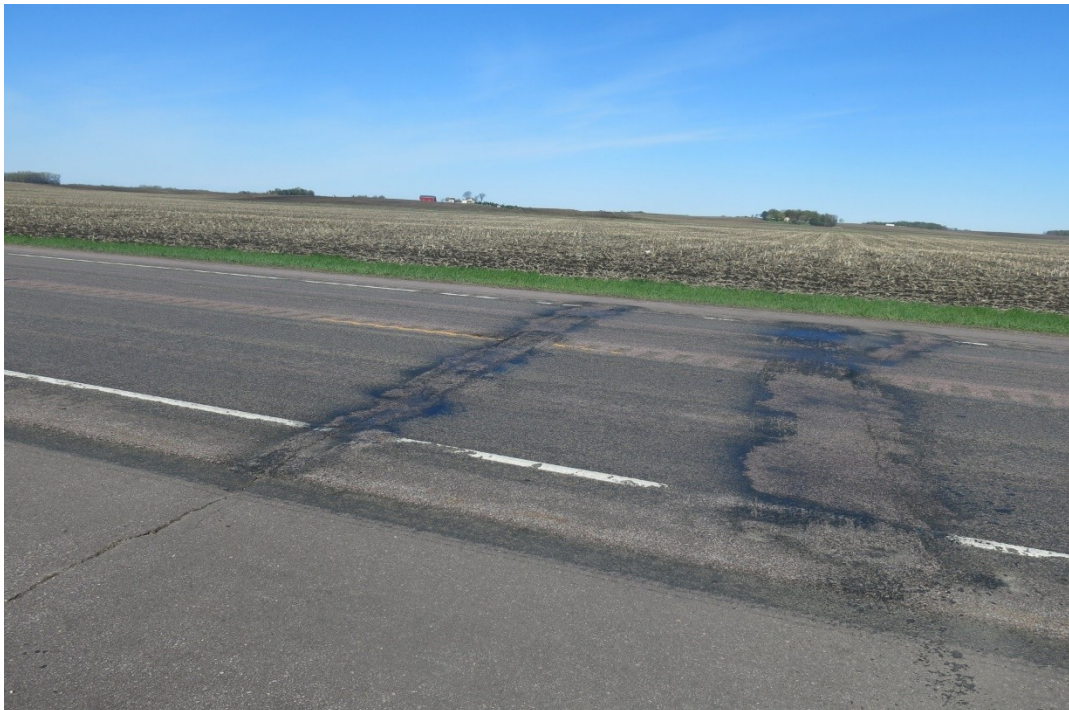
Figure 4.16 Deteriorated pavement surface.

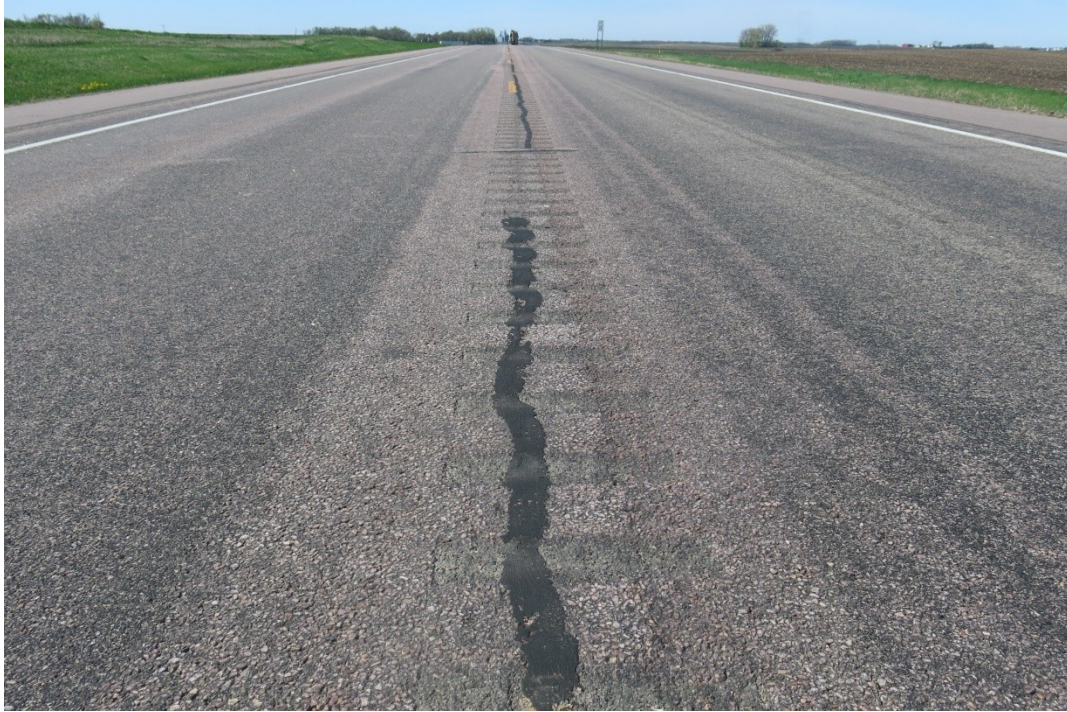
Figure 4.17 Sealed longitudinal cracks.

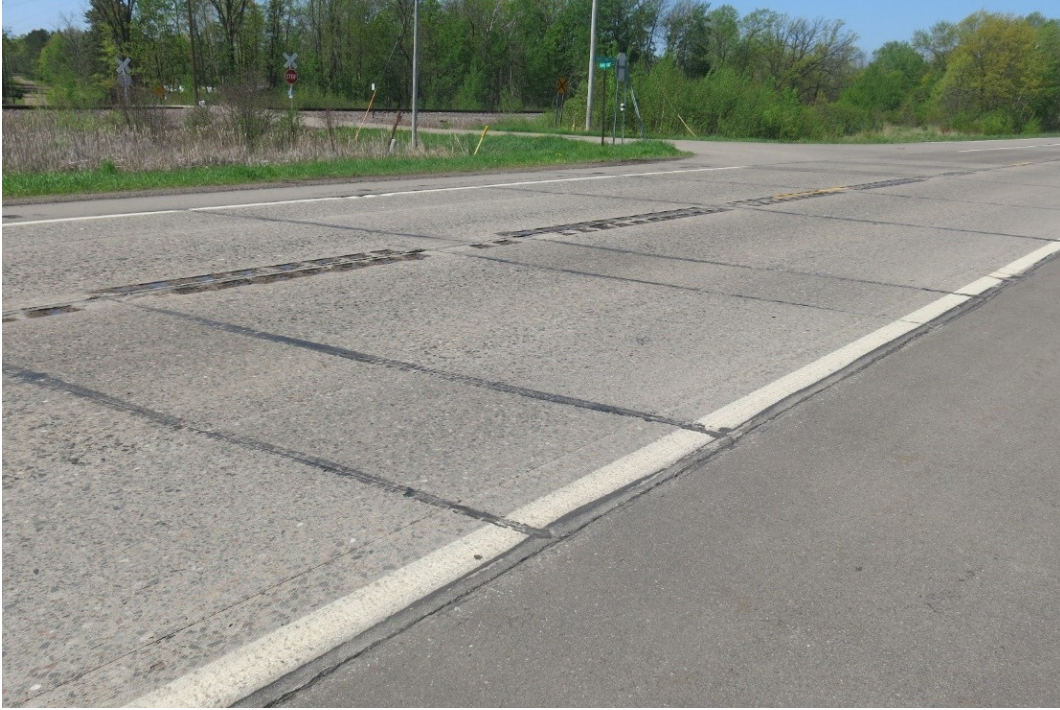
This project site covers approximately 9-mile stretch on MN 210 starting near Deerwood, MN and ending near Aitkin, MN as shown in Figure 4.18. In the Construction Project Log in MnDOT's Roadway Data the original 8-in concrete pavement was built in 1991. This site underwent partial- and full-depth repairs of transverse joints and slabs (Figure 4.19), with the work completed within the past two years. Diamond grinding was done (Figure 4.20) after the repair work, and the joints are sealed. Transverse tining on the original pavement surface can be observed at some locations (Figure 4.20). The site visit in this project was to evaluate the initial condition and monitor how the condition progresses over the years. Spalling and cracking were observed at transverse (Figure 4.21) and longitudinal joints (Figure 4.22), with severity levels ranging from low to high. Sporadic deterioration, potentially related to ASR cracking, was also observed (Figure 4.23).

Figure 4.19 Partial- and full-depth repair.

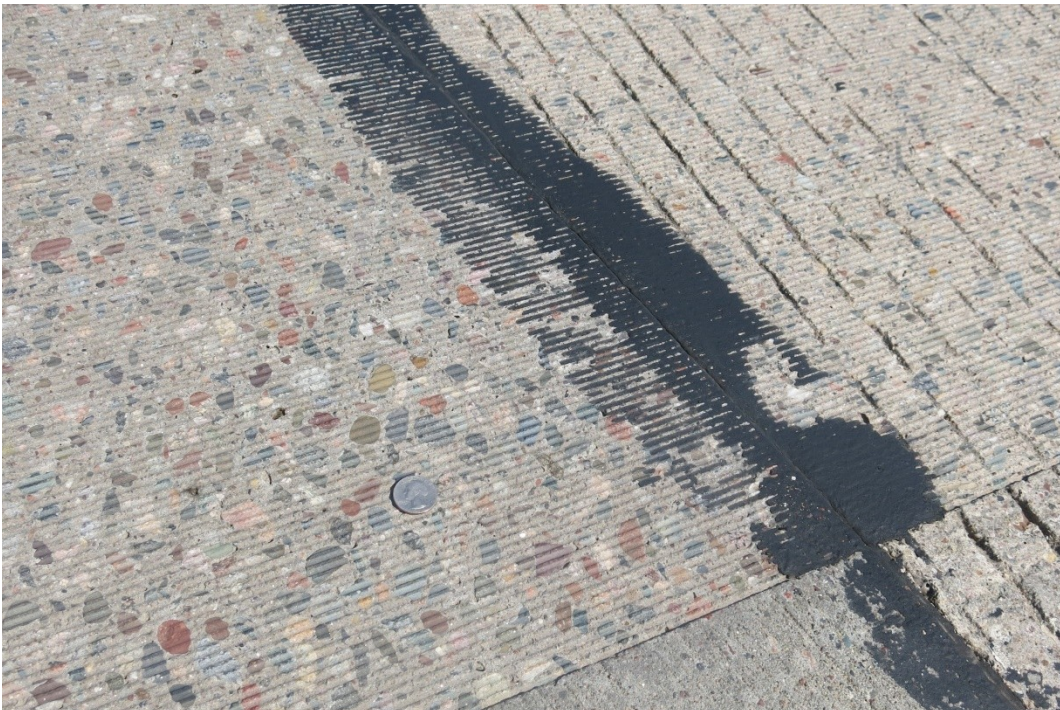
Figure 4.20 Diamond grinding.

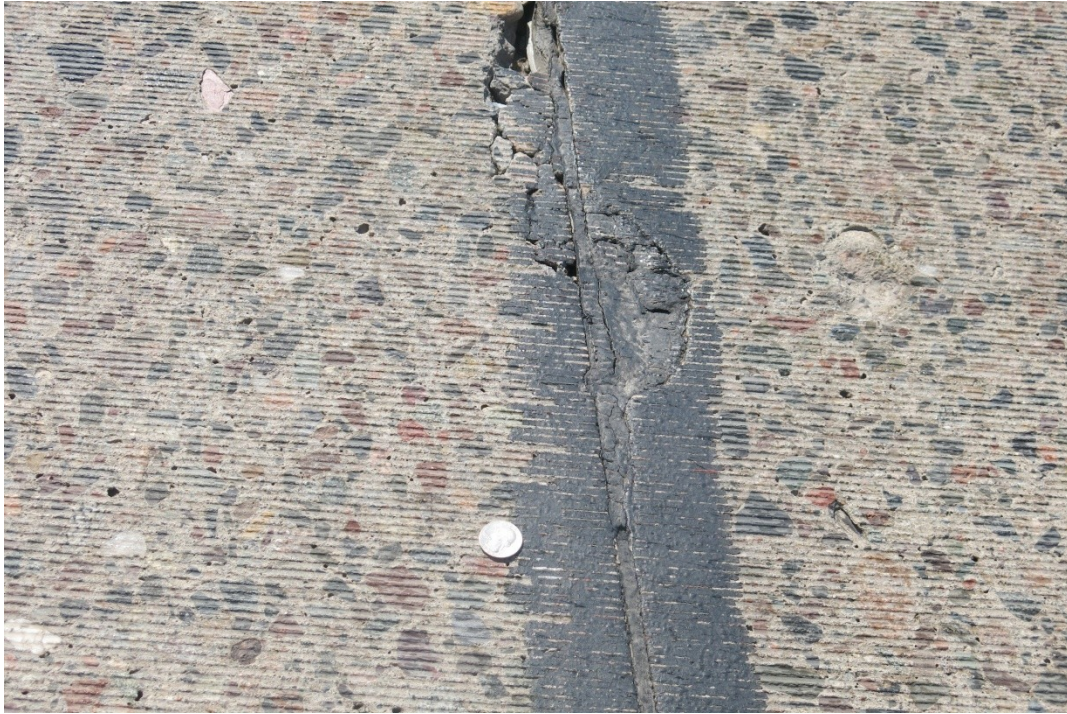
Figure 4.21 Spalling at transverse joint.

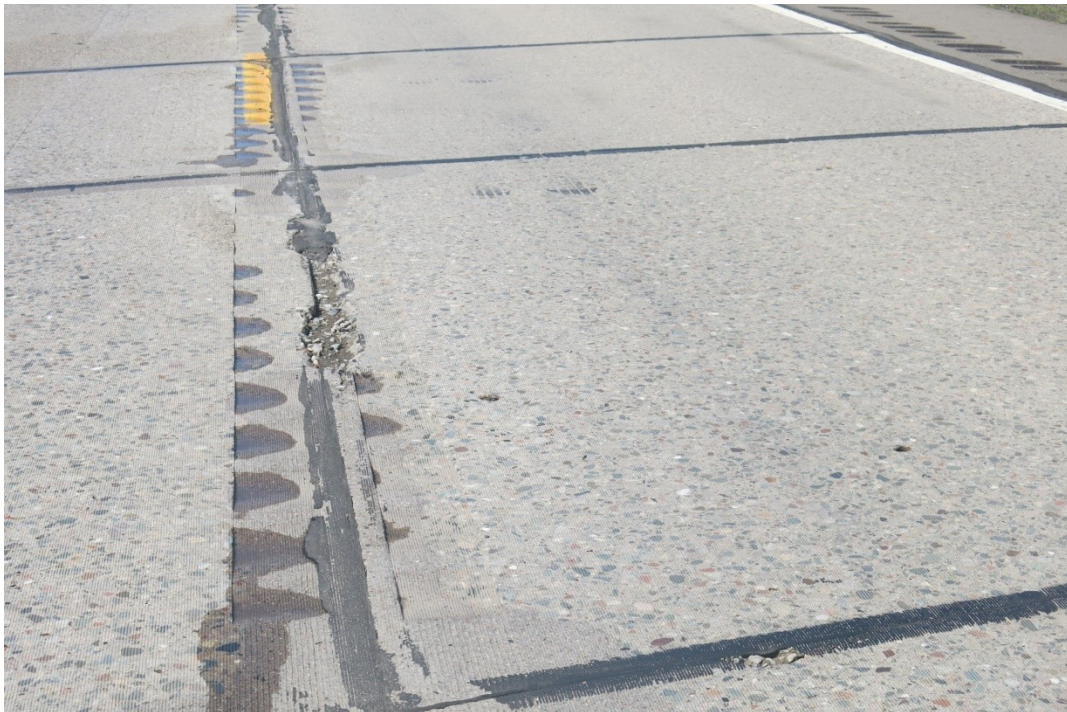
Figure 4.22 Spalling at longitudinal joint.

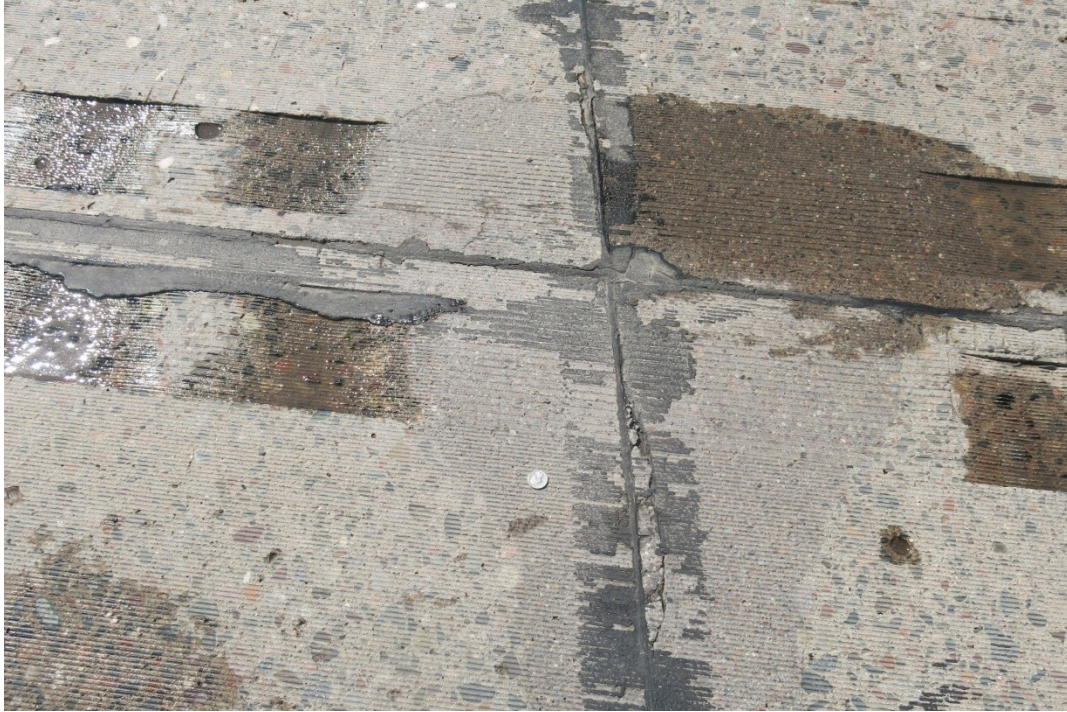
Figure 4.23 Cracking in the vicinity of joints.

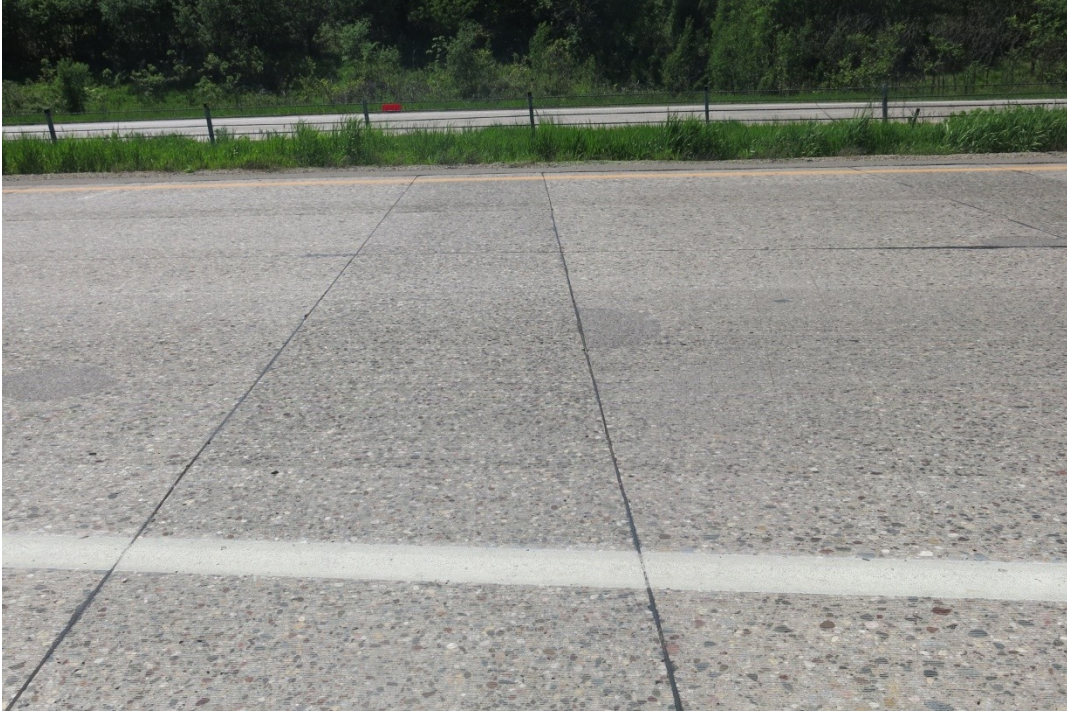
Figure 4.26 Diamond ground pavement surface.

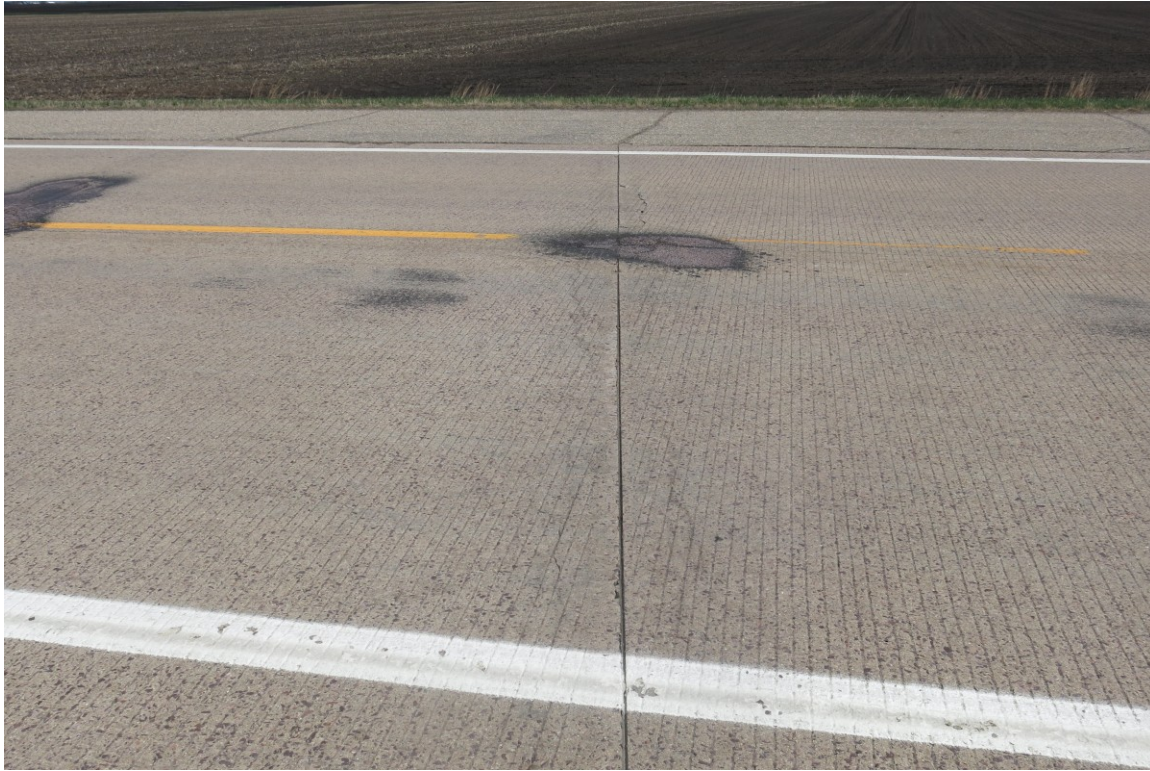
Figure 5.2 Surface distress (Site #1).

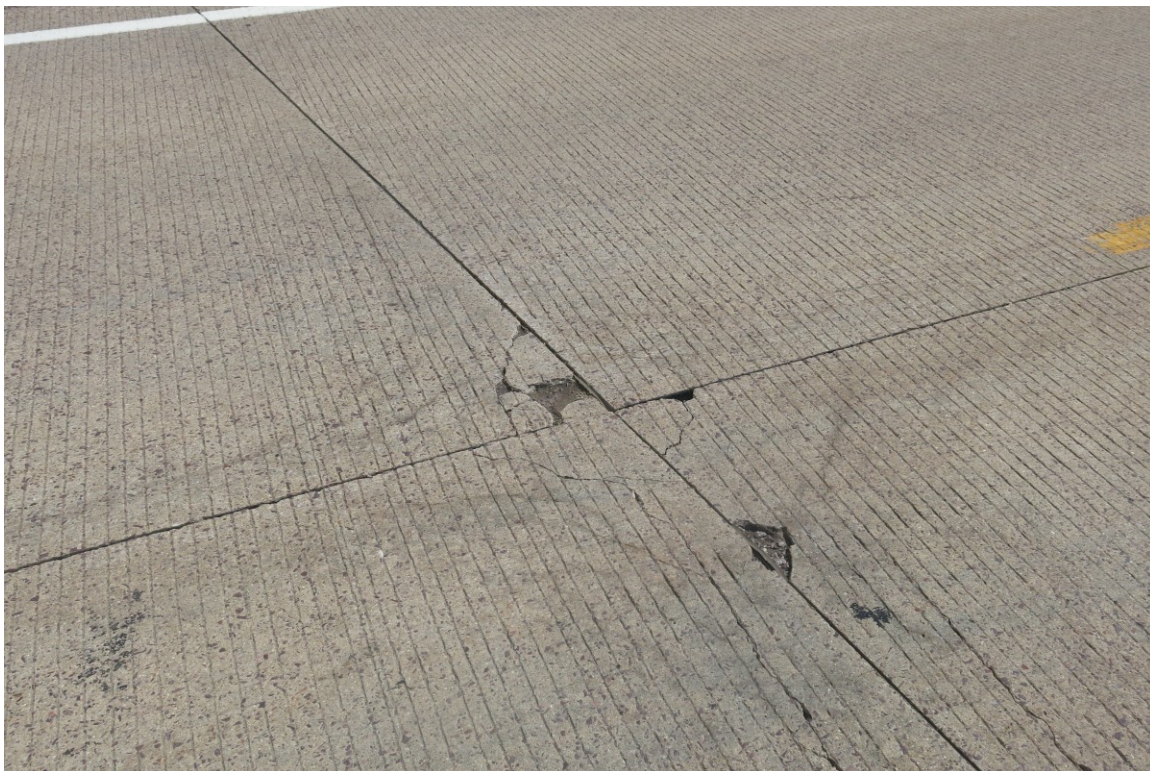
Figure 5.3 Surface distress (Site #2).

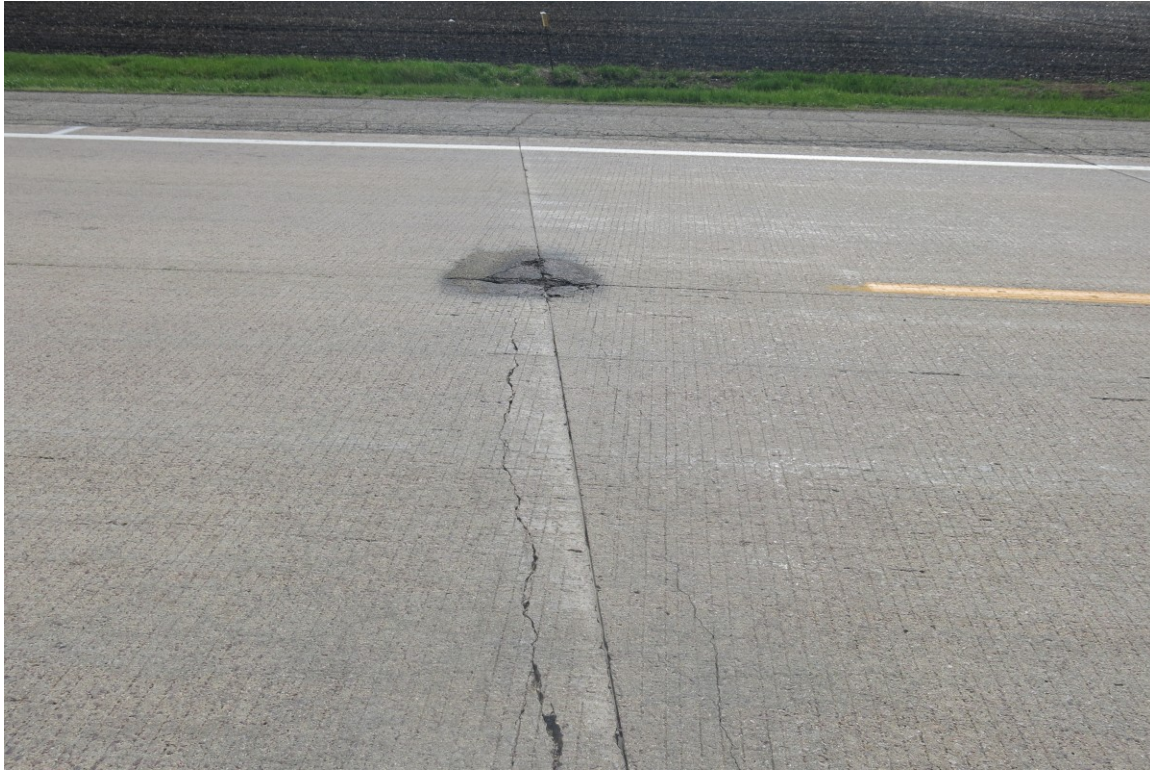
Figure 5.4 Surface distress (Site #2).

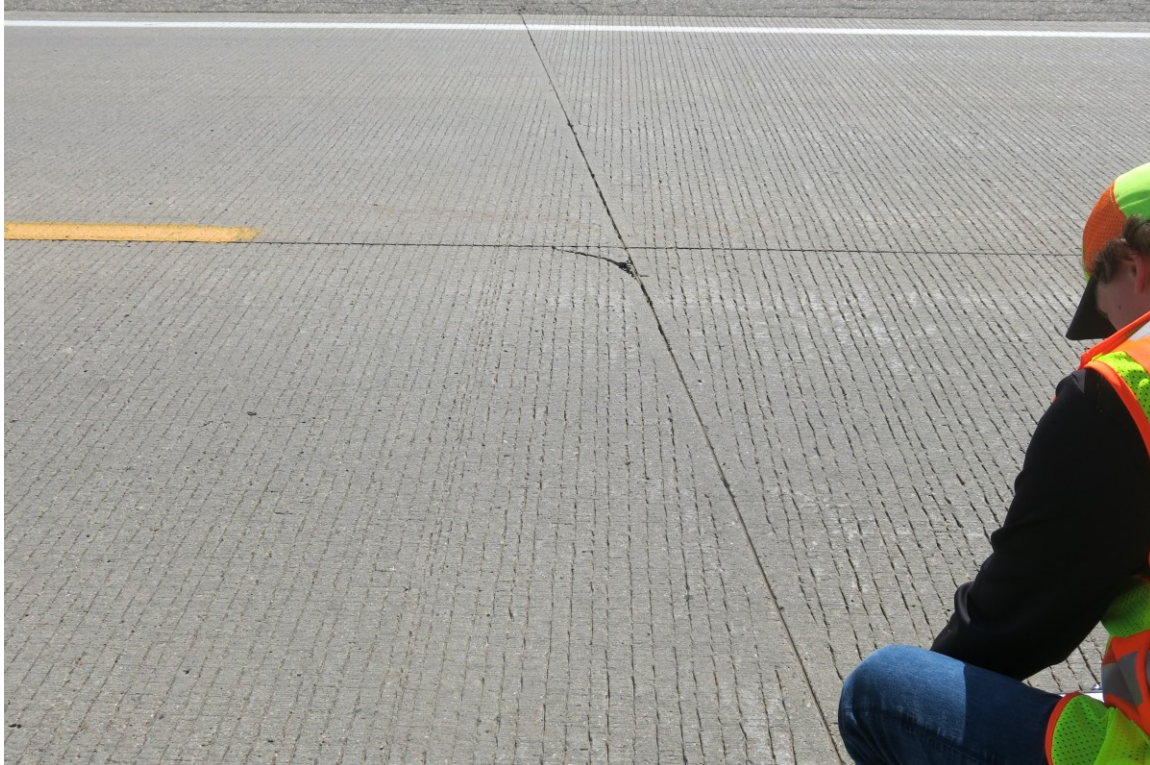
Figure 5.5 Surface distress (Site #3).

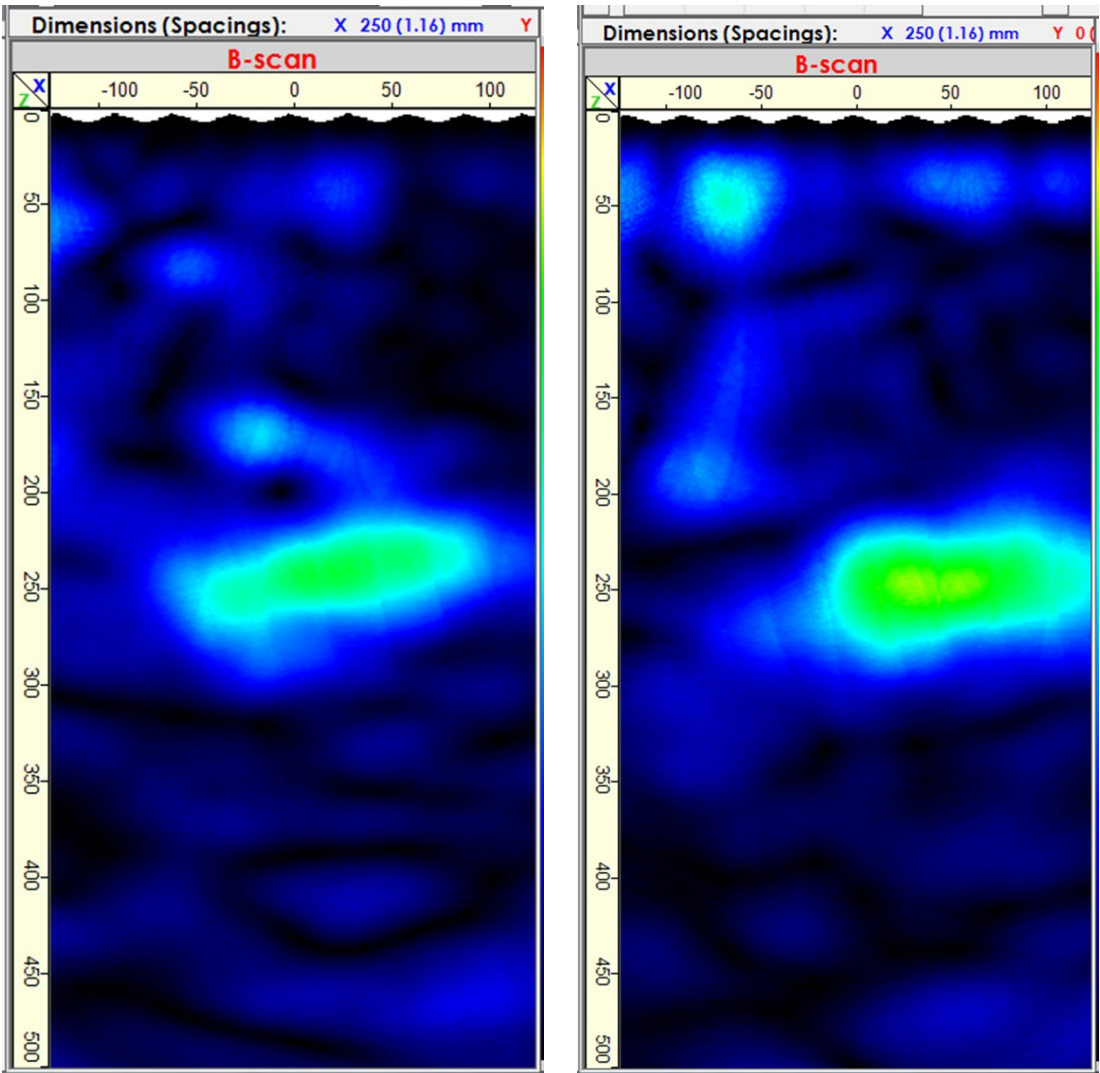
transition from the dense pavement medium. The lighter-colored regions between the surface and the base indicate areas where signals travel through a medium of different density, suggesting potential cracking. Some slabs, particularly from Site #2, produced these images with higher intensity (Figure 5.13). Nonetheless, it is difficult to draw a firm conclusion. Further evaluation, such as physical sampling of the pavement cross-section, is needed to verify the connection between ultrasonic tomography imaging and ASR-associated cracking. Notably, no discernible differences were observed between joint locations and mid-slab areas.

Figure 5.13 Site #2 images pointing to potential cracking.
