DOT HS 813 691

**Special Crash Investigations:
On-Site Ambulance Rollover
Crash Investigation;
Vehicle: 2019 Ford E350 Type III
Ambulance;
Location: North Carolina;
Date: January 2022**

Special Crash Investigations
On-Site Ambulance Rollover Crash Investigation
Case No.: CR22003
Vehicle: 2019 Ford E-350 Type III Ambulance
Location: North Carolina
Crash Date: January 2022

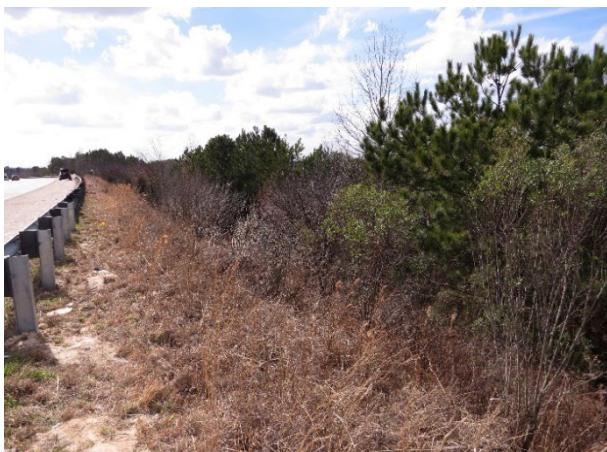
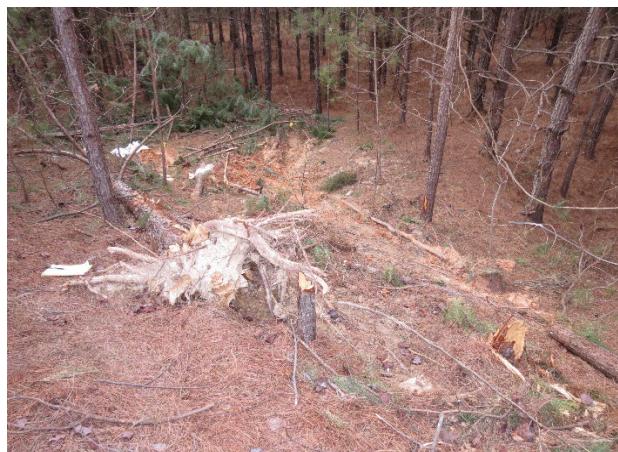
Figure 4. Facing southwest and viewing the shoulder/ embankment drop-off as seen from Event 2

Figure 5. Facing southwest and viewing the shoulder/ embankment drop-off as seen from Event 2

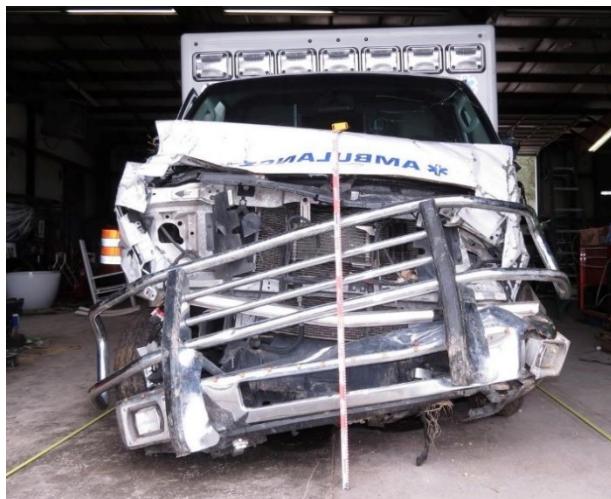
The ambulance sustained moderate damage to the front plane due to impact with the guardrail (Event 1, Figure 7). The direct damage measured 166 cm (65.4 in) and extended across the entire front bumper and the lower vertical support beams of the bull bar. During the roll sequence the right end of the bumper bar separated from the frame. The left side was still attached. To measure the crush profile, the bumper was repositioned to replicate its attachment. The residual crush profile was C1= 51 cm (20.1 in), C2= 37 cm (14.6 in), C3= 35 cm (13.8 in), C4= 34 cm (13.4 in), C5= 33 cm (13.0 in), C6= 38 cm (15.0 in). The maximum crush of 51 cm (20.1 in) was located on the left bumper corner. For comparative purposes, the severity of the impact was calculated by the barrier algorithm of the WinSMASH program. The total change in velocity (delta V) was 30 km/h (19 mph). The longitudinal and lateral components were -28 km/h (-18 mph) and -10 km/h (-6 mph). The calculated results fit the collision model and were considered high due to the aftermarket bull guard installed on the front end of the ambulance and overlapping damage from the non-horizontal forces associated with the rollover event. The truck deformation classification¹ (TDC) assigned to this damage pattern was 01FDEW2.

Figure 7. View of the front of the ambulance and damage from Event 1

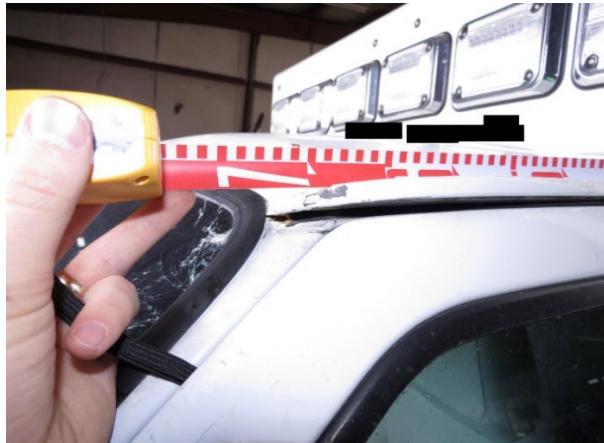
The ambulance sustained minor damage because of the rollover (Event 2). The roof rail welds along the driver and passenger sides were fractured on the cab (Figure 8 and 9). The ambulance landed on the left-roof-side-rail of the patient compartment during the rollover, but there was no corresponding structural damage. The right-rear-top corner of the patient compartment struck the ground during the rollover but there was no structural or crush damage. There were surface abrasions across the ambulance as it traveled through the brush growing along the embankment. The TDC assigned to this event is 33TPDO1.

Figure 8. Left side roof weld fracture

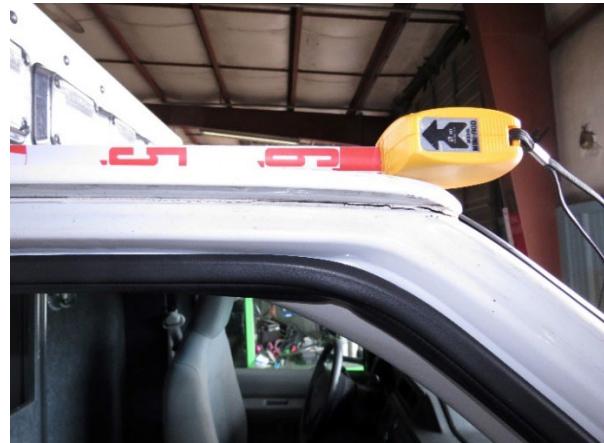
Figure 9. Right side roof weld fracture

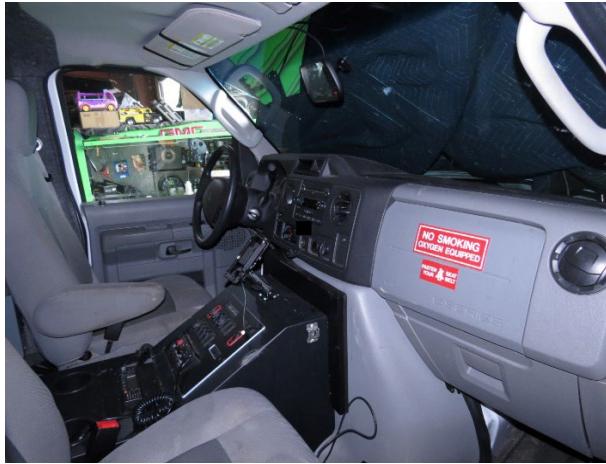
The interior damage to the ambulance cab was minimal (Figure 10). There were no measurable intrusions. The knee bolster panel was displaced from the driver's right knee contact during Event 2 (Figure 11). There was also a single crack in the windshield that occurred due to the external crash forces (non-occupant contact) of the rollover.

Figure 10. View of the interior of the cab

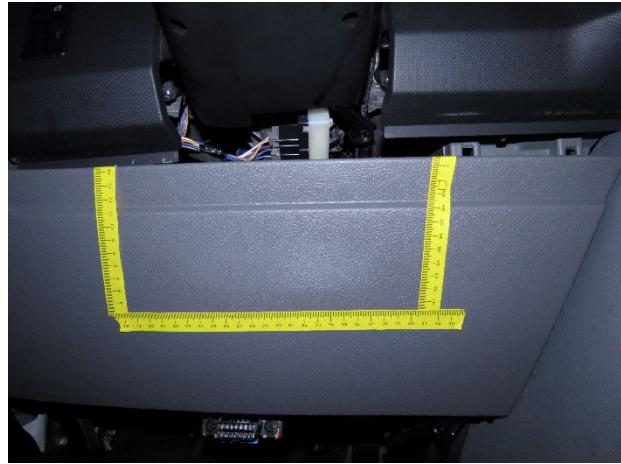
Figure 11. Driver's right knee contact to knee bolster

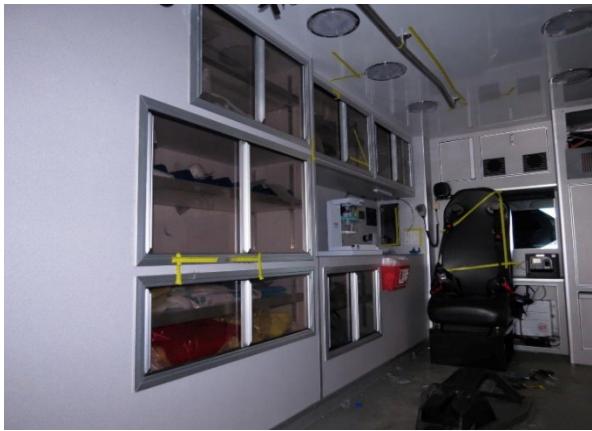
The patient compartment interior was intact with no structural damage despite the rollover event (Figure 12). There were many contact points from the EMT and patient. The EMT was unbelted and seated in the rear-facing captain's chair. There was a contact embedded into the seat back of the captain's chair from the EMT loading it during Event 3 (Figure 13). The counter on the left side of the patient compartment housed several medical devices. One of the devices, a suction container with an oxygen flow meter was broken off its fixture (Figure 14). The flow meter was missing, and the container was shattered. These components were broken due to equipment coming loose during the crash events and are not linked to occupant contacts. There was a 90 cm (35 in) long grab handle that ran along the roof of the compartment and hung down 3.5 cm (1.3 in). The forward section of the handle was bent upward 2 cm (0.8 in).

Figure 12. View of the left rear of the patient's compartment (tape at the left bottom indicated the soft tissue contacts to the aluminum trim)

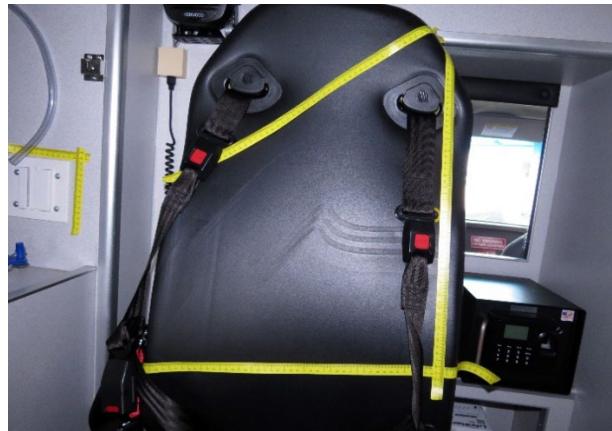
Figure 13. EMT contact to the captain's chair seatback

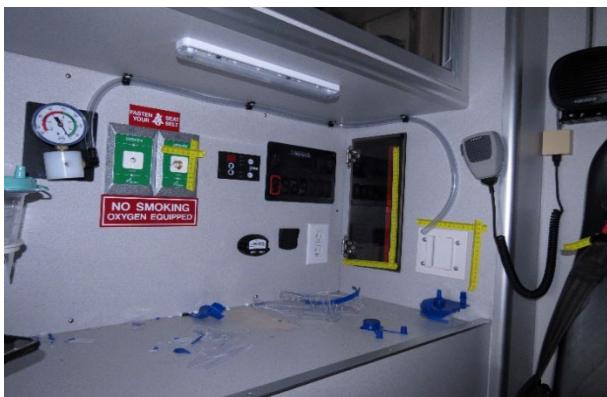
Figure 14. EMT contacts to the left side counter

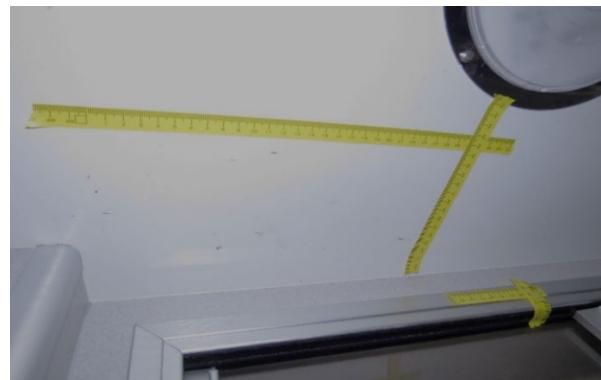
Figure 15. Blood spatters on the top left ceiling

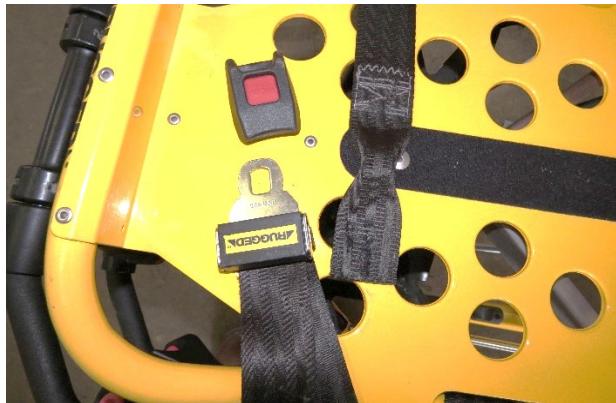
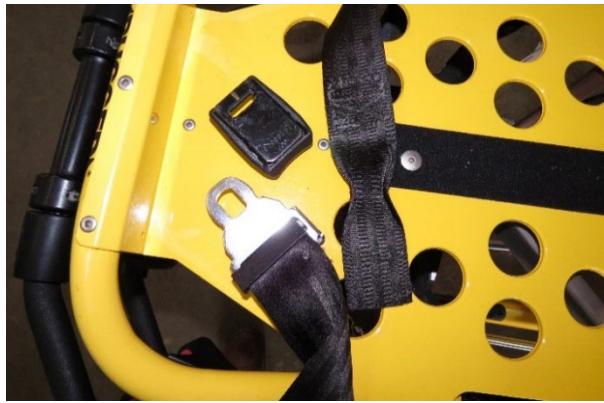
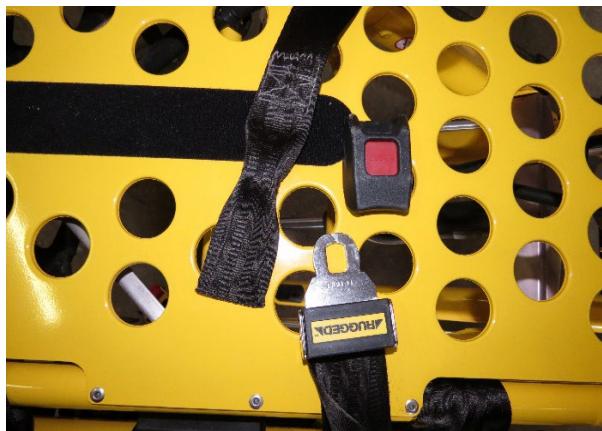
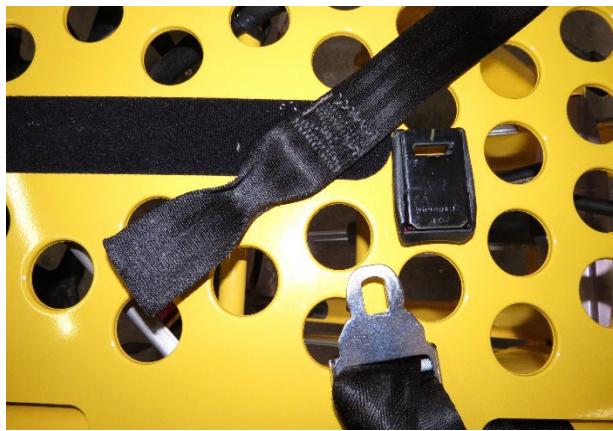
It was noted that the latch plates remained in the buckles of the foot and thigh straps. The hourglass-shaped stitching which should have secured the buckles to the fixed-length webbing had torn (Figures 21 to 24). Remains of the stitching were embedded in both sides of the webbing and did not show signs of being cut. The stitching failure was due to excessive loading from the patient's lower extremities during Events 2 and 3. There was no other damage to the cot or fastener systems.

Figure 21. View of the foot strap restraint face

Figure 22. View of the foot strap restraint back

Figure 23. View of the thigh strap restraint face

Figure 24. View of the thigh strap restraint back
