# **INVESTIGATION OF MAINTENANCE BASE REPAIRS OVER EXPANSIVE SOILS: YEAR 1 REPORT**

Report 0-4395-1

Research Project Title: Optimum Spot Base/Subgrade Repair Techniques for Moderate to High  
Traffic Highways over Highly Expansive Subgrade Soils

October 2002

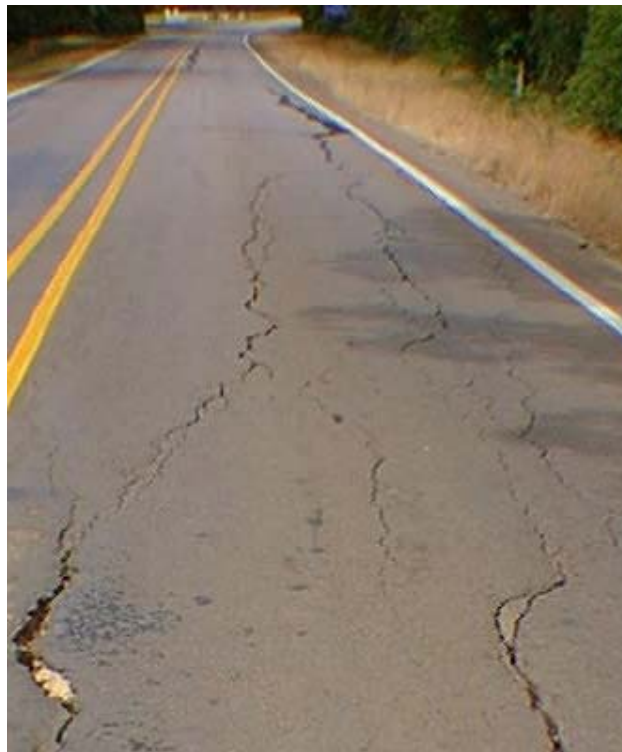
**Figure 1. Example of Longitudinal Cracking.**

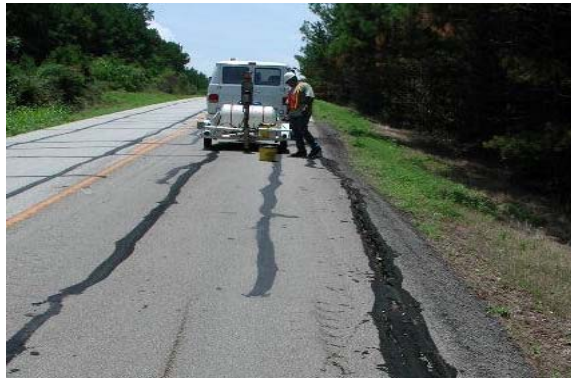
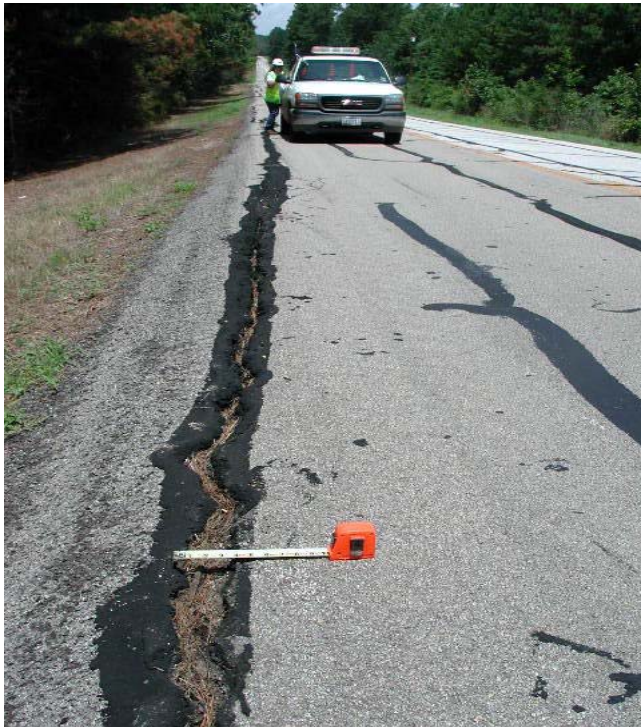
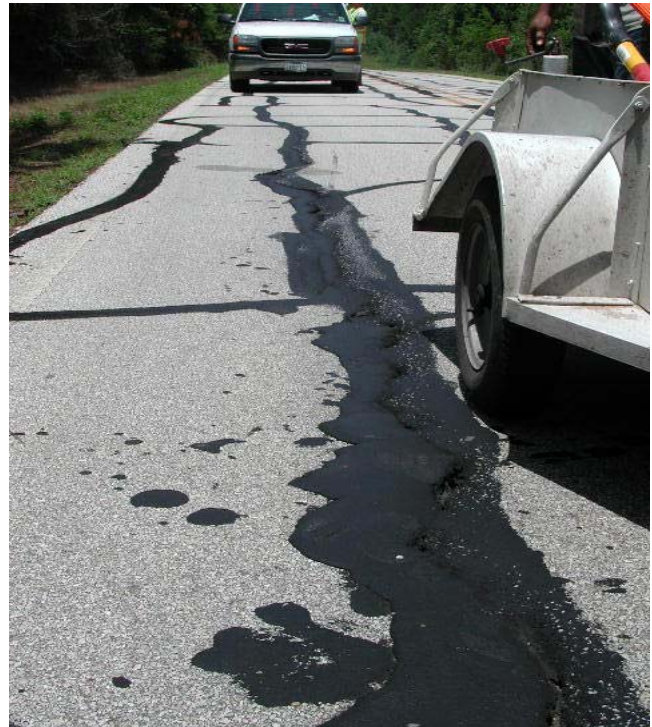
*Overall Road Summary:* The combination of stiff bases, steep side slopes, and highly plastic soils appears to have resulted in less than desirable performance from the rehabilitation. Extensive block cracking, longitudinal cracking, and substantial maintenance requirements on the section all seem to indicate a better repair process must exist.

**Figure 6. Views of FM 226 in July 2002.**

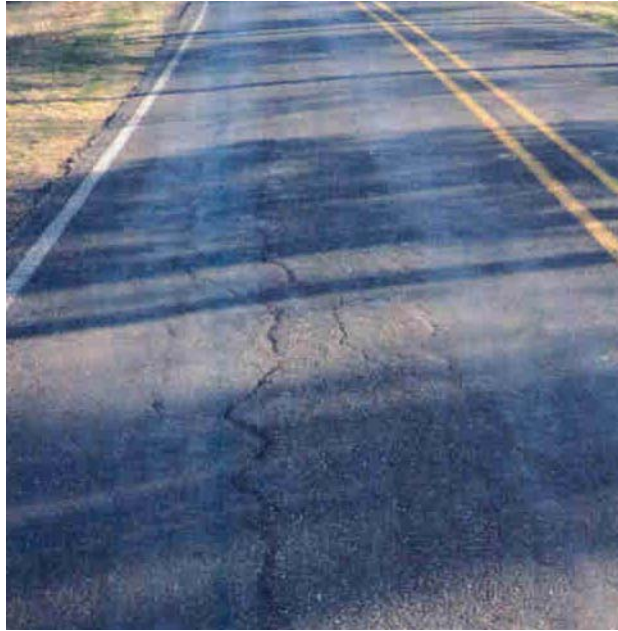
*Primary Distress(es) before Treatment:* Longitudinal cracking and faulting ([Figure 7](#)). Some localized base failures from logging traffic have also occurred.

**Figure 7. Cracking Distress on FM 1818.**

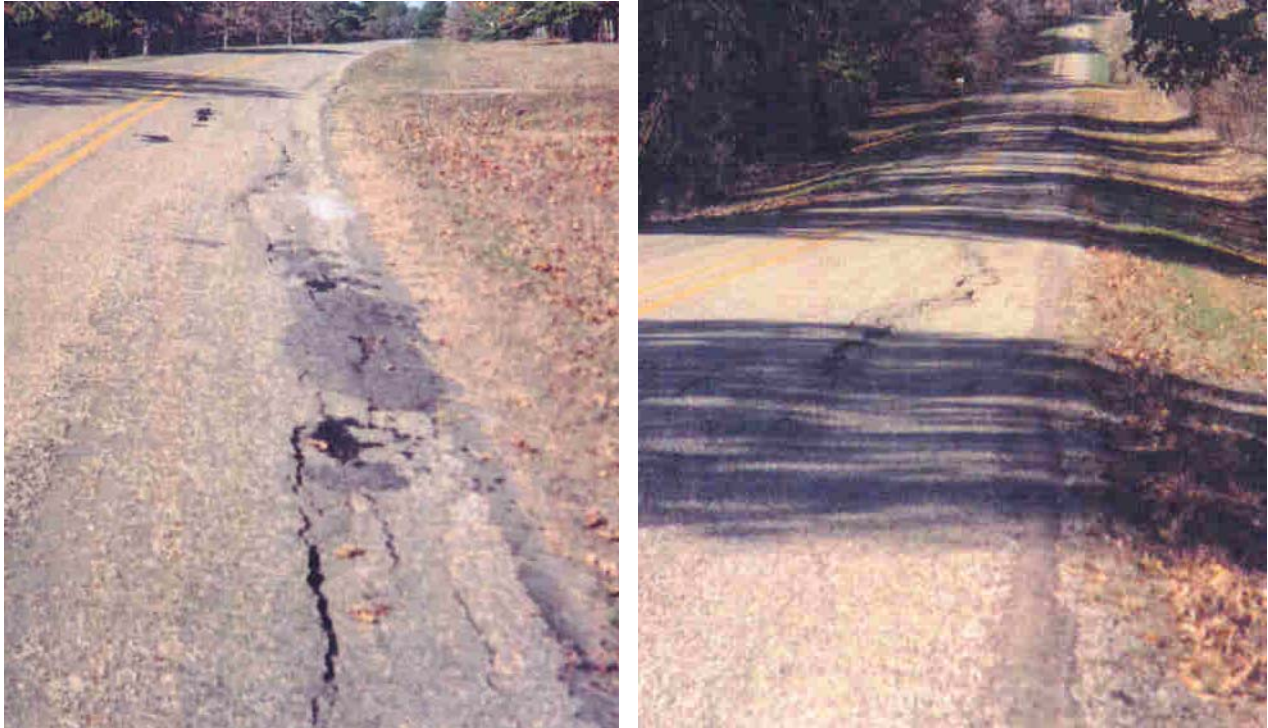
*Primary Distress(es) before Treatment:* Edge Cracking, faults, and rutting ([Figure 8](#)). According to Area Maintenance personnel, some of the longitudinal cracks were up to 2 inches wide before the rehab.

**Figure 8. Edge Cracking and Faulting Distresses on FM 2076 before Treatment.**

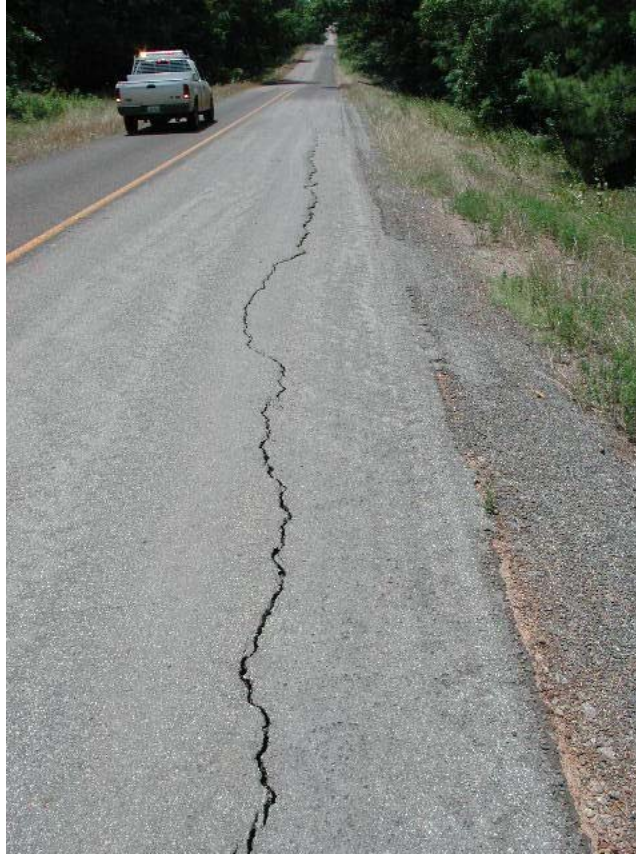
Three severe longitudinal cracks exist in the rehabilitated section under examination. [Figure 9](#) shows a wide, faulted crack in the westbound direction in June 2002. Area Maintenance personnel indicate cracking reoccurred shortly after completion of the rehabilitation. Although the road does not yet exhibit the breakup shown in [Figure 8](#), the wide cracking that exists will certainly allow water into the pavement and result in accelerated pavement deterioration.

**Figure 9. Severe Longitudinal Crack in FM 2076 WB Rehab Section.**

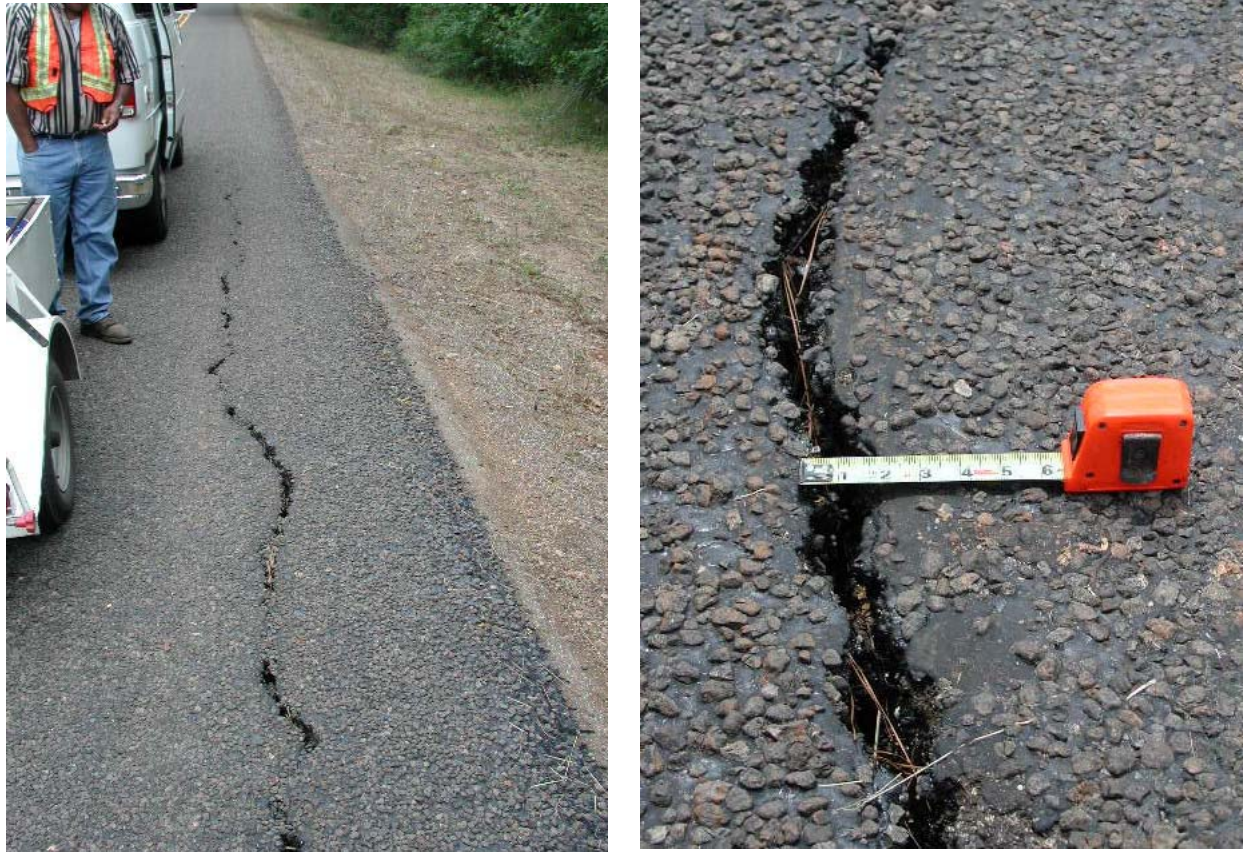
FWD data collected on FM 2076 reveal very stiff base layers exist both in the rehab section investigated, and in the existing section. This is consistent with the cores, which revealed a cement-treated base layer existed even several hundred feet outside the limits of the maintenance rehabilitation. Base moduli ranged from 828 to 1175 ksi.

**Figure 10. Core Location by Severe Crack on FM 2076 EB in Rehab Section.**

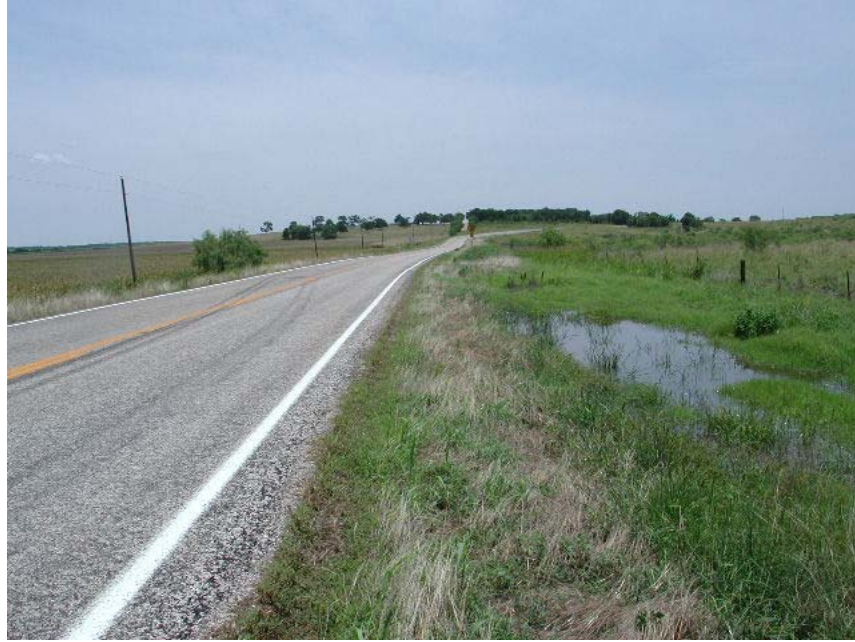
*Field Observations:* A control section exists between two sections utilizing the geogrid reinforcement on FM 1915. The first geogrid section, shown in Figure 11, starts at the Little River relief bridge and is 0.8 miles long. The section had one blade-on patch, a longitudinal crack approximately 4 feet long, and a short section with severe rutting (Figures 12 and 13). Numerous longitudinal cracks exist in the control section, which is also 0.8 miles long. Figure 14 shows these distresses. The second section with the grid reinforcement, which is 0.6 miles long, had no visible defects. Figure 15 shows this geogrid section on FM 1915.

**Figure 11. First Geogrid Section on FM 1915.**

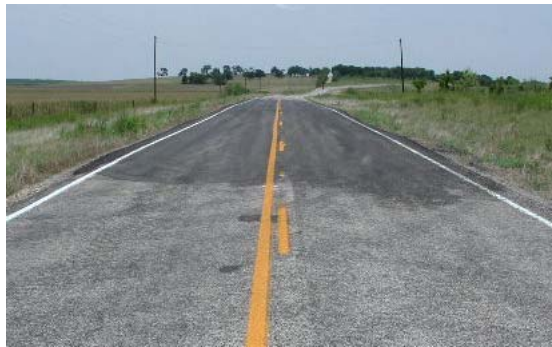
**Figure 12. Blade-on Patch on First Geogrid Section on FM 1915.**

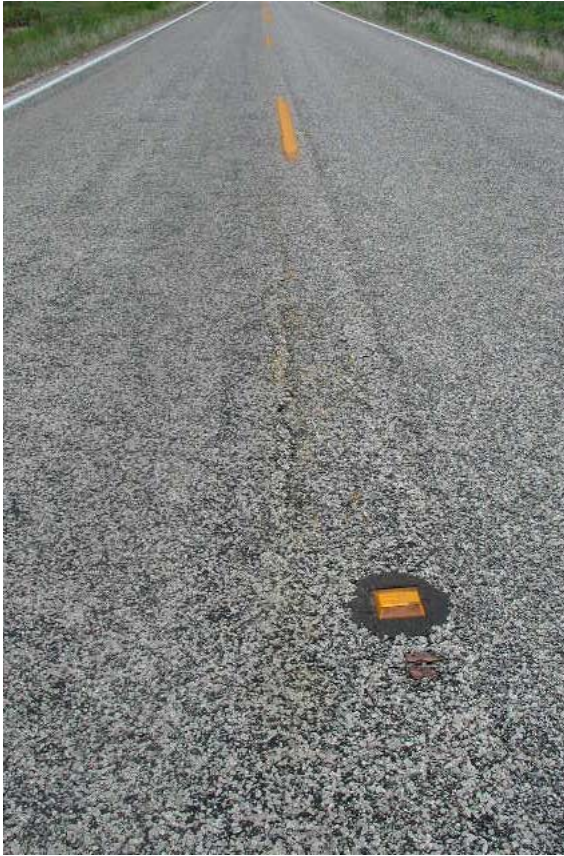
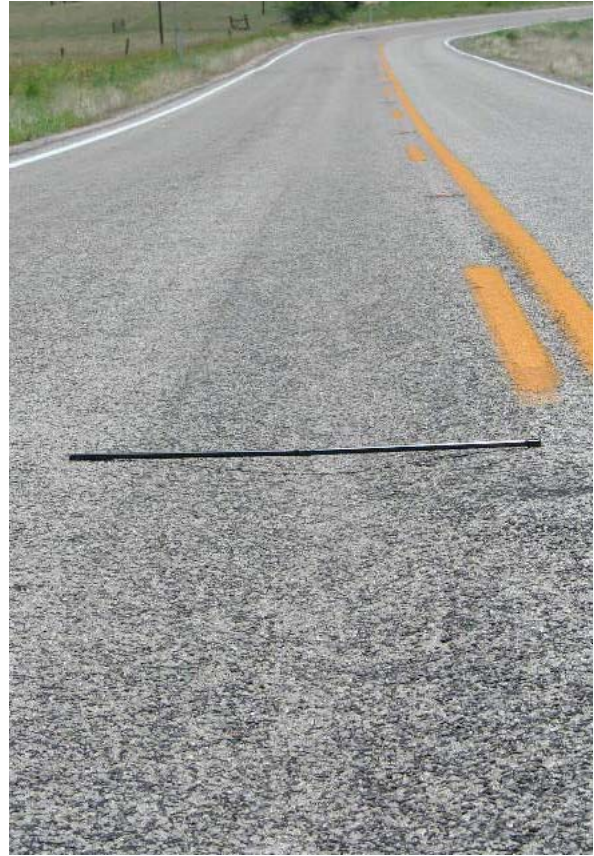
**Figure 13. Longitudinal Crack and Rutting on First Geogrid Section on FM 1915.**

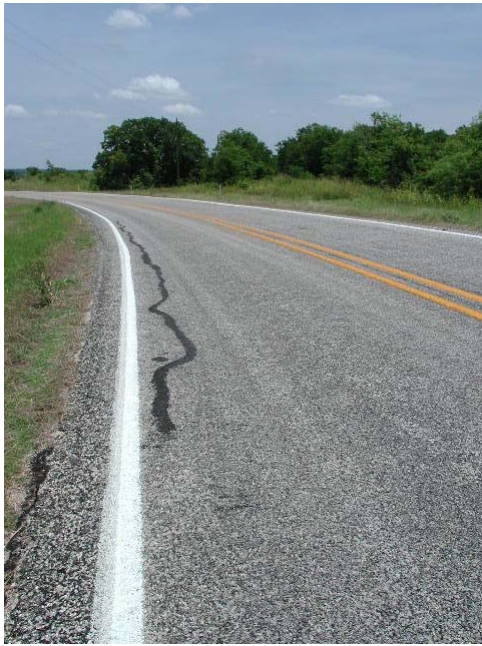
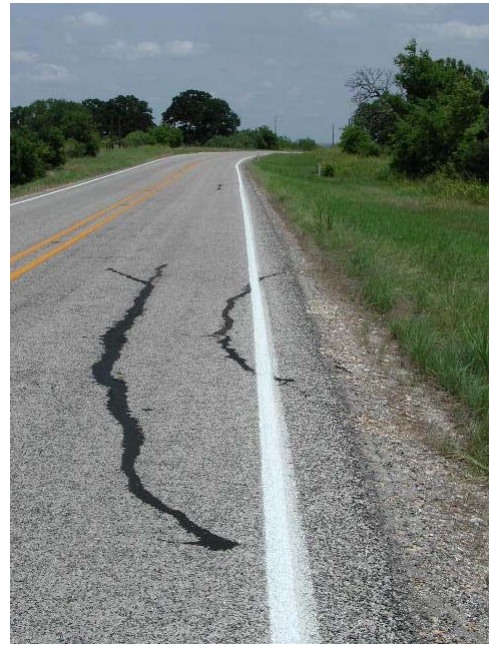
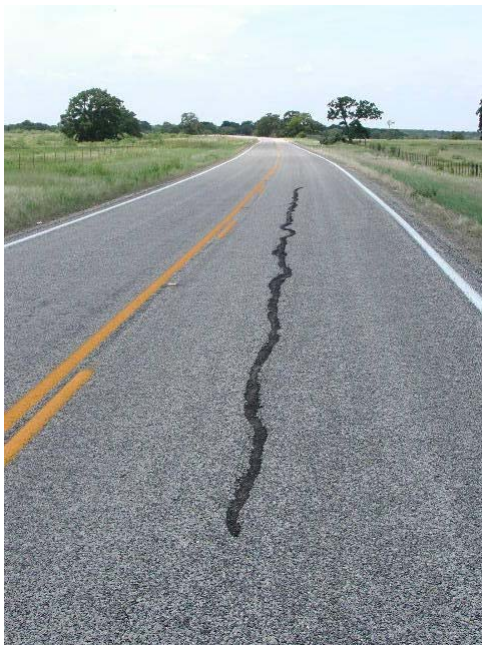
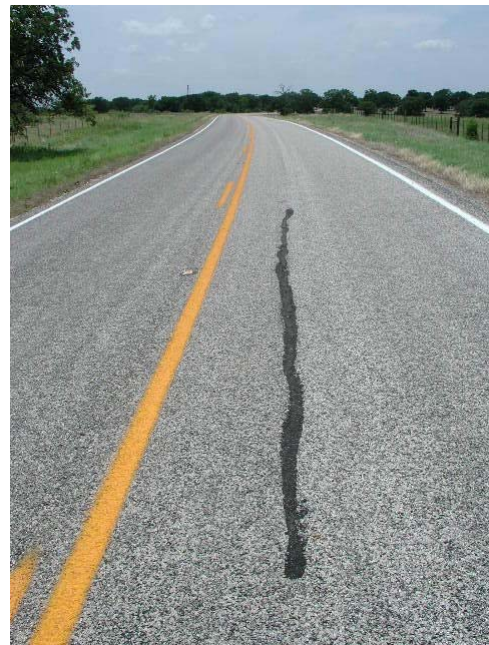
**Figure 14. Longitudinal Cracking on Control Section on FM 1915.**

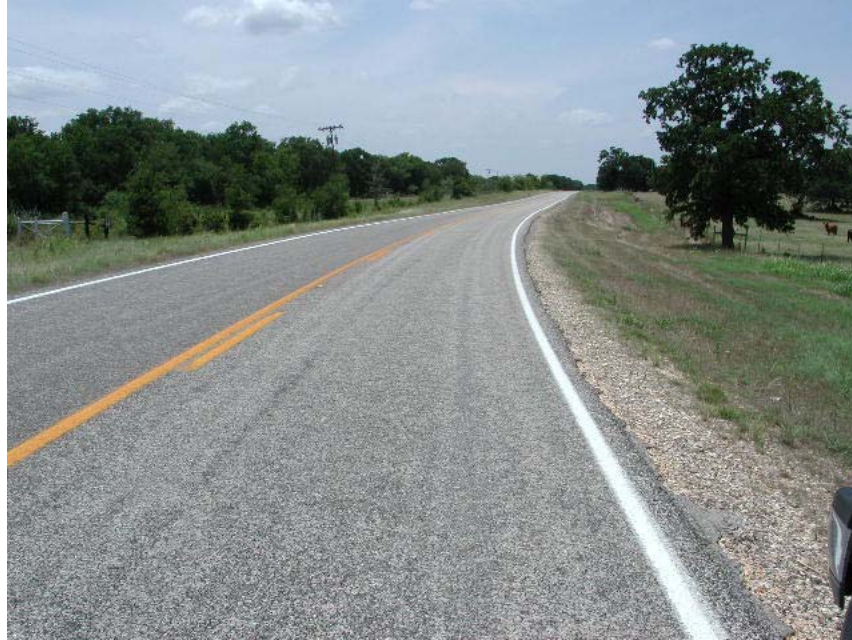
**Figure 15. Second Geogrid Section on FM 1915.**

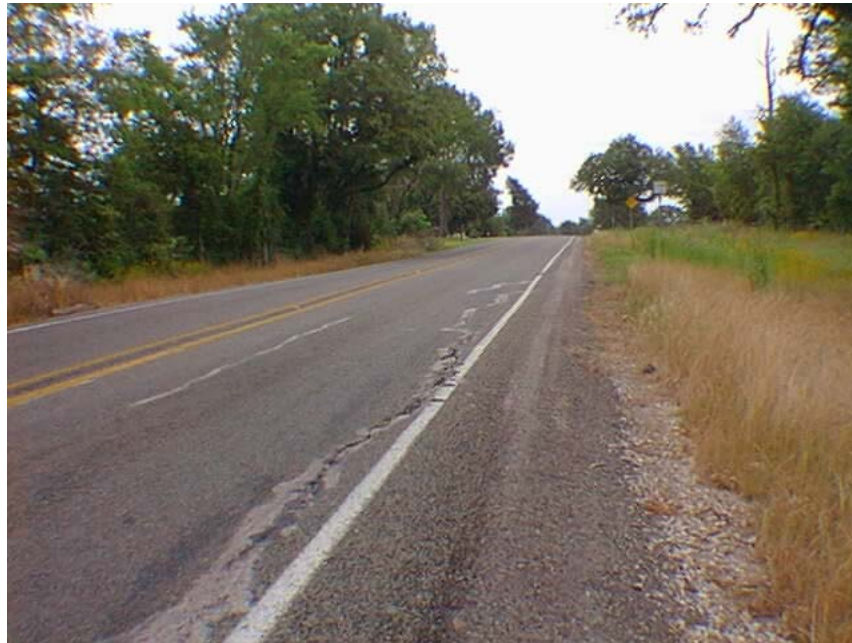
*Primary Distress(es) before Treatment:* Longitudinal cracking ([Figure 16](#)).

**Figure 16. Representative Distresses on OSR.**

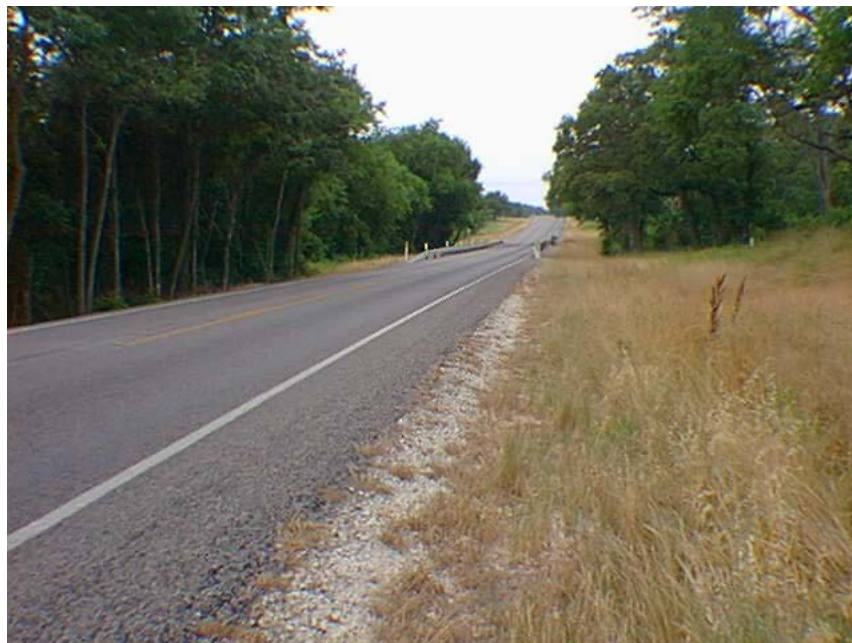
*Field Observations:* The section shows no signs of distress in the sections with geogrid reinforcement. [Figure 17](#) shows a representative section.

**Figure 17. Representative Section of OSR with Geogrid Reinforcement.**

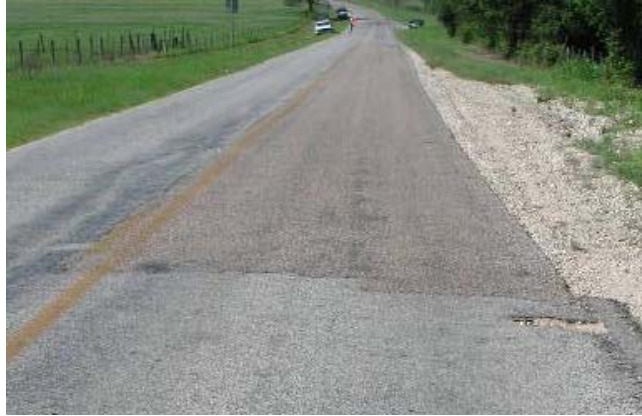
*Treatment(s) Applied:* FM 20 was rehabilitated in 1999, and maintenance personnel reported some base failures occurred shortly after the rehab. Maintenance forces removed 8 to 10 inches of base and placed new base treated with cement in January 2001. Maintenance forces report that approximately 3 percent cement was added to the new base. [Figure 20](#) shows the site.

**Figure 20. Base Repair Site on FM 20.**

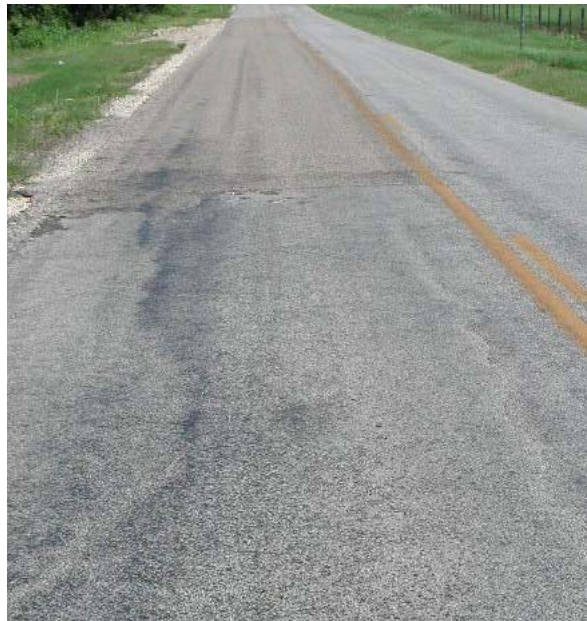
*Field Observations:* There is some dry-land cracking evident both on the existing structure and in the patch area. In the existing structure some of the cracks are slightly faulted, as shown in [Figure 21](#). In general, the cracks in the patch are minor longitudinal cracks. The location of the patch is near the interface of Crockett fine sandy loam and Houston black clay soils. The main limitation of both these soils for roadways is their low strength and shrink-swell ([44](#)). There are no signs of load-induced distress in the patched section.

**Figure 21. Cracking on FM 20 Section.**

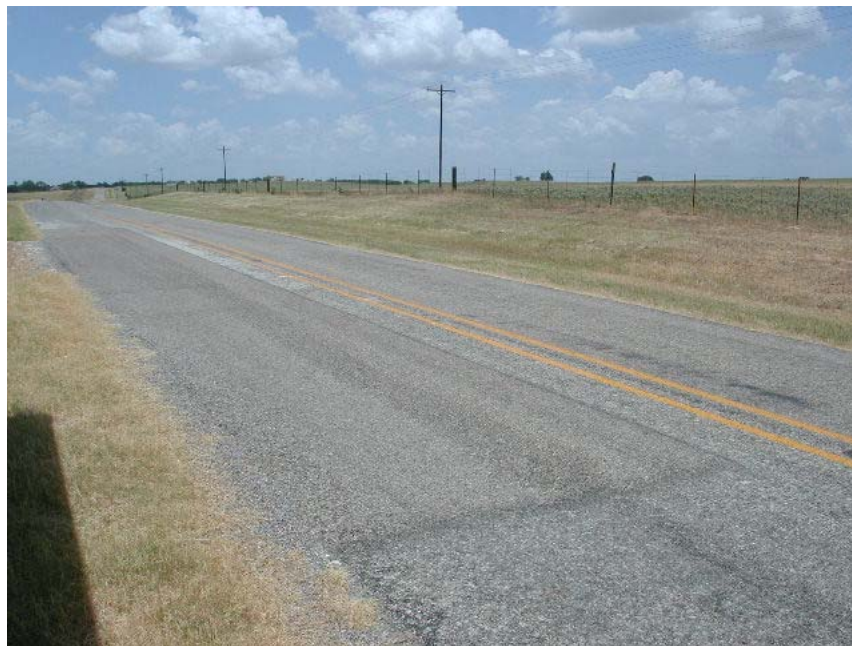
*Field Observations:* No distresses evident. [Figure 22](#) shows the repaired section.

**Figure 22. Patch on FM 2505.**
