BRIDGE STEEL COATINGS TOLERANT OF MINIMAL SURFACE PREPARATION

**Construction Report
June 1996**

**Kimberly L. Gordon
Research Project Manager**

Construction Report

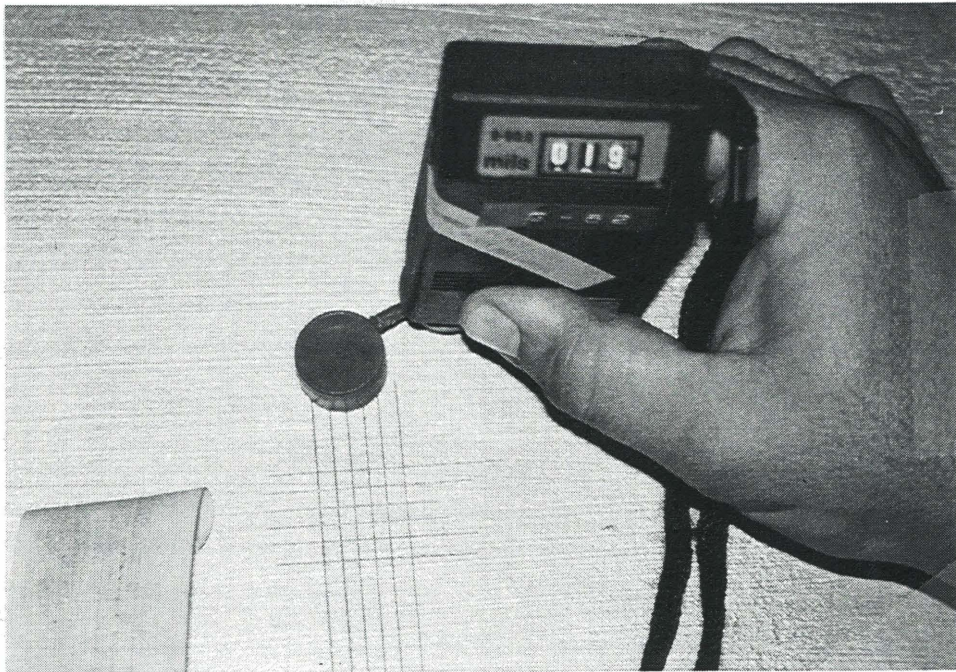
Figure 2. Compatibility Test

Compatibility tests results are rated from 0 to 5. A rating of 5 indicates no peeling or removal between the new and old coatings. A rating of 4 indicates trace peeling or removal along the incisions or at their intersections between the new and old coating. The ratings continue to decrease as the amount of paint that is removed or peels away increases. A rating of zero indicates that more than sixty-five percent of the new paint has peeled away from the old paint. Table 3 lists the average test results for each bridge.

Bridge	Test Results on Exterior Beam
Bridge 1(A)	~ 5B
Bridge 1(B)	4B
Bridge 34(C)	5B
*Bridge 2	5B
Bridge 3	5B
Bridge 4	5B
Bridge 5	5B
Bridge 7	5B

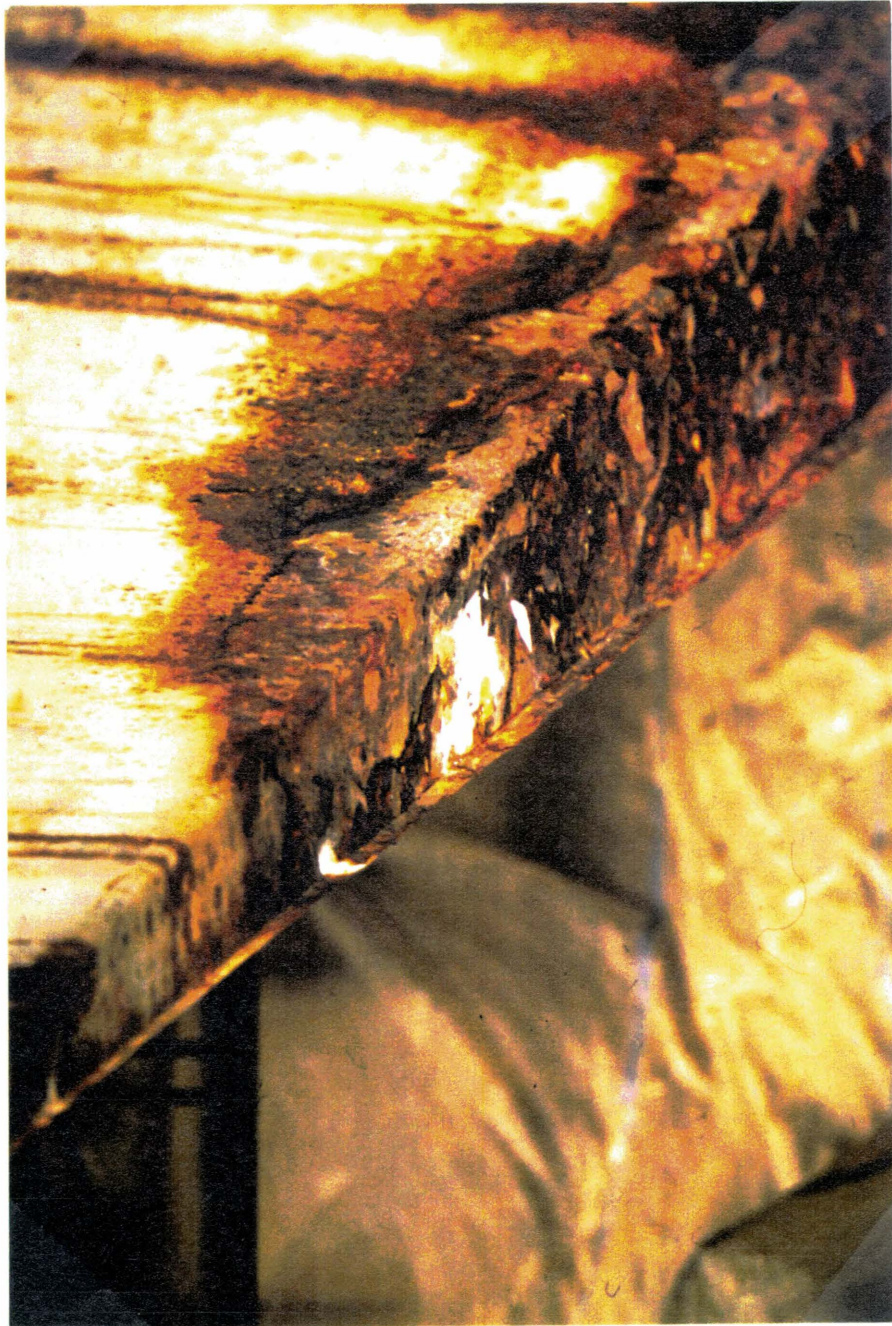
Figure 3. Rust and Calcium Deposits

The bridges in this evaluation were cleaned in accordance with one of the SSPC cleaning standards listed in Table 4. A tarpaulin was used to collect debris and wash water. Bridges were enclosed when blast cleaning was necessary. An example of the debris and rust on the bridge steel beams before cleaning is shown in Figure 3.

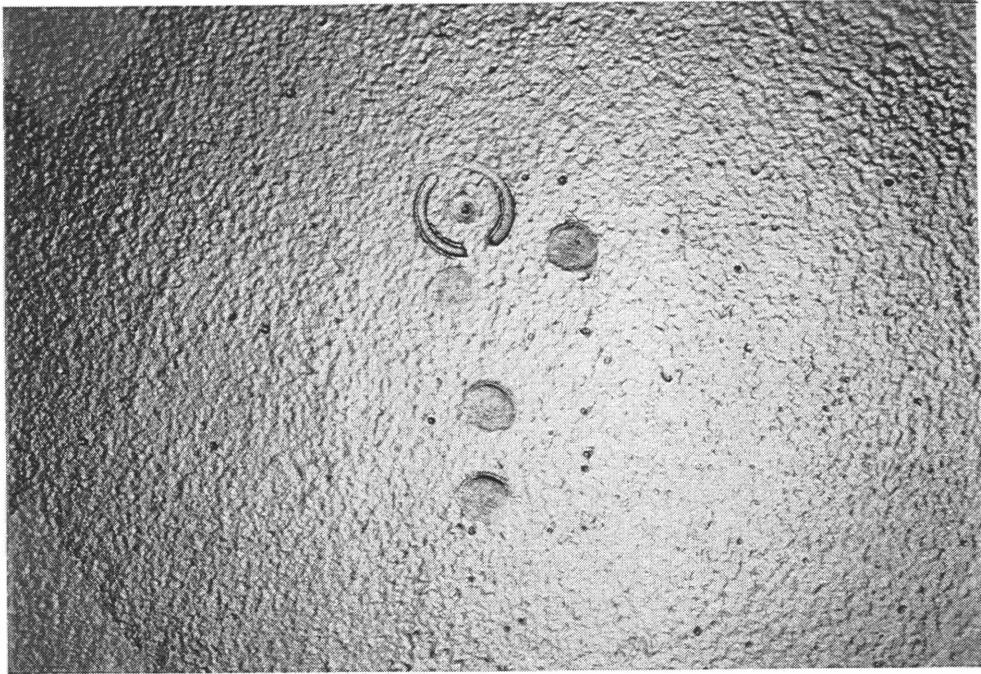
Figure 5. Bridge 3 - Alumanation Coating

At the final inspection of the bridge a few weeks after application, the parties participating in the inspection were not pleased with the appearance of the coating systems, particularly the Alumanation. It was difficult to get an even coating from this paint system. When applied, the paint appeared to have shadows and looked as if it were several different shades of gray. The contractor agreed to touch-up the bridge with paint in several problems spots to the engineers' specifications before the project was finished. The contractor went over the beams with a fine mist of the Alumanation paint for the center and west spans approximately 0.10 mm (4 mils) thick when wet.

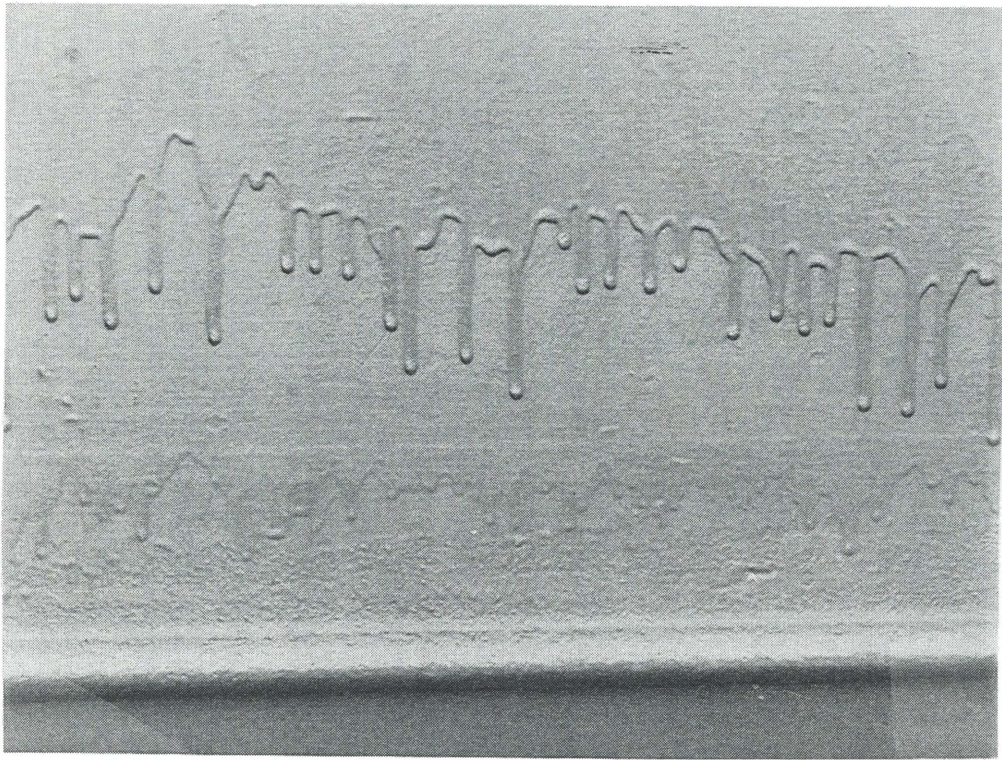
Figure 6. Bridge 5 - Top Coat of Rust Grip

The center span of this bridge was painted first then the remaining two spans. The contractor used a 0.432 mm (0.017 in) diameter tip to apply the paint. Rust Grip ran easily when applied, shown in Figure 6, and took four coats of paint for complete coverage. The manufacturer's representative suggested a larger size tip, 0.533 mm (0.021 in) diameter, for better coverage and fewer runs. A size 0.635 mm (0.025 in) diameter airless paint tip was used but this seemed to make little difference in the coverage and paint still ran.

When the coating system dried, it was very difficult to remove or scrape a section of the paint off even with the edge of a key. With the exception of the train schedule and runs, the operation proceeded with little incident. Figure 7 depicts the appearance of the bridge during application.

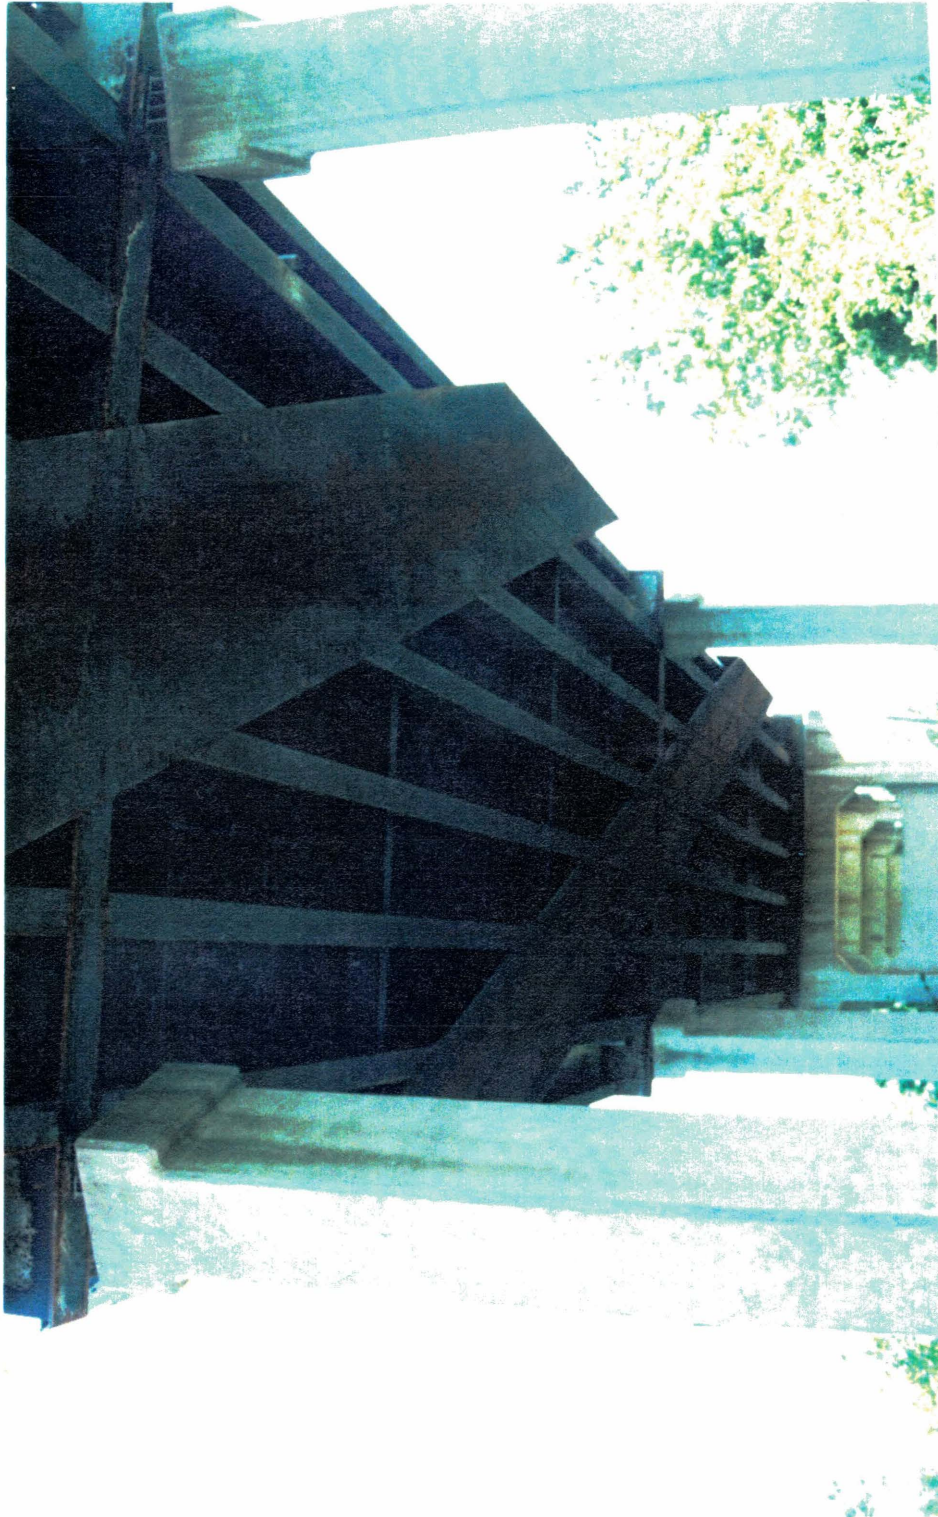
Figure 8. Bridge 7 - Blast Plates

This bridge had two blast plates, shown in Figure 8, that were removed from the steel beams. There was a lot of rust, debris, and animal nests between the blast plates and the steel beams. The areas were cleaned according to the standards and painted. The blast plates were not replaced.
