# **EVALUATION OF PYRAMENT BRIDGE DECK OVERLAY**

**Final Report  
November 1996**

**Kimberly L. Gordon  
Research Project Manager**

**Research, Development & Technology Transfer  
Oklahoma Department of Transportation  
200 N.E. 21st Street, Room 2A2  
Oklahoma City, OK 73105  
(405) 521-2671  
FAX (405) 521-6528**

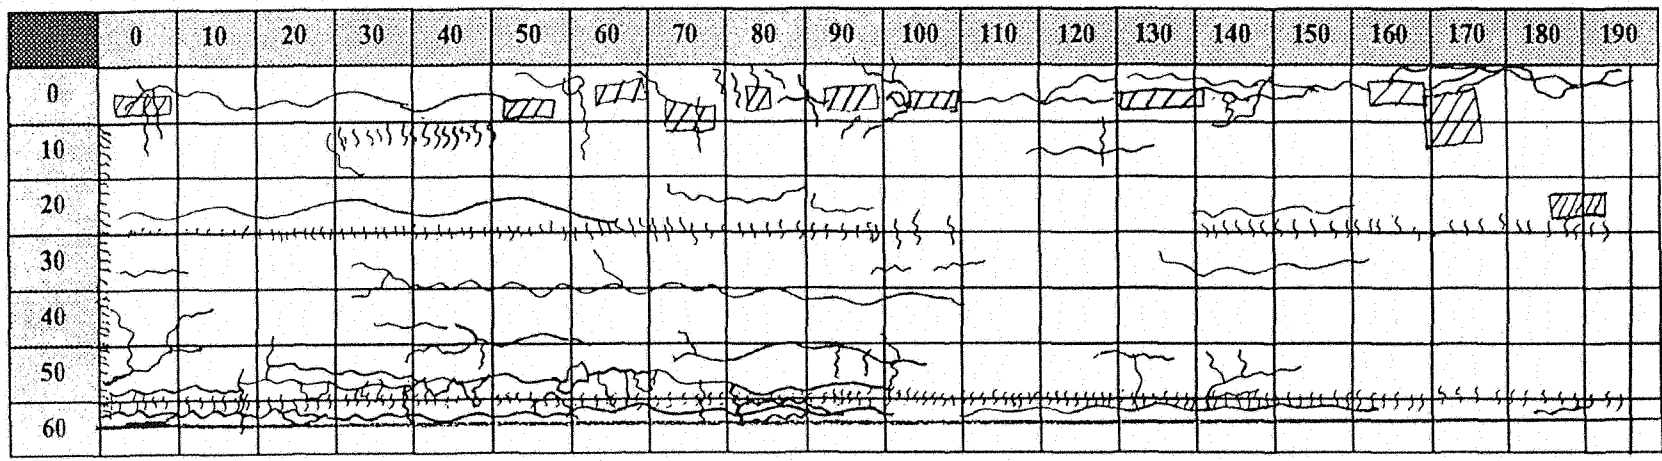
Figure 2. Visual Survey and Crack Map of North Bridge.

The crack map surveys for each structure are shown in feet. The northwest corner of the north structure treated with the silane penetrating water sealer is located on the top left corner of the crack map. Deteriorated areas that were patched during reconstruction are listed in the table above numbered from left to right. Patch five, for example, is located at approximately 0 x 60 on the survey grid and measures 0.88 meters (2.90 feet) in length and 0.76 meter (2.50 feet) in width. The patches are located near the outside lane on the shoulder.

Most of the longitudinal and block cracks on this structure are located on the shoulders. Transverse cracks generally show up near the edge of the lanes.

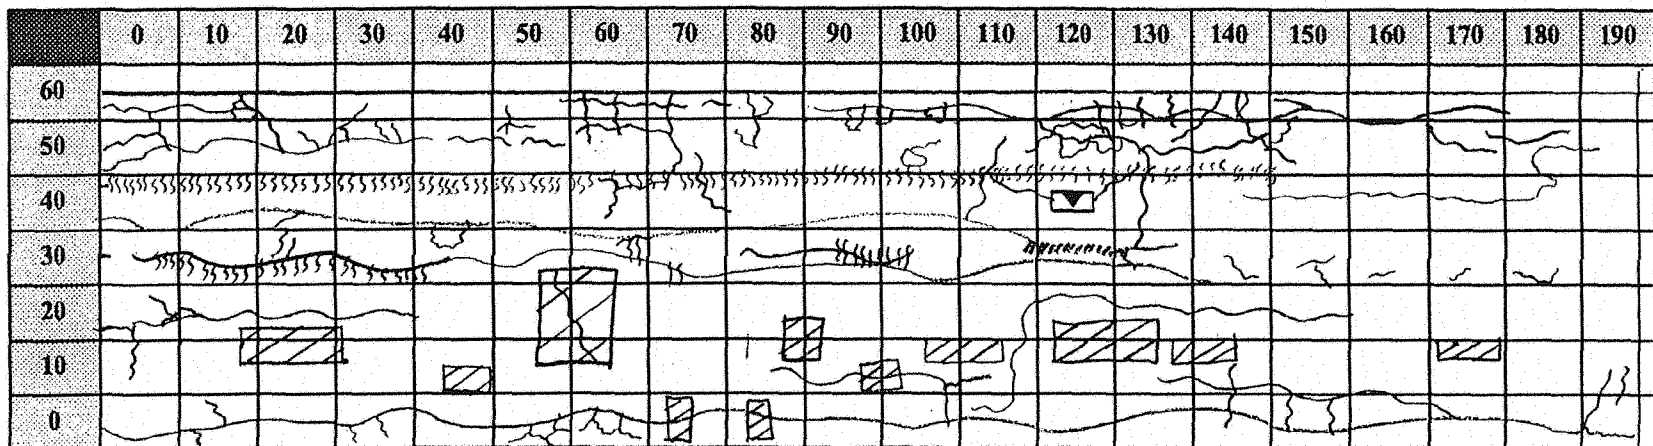
Figure 3. Visual Survey and Crack Map of South Bridge.

The grid on the survey is numbered differently from the grid on the north structure. Patch 10 is located in the southeast, or bottom right corner of the grid at the 10 x 170 location. The patches are near the wall on the outside shoulder.

There is one delamination on this deck at approximately 40 x 120 on the survey grid. Generally speaking, the cracking trends for this deck are the same as for the north structure; however, there is more longitudinal cracking in the driving lanes for this deck.

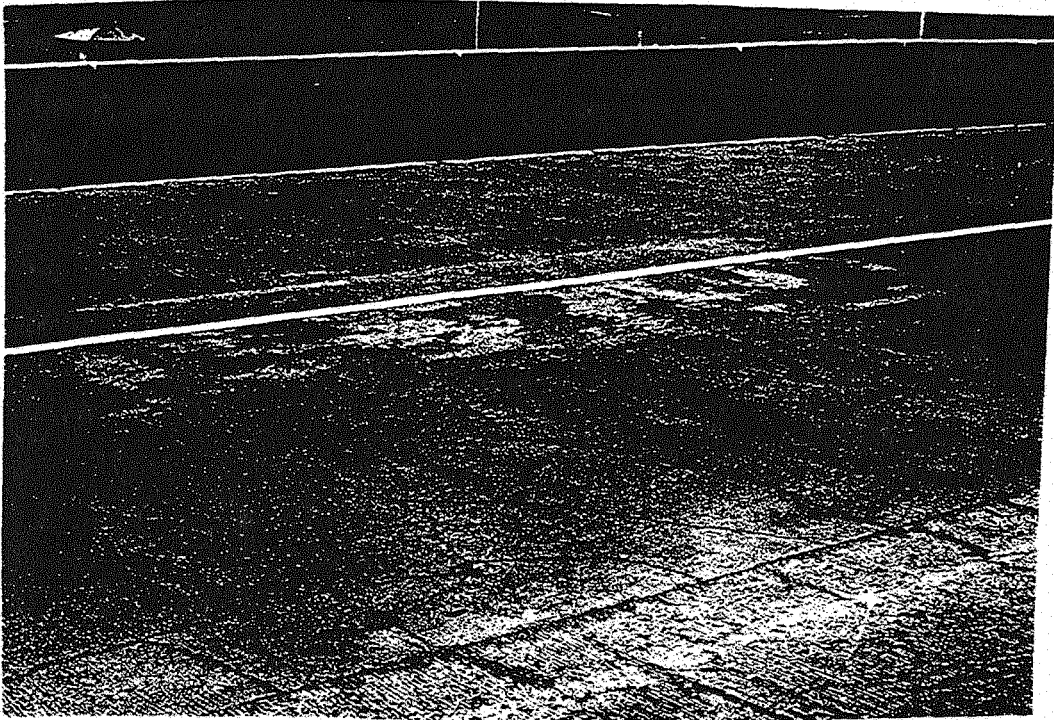
**Figure 4. Cracks in Pavement.**

A crack survey, shown in Figures 2 and 3, was performed on each bridge deck. The maps also show the areas that were patched during reconstruction. The surface areas of the patches are noted on Tables 1 and 2 following each crack survey. Figures 4 and 5 are photographs of widespread cracking and abrasions found on the decks.

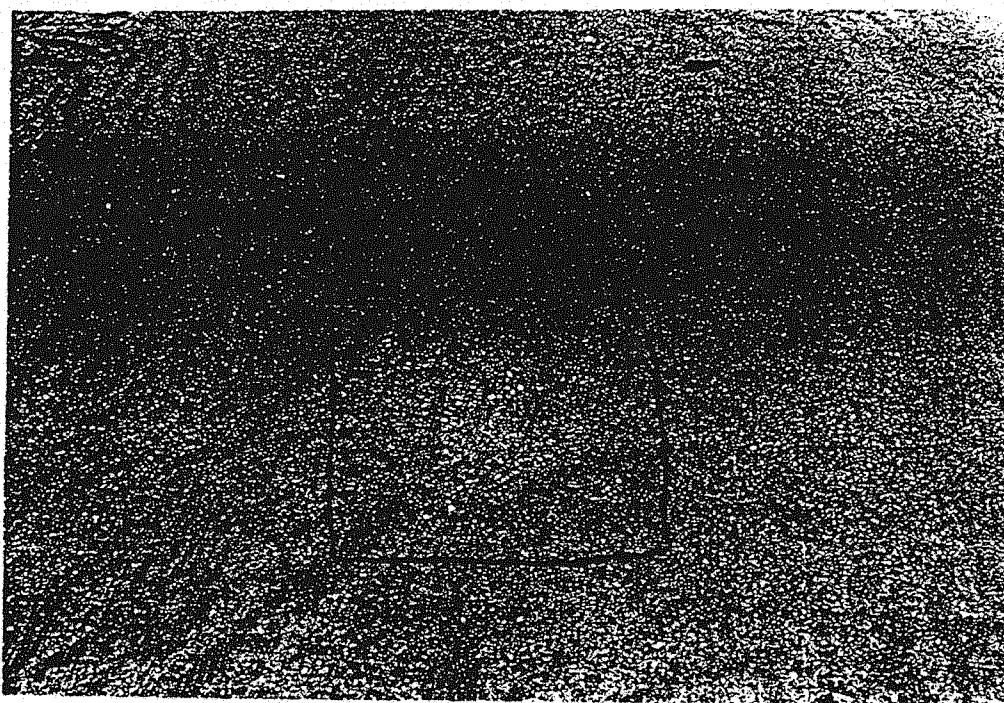
**Figure 6. Delamination on the Deck.**

The delamination sounding or chain drag survey is used to locate delaminated areas on the deck. The test is conducted using the supplies and procedures outlined in ASTM designation D 4580 "Standard Practice for Measuring Delaminations in Concrete Bridge Decks by Sounding." Delaminated areas found on the deck are marked off and noted in the visual survey notes. A photograph of this section is shown in Figure 6.

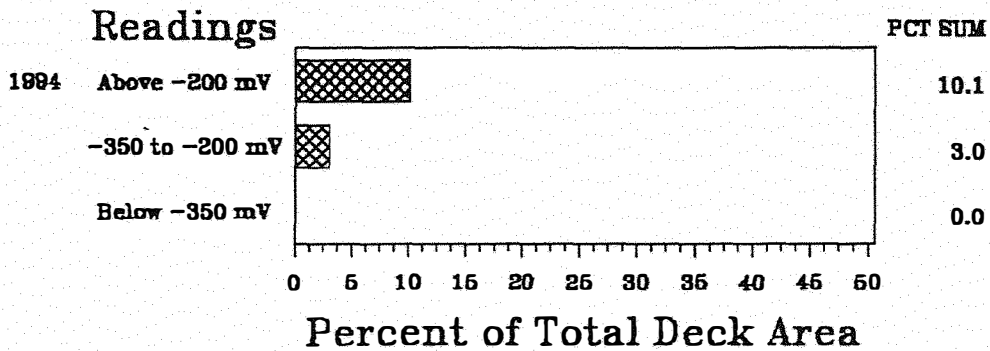
Figure 9. Percentage of Deck Corrosion on North Structure.

The graphs in Figures 9 and 10 indicate that a very small percentage of the deck is showing signs of corrosion activity. Increases in the level of corrosion activity from the time that the decks were reconstructed until 1994 are less than 0.5 percent, shown in Figure 11, for each structure when only readings lower than  $-350$  mV are considered.

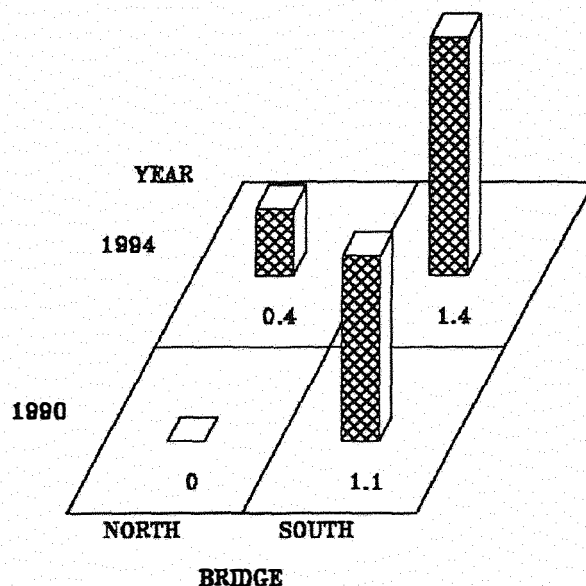
**Figure 11. Change in Corrosion Levels between 1990 and 1994.**

Less than two percent of both bridge decks surveyed in this study had half-cell readings below -350 mV, the generally accepted standard for deck corrosion. There was a 0.3% increase in corrosion levels between 1990 and 1994. Readings were lower, below -300 mV, near the joints on the deck and higher, above -200 mV, where the outside lanes were widened during reconstruction.

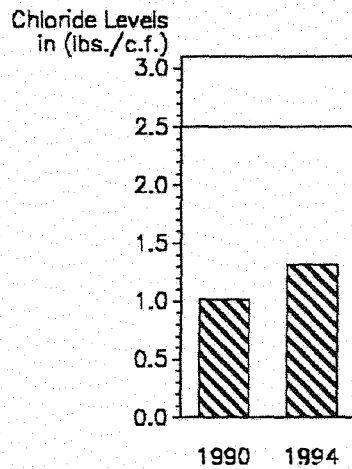
**Figure 12. Change in Chloride Levels between 1990 and 1994.**

Readings were not taken between 1990 and 1994.  
Maximum acceptable level is 2.5 pounds/cubic yard.  
Data for both structures shown in the year indicated.

Sample 5 from the north structure had an unusually high chloride ion content reading. Other readings from this deck were well below the maximum acceptable level for chloride contamination. The chloride content results from the south structure were higher than the readings from the north structure; only two samples were taken.

The average chloride ion content for both decks did not exceed the maximum acceptable level for severe chloride contamination. Test results for the north structure were relatively low. The increase in the average chloride ion content of both bridge decks was less than eight kilograms per cubic meter (one-half pound per cubic yard) between the time of the initial test and the most recent test in 1994. While the results from the south structure did not exceed the maximum levels, the chloride content was high; only two samples were taken from this deck.
