MODIFICATION AND EVALUATION of SENTRE IMPACT ATTENUATION DEVICES

MARCH, 1990

OKLAHOMA DEPARTMENT OF TRANSPORTATION

This report covers a study of SENTRE Impact Attenuation Devices, done to identify potential design or installation improvements, to make these improvements, and evaluate performance of the devices once the indicated modifications were made.

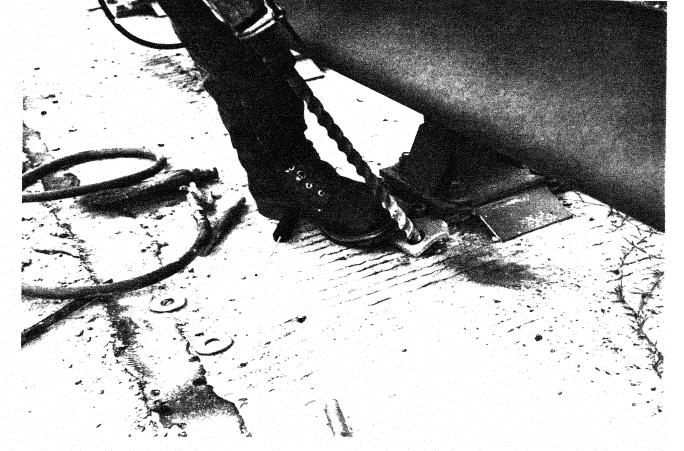
Figure 3. Drilling holes for "MP-3" anchors during retrofit.

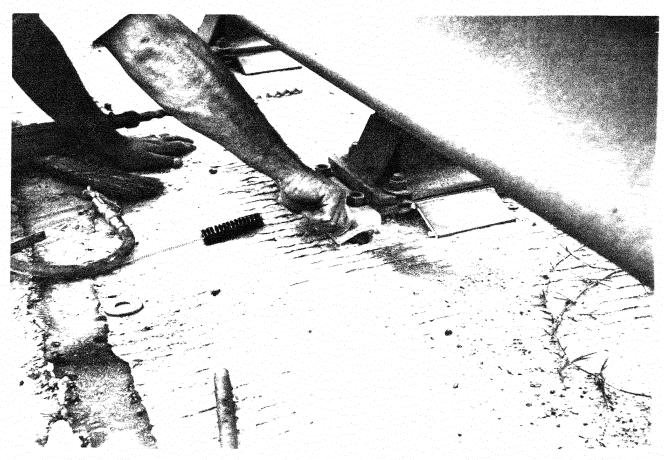
Figure 4c Placing 'MP-3" anchors after cleaning hole - retrofit phase.

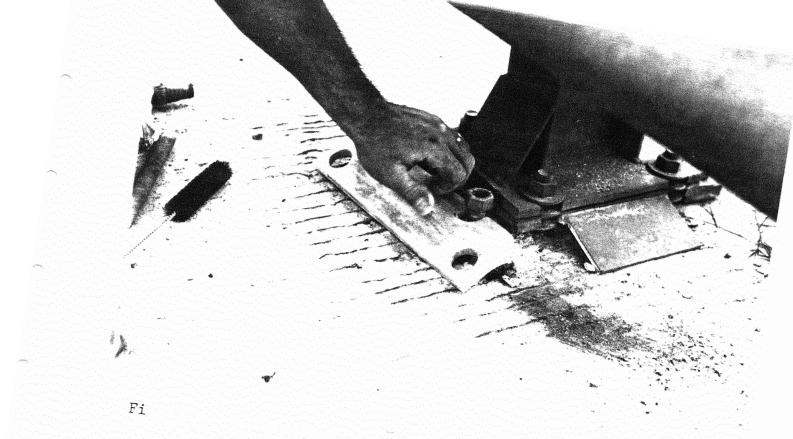
gure 5. Reinstallation of slip base, retrofit phase.

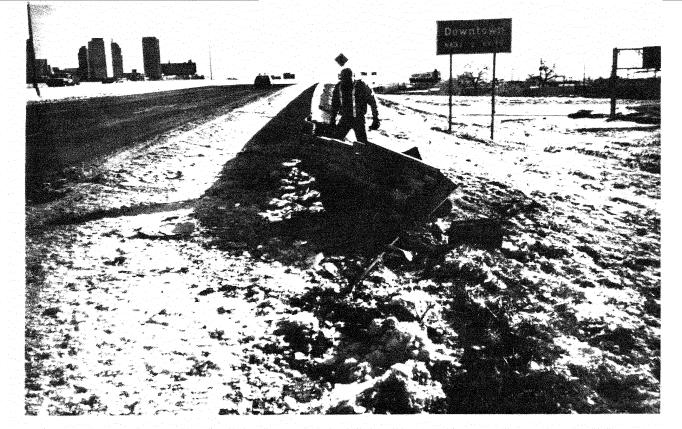
Figure 7. After collision - unit functioned as intended.

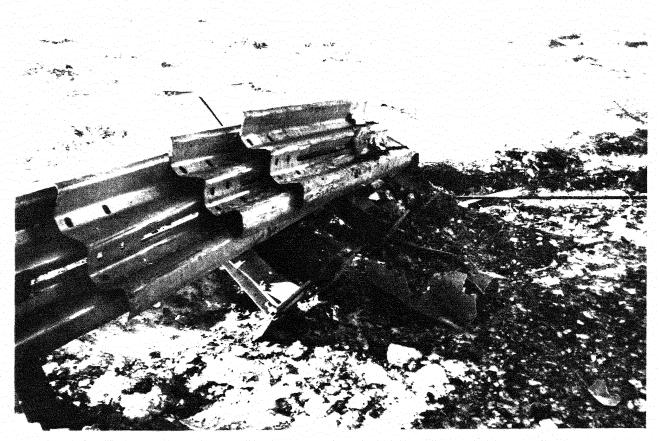
Figure 8. Unit after collision - unit functioned as intended.

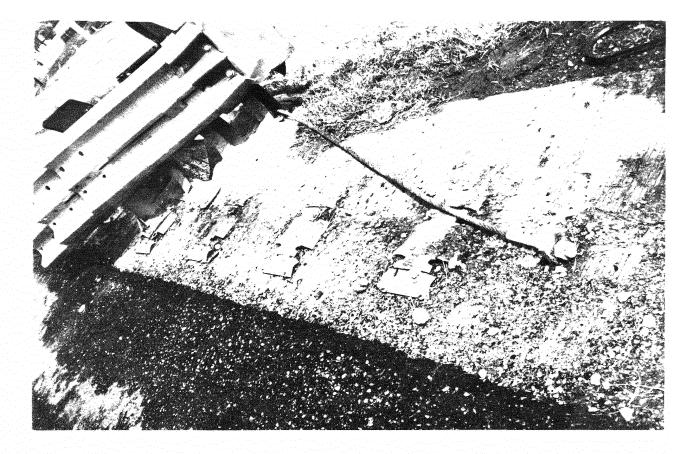
Figure 9. After impact, first three slip bases performed as intended.

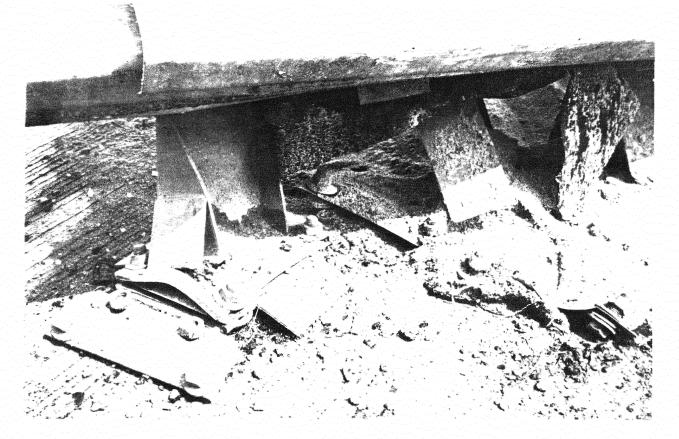
Figure 11. Slip base after impact, base did not perform.

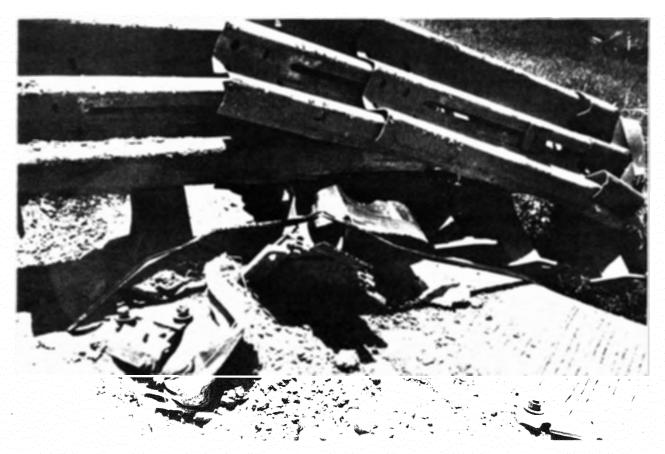
Early in the evaluation period, many of the collisions involving the SENTRE units resulted in a failure of the anchor bolts to hold the base plates to the concrete pad. This was eliminated by a design change, made by the manufacturer. The "Molly Wedge" anchor bolts originally used, were replaced with Hilti MP3 anchors set in drilled holes, with "C-10" a two-part epoxy system. "EASI" reinforcing clips were installed on the

Figure 120 SENTRE unit after impacto unit generally performed as intended, but anchor bolts were pulled out of slabo

slip bases at the same time the MP3 anchors were installed. "EASI" clips, and instructions for their installation, are shown in Figure 5 on the following page. All SENTRE units being evaluated received these modifications. Instructions for installing MP3 anchors are reproduced in Figure 5. Another factor which contributed to unit failures early in the evaluation period, was that pinch bolts were frequently over-torqued by the installation crews, making it impossible for the slip bases to function as intended. Pinch bolts should have been torqued to between 60 and 70 ft-lbs. In most cases, they were uniformly torqued to 125 ft-lbs. This was corrected during the retro-fit phase. This effect can be seen from the collision listing, Table 3, page 13.
