DOT HS 813 715

**Special Crash Investigations:  
On-Site Rollover Crash  
Investigation;  
Vehicle: 2019 Subaru Outback  
Limited;  
Location: North Carolina;  
Crash Date: November 2022**

**Special Crash Investigations  
On-Site Rollover Crash Investigation  
Case Number: CR23001  
Vehicle: 2019 Subaru Outback Limited  
Location: North Carolina  
Crash Date: November 2022**

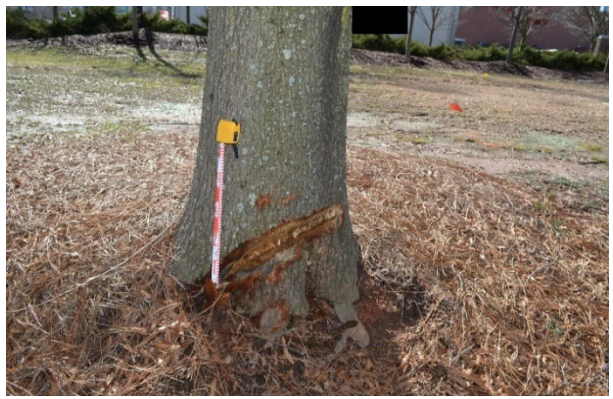
The front left tire of the Subaru struck the curb (Event 1) at an EDR-reported speed of 108 km/h (67.1 mph), causing it to partially separate from the vehicle. The Subaru then ramped onto the sidewalk, striking the curb with its left rear tire (Event 2). It continued up the incline with a slight right yaw (Figure 4), where the left rear tire/rim ramped up and cut into the base of a large 40 cm (15.7 in) diameter tree (Event 3, Figure 5).

*Figure 5. Looking at Event 3, the first tree struck*

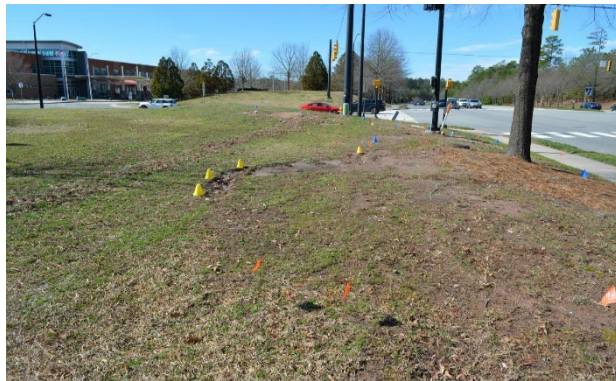
The first tree strike caused the Subaru to roll right around its longitudinal axis onto the right tires. As it continued traveling forward, it glanced off a lamppost (Event 4, Figure 6) and struck a second large 40 cm (15.7 in) diameter tree non-horizontally along its right A and B-pillars (Event 5, Figures 7 and 8). This second tree strike caused the Subaru to rapidly rotate clockwise, where it tripped over its left rear tire and initiated a left-side-leading rollover event (Event 6, Figure 9).

*Figure 9. Facing west, viewing the trip-over point and rollover event initiation*

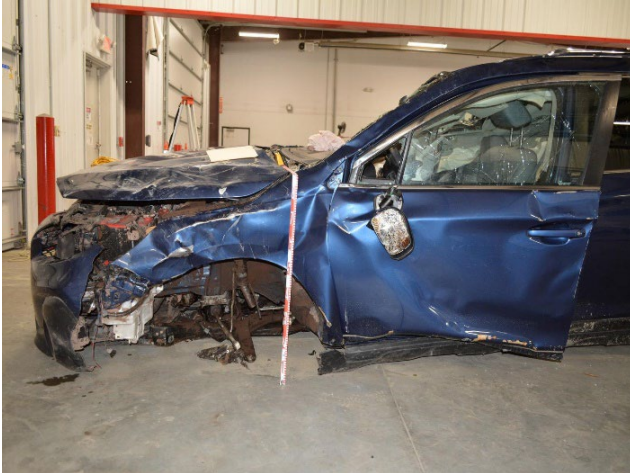
The Subaru sustained major damage to the left front tire/wheel assembly (Figures 12 and 13) when it struck the left curb (Event 1). The tire was holed in several points and had separated from the rim. The rim flange had separated from the rim body due to the impact. There was overlapping damage to the left front panel and the driver's door sill from the curb strike and the rollover event. As the Subaru continued across the sidewalk, the left rear tire struck the curb causing the tire to be holed and separated from the rim (Figure 14, Event 2). The collision deformation classification<sup>1</sup> (CDC) assigned to Events 1 and 2 was 12FLWN3 and 12FLWN9.

*Figure 12. Damage to the left front of the Subaru from Event 1*

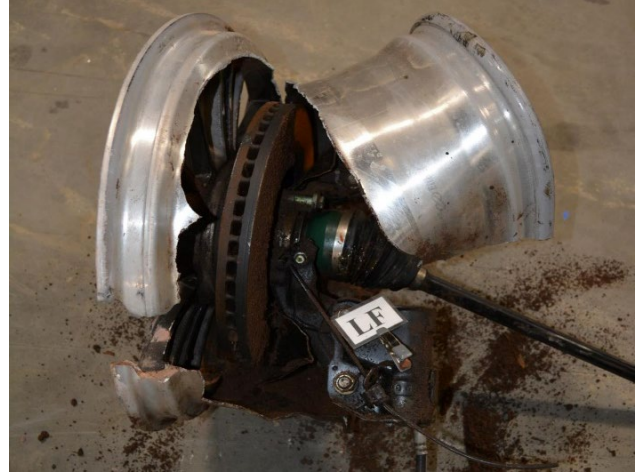
*Figure 13. Damage to the center left front wheel assembly*

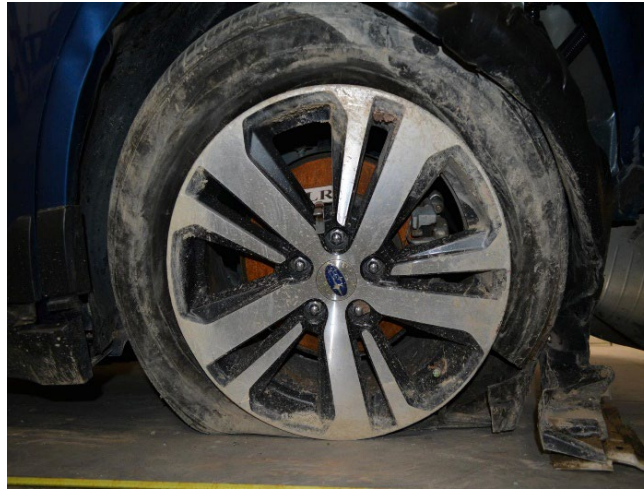
*Figure 14. Damage to the left rear tires from Events 2 and 3*

The Subaru crossed over the sidewalk and began riding up the hill and over the lower trunk of the first tree that was positioned 24.5 m (80.4 ft) from the initial curb strike and 5.2 m (17.1 ft) from the road edge. The Subaru's left side was at this point ramped up on the root system and was no longer horizontal. The left rear wheel rim struck the tree trunk and cut a deep gash into the hard wood as seen in prior Figure 5 (Event 3). The CDC assigned to this event was 10LBWN1.

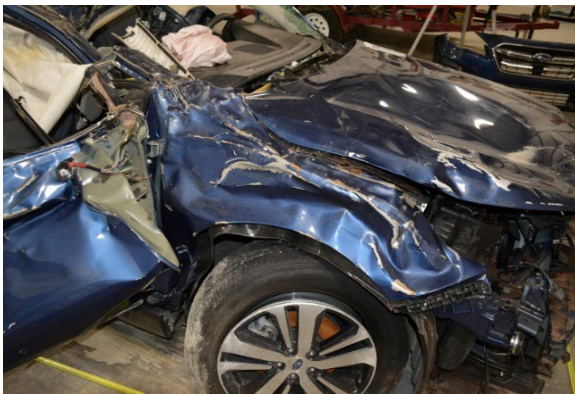
The Subaru struck the second tree (Event 5) that was positioned 39.2 m (128.6 ft) from the initial curb impact and 5.4 m (17.7 ft) from the roadway. The force of this impact deployed the driver's and passenger's frontal left and right ICs, and front passenger's seat-mounted air bags. Due to the roll to the right, the Subaru was non-horizontal at the point of impact. The damage started 47 cm (18.5 in) forward of the vehicle's right front axle and extended rearward 332 cm (130.7 in) to the right C-pillar. The direct damage started along the top edge of the right front fender (Figure 15) and ran down the side of the vehicle across the A-pillar, B-pillar, and C-pillar. The right B-pillar received most of the force of this impact and had a partial tension separation at the top of the metal frame (Figure 16, yellow arrow). The B-pillar was crushed vertically 24 cm (9.4 in) and had a lateral component of 45 cm (17.7 in). All damage from this event overlapped with the rollover damage. There was a complete tension separation in the A-pillar 17 cm (6.7 in) from its base along the metal frame (Figure 17). Heavy abrasions ran longitudinally along the entire right side (Figure 18). The right front door was also heavily damaged in this event but due to the post-crash extrication the door damage from Event 5 is unknown. The CDC assigned to this damage pattern was 00RFHW3.

*Figure 15. Damage along the right front panel from Event 5*

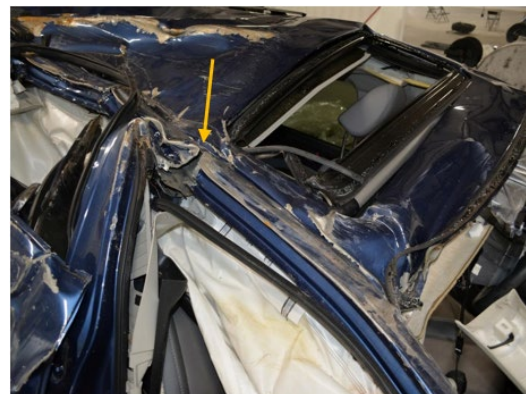
*Figure 16. Damage to the right B-pillar and roof rail with the tension tear (yellow arrow)*

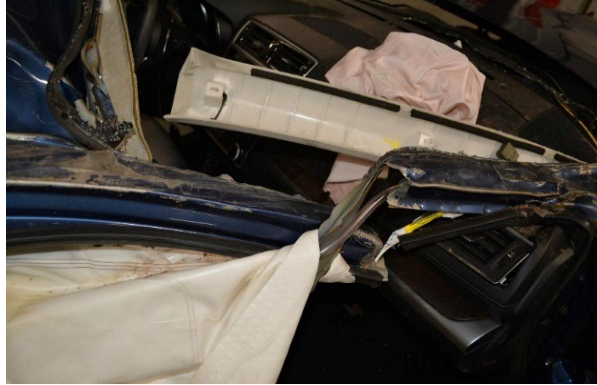
*Figure 17. Right A-pillar separation during Event 5*

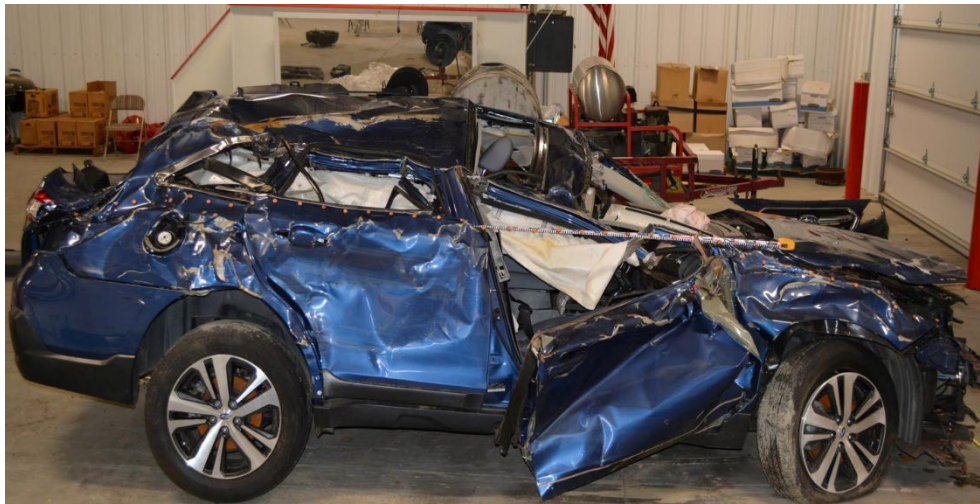
The mass of the Subaru carried it non-horizontally through the impact with the first tree and into a 30 cm (11.8 in) diameter light pole striking it along the right roof rail (Event 4). The pole was positioned 31.9 m (104.7 ft) from the initial curb impact and 3.9 m (12.8 ft) from the roadway. The pole was replaced at the time of the SCI inspection, and the damage to the Subaru overlapped with the damage from the second tree impact and the rollover event damage. The CDC assigned to this event was 00RPH999.

*Figure 18. Overlapping damage to the right side from Events 4-6*

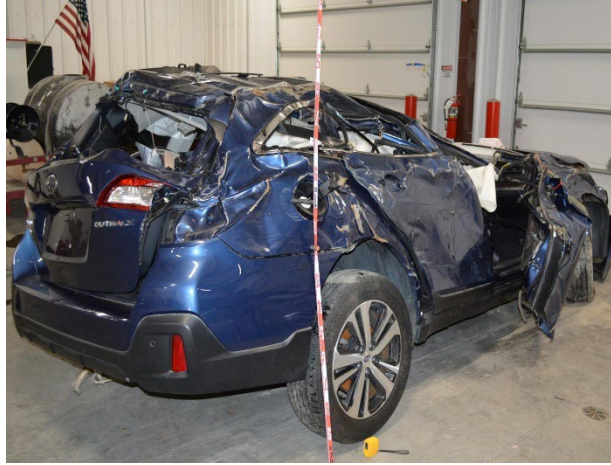
As the Subaru rolled from its roof to the right side, its back plane struck a 40 cm (15.7 in) diameter traffic control pole (Figure 19, Event 7). The force of the impact interrupted the rollover event, and the Subaru rolled back onto its roof facing east at rest approximately 73 m (240 ft) from the initial curb impact. The CDC's assigned to this damage was 00BREN2.

*Figure 19. Damage to the back of the Subaru from Event 7*

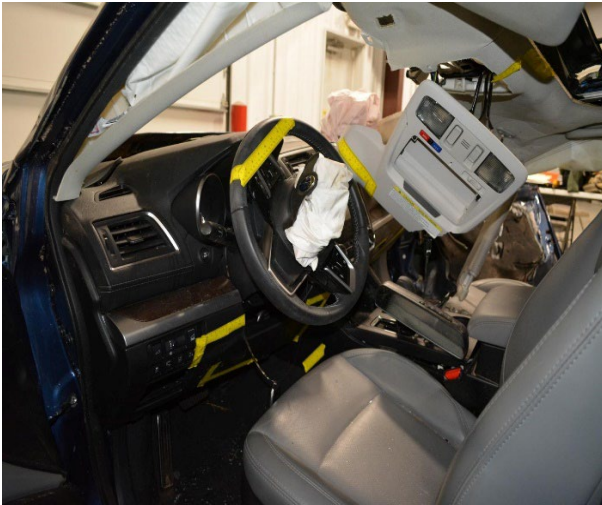
There was severe interior damage (Figure 20) that consisted of several intrusions. The windshield header at the top of the right A-pillar intruded vertically 40 cm (15.7 in) and was laterally intruded 44 cm (17.3 in). The passenger A-pillar (Figure 21) also had complete tension separation 17 cm (6.7 in) from the base along the metal frame and was pushed down into the occupant space. The passenger's B-pillar (Figure 22) was vertically intruded 24 cm (9.4 in) and had a 45 cm (17.7 in) lateral intrusion component. The intruded B-pillar displaced the front

passenger's seatback approximately 20° laterally into the center console area. The front passenger's door panel came loose during the post-crash as EMS personnel attempted extrication through the right front door.

*Figure 20. View of the interior damage to the front row of the Subaru*

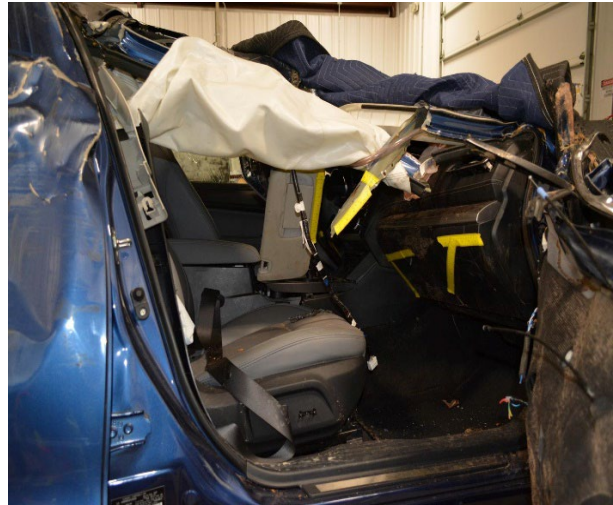
*Figure 21. View of the intrusion and deployment damage to the front passenger's seat and right A-pillar area*

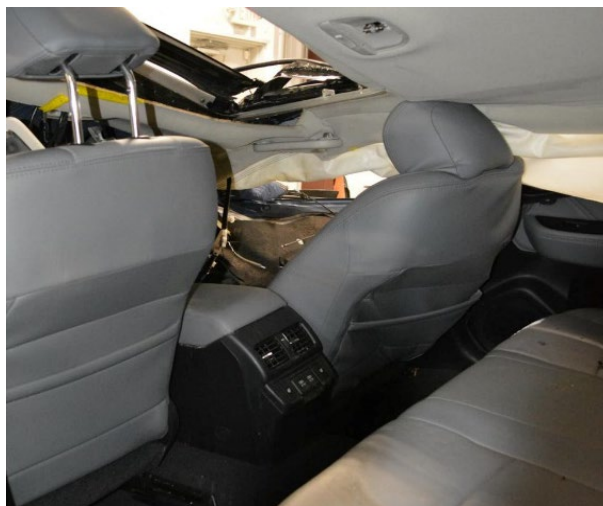
*Figure 22. View of the front row intrusion from the second row and B-pillar intrusion*
