# Evacuation and Rescue of Elderly and Disabled Passengers from Paratransit Vans and Buses

Ketron, Inc.  
58 Charles St.  
Cambridge, MA 02141

October 1984  
Final Report

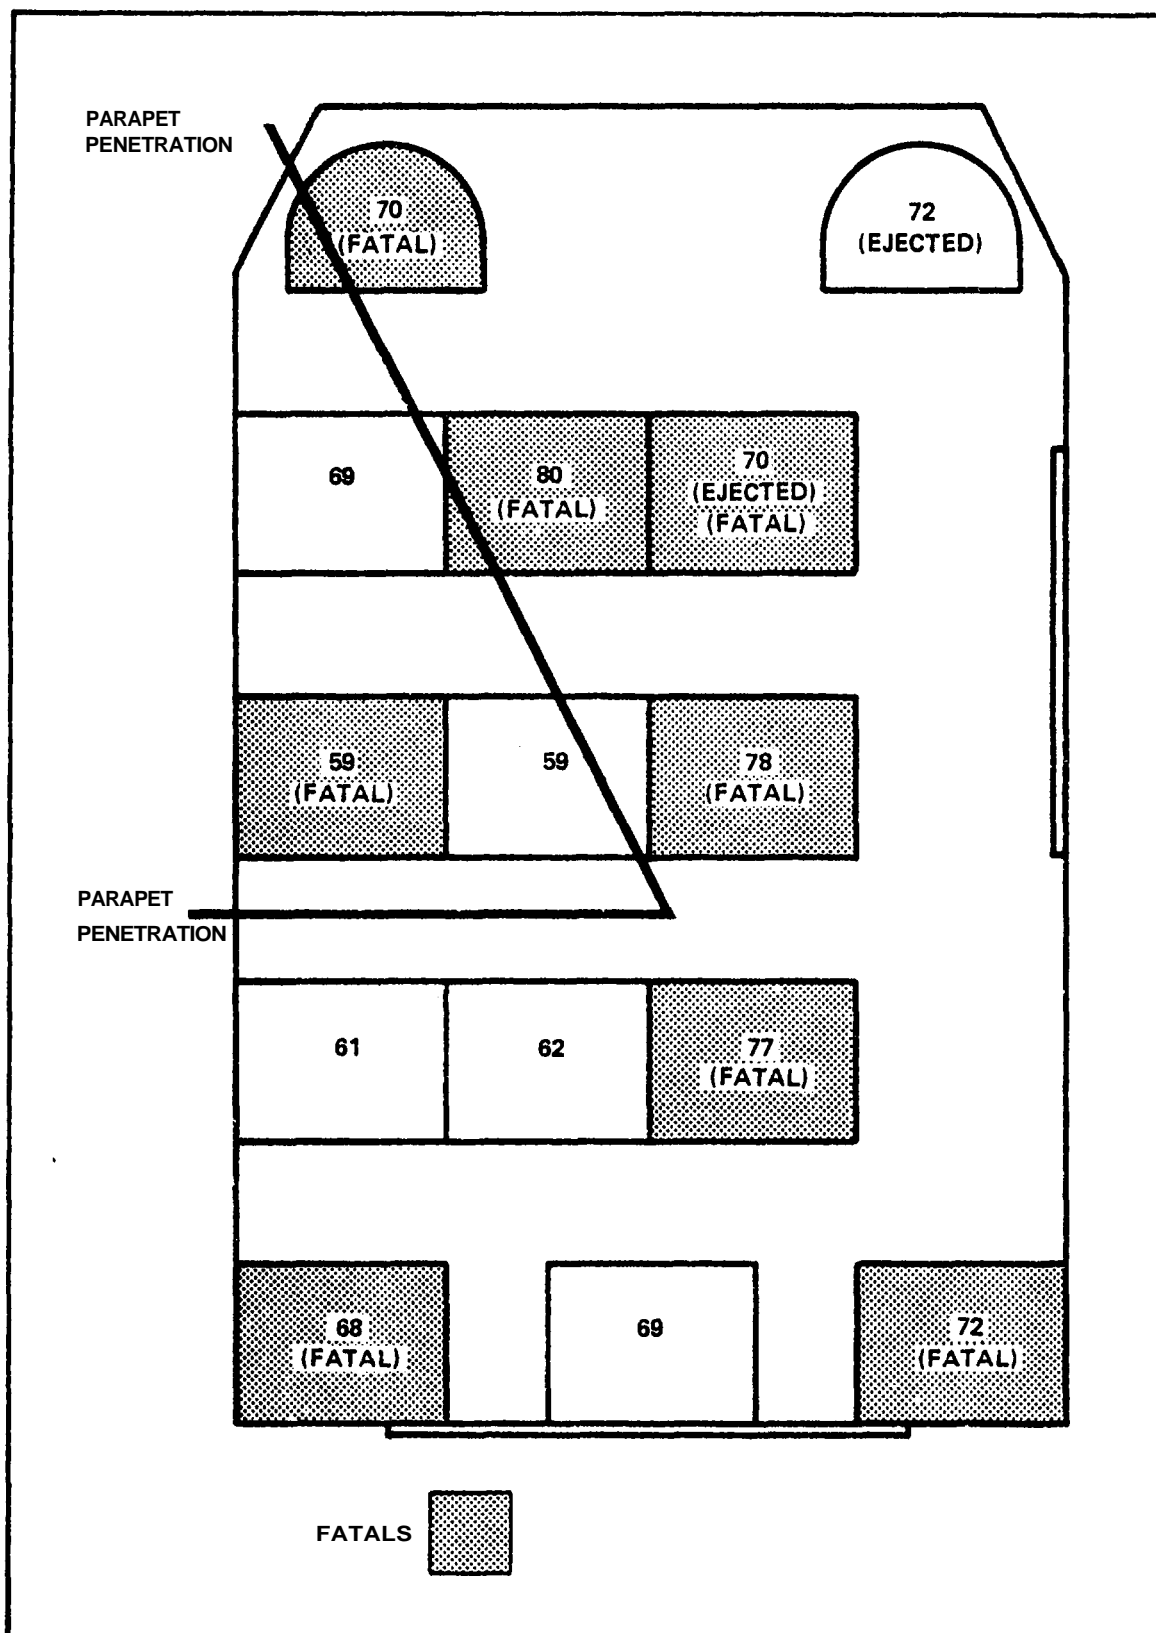
FIGURE 3-8. DELTA, UTAH, VAN SEATING CHART

All of the occupants had to be extricated from the vehicle except the passenger in the right front seat and the passenger on the far right of the first bench seat. (See Figure 3-8.) Both of these passengers were ejected into an irrigation canal. The 72-year-old passenger sustained a shoulder injury but managed to swim to and crawl up the embankment. The other's body was found several hundred feet downstream. An autopsy was not performed.

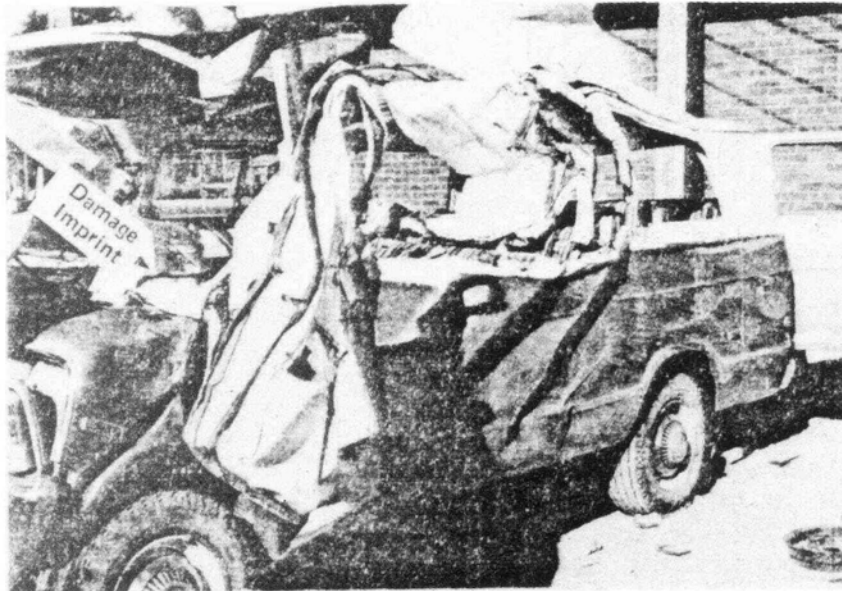
Figure 3-9 shows the front left of the van. The damage to the roof, left side, roof supports, and seatbacks was caused by the parapet when it penetrated the van along the left side windows from

Note damage imprint from bridge parapet at top of left front fender and at top of left side instrument panel. Note buckling of side panel to rear tire area.

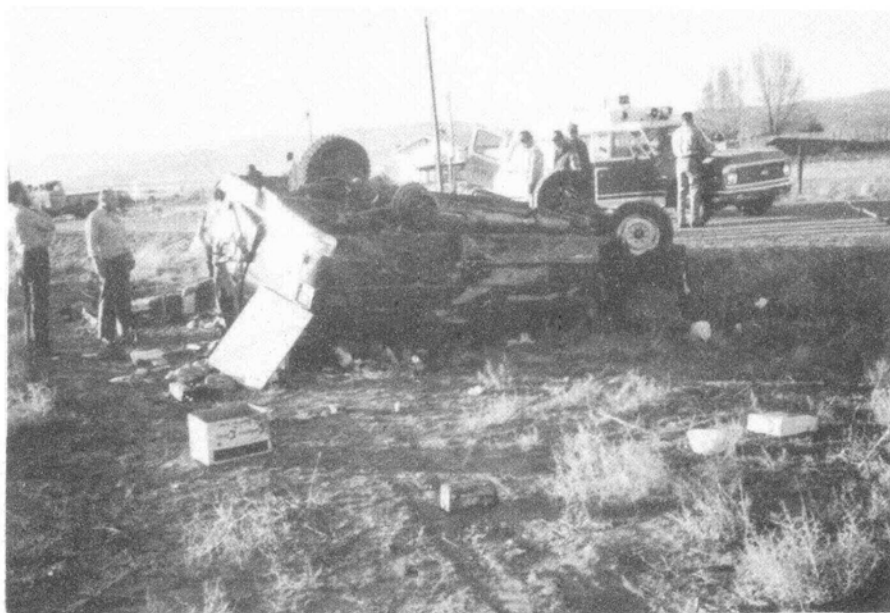
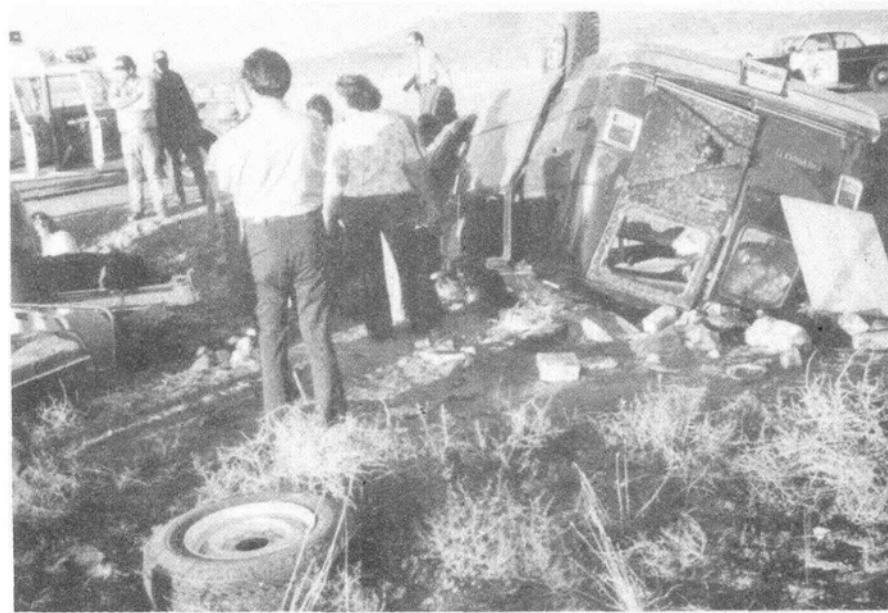
FIGURE 3-11. SUSANVILLE, CALIFORNIA, ACCIDENT;  
VAN IN FINAL RESTING POSITION  
AT ACCIDENT SITE

Figure 3-11 shows the van in its final resting position. Being upside down made gaining access to the victims extremely difficult, as did the crushing of the roof and the distortion of the body.

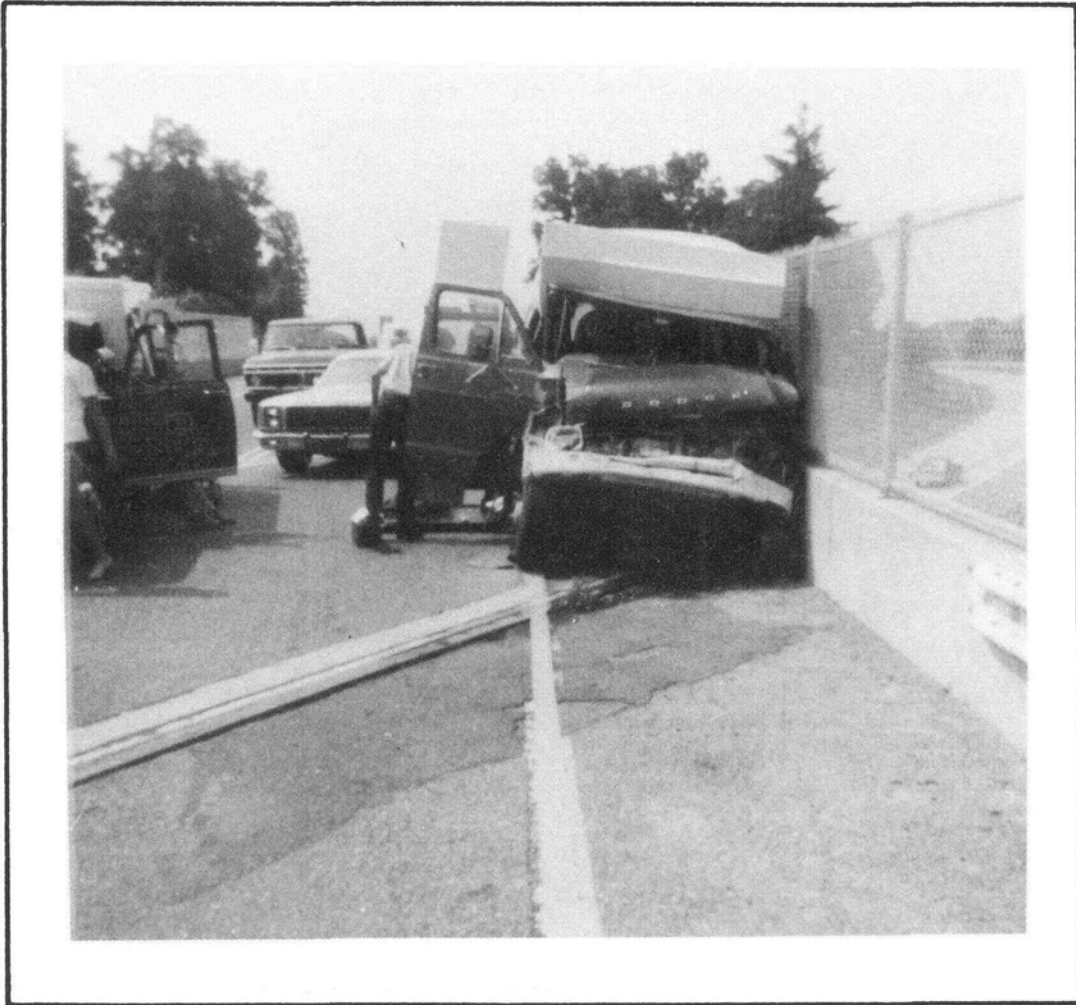
FIGURE 3-12. PARATRANSIT VAN IN FINAL RESTING POSITION AFTER  
MULTIPLE VEHICLE COLLISIONS: HOWARD COUNTY, MARYLAND

Despite the four collisions, the van remained nearly intact. Figure 3-12 shows the front of the van crushed considerably, but the raised roof stayed in position and the wheelchair lift at the side doors remained operable (Figure 3-13). Figure 4-14 shows emergency first aid being provided to one of the six persons (aged 68, 74, 80+, 84, and 89) on board. It appears from Figure 3-14 that one of the passenger bench seats partially failed as a result of the collisions. Evacuation of the passengers was facilitated by using the side doors and by lowering the wheelchair lift.

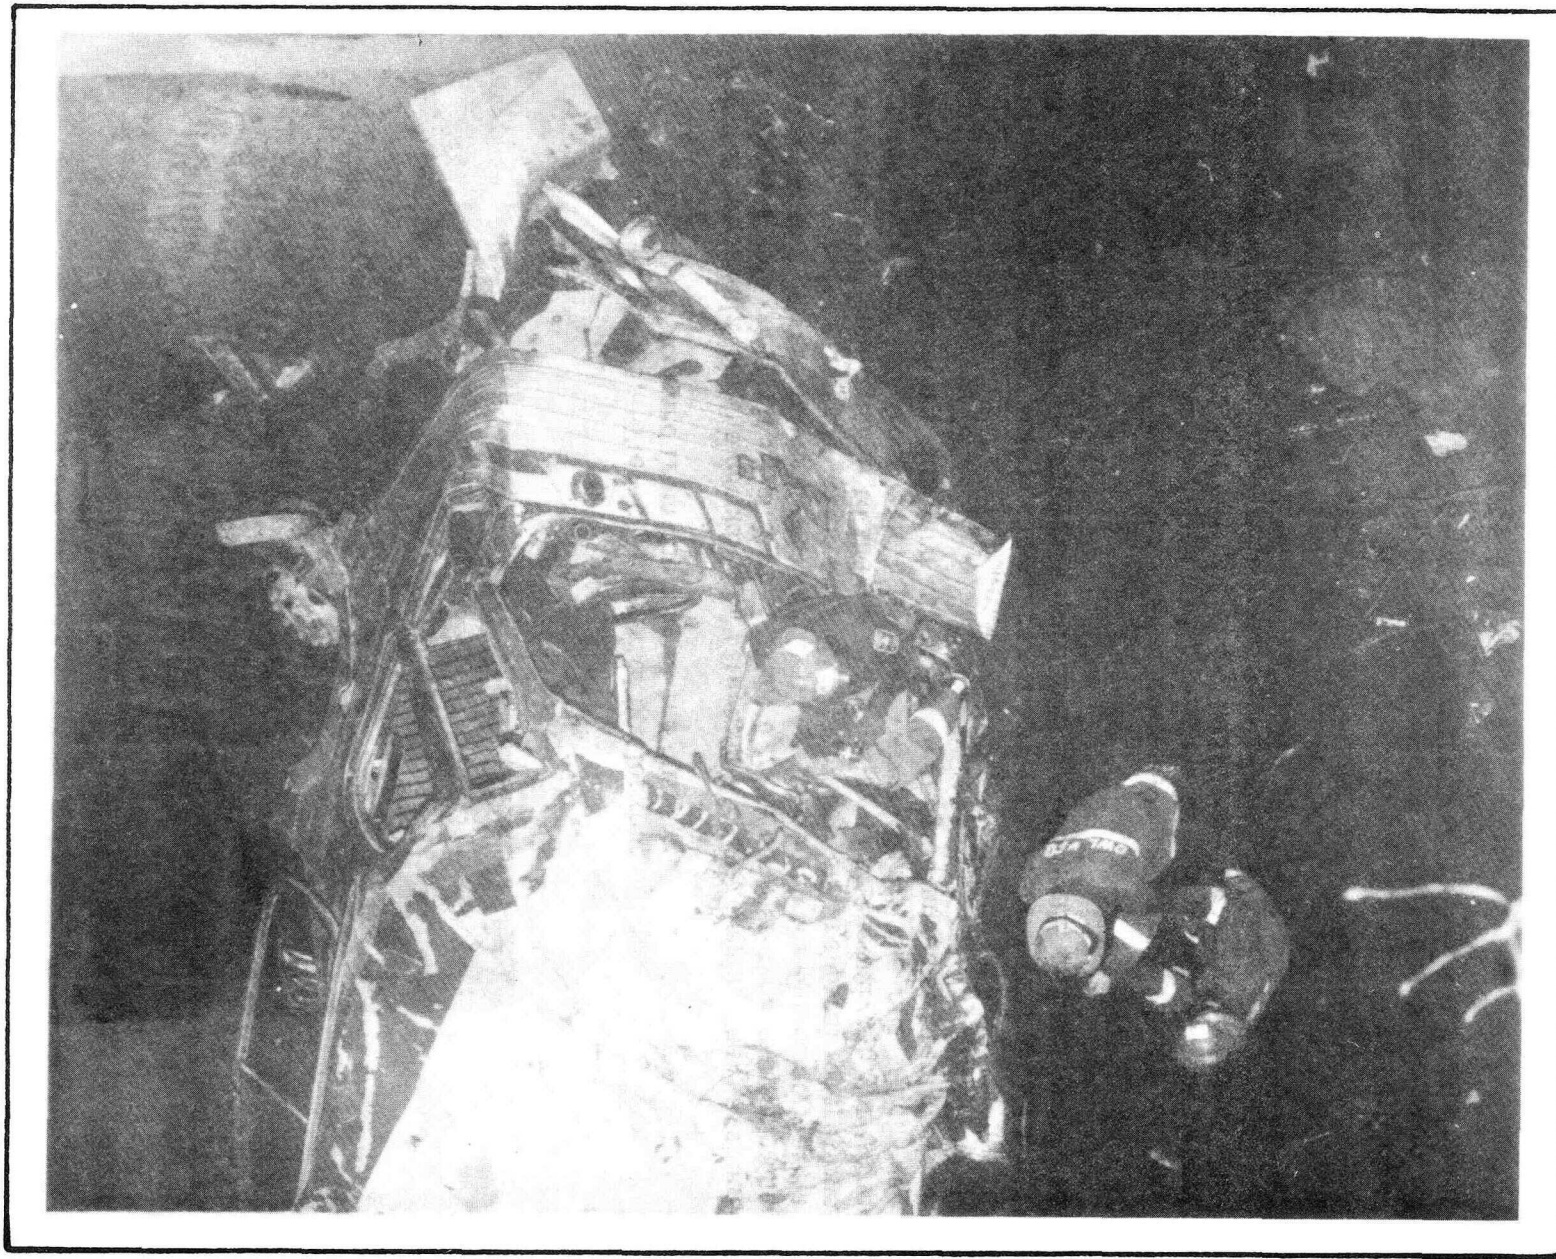
FIGURE 4-18. TRIANGLE, VIRGINIA, TRANSIT BUS ACCIDENT: FRONT OF BUS AFTER BEING UPRIGHTED

As the bus scraped along the embankment flanking the ditch, the windshield and right windows were shattered, causing glass fragments to be propelled into the bus and permitting partial ejection of some
