DOT/FAA/W/92-1
DOT-VNTSC-FAA-92-6

1991 LLWAS Anemometer Test Program

Research and
Special Programs
Administration
John A. Volpe National
Transportation Systems Center
Cambridge, MA 02142-1093

Final Report
September 1992

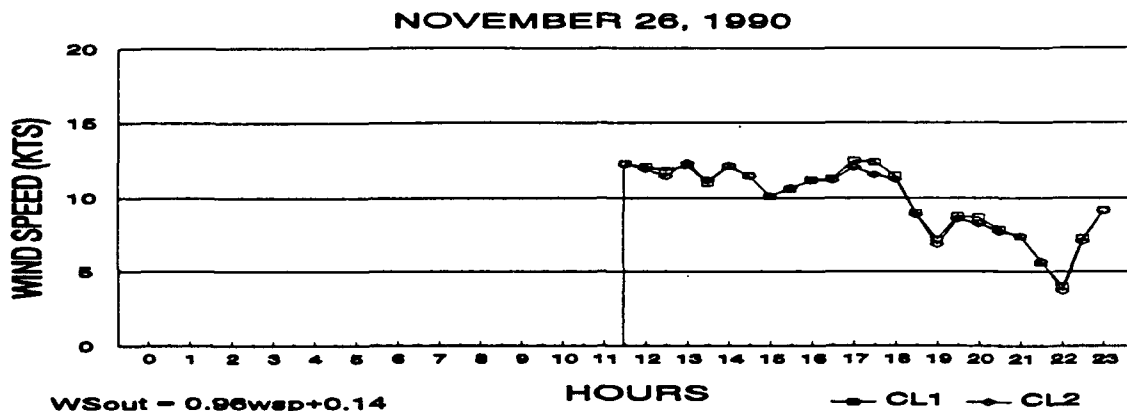
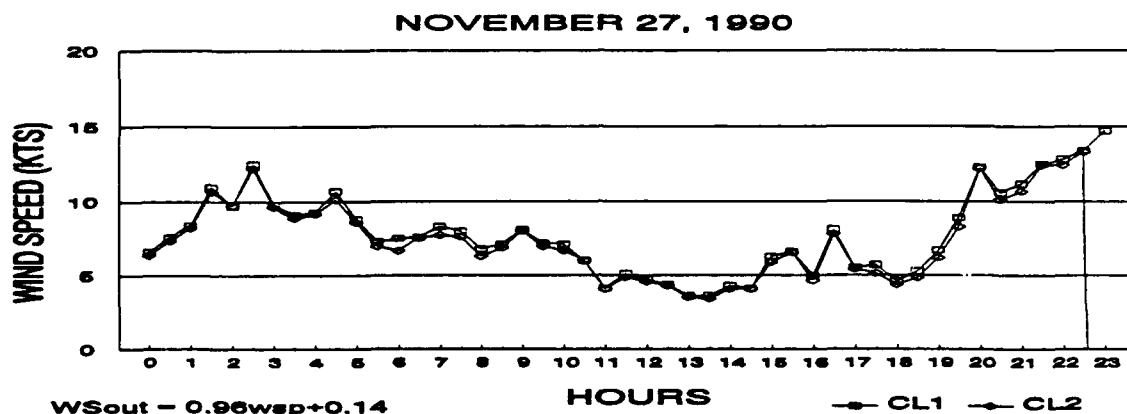
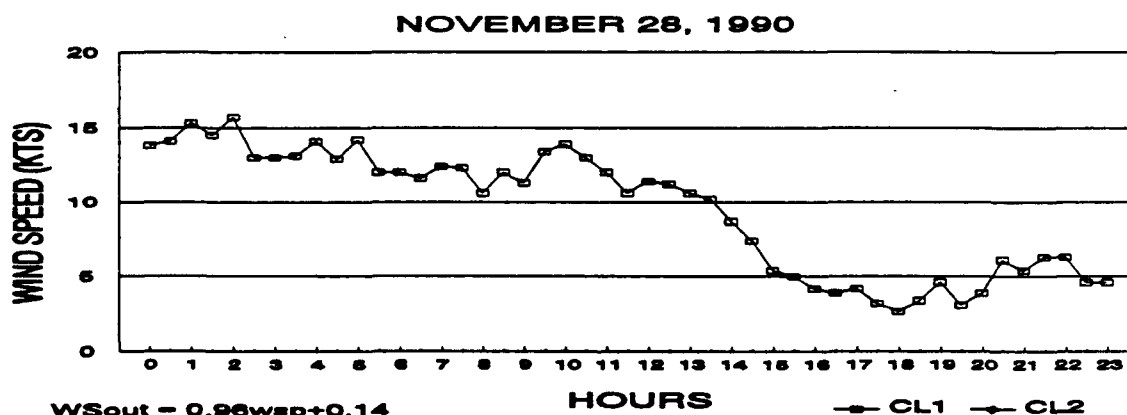
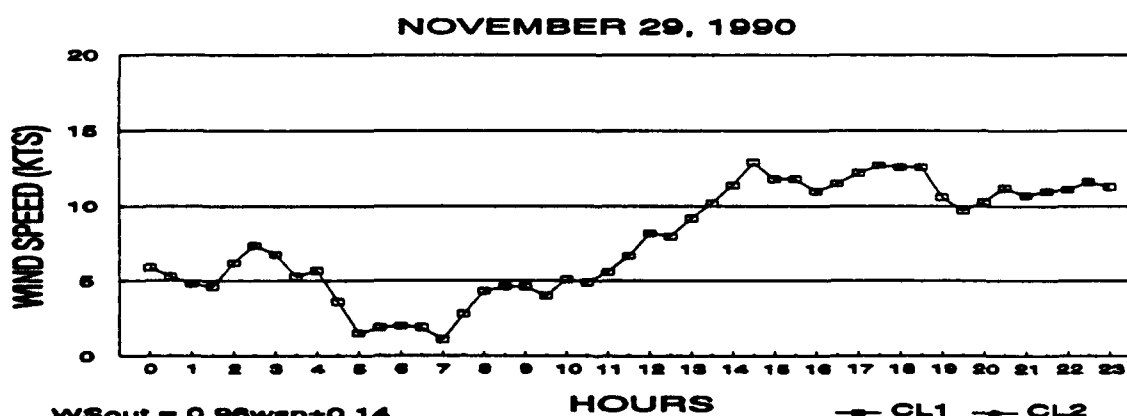
FIGURE 4-8. COMPARISON OF CL2 AND CL1 WIND SPEED ON 11/26-29/90

Figures 4-8 through 4-11 show wind speed plots for all the sensors operating during this event, which occurred very early in the test period. Figure 4-8 shows that the two Climatronics sensors tracked well through the event; CL2 was not in service after the event. Figure 4-9 shows agreement to within 1.5 knots between ST2 and CL1 through the event and for the following day. Larger disagreements were noted on the day before and the second day after the event when the wind direction was southerly. Figures 4-10 and 4-11 show variable agreement between the two Rosemount sensors and CL1; the errors are larger at low wind speeds, as would be expected for the pressure-sensing Rosemount units.

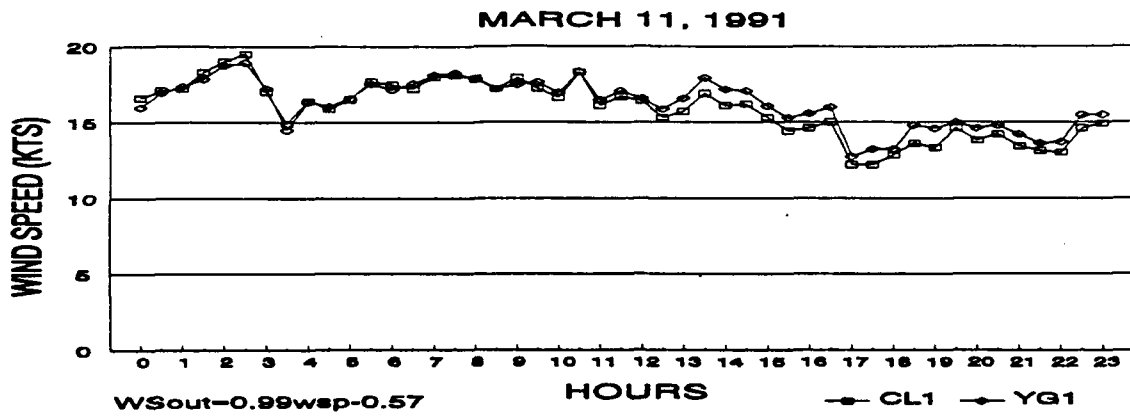
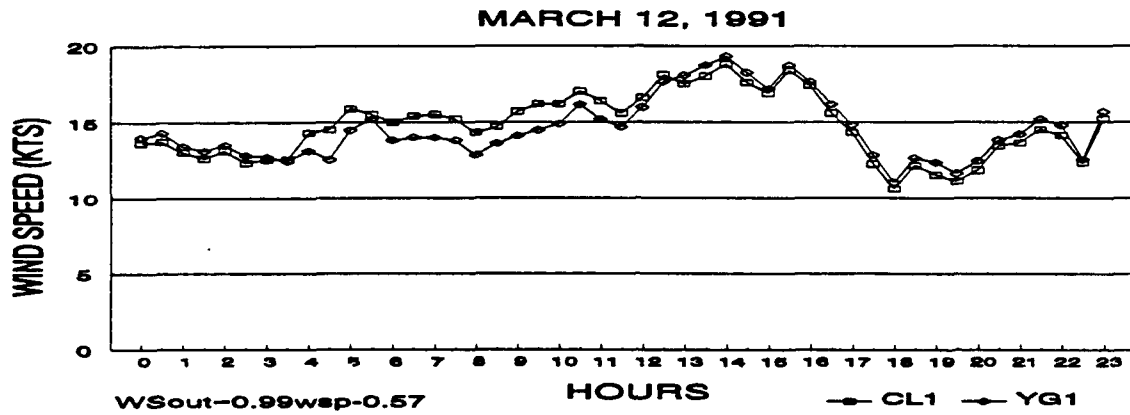
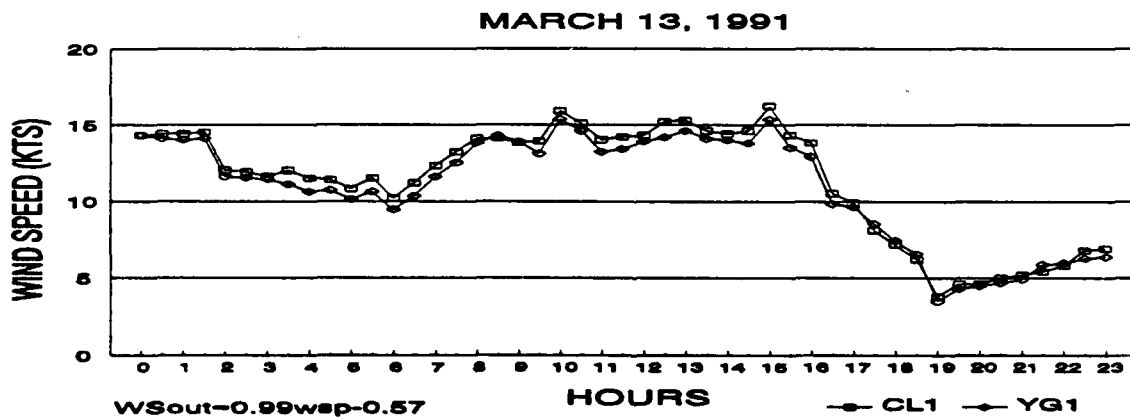
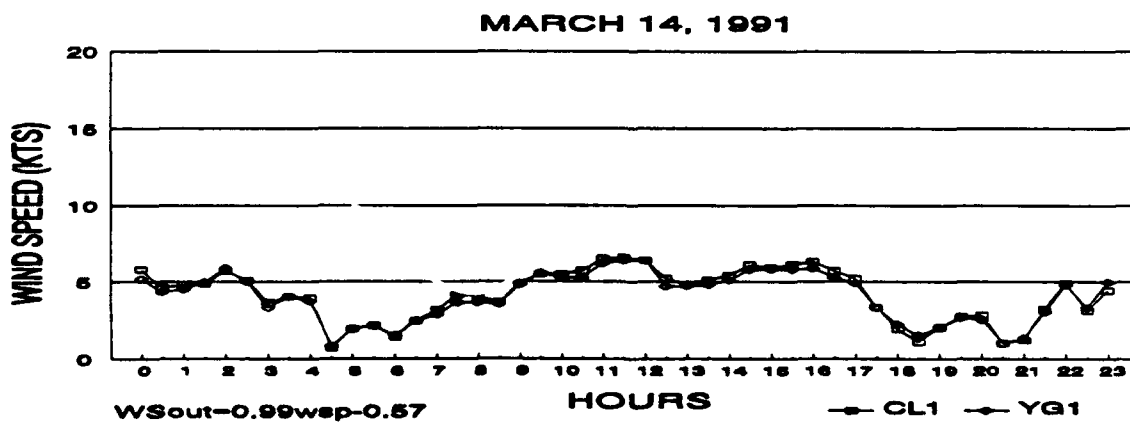
FIGURE 4-13. COMPARISON OF YG1 AND CL1 WIND SPEED ON 3/11-14/91

4.4.3.2 3/12/91 Icing Event - The March 12, 1991 icing event is an interesting case study because there is some evidence that the R. M. Young 1 sensor slowed down slightly during the icing period and early in the subsequent glazing period.

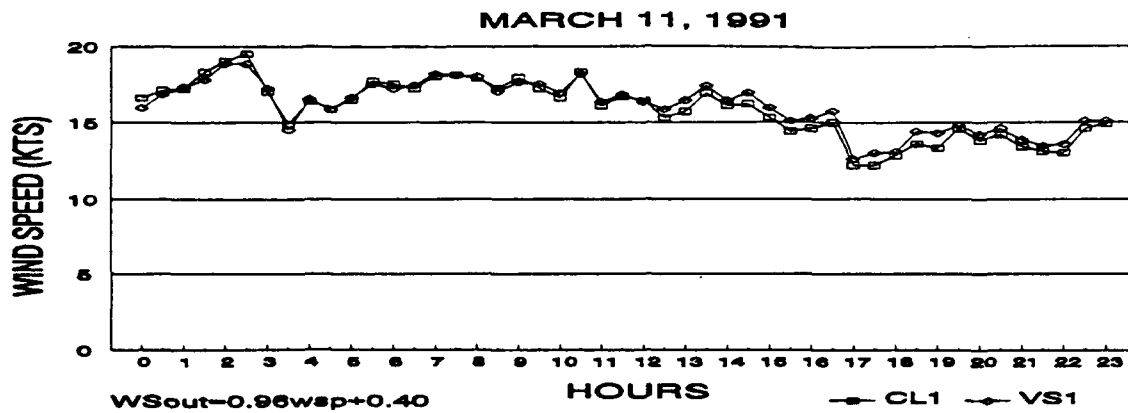
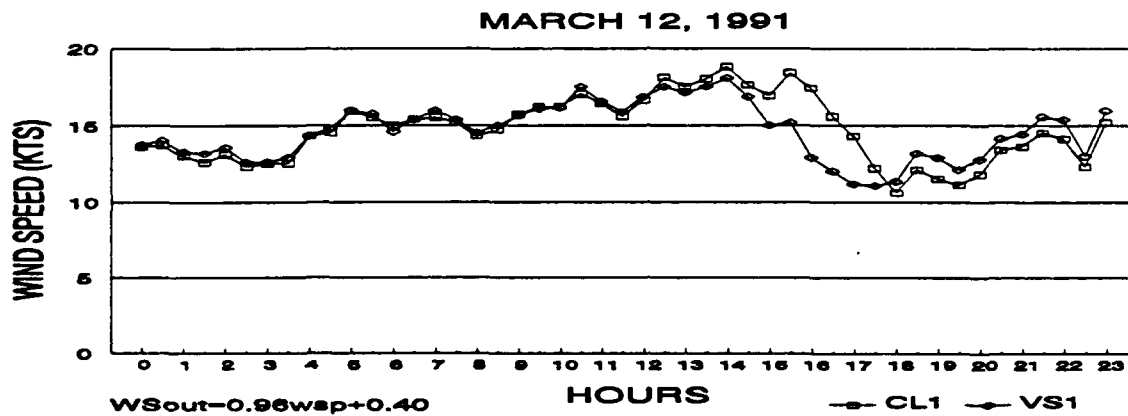
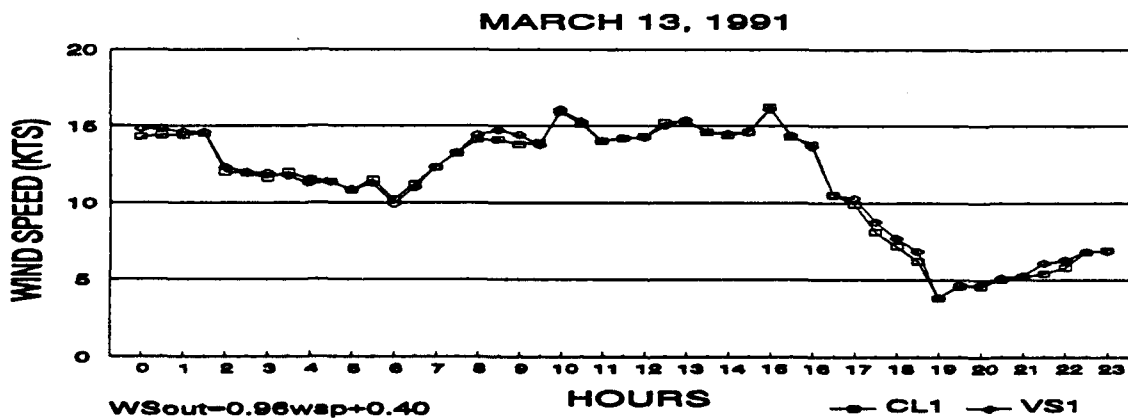
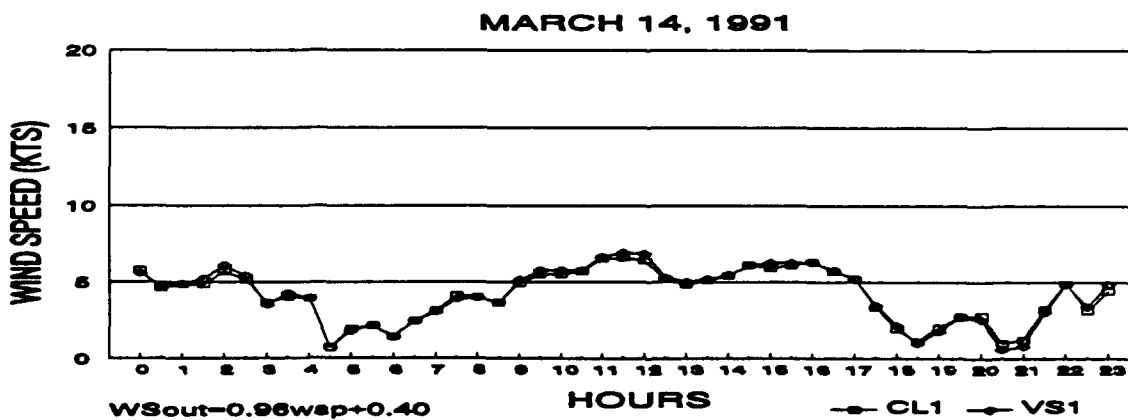
FIGURE 4-15. COMPARISON OF VS1 AND CL1 WIND SPEED ON 3/11-14/91

4.4.3.3 3/12/91 Snow Event - The March 12, 1991 snow event is an interesting case study because there is evidence of effects on the two Vaisala cup anemometers, probably due to blowing snow. The snow event follows the icing period in Section 4.4.3.2. The wind conditions were similar (Figure 4-12) and the same comments on the other sensors pertain.

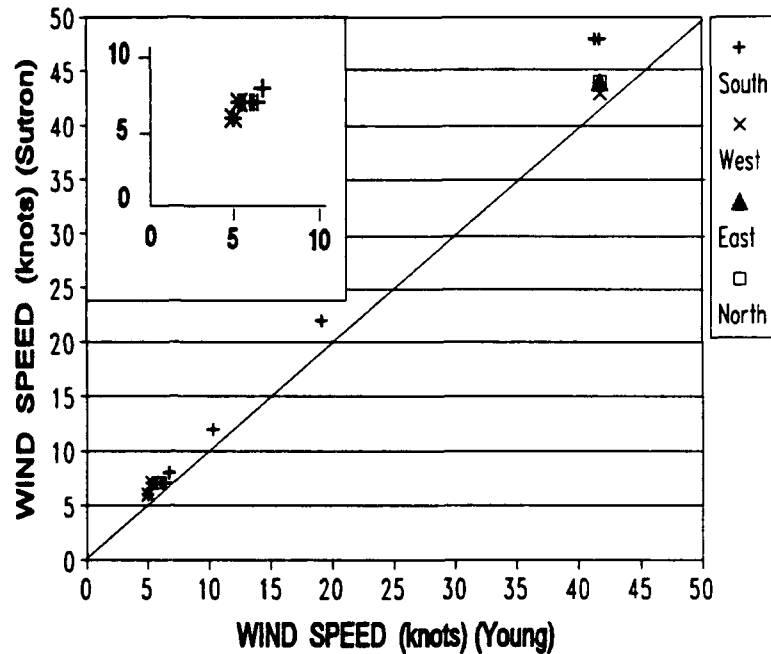
FIGURE 5-3. SUTRON CALIBRATION (S/N 90SC1)

The Sutron and Armtec field test readings of two knots higher than all the other sensors were substantiated for both sensors at low wind speed as shown in Figures 5-3 and 5-4.

Most of the Sutron data was for one direction (south). The Sutron sensor was reading almost 2 knots higher than the R.M. Young reference for winds below 15 knots. The error became larger for higher wind speeds, reaching an error of about 7 knots at a reading of 42 knots. The spread in calibration for different directions at 42 knots was about 5 knots.

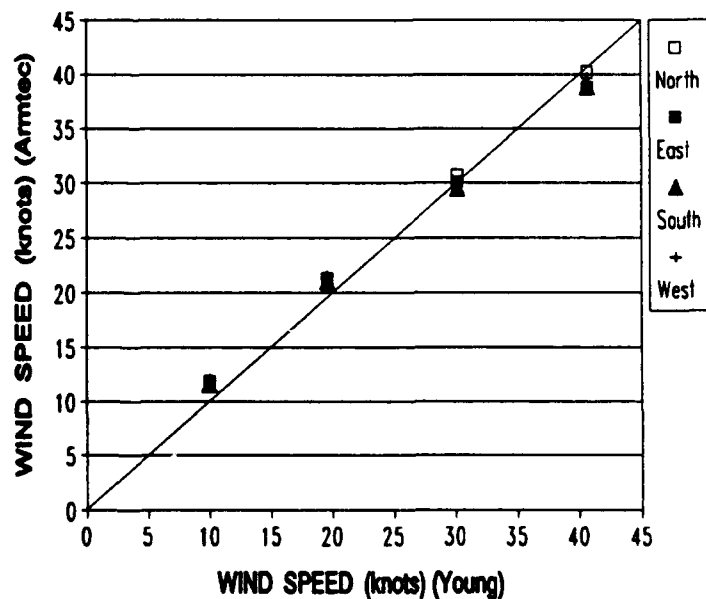
FIGURE 5-4. ARMTEC CALIBRATION (S/N 171)

At 10 knots, the Armtec sensor was also reading almost 2 knots higher than the R. M. Young reference sensor in all four directions. The Armtec sensor readings came into closer agreement with the R. M. Young sensor as the wind speed increased.

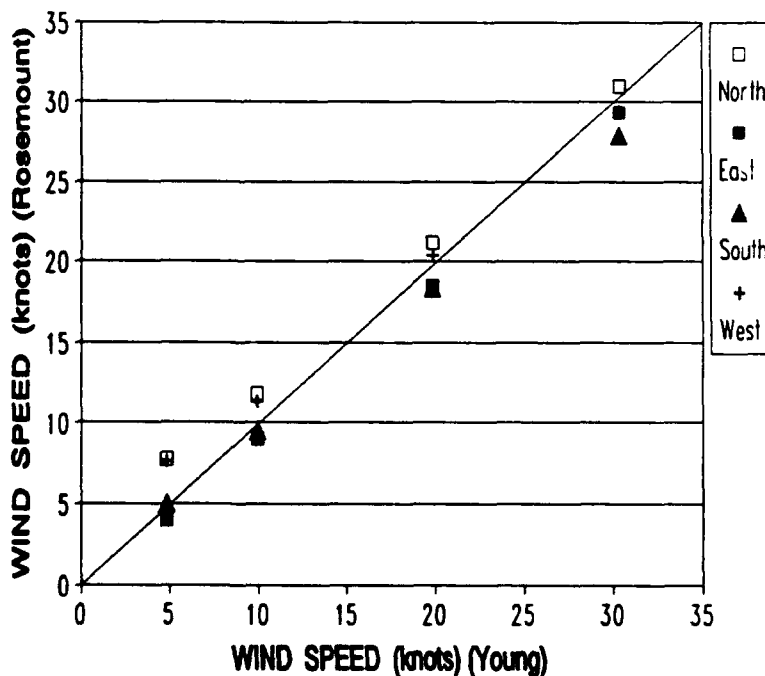
FIGURE 5-6. ROSEMOUNT CALIBRATION (S/N LLWAS1)

Figures 5-6 and 5-7 show the calibrations of the two Rosemount sensors. Four wind directions (north, east, south, and west) were tested for most wind speeds. RS1 (S/N LLWAS1) had been modified during the field testing to improve its response at low wind speeds. This modification limited RS1 to measuring wind speeds to a maximum of about 35 knots. RS2 (LLWAS2) was tested at wind speeds over the normal range (up to 42 knots).

Both Rosemount sensors showed somewhat greater differences from the R. M. Young reference sensor at low wind speeds than at high wind speeds, as would be expected for a pressure sensor. Since the signal is proportional to the square of the wind speed, a pressure offset will produce a greater error at lower wind speed. The modified RS1 sensor did show at best, a slight improvement in performance over the other Rosemount unit at the low wind speeds, but the improvement was at the cost of

reduced dynamic range. The Rosemount sensors also showed significant calibration variations (4 knots) with direction at both high and low wind speeds.

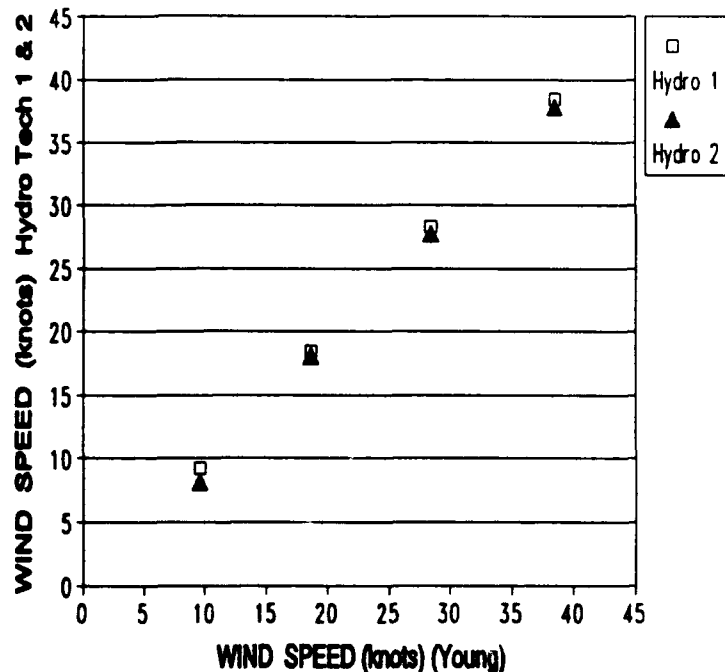
FIGURE 5-8. HYDROTECH CALIBRATIONS (S/N 131, 132)

Figure 5-8 shows the calibration for the two Hydro Tech anemometers. Their response was consistent at high speeds, but somewhat different at low speeds. This difference represents the high starting threshold noted in section 5.2.4.

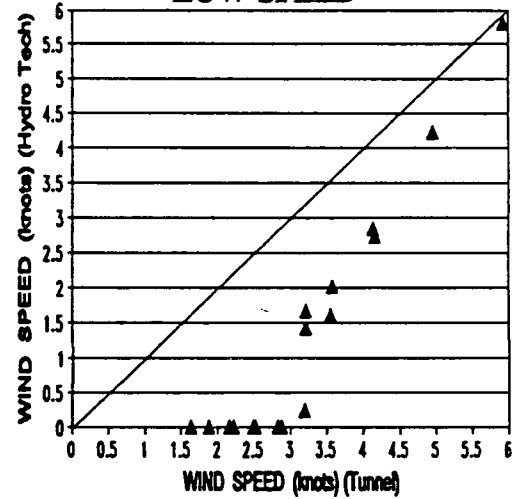
**FIGURE 5-13. HYDRO TECH:
LOW SPEED**

The R. M. Young anemometer was indeed the most sensitive and had the lowest starting threshold. Climatronics, Vaisala, and Belfort (cup) had starting thresholds in close proximity to each other. The Hydro Tech anemometer had the highest starting threshold at about 3 knots. Note that this higher starting threshold results in significant measurement errors at wind speeds up to five knots. The second Hydro Tech anemometer was also tested for suspected problems. The starting threshold on the second Hydro Tech was somewhere between 5.5 and 7 knots, probably due to a bad bearing.
