DOT HS 813 724

**Special Crash Investigations:  
Remote Move-Over-Law Crash  
Investigation;  
Vehicle: 2016 Chevrolet Silverado  
2500;  
Location: Washington;  
Crash Date: May 2021**

**Special Crash Investigations**  
**Remote Move-Over-Law Crash Investigation**  
**Case No. DS22005**  
**Vehicle: 2016 Chevrolet Silverado 2500**  
**Location: Washington**  
**Crash Date: May 2021**

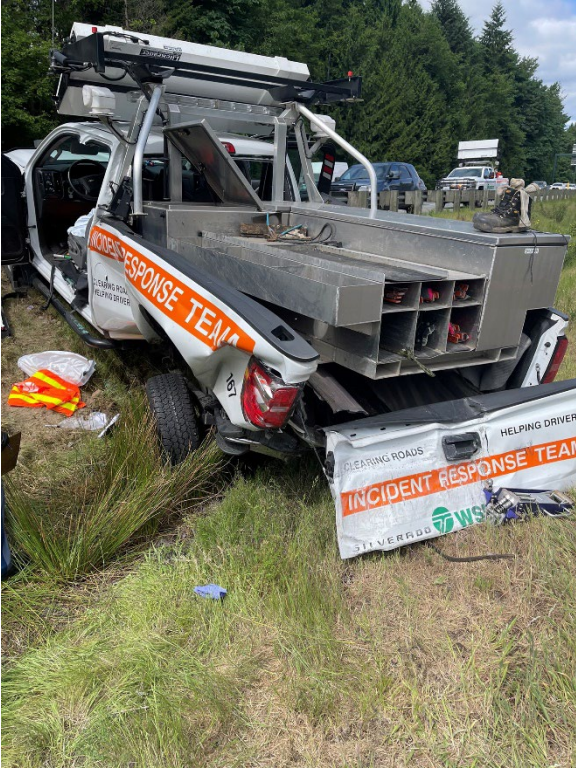
According to the police, the Toyota traveled through the lane closure striking one or more traffic cones before its front plane struck the back plane of the Chevrolet. This caused the Chevrolet to depart the left roadway edge and cross the grass median where its front plane struck an embankment and guardrail where it came to rest facing west (Figure 1). The Toyota traveled off the left roadway edge and came to rest facing east in the center median (Figure 2), and the engine compartment caught fire.

*Figure 1. 2016 Chevrolet Silverado 2500 at rest looking north (police photo)*

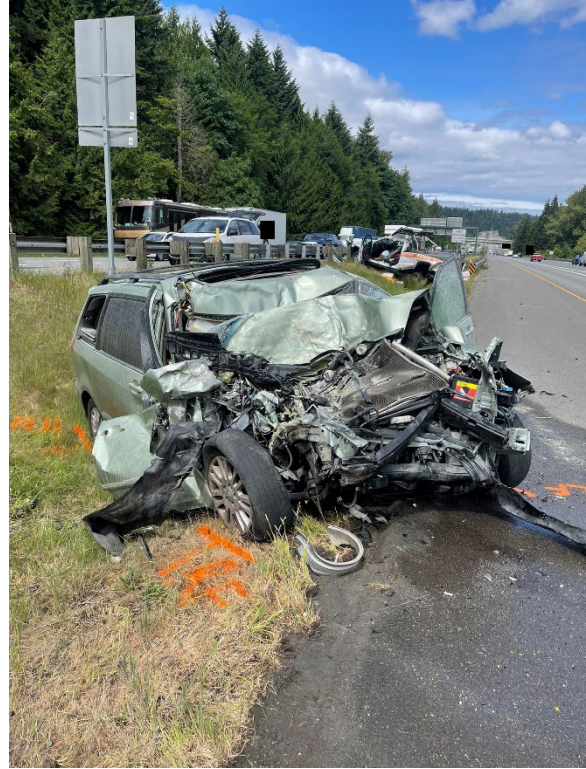
*Figure 2. 2008 Toyota Sienna at rest looking north (police photo)*

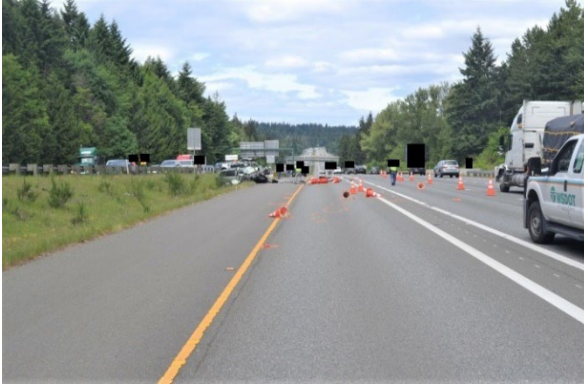
*Figure 3. Crash site looking north at toll lane closure zone (police photo)*

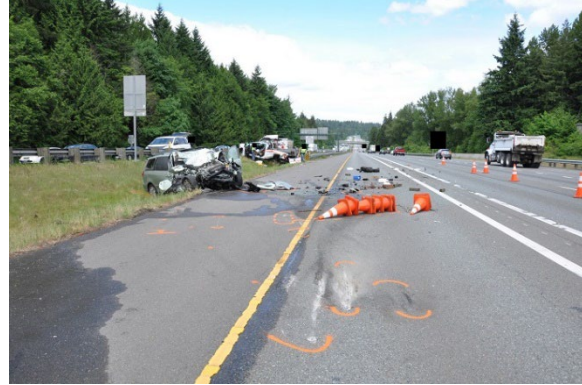
The front plane of the Toyota struck one or more traffic cones marking the lane closure (Event 1). It continued traveling northbound for approximately 40 m (131 ft) until its front plane struck the back plane of the Chevrolet (Event 2). The damage flow to both vehicles and scrape marks in the pavement at the point of impact (Figure 4) suggested the front end of the Toyota under-rode the back plane of the Chevrolet. Impact pushed the Chevrolet forward and left where it departed the left roadway edge. Its front plane struck the grassy upward sloping embankment in the center median (Event 3) and a wood and metal guardrail (Event 4) where it came to rest facing west with its front plane in contact with the guardrail. The Toyota traveled off the left road edge and came to rest facing east in the center median. The Toyota's post-crash engine compartment fire (Event 5) was extinguished by the first police officer to arrive on-scene.

*Figure 4. Point of impact, Event 2, crash site looking north (police photo)*

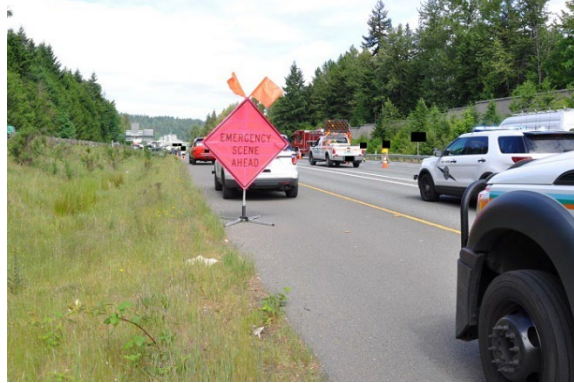
influence of drugs. It is unknown if she was aware of the state's Move-Over-Laws and the appropriate driver response to such conditions. It is unknown if she observed the roadside warning signs, traffic cones marking the lane closure, or the presence of the Chevrolet in the toll lane. The PCR stated the driver did not brake prior to impact, and she stayed in her original travel lane after striking one or more traffic cones.

*Figure 5. Warning sign, crash site looking north  
(police photo)*

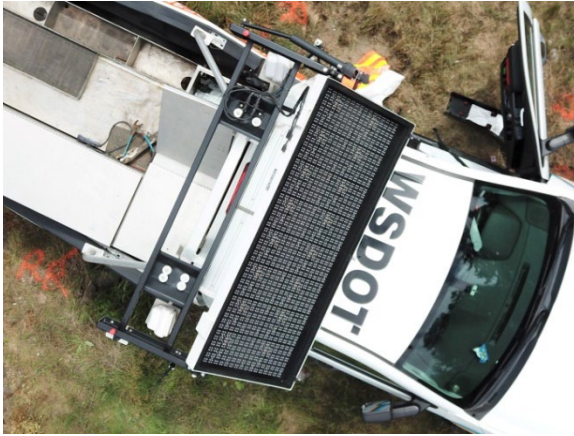
The Chevrolet had a LiteReader message board manufactured by LiteSys Inc. mounted to a framework connected to the toolbox extending above the roof of the cab (Figure 6). The message board had two lines of 25 cm (10.0 in) characters illuminated in LED lights. The message displayed at the time of the crash was unknown. During the crash, the message board rotated forward of its original, rear-facing position. The vehicle had emergency responder lamps on the front and rear planes, and four-way amber flashers.

*Figure 6. LiteSys Inc. LiteReader LED message board, 2016 Chevrolet Silverado (police photo)*

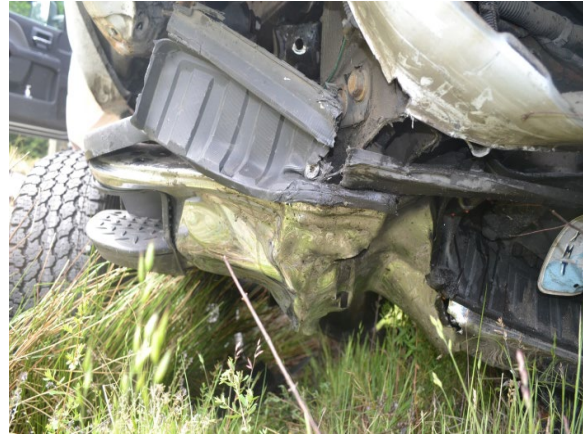
The Chevrolet sustained damage to the front, back, left and right planes, and the undercarriage. The back and left plane and undercarriage were damaged in the impact with the front plane of the Toyota in Event 2. Direct damage was present on the tailgate, which was hanging by metal cables. The back bumper was crushed and rotated under the vehicle frame (Figure 7). The left cargo bed was buckled and the left rear axle was displaced forward reducing the length of the left wheelbase. The left plane and undercarriage were damaged by override contact with the Toyota’s front end and hood. It is likely the extent of crush to the back plane was mitigated by the vehicle’s metal toolbox and the underride dynamics of the Toyota. The estimated collision deformation classification (CDC) for the Chevrolet in Event 2 was 06BDEW2. The front plane and possibly the undercarriage were damaged in the contact with the embankment in Event 3. Police reported this contact. The estimated CDC for the Chevrolet in Event 3 was 12FDEW1. The front plane struck a wood and metal guardrail that remained in contact with the vehicle’s front bumper guard at final rest. The front plane of the Chevrolet was shielded by an unknown brand metal bumper guard and crush damage appeared to be minor. The right front fender was slightly crumpled and the bumper guard was slightly bent. The estimated CDC for the vehicle in Event 4 was 12FDEW99.

*Figure 7. 2016 Chevrolet Silverado back plane damage to bumper (police photo)*

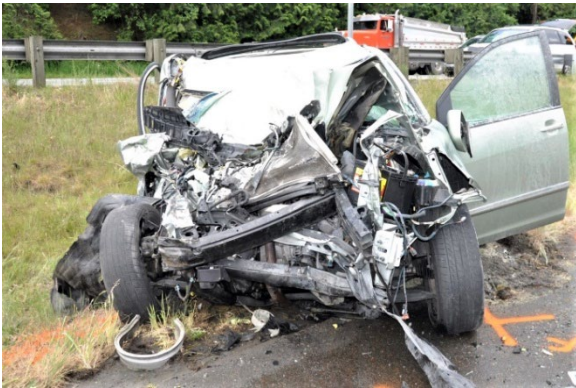
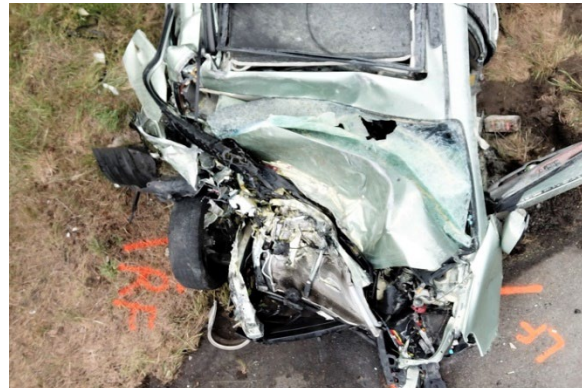
The Toyota sustained unknown severity crush in the Event 1 impact with traffic cones and severe crush damage to the front plane in the Event 2 impact with the Chevrolet (Figures 8 and 9). The front bumper fascia and grille were missing and the backing bar was bent upward. Longitudinal crush extended into the engine compartment and the radiator was pushed upward. The hood and roof were deformed and the windshield was fractured and holed. The right front axle was moved rearward reducing the right wheelbase, and the right front tire was cut and de-beaded. The right front fender and the right-side doors were deformed. The right front door appeared to have opened, possibly due to latch and post separation. The left plane appeared less severely damaged than the right plane. The left front fender was deformed and the left doors appeared to remain operational. The estimated CDC for the Toyota in Event 1 was 12F9EN99 and the estimated CDC for Event 2 was 12FDEW4. The CDC was based on police photos only.

*Figure 8. Front-plane damage, 2008 Toyota Sienna (police photo)*

*Figure 9. Front-plane damage, top view, 2008 Toyota Sienna (police photo)*
