DOT HS 813 692

**Special Crash Investigations:  
Remote Move-Over-Law Crash  
Investigation;  
Vehicle: 2020 Ford F-150;  
Location: Utah;  
Crash Date: April 2022**

**Special Crash Investigations**  
**Remote Move-Over-Law Crash Investigation**  
**Case Number: DS22013**  
**Vehicle: 2020 Ford F-150**  
**Location: Utah**  
**Crash Date: April 2022**

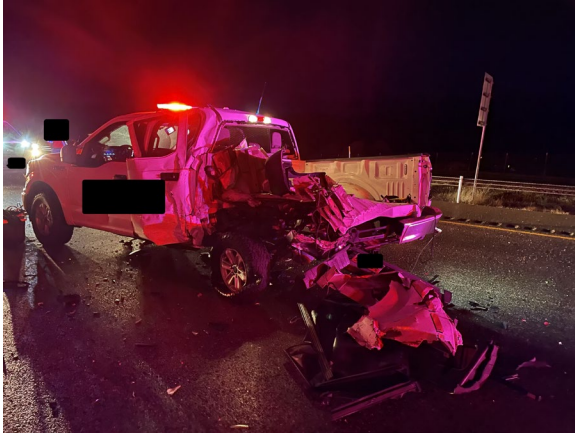
*Figure 1. The 2020 Ford F-150, looking south (police photo)*

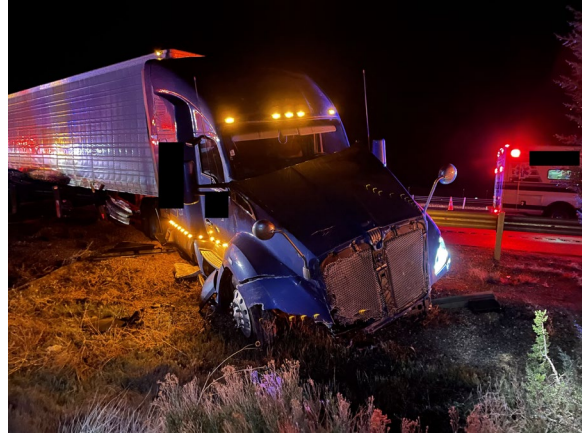
*Figure 2. The 2014 Kenworth tractor-trailer, looking south (police photo)*

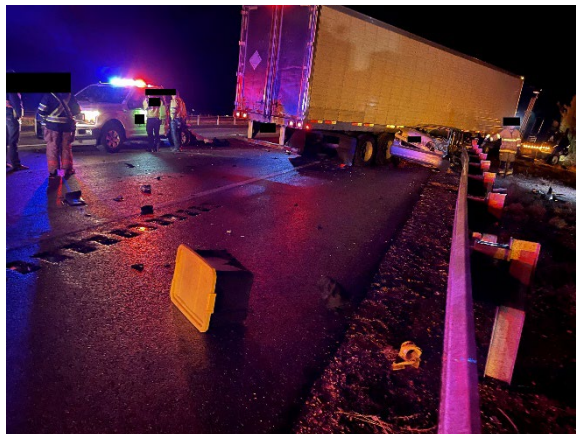
The Kenworth struck and overrode the guardrail (Event 6). The Kenworth came to final rest with the tractor off-road and the trailer in the right lane in contact with the Honda (Figure 4).

*Figure 4. Final rest, looking north  
(police photo)*

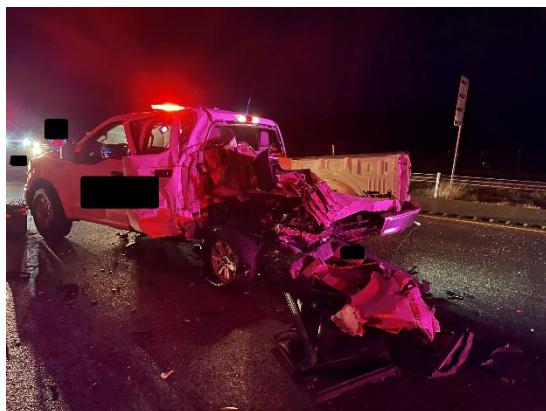
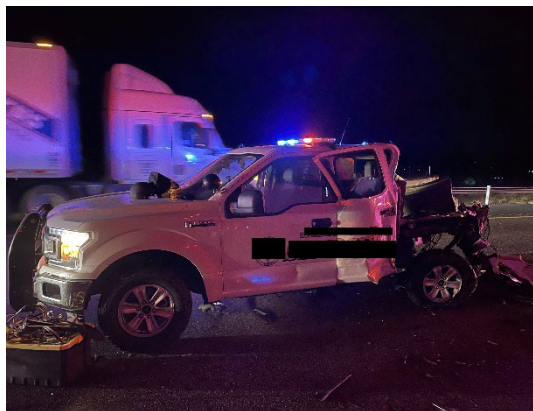
The Ford sustained severe back plane damage from the impact with the front plane of the Kenworth (Figures 5–6). The Field L extended from the left bumper corner to the right bumper corner. The direct damage began at the left bumper corner and extended approximately halfway across the rear plane. The tailgate was detached from the vehicle. The left side of the bed was displaced and overridden, and the back of the cab was crushed forward. There was induced damage and buckling to the cab and left rear door. The left rear tire was de-beaded and was displaced forward, shortening the wheelbase. The left and rear window glazing was disintegrated. The collision deformation classification (CDC) was 07BYAW7.

*Figure 5. The 2020 Ford F-150  
(police photo)*

*Figure 6. The 2020 Ford F-150  
(police photo)*

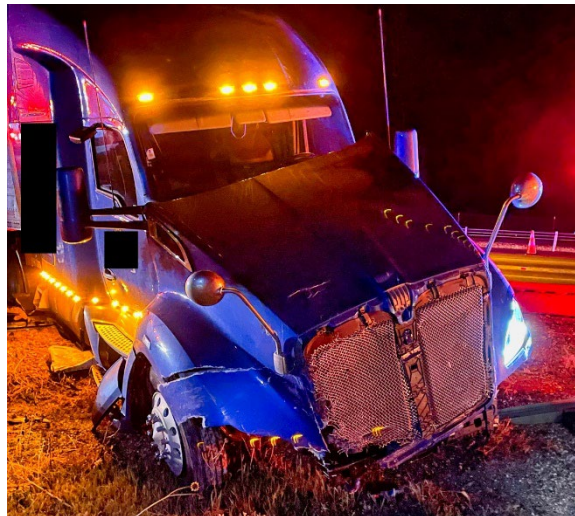
The Kenworth sustained moderate front plane damage from the impacts to the back plane of the Ford, right plane of the Honda, and the impact to the metal guardrail (Figure 7). The impact damage could not be separated. The overall truck deformation classification (TDC) was 12FDEW1. The trailer sustained minor damage to the right plane from the impact with the left plane of the Honda (Figure 8). The TDC for this impact was 12RTFWA.

*Figure 7. The 2014 Kenworth T680 tractor, looking south  
(police photo)*

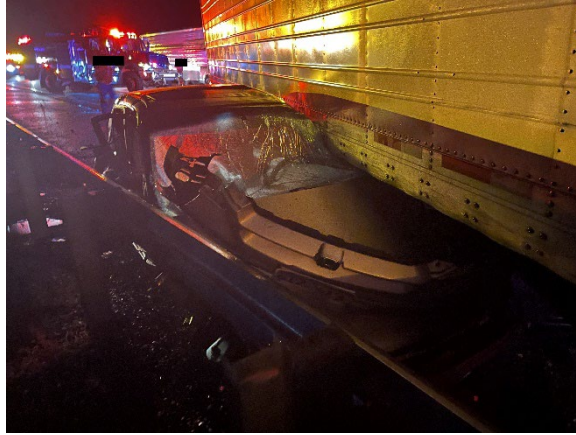
*Figure 8. The Wabash trailer, looking south  
(police photo)*

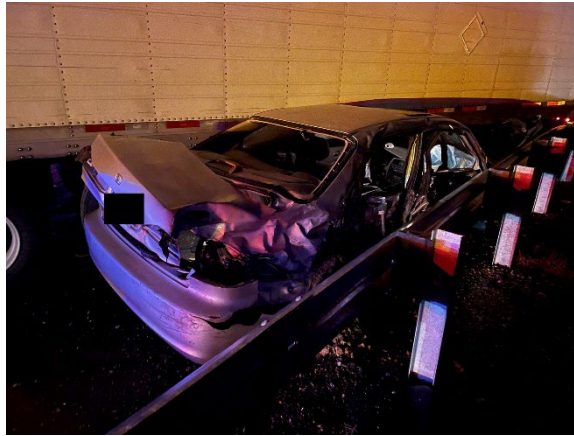
The Honda had damage to both the right and left planes from impacts with the front of the Kenworth, the side of the Wabash trailer, and the guardrail (Figure 9). The vehicle also had damage of an unknown nature from the previous crash.

*Figure 9. The 1998 Honda Accord, left and right plane damage, looking north  
(police photo)*

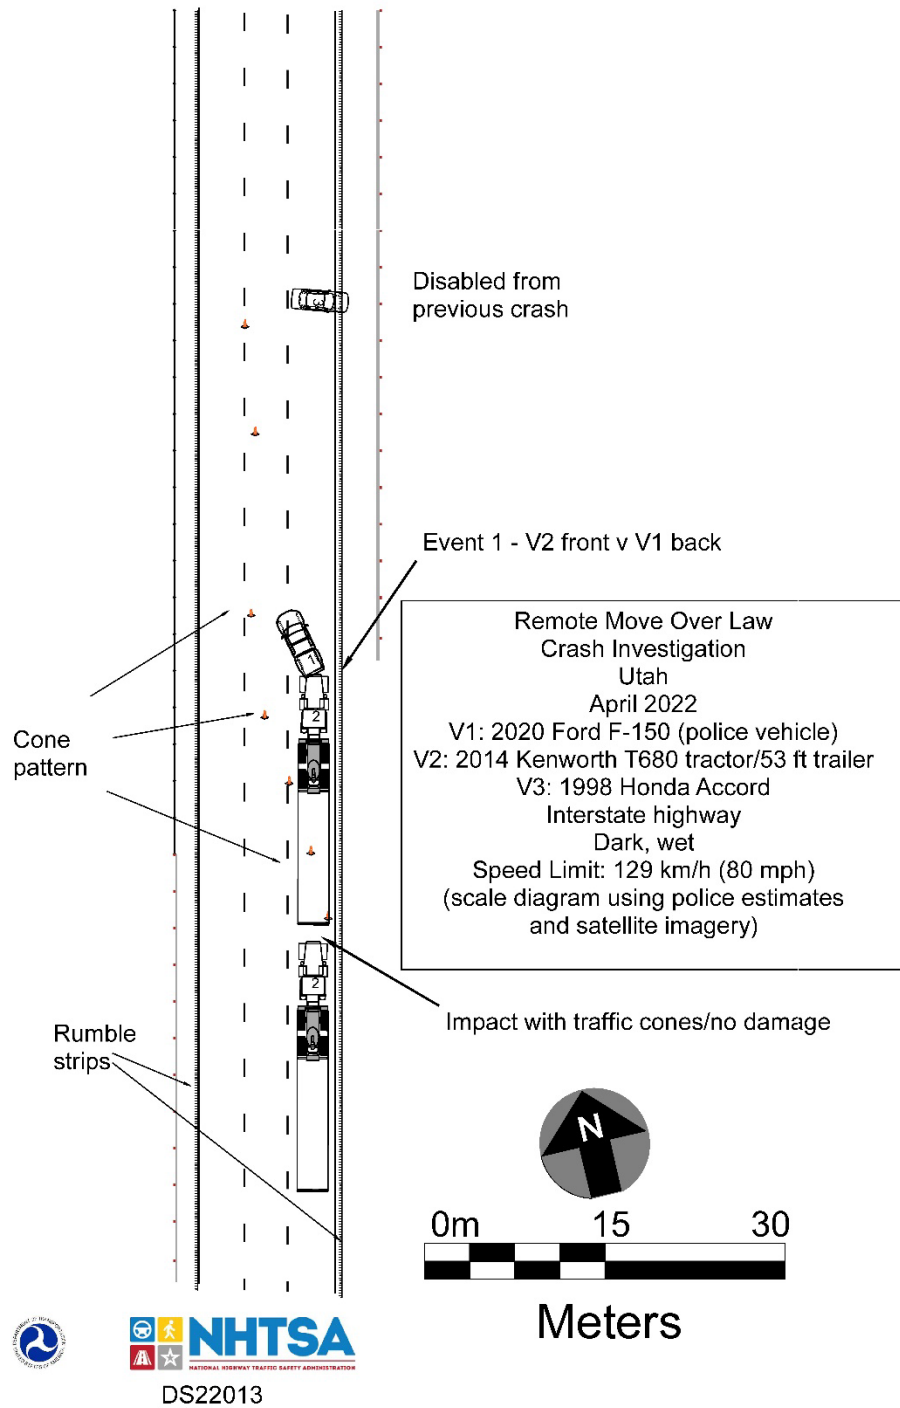
## Crash Diagram (Event 1)

The Kenworth drove through the cone pattern and struck the Ford's back plane with its front plane (Event 1). The Ford was rotated counterclockwise and came to final rest in the middle lane facing south. The Kenworth continued north and struck the Honda's right plane with its front plane (Event 2). The Honda rotated clockwise, struck a guardrail (Event 3), struck the Kenworth a second time (Event 4), and struck the guardrail a second time (Event 5).
