Evaluation of Corrugated HDPE Pipes Manufactured with Recycled Content

August 2025

Final Report 2025-32

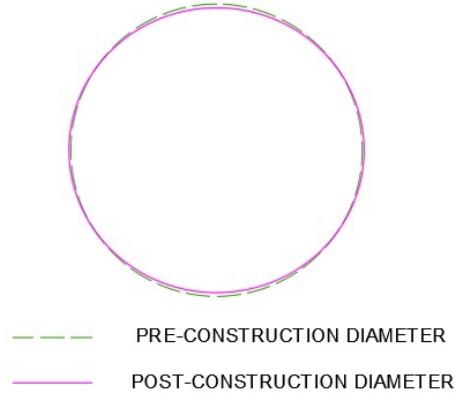
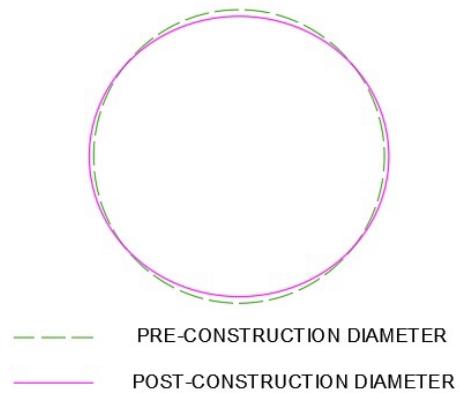
Figure 2.23 Illustration of culvert deflection prior and post construction

Recycled HDPE Pipe (AASHTO M 294 R)			
Direction of Measurement	Pre-Construction Diameter	Post-Construction Diameter	Deflection (Percent)
Horizontal	35.81 in.	36.25 in.	1.2
Vertical	35.91 in.	35.00 in.	-2.5
Diagonal	35.94 in.	36.38 in.	1.2

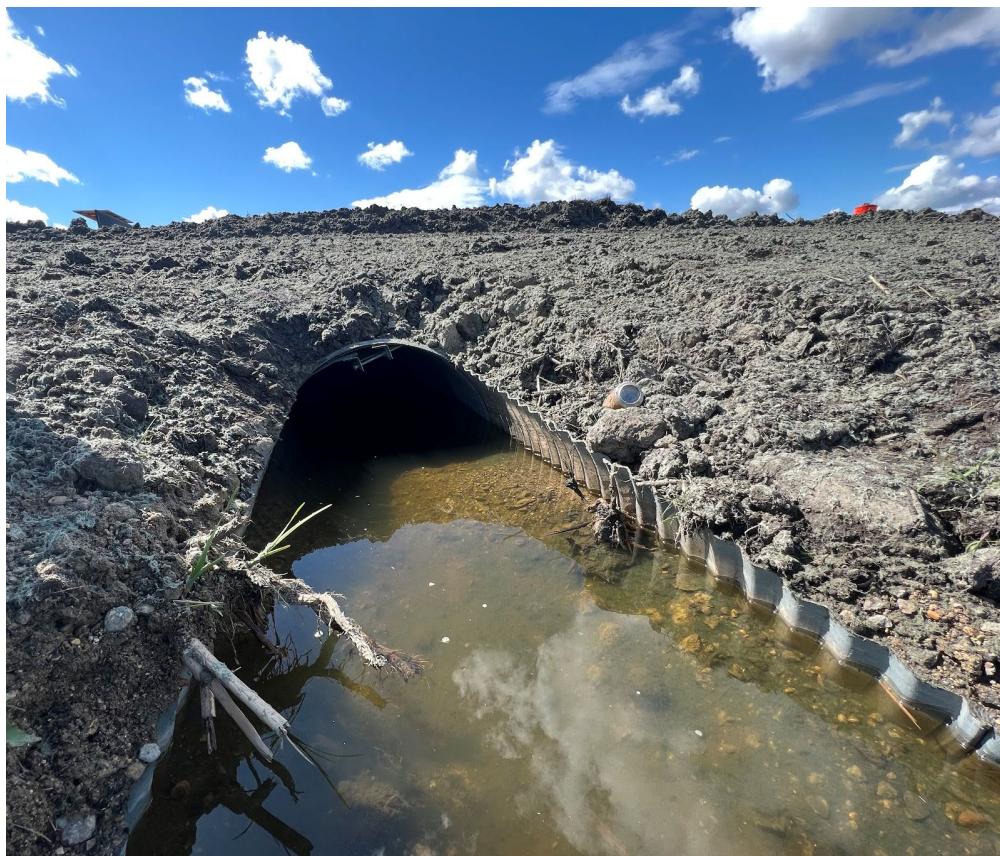
Ultimately due to severe flooding of the Fosston area abruptly after installation, interior water levels were too high to initiate deflection measurements within thirty days due to hazardous working conditions (Figure 2.24). This was a deviation from MnDOT standard 2501 C.4.

Figure 2.24 Photograph of culvert taken 30 days after installation

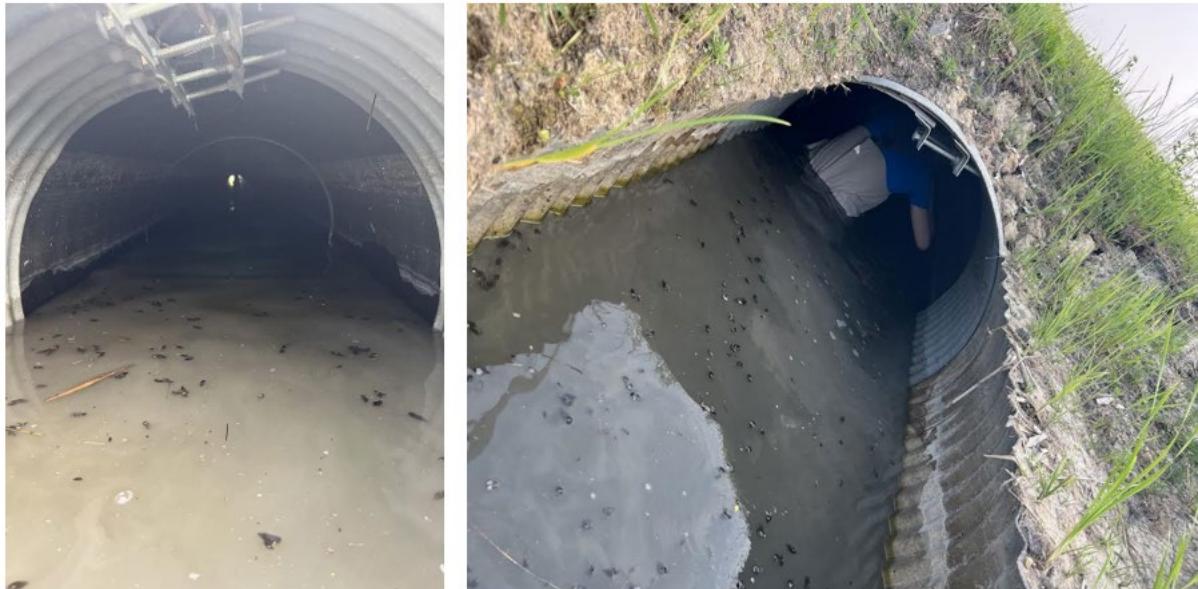
time, indicating that the water level was just below the springline of the pipe, leaving approximately 18 inches of air space above the water to the top of the pipe. While these water levels were still quite high, entry into the culvert was possible, and we were able to inspect the strain gauges, string potentiometers, and joints. Upon inspection, the strain gauges appeared to still be intact, with the two-part polysulfide liquid polymer M-Coat® sealant and adhesive strips holding. However, we were not able to test the electrical function of the gauges as the water levels were too high to safely test. Additionally, due to the continuously high water levels and the subsequent freezing and thawing of the ice over the winter and spring, the string potentiometers were seized up. Specifically, the spring coils attached to the retractable wires in all of the string potentiometers had seized. Therefore, if live-load data is to be eventually collected, the string potentiometers will have to be replaced or a different measurement method employed.

Figure 3.7 June 12, 2023, water levels and inspection

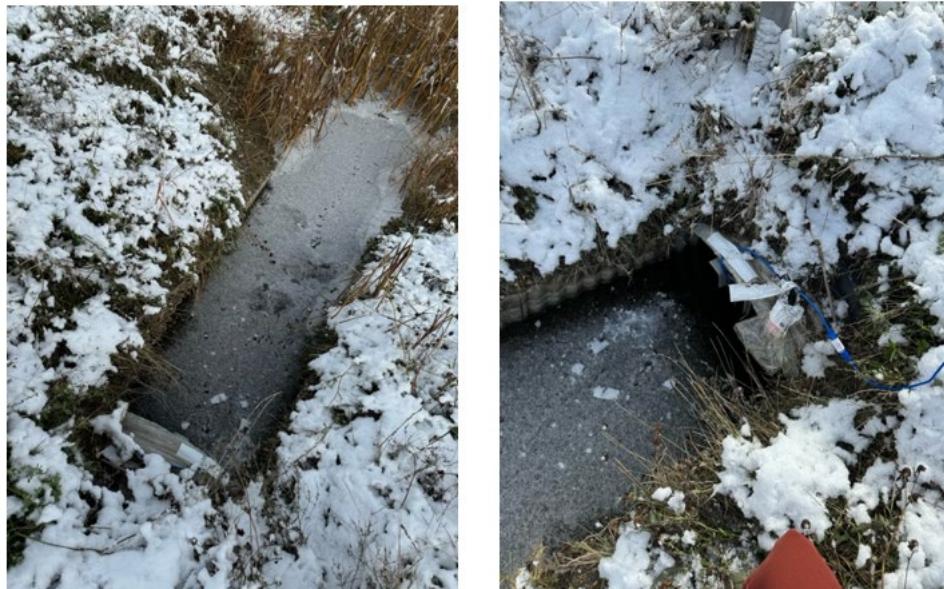
Figure 3.11 Inspection; 2 in. of ice was estimated, and the culverts were not accessible

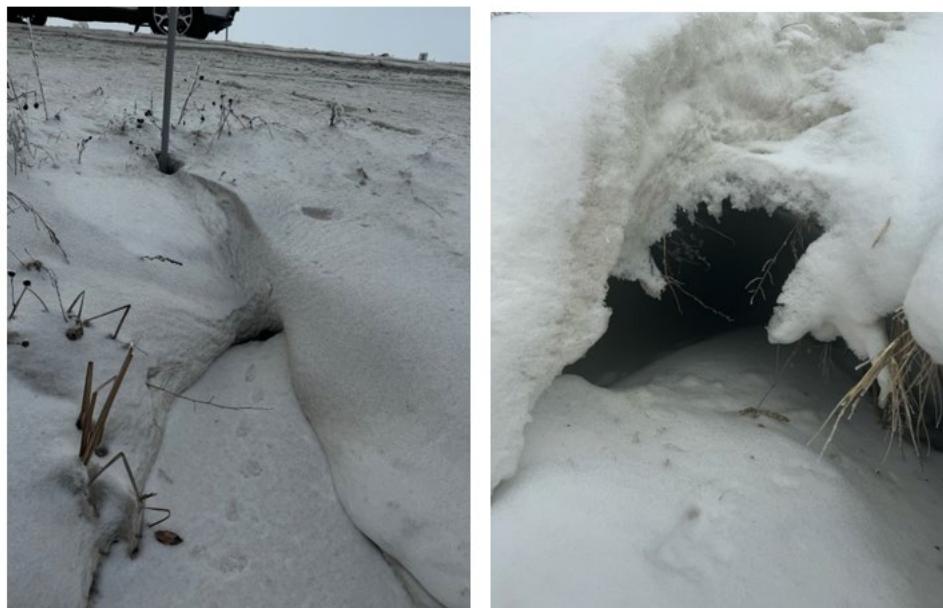
Figure 3.12 January 27, 2024, photos - pipes were deemed unsafe to enter

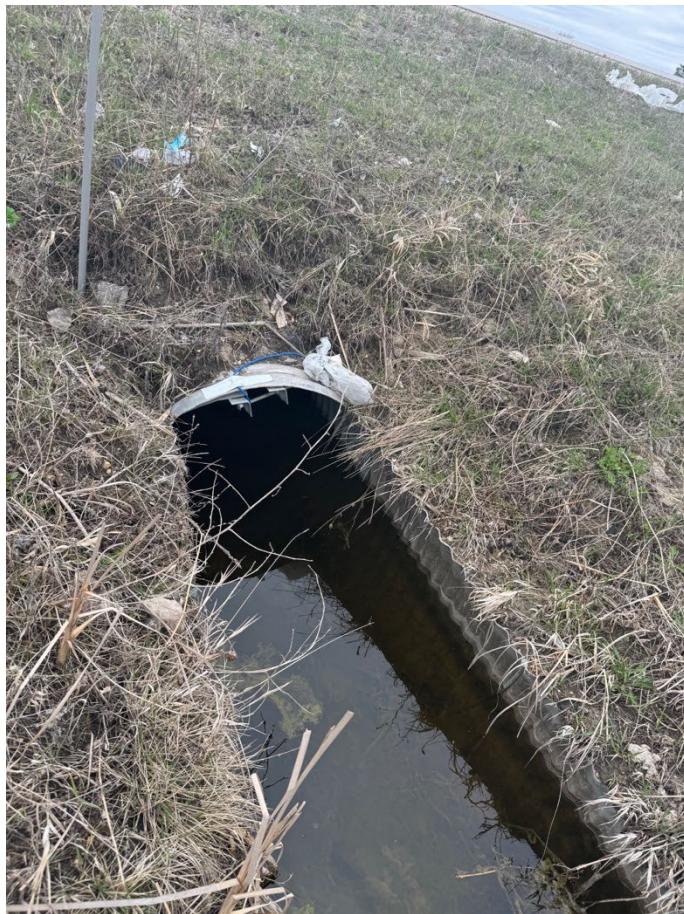
Figure 3.13 April 28, 2024, site visit - water level was over 60% full, and the pipes were deemed unsafe to enter

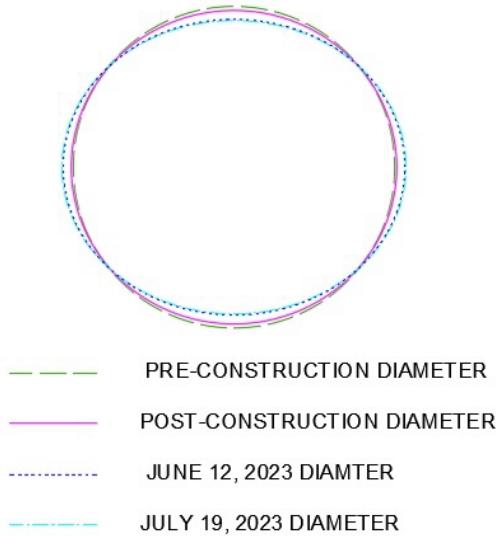
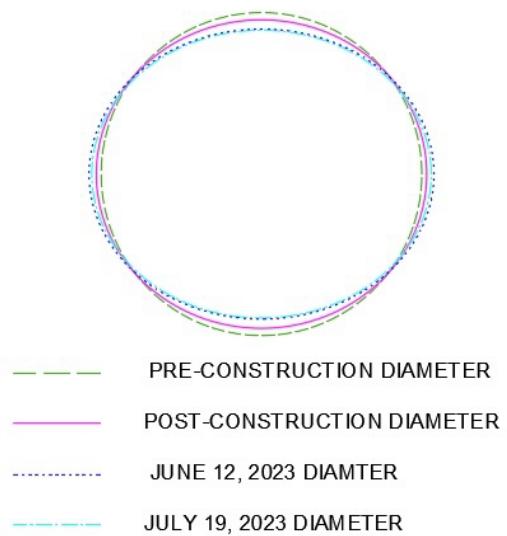
Figure 3.3.14: Illustration of culvert deflection from prior to construction to July 19, 2023

Though accurate measurements of the pipe deflections were not possible due to high water levels and unsafe conditions, a summary of the roughly measured pipe diameters and percent deflections for both the M 294V and M 294R pipes is shown in Table 3.1 and a graphical depiction of the culverts is shown in Figure 3.14. As evident from the measurements, the deflections of both the M 294V and M 294R pipes have apparently exceeded MnDOT's 5% maximum requirements. This could be due to a number of different factors, summarized below.

First, this could be related to the installation of the pipes. The pipes installed underneath the eastbound lanes were monitored by both Michael Pluimer (PI) and MnDOT personnel. It was noted that the backfill around the pipes was compacted in larger lifts than typically recommended. The contractor deemed that this was acceptable for the type of backfill being used. However, soil samples were retained and could be further tested to determine the strength of the materials and validate this assessment if desired by MnDOT. Due to the scheduling of the project, Michael Pluimer was not available for the installation of the pipes underneath the westbound lanes. The installation was monitored and documented by graduate student, Katie Padden, and reported in Task 5. It may be worthwhile to inspect the deflections of the pipes underneath the eastbound lanes to see if there are any differences from those underneath the westbound lanes.

It should be noted that while the pipes have apparently exceeded the maximum MnDOT deflection requirements, the pipes did not continue to increase in deflection from the June 12, 2023 to April 28, 2024 measurements. Additionally, visual inspection of the pipes did not show any significant distortions or damage. Finally, there does not appear to be any significant difference in performance between the virgin and recycled pipes. If anything, the recycled pipes are performing slightly better than the virgin pipes, though the deflections are very comparable.

sediment and water in the pipes. Additionally, since the water levels in the pipes made it difficult to accurately measure deflections and monitor the pipes over time, it is recommended to identify an additional test site for further analysis. An LCA showed significant environmental benefits to using corrugated HDPE pipes manufactured with recycled content, and an LCCA showed some potential economic savings.
