# **RECYCLING PORTLAND CEMENT CONCRETE PAVEMENTS IN OKLAHOMA**

**Final Report**

**Tim Borg, P.E.  
Project Manager**

**State of Oklahoma  
Department of Transportation  
Research & Development Division**

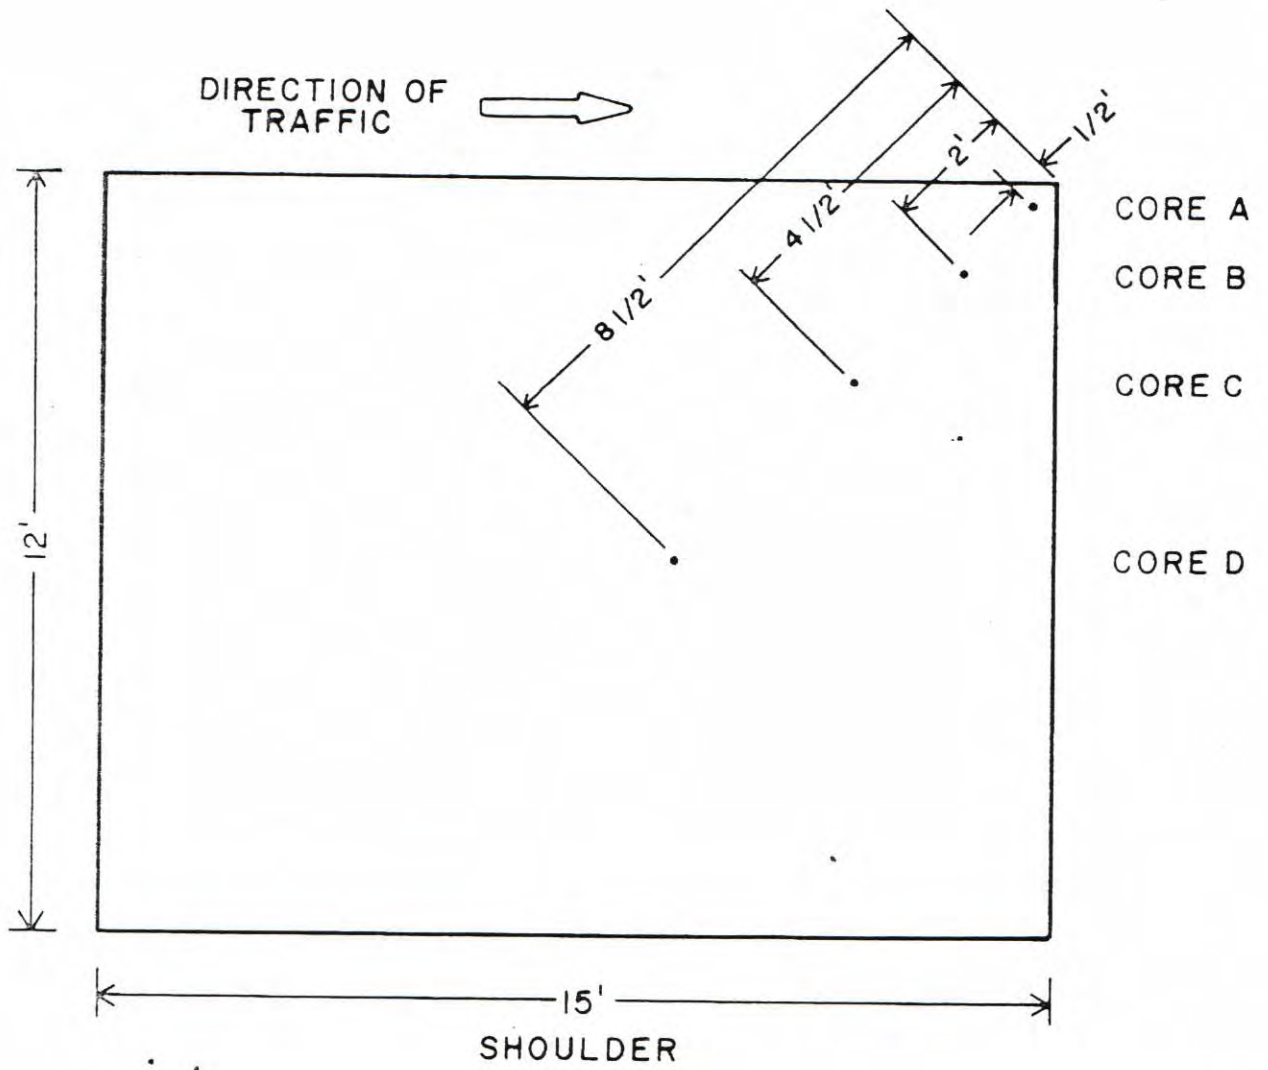
Cores were taken from four selected slabs on the project. One core each was taken at 6 inches, 2 feet, 4.5 feet, and 8.5 feet diagonally from the corner of each slab (see Figure 2). Three of the four cores taken 6 inches from the corner crumbled upon removal. The fourth core had a compressive strength of 3,223 pounds per square inch. Table 1 shows the compressive strength of each core.

Figure 2. Core Hole Locations

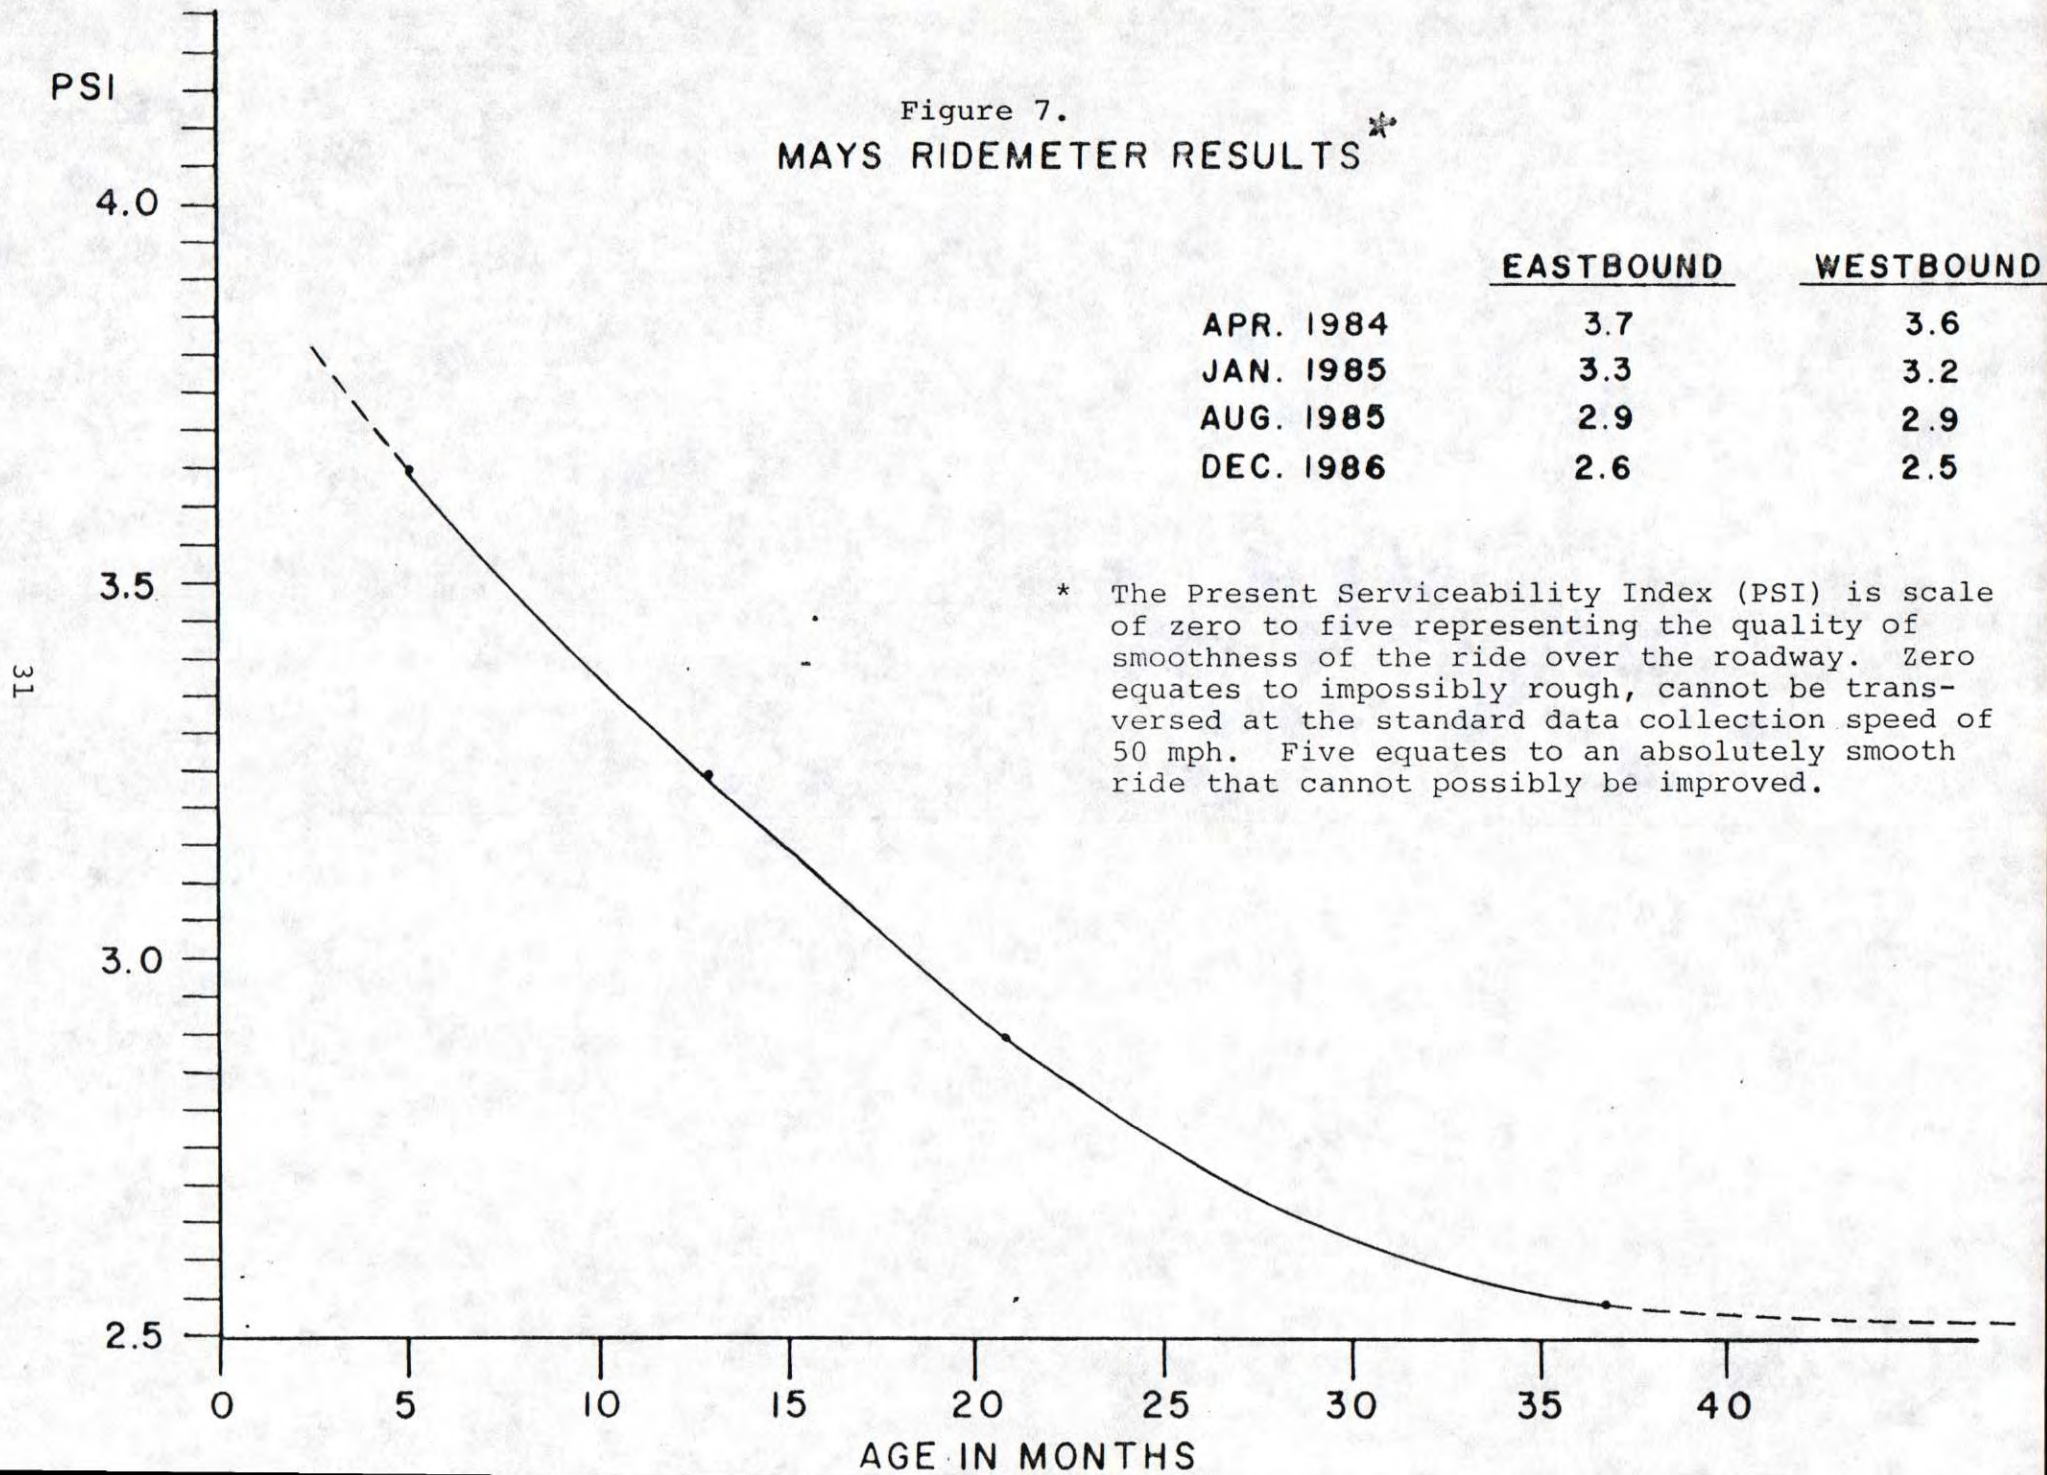
The measure of the ride quality of the pavement can be seen in Figure 7. A Mays Ride Meter mounted in a trailer was pulled over the project to evaluate its smoothness. A Present Serviceability Index (PSI) of zero to five described the ride quality. Zero meant impossibly rough, while five related to an absolutely smooth ride. The tabulated data show a deterioration of the ride quality. However, Figure 7 shows the relationship

Figure 7.  
MAYS RIDEMETER RESULTS\*

time had to the quality of the ride. While the quality of the ride has decreased, it did so at a lessening rate.

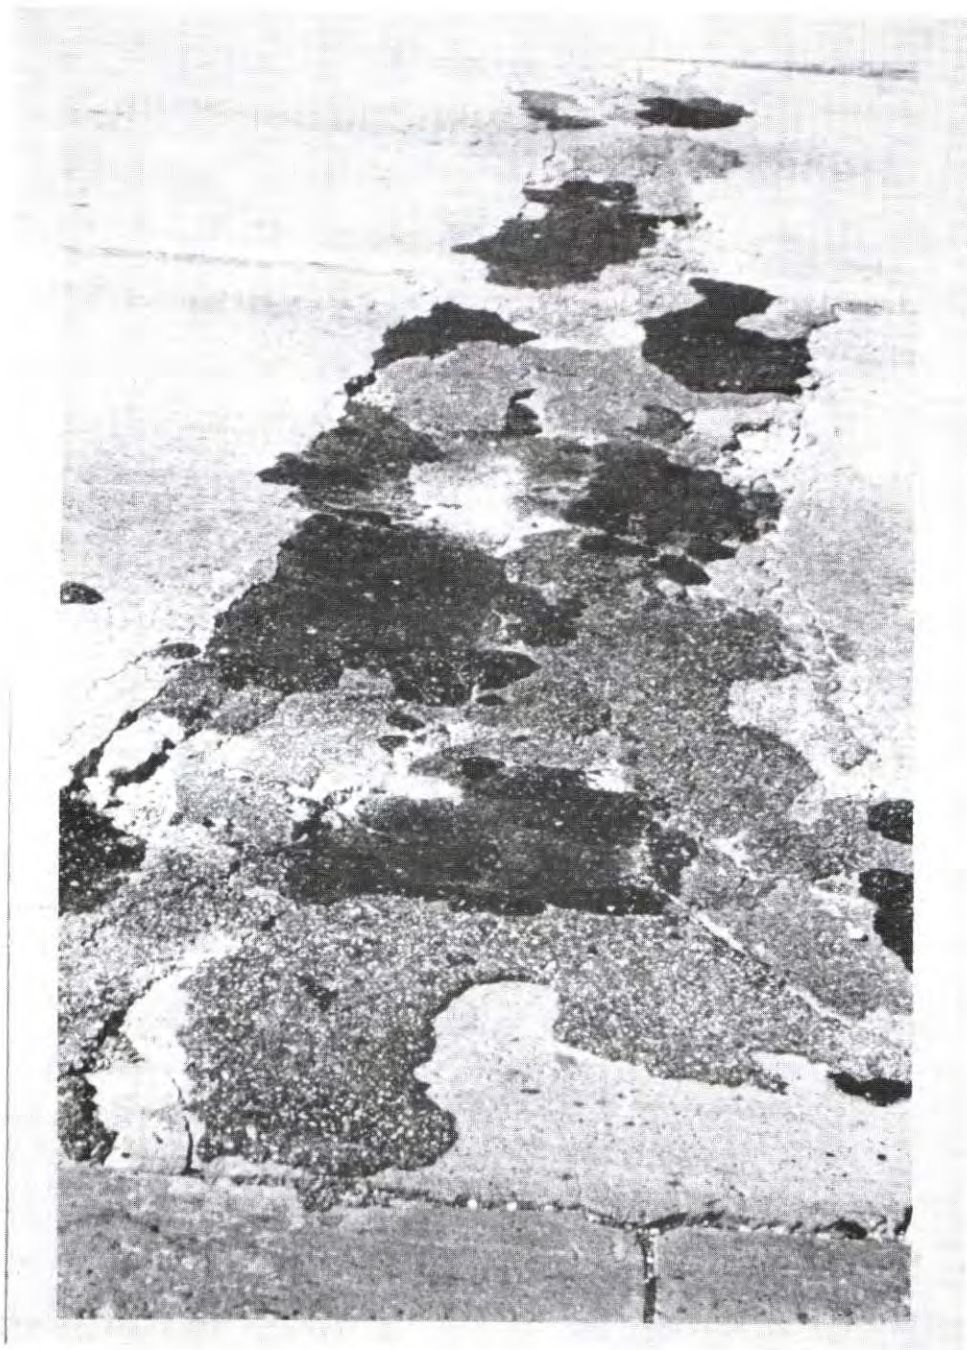
The primary reason for the rehabilitation of this highway was D-cracking failure at the joints. This failure could be described as a series of closely spaced cracks that appear on the surface adjacent and roughly parallel to transverse and longitudinal joints and cracks. Research has found that "D-cracking is a surface manifestation of deterioration that

Figure 1. Deteriorated Joints

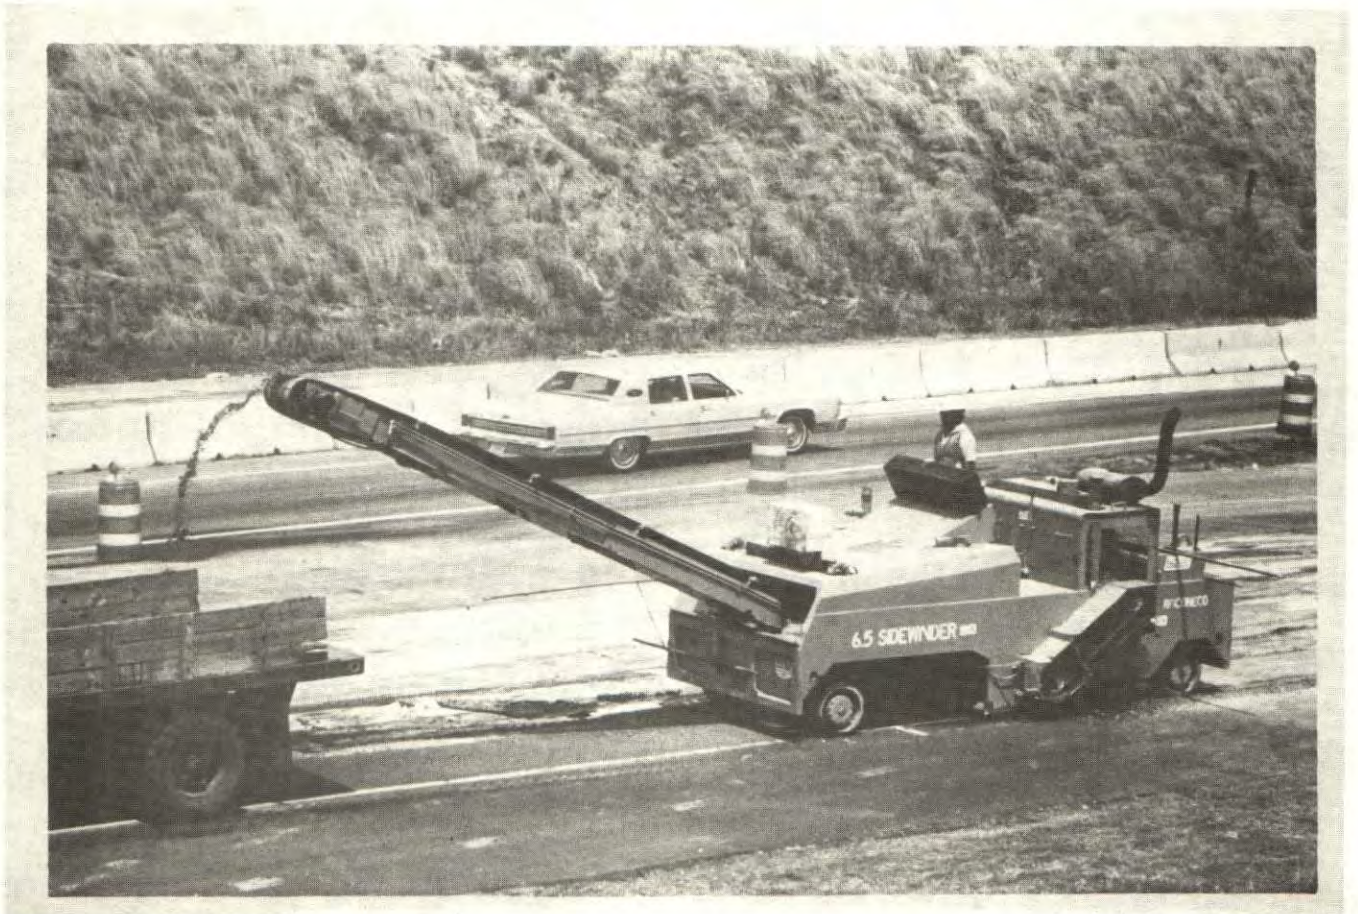
Removing the old guardrail and cold milling all asphalt patches and spot overlays was the first step. The asphalt would contaminate the coarse aggregate if not removed before breaking. The cold milled asphalt was used as fill on the backslopes of some bridge approaches to widen the shoulders.

Figure 3. Cold Milling Asphalt Patches

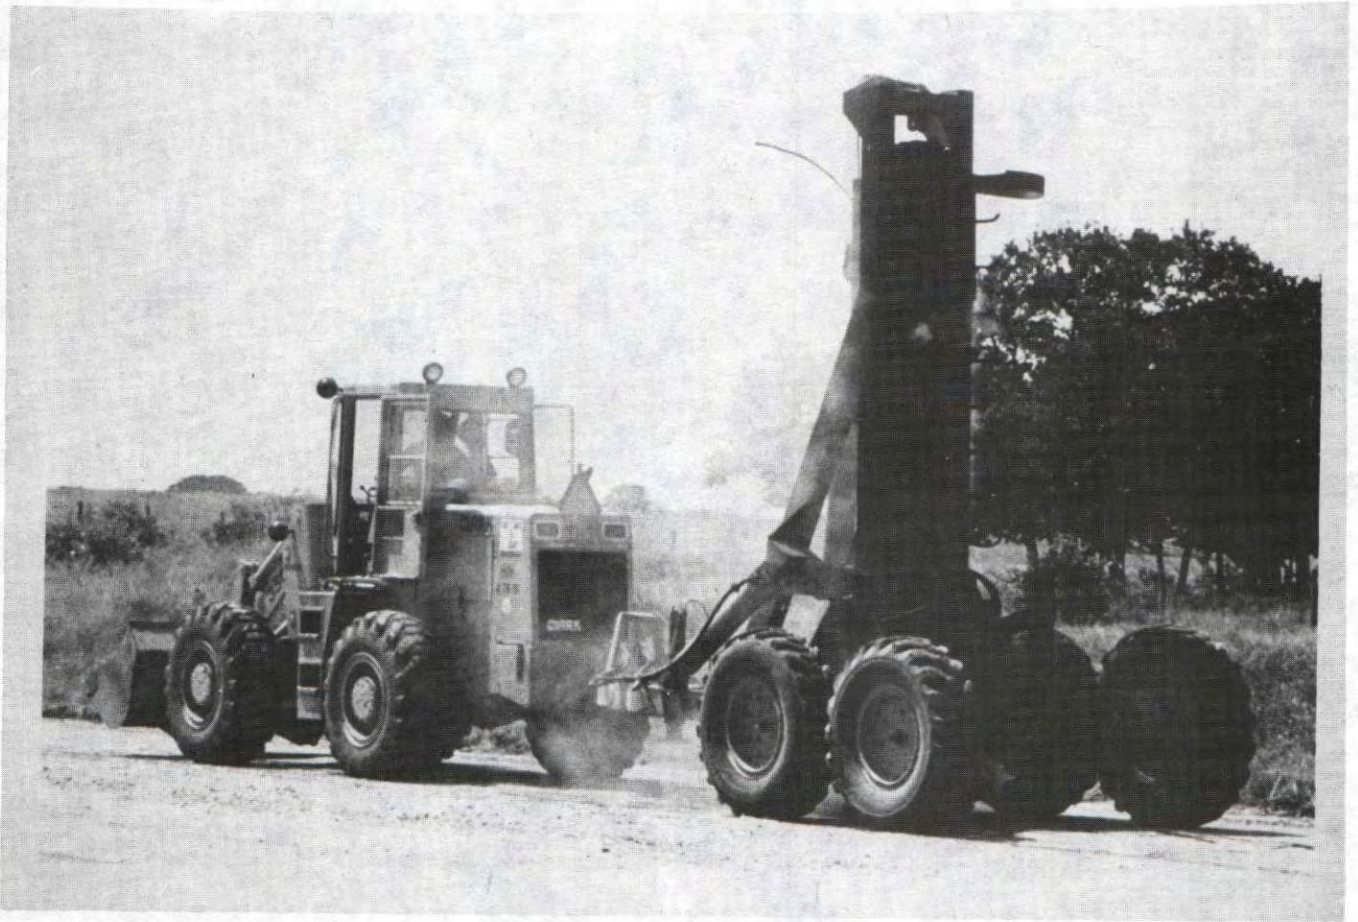
Breaking the existing pavement was the next step in the pavement removal. The contractor used two breaking hammers: a Link-Belt diesel pile driver on a shop built frame and a Pettibone-Universal Pavement Crusher which uses an MKT diesel pile driver. Both pile drivers exerted 18,000 foot-pounds of energy thru a steel shoe that contacted the pavement. Several different breaking patterns were tried. Starting at the centerline and alternately working toward the shoulder 18 inches at a time seemed to disturb the soil cement shoulders the least.

Figure 4. Breaking the Pavement

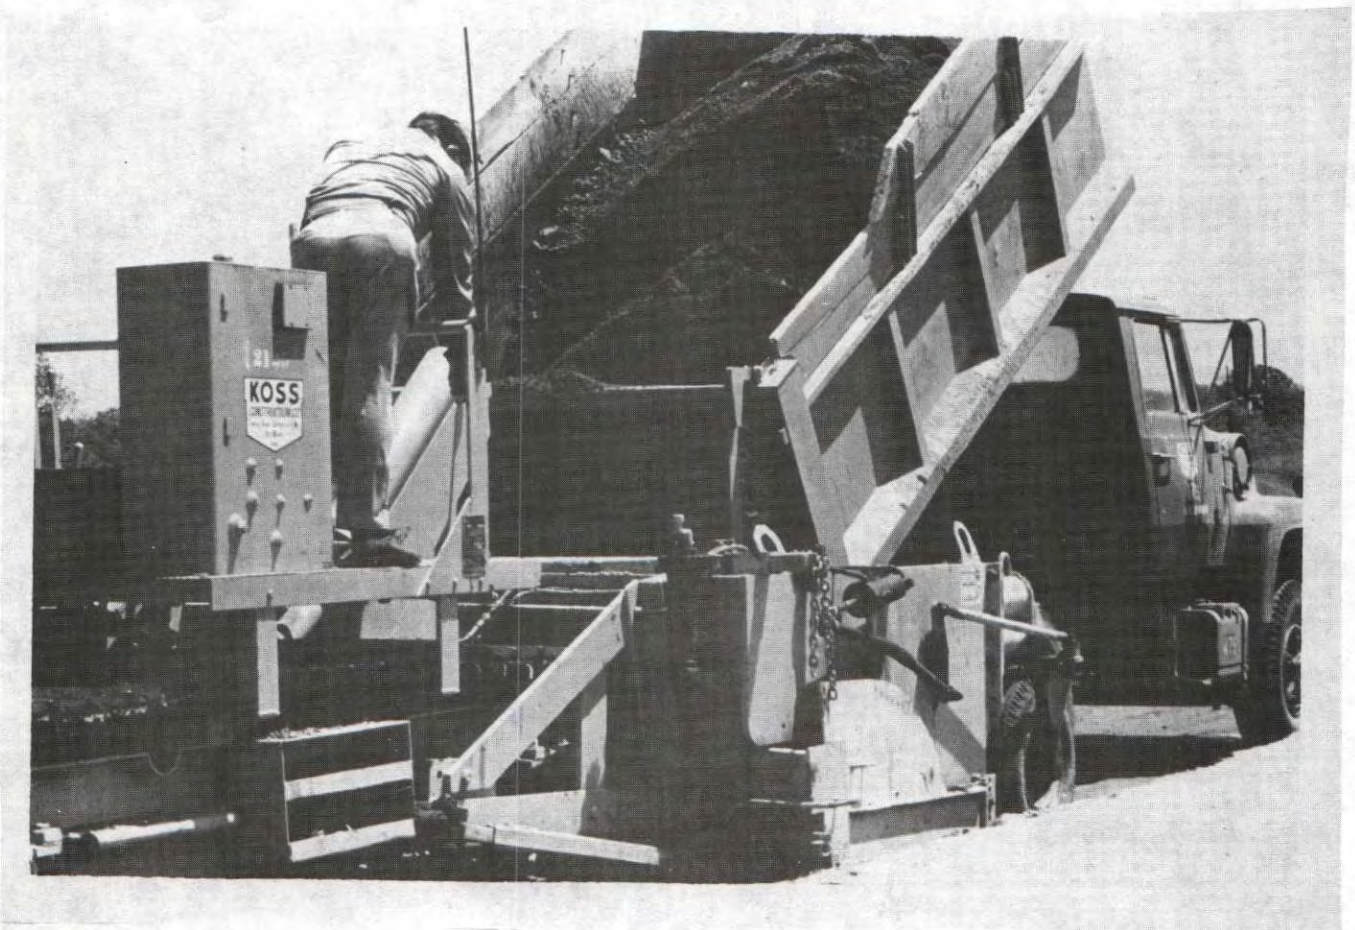
After removing the existing pavement on the first section, it was found that the pavement breaking hammer had consolidated the soil asphalt base. To restore the grade and eliminate the need to mill the shoulders, an average of 3.5 inches of soil asphalt was added to the base. This elevated the surface of the new ten inch thick pavement a minimum of two inches above the uneven, worn shoulders. A pugmill was used on the site to produce 6,560 cubic yards of soil asphalt. The material was placed, blended with the existing soil asphalt base with a pulver-mixer and compacted. An autograder milled a precision grade prior to placing the concrete. Excess soil asphalt was stockpiled for use in the base of the next section.

Figure 12. Adding Soil Asphalt to Base
