POLYMER CONCRETE OVERLAY

SH 51 BRIDGE DECK

INTERIM REPORT

Project No. 80-03-1, Item 2409

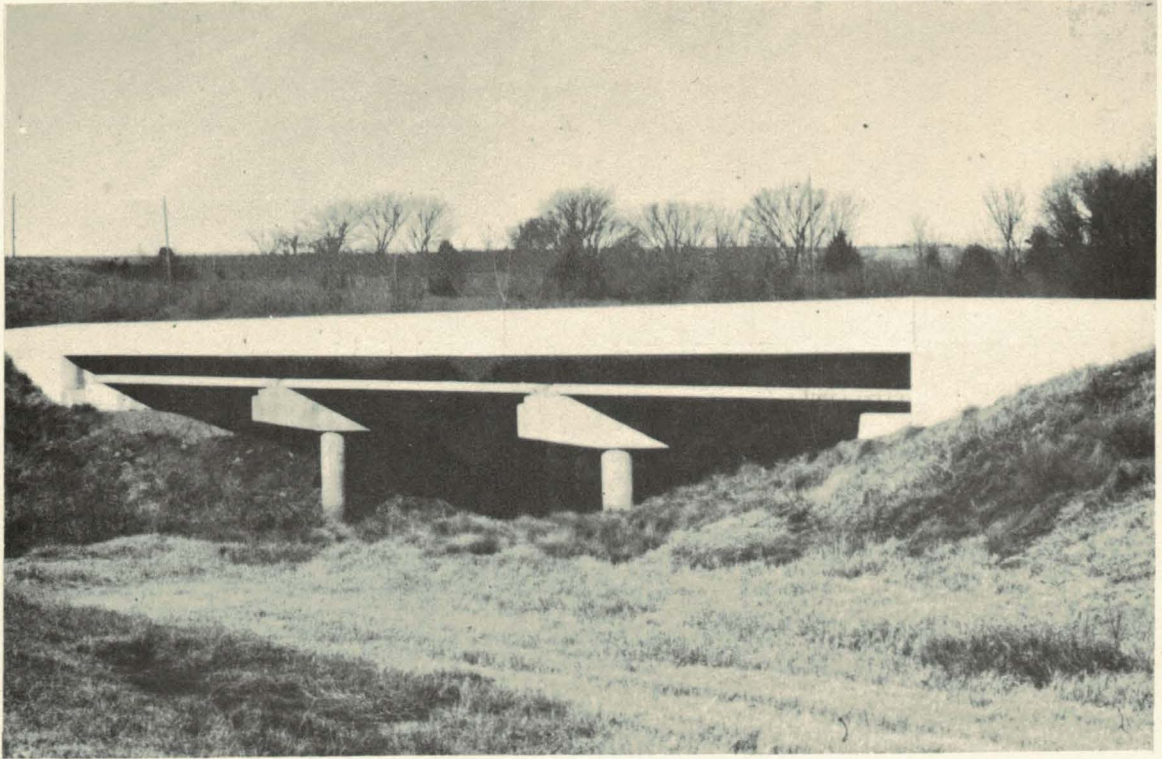
Figure 1. The original bridge on westbound SH 51, Payne County.

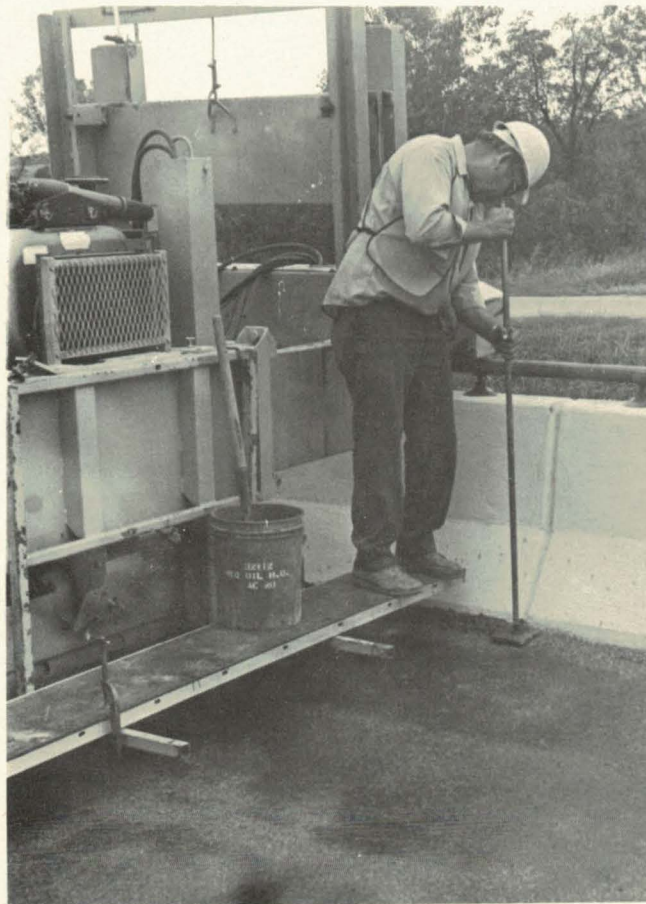
The vibrating screeds of the paver could not work directly against the parapet wall; therefore, a man with a tamping tool stood on the back of the paver, compacting and leveling a 4 in (100 mm) wide section of overlay along the parapet. The paver could not finish the last 3 ft (.9 m) of the lane because of the 45 degree skew. The parapet wall stopped before the paver could pass over the end of the lane. The remaining area in the right lane was placed and compacted by hand. After paving the right lane, the Concrete-Mobile was flushed with solvent along with the resin pumps. This removed residual catalyzed resin before it hardened.

Figure 12. The paving machine could not compact the last 4 in (10cm) against the parapet wall.

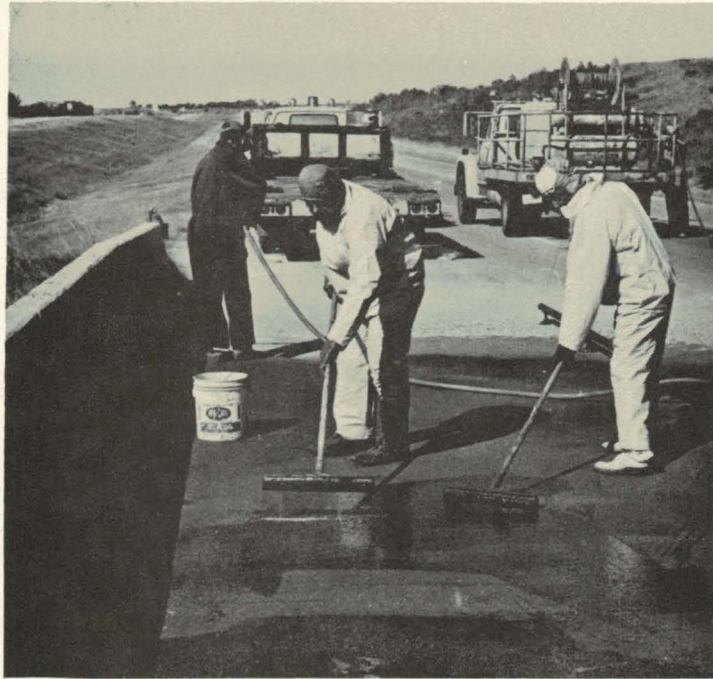
Figure 15. Areas having lean resin content were squeegeed with additional resin.

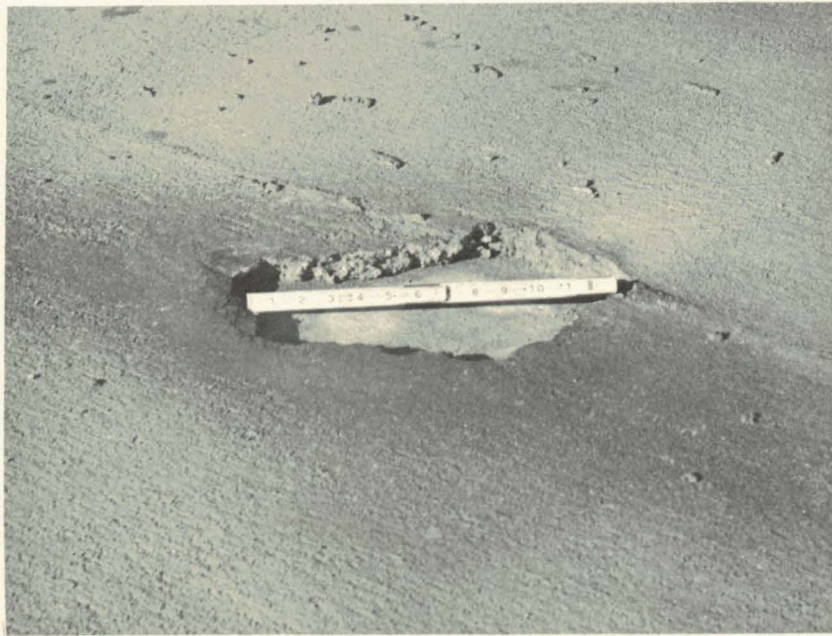
test revealed over 100 ft. (12 ft. of overlay) that did not bond to the deck. Also, in the center area about 12 ft. from the west end of the bridge, a portion of the overlay 8 ft. (12 ft.) long failed to adhere completely. However, this about 12 ft. (12 ft.) thick on top of the overlay did adhere, probably due to air-violet radiation from the sun. A plan of the deck showing the location and relative size of the delaminated areas and resulting patches is shown in Appendix C.

Figure 18. Delaminations ranged from small to large.

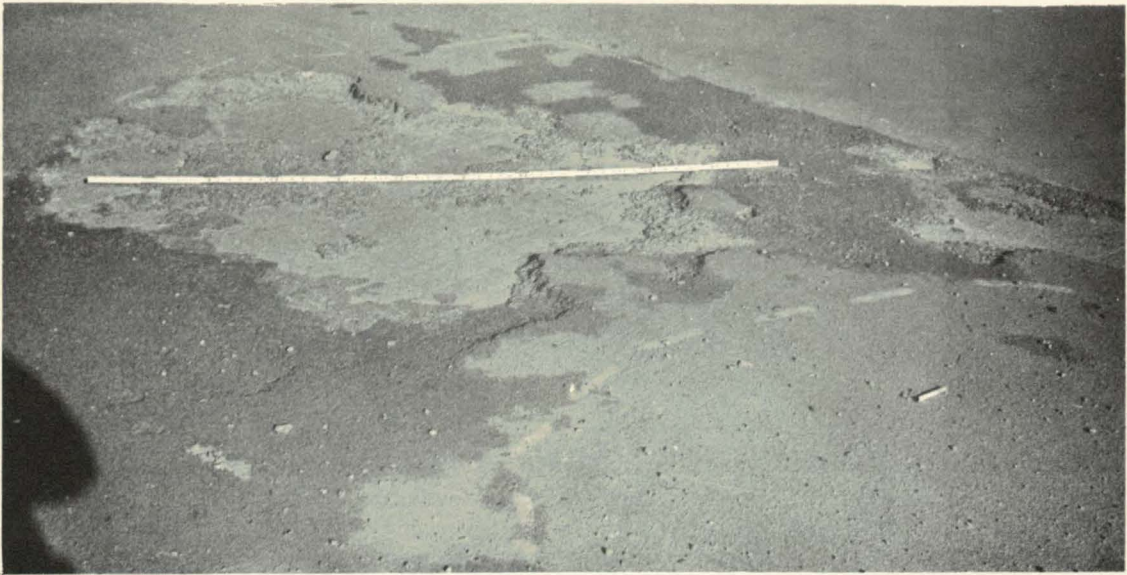
Figure 19. Some delaminations were very large; an 8 ft (2.4m) measuring stick.

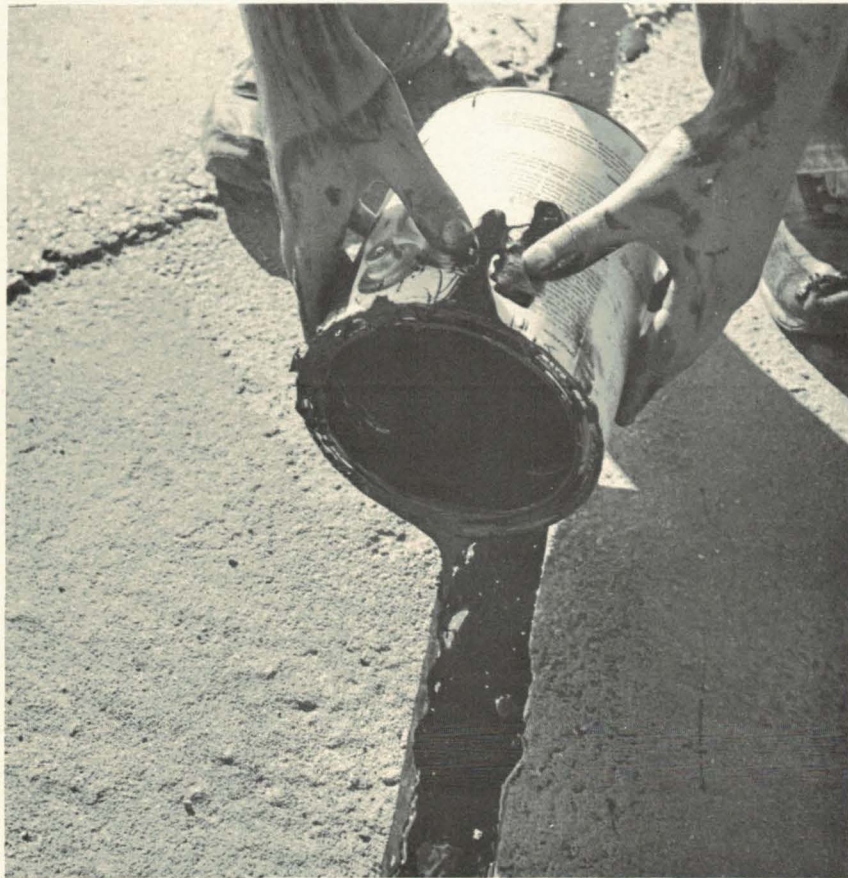
It had been used to fill the two expansion joints as paving proceeded across the deck. A concrete saw and crew sawed out the 2 in (50 mm) wide groove material resulting on the sand. Filled the joint with a two component rubber compound, was poured into the joint to level out. It was not trucked and was finished very well.

Figure 20. Expansion joints were filled with a rubber-like material.

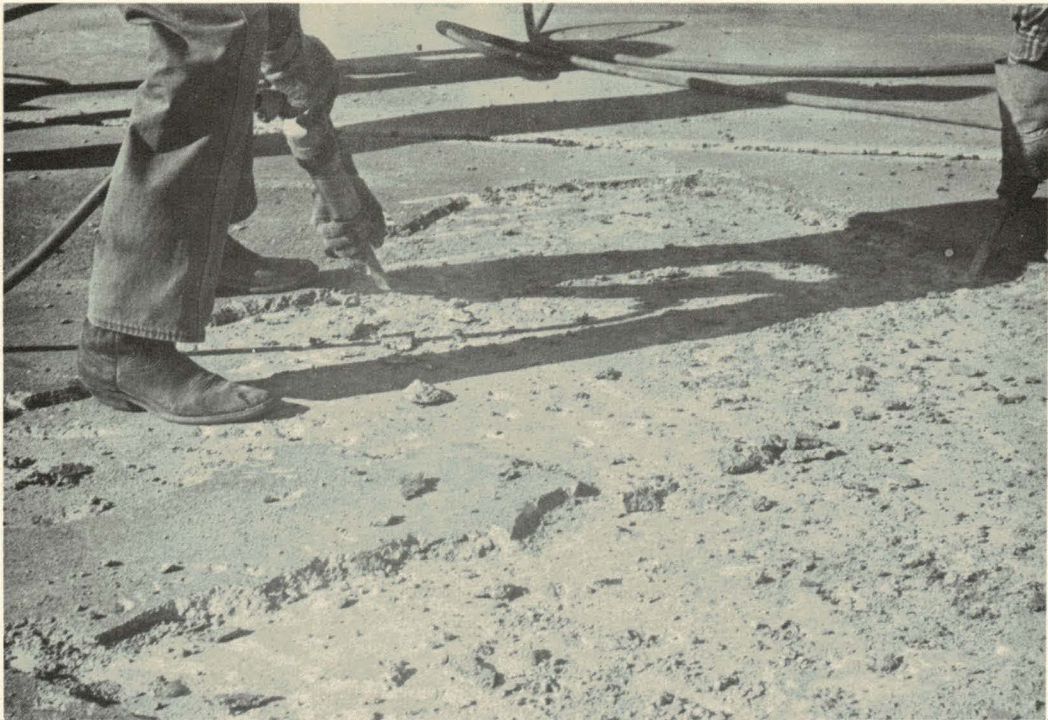
Figure 21. Unsound polymer concrete was jackhammered away.

On Wednesday, November 4th, the delaminations were removed with jackhammers. To mix the polymer concrete, a portable drum mixer was used. As before, one half percent by weight of benzoyl peroxide was added as catalyst.

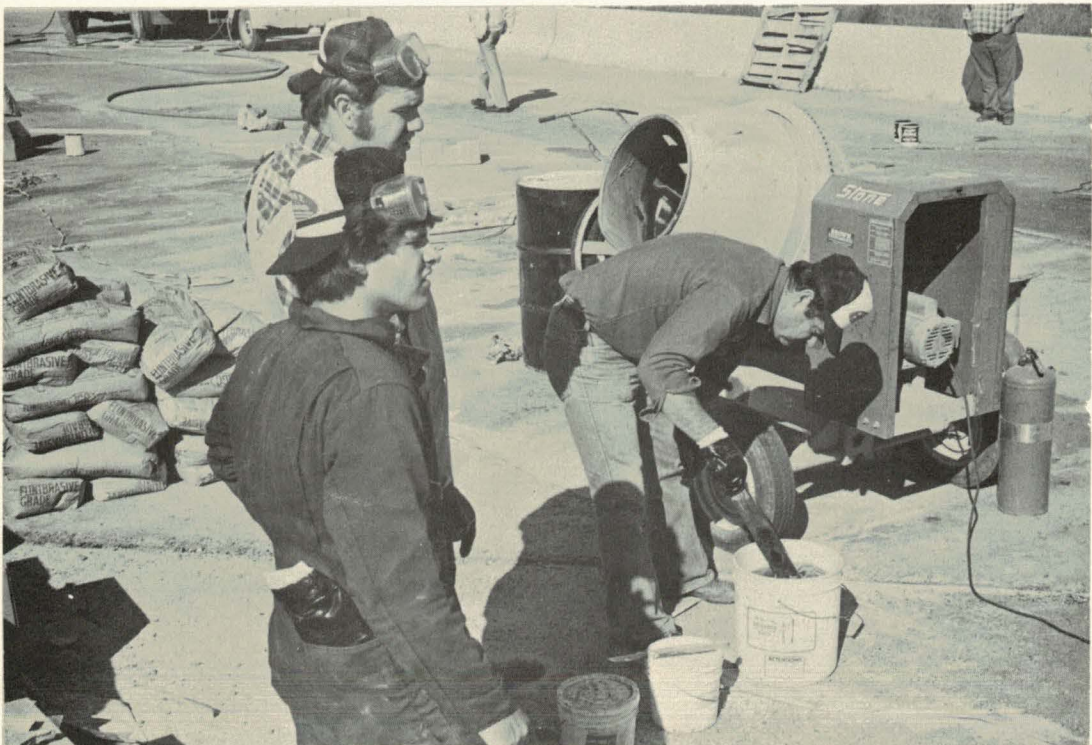
Figure 22. For patching, polymer concrete was mixed with a portable mixer and placed by hand.

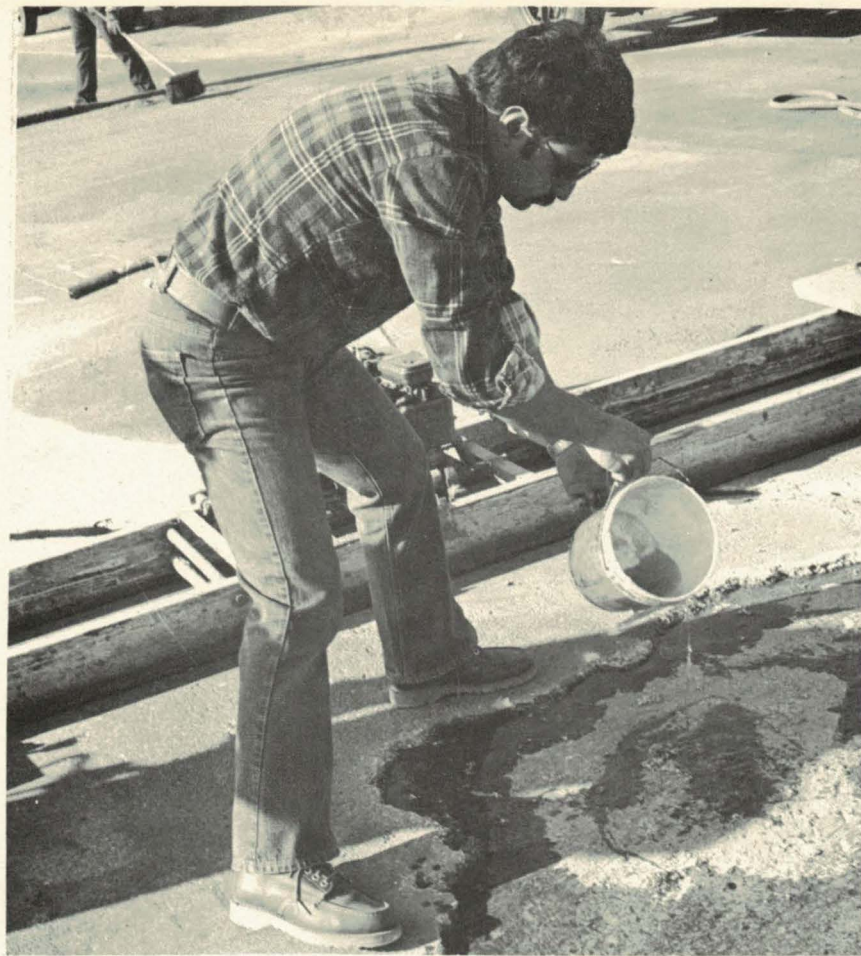
Figure 23. Delaminations were generously tackcoated.

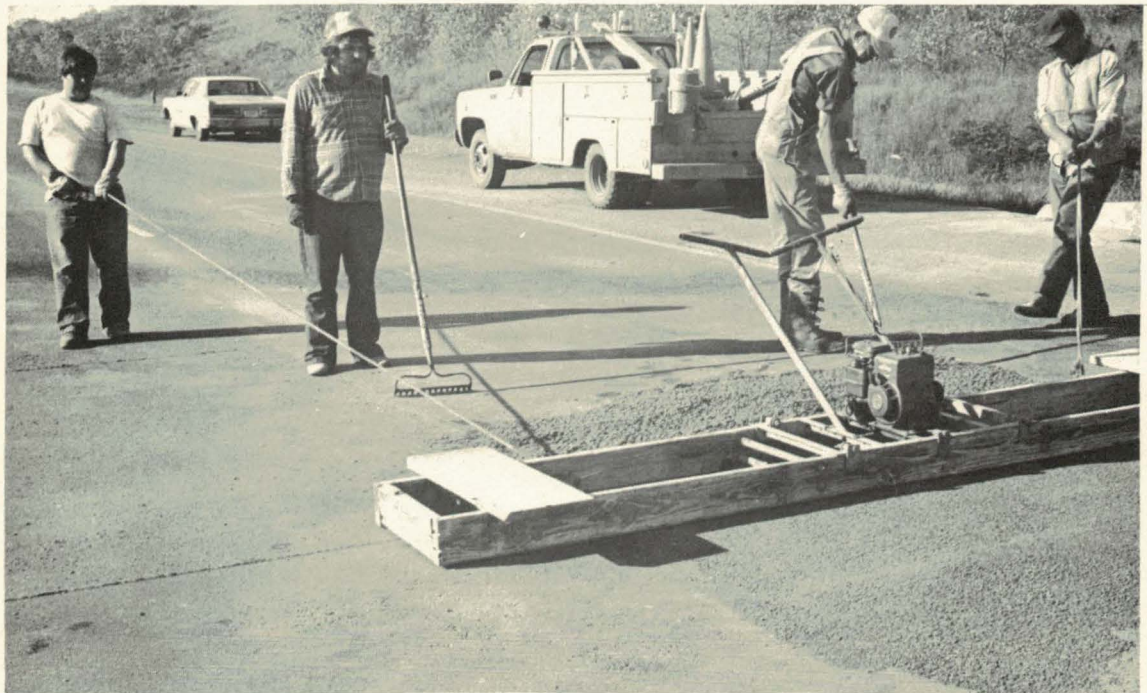
Figure 24. A shopbuilt screed compacted the patches.

A screed was made by bolting a common electric vibrating concrete "snake" to an 8 in (200 mm) I-beam. Though heavy, four men were able to utilize the device most successfully.

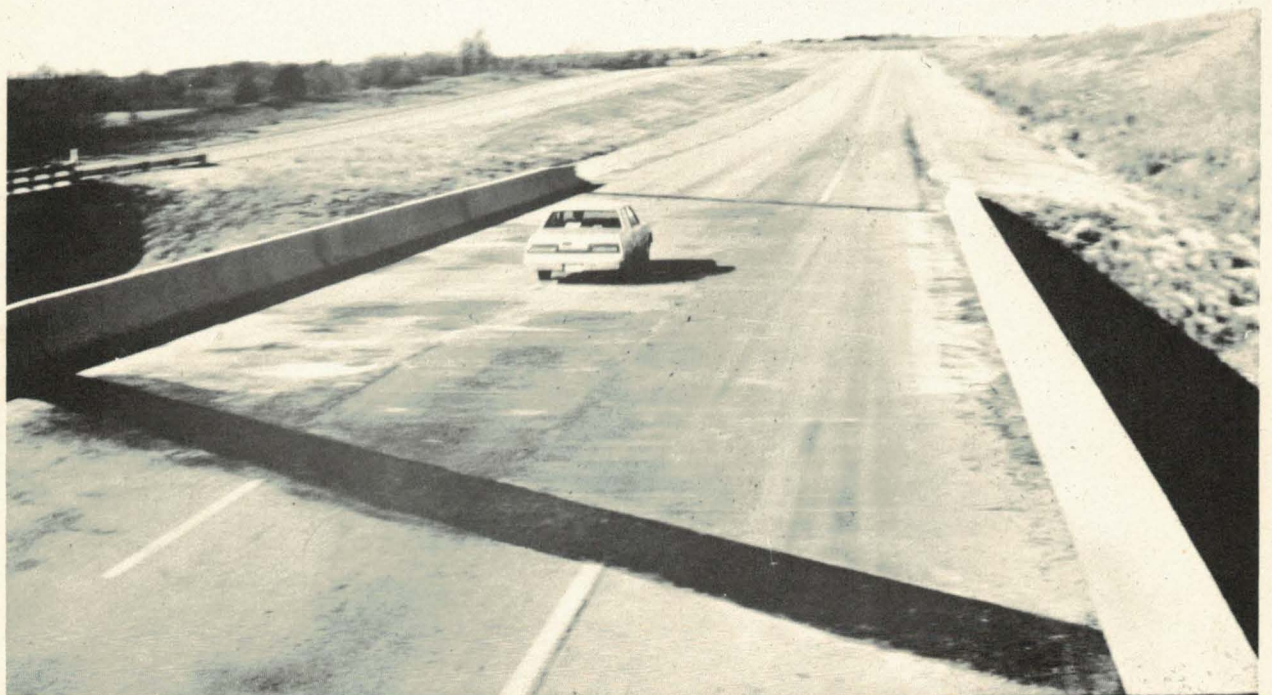
Figure 26. The bridge with its multi-colored patches as it appeared three months after initial construction.

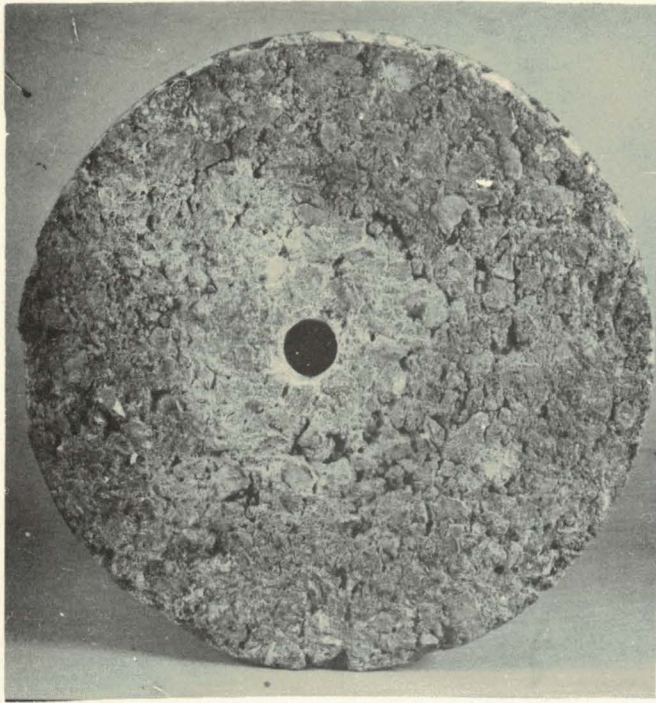
Figure 1. Resin Lean Polymer Concrete

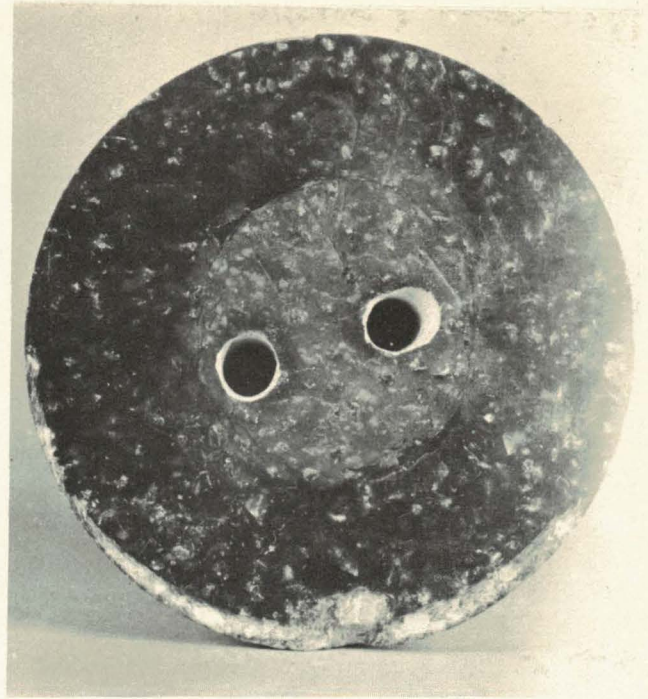
Figure 1. Resin Rich Polymer Concrete

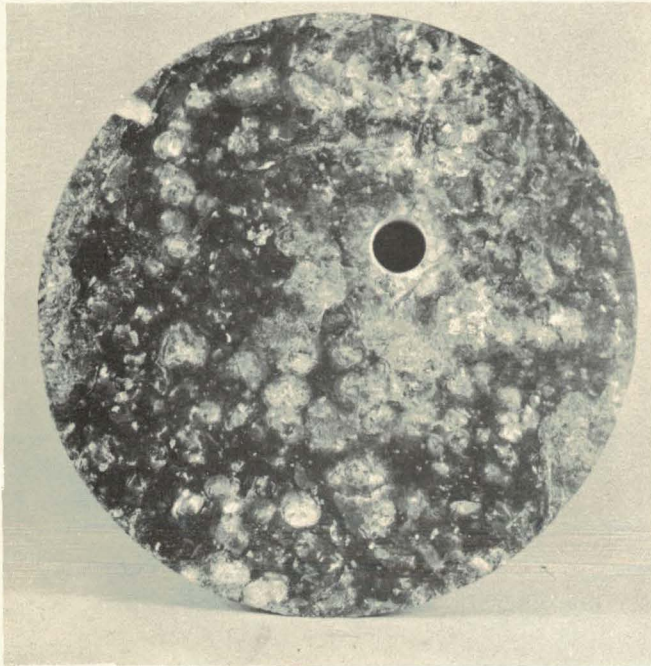
Figure 3. Polymer Concrete Patch

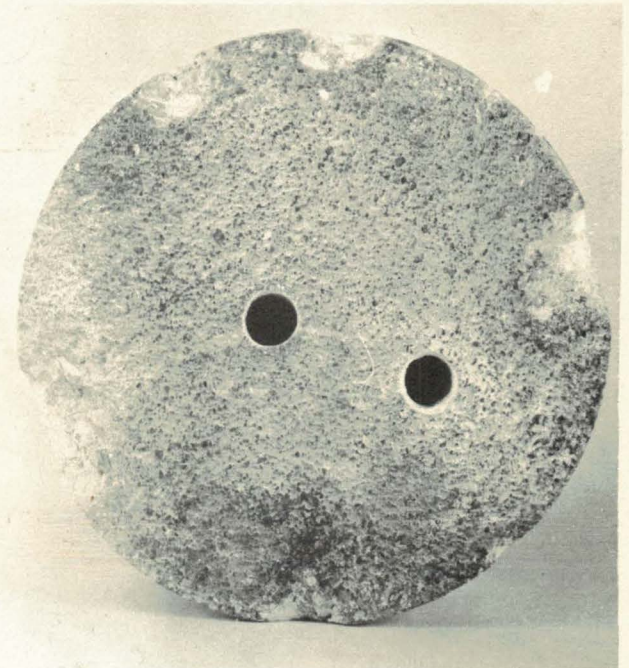
Figure 4. Excellent Polymer Concrete
