FHWA-DP 64/EP 7-1

Demonstration
Projects Division

In-Service Evaluations of Experimental Traffic Barriers

An Interim Report

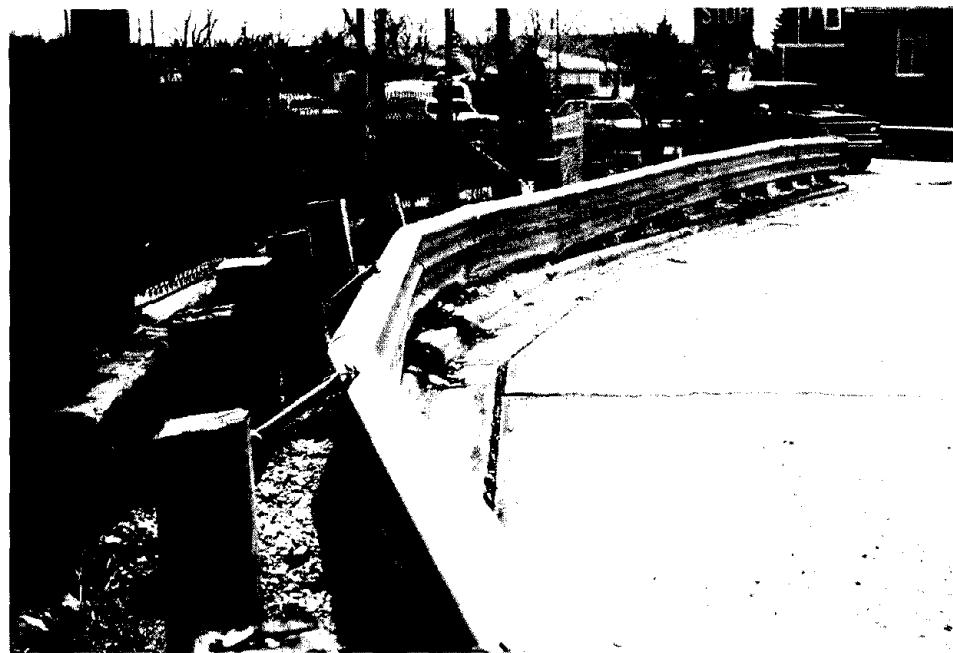
Before the final inspection, the SERB was impacted near one of the modified splices and "jammed" when it deflected backwards and upwards so it did not revert to its original position. The 8 inch x 8 inch wood post was deflected about 6 inches, but even in this position, the railing was still functional. Since then, the SERB has been struck repeatedly. As can be seen from Figures 2 and 3, it currently needs to be repaired since several posts have been damaged and much of the mounting hardware has been destroyed. In spite of the numerous hits, the SERB guardrail has not been penetrated nor has it caused any serious reported injuries. It is noteworthy that no repairs were performed on this barrier until it had been in place over three years.

FIGURE 2: Although one post has been broken and much of the mounting hardware is damaged, the SERB guardrail remains an effective barrier.

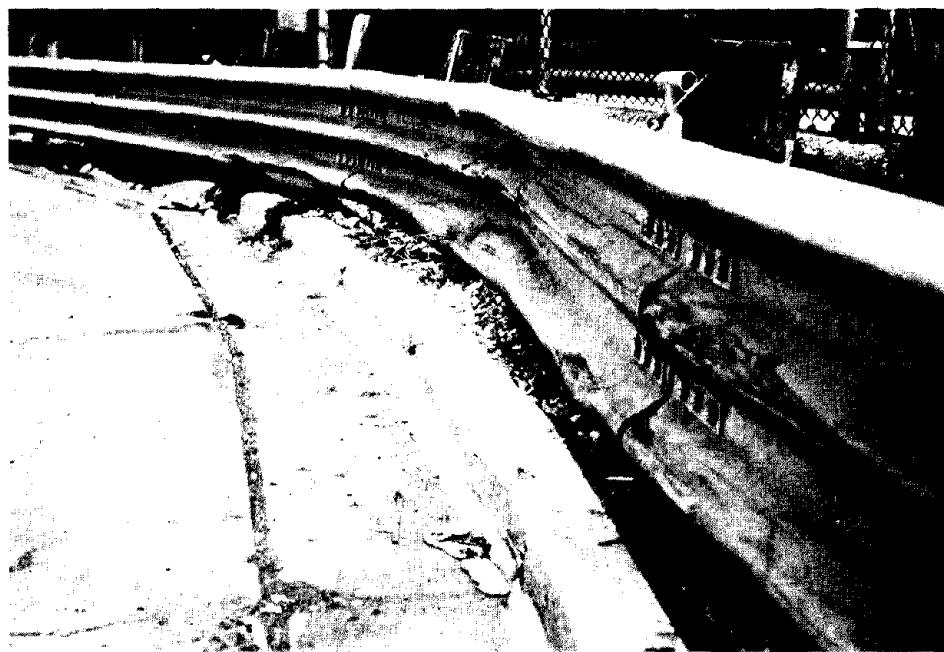
FIGURE 3: Once-straight section of tubular thrie beam has been "curved" by numerous hits.

This site was originally selected to determine if the SERB guardrail would function satisfactorily when installed along a short radius curve. Although the rail has not been penetrated and has not required continuous maintenance, the cumulative damage to the system was considerable, and sections of the barrier were replaced in-kind after three years of service. The repair work reportedly cost \$5,226 and was accomplished with no significant problems.

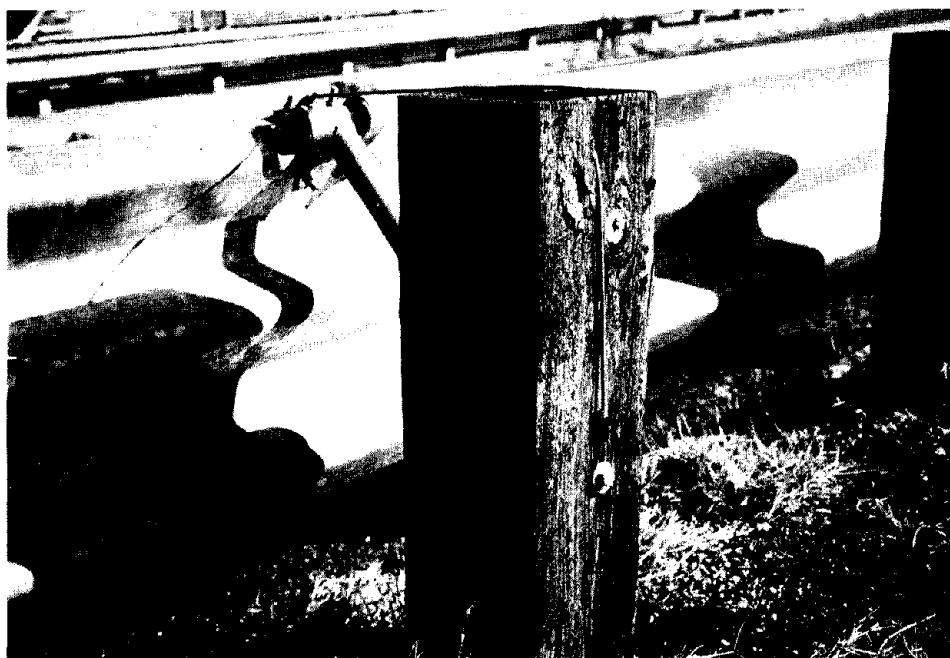
The installation has performed remarkably well since its completion in early 1983. Repeated hits, however, caused several of the lag bolts (used to attach one end of the restraining cables to the wood posts) in the immediate impact area to loosen and eventually pull out. This problem was solved by using longer cables which extended over the top and down the back side of the support posts. This modification is shown in Figure 4, and has been the only maintenance performed on the SERB to date.

FIGURE 4: Extended restraining cable prevents lag-bolt pullout, but back edge of post should be reinforced to eliminate problem shown above.

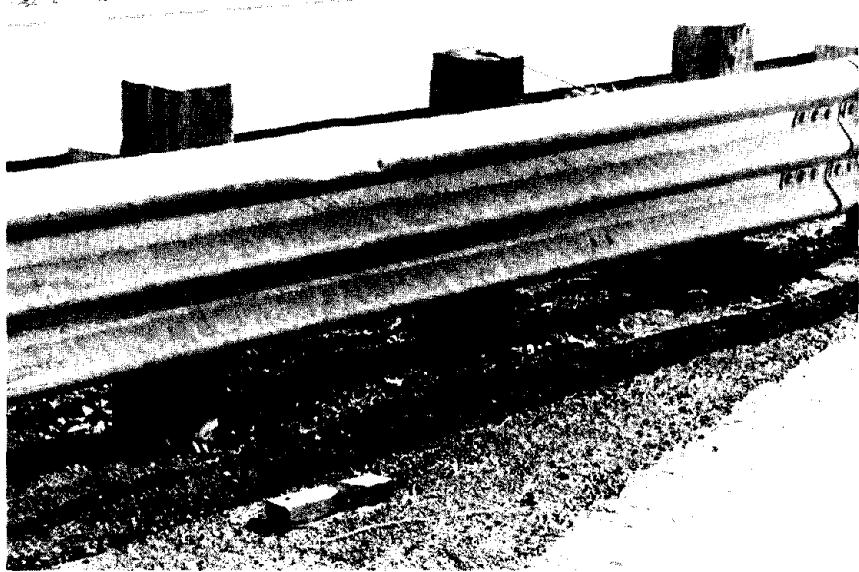
In its first year of service, this SERB sustained 18 hits. Only two of these were investigated by local police; there were no injuries reported. Both of these accidents involved passenger cars - a 2,165 pound 1983 Subaru and a 2,800 pound 1983 Mercury Cougar - which hit the rail at approximately 40 degree angles. In both cases, the SERB attenuated the force of the impacts and redirected the cars parallel to the rail. The only permanent damage to the SERB guardrail after its first year in place is the dent in the rail element shown in Figure 6.

FIGURE 6: Total permanent damage after one years' service and approximately 20 hits.

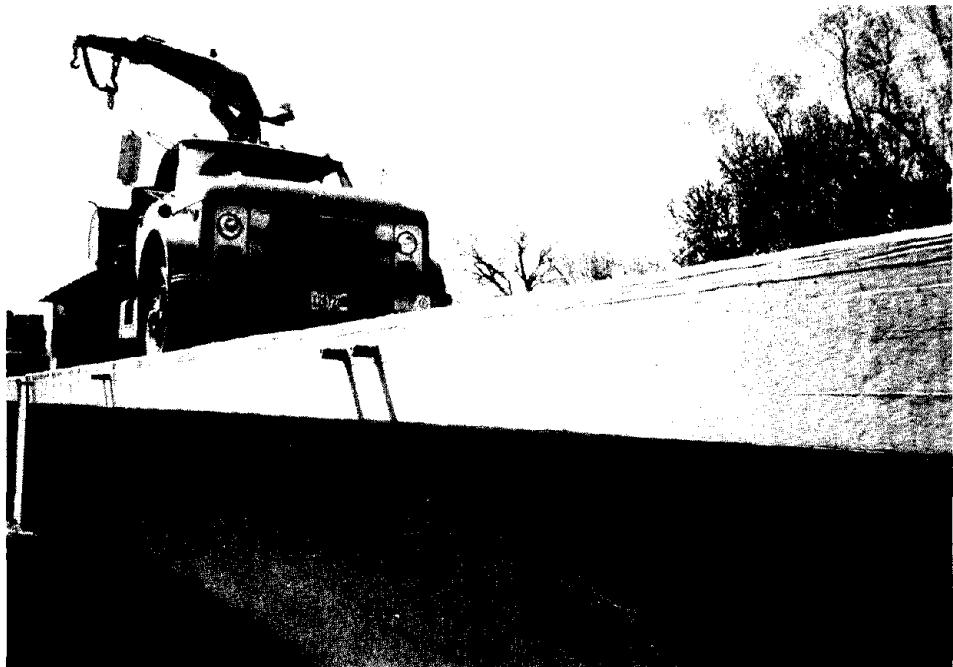
FIGURE 13: On new construction, accurate placement of the base plate anchor bolts is essential.

most critical factor during construction. They must be accurately spaced to accommodate the 8-foot, 4-inch post spacing and must protrude far enough from the edge of the deck so the base plate can be firmly attached. In one case, the base plates were extended from 7 inches to 9 inches and the anchor bolt holes were lowered 2 inches so the bolts could be placed to obtain adequate concrete cover and to avoid the deck reinforcing steel. In another case, a separate steel angle was needed at each post to provide adequate bearing for the base plates (see Figure 14).

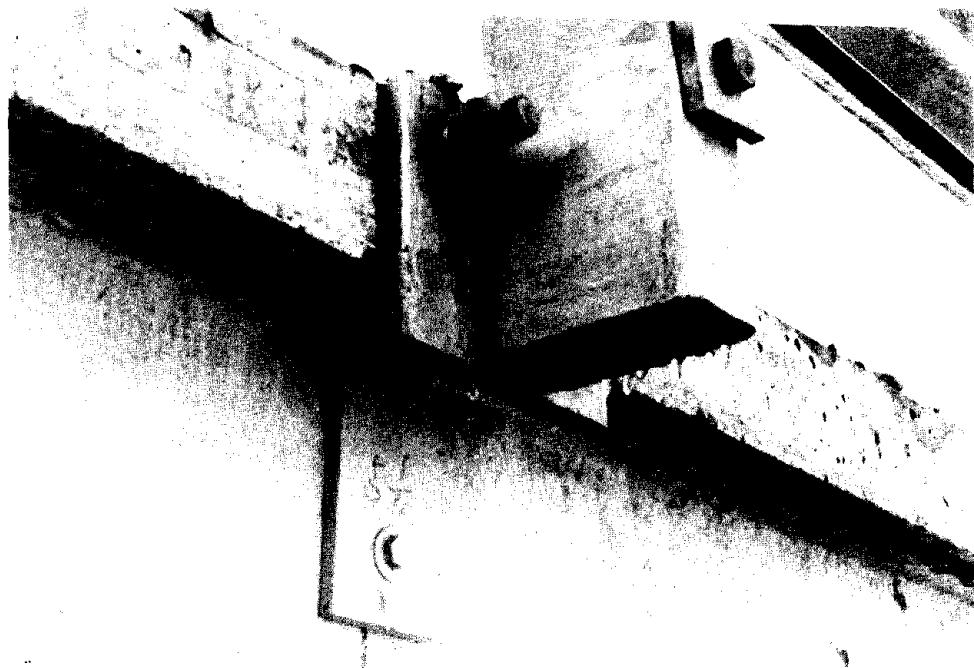
FIGURE 14: Since this bridge deck was only 5 inches thick, a separate steel angle was used at each base plate to prevent its bending when the SL1 rail is hit.

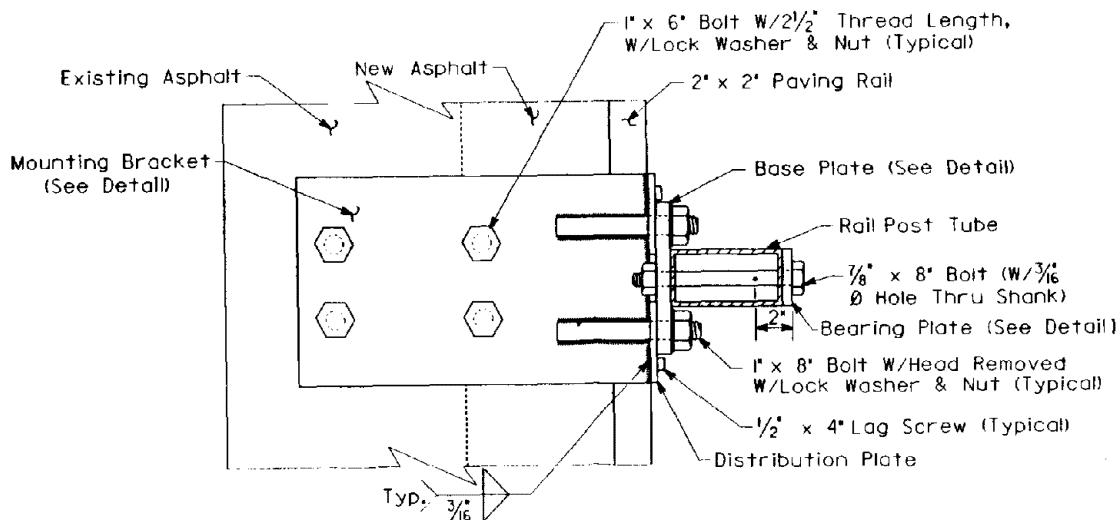
The major problem encountered in this retrofit project was designing a special connection detail to which the base plate could be bolted. The final design is shown in Figure 17.

FIGURE 17: Special design required for SL1 retrofit rail base plate connection on existing timber bridge increased cost significantly.

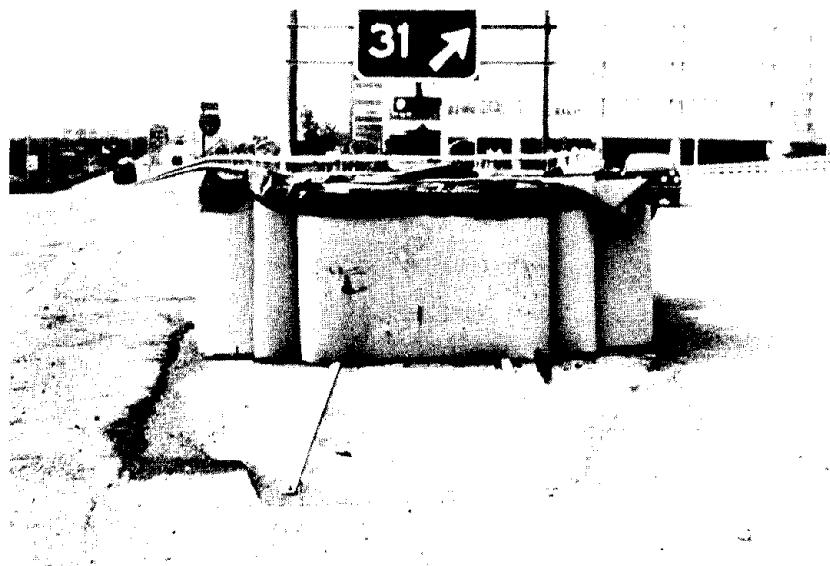
Since their installation in late 1984, several of the CIAS units have been hit, both end-on (Figure 26) and along the side (Figure 27). In fact, at least 10 hits have been noted. Eight of these were hit-and-run accidents, indicating satisfactory crash cushion performance and requiring little maintenance. However, two hits did require replacement of the entire units. One of these accidents involved a Toyota pickup and the second (see Figure 28), a Buick sedan. Neither driver was reported to be injured.

FIGURE 26: This is the result of an end-on crash into the unit shown in Figure 22. CIAS collapsed uniformly as it slid on steel rails.

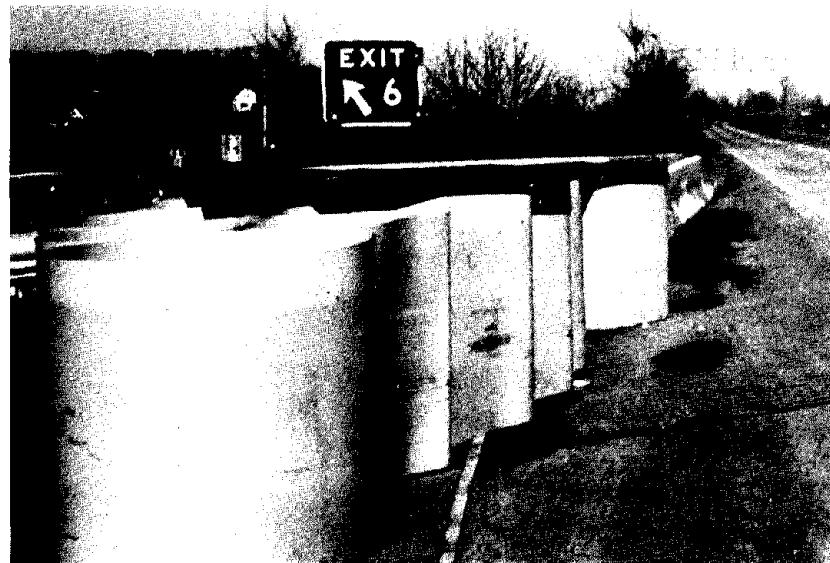
FIGURE 27: Result of side impact into unit shown in Figure 23.

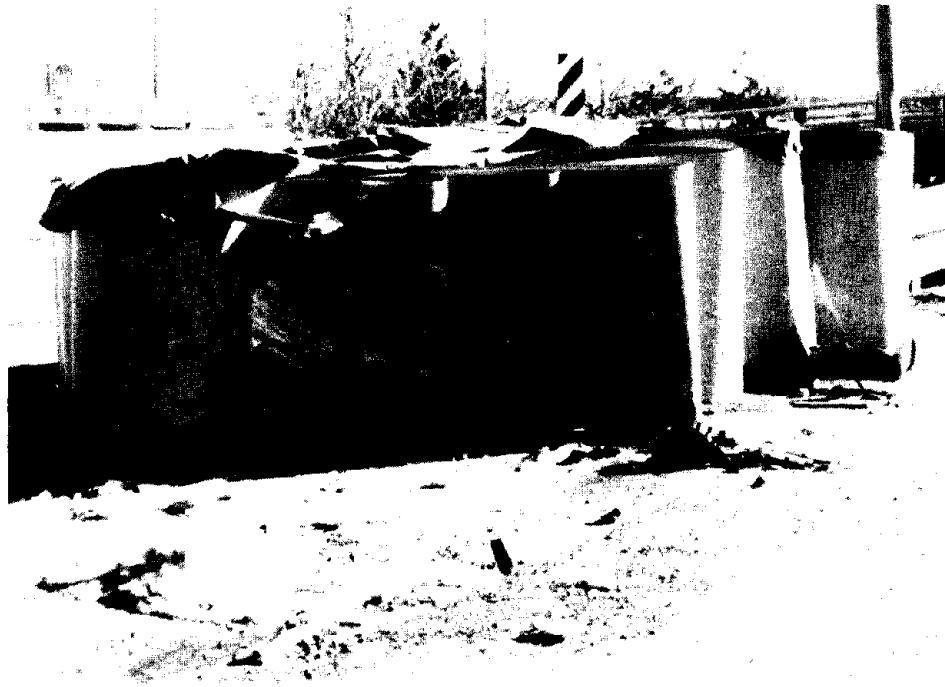
FIGURE 28: This CIAS required complete removal and replacement with a spare unit.

1. Drilling holes through the backwall can be avoided by setting the anchor bolts in the back-up wall before the concrete is placed.
2. Settlement of the steel rails into an asphalt surface can be minimized by setting the cylinders on two channel irons, sized to prevent settlement into the asphalt. This would eliminate the need for an expensive concrete pad at many locations.
3. While sand-filled systems are not repairable and have to be replaced as a result of only minor or brush hits, the CIAS can normally be repaired in-place by pulling or jacking the dented units. After major impacts, there is no scattered debris. Crushed units can be replaced in kind and re-rolled off-site for later re-use.

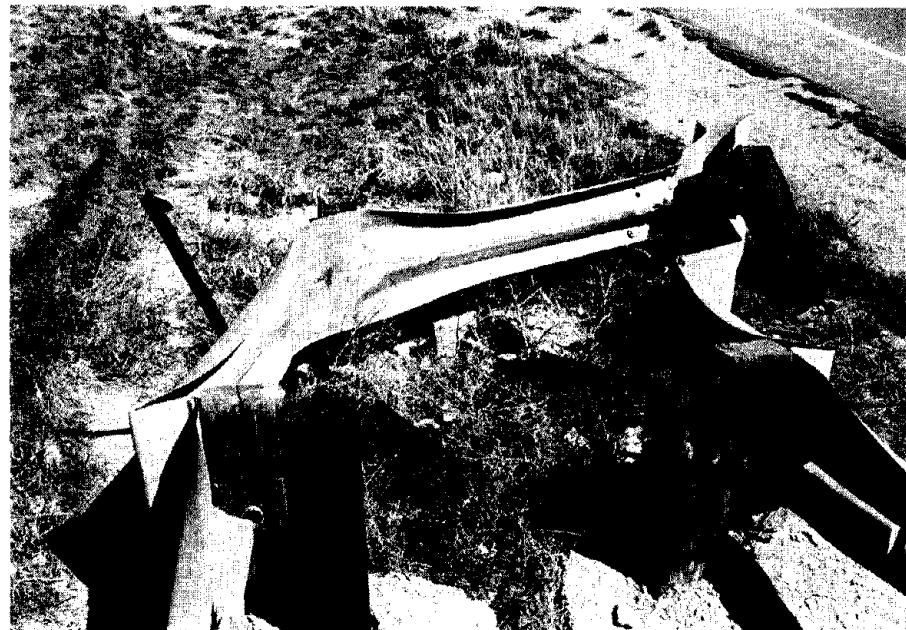
the first accident (see Figure 34) was \$783 and the second, \$885. The first accident was an end-on hit at 30 mph. The

FIGURE 34: Extent of damage from end-on hit.

vehicle suffered moderate damage but insufficient information was recorded as to the driver's injuries. The Type 3F median end treatment performed as designed. Little information was available about the second accident except that the impact was from the side at an estimated speed of 40 mph. It was observed that the performance of the Type 3F median barrier with this type of impact was similar to that of a standard W-beam guardrail.

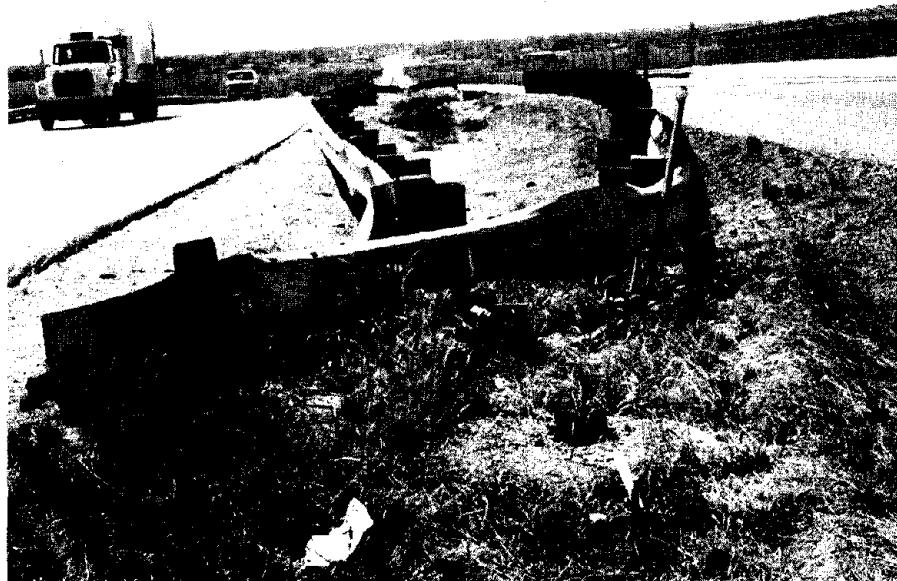
FIGURE 35: Impacting vehicle was safely decelerated without vaulting the guardrail.

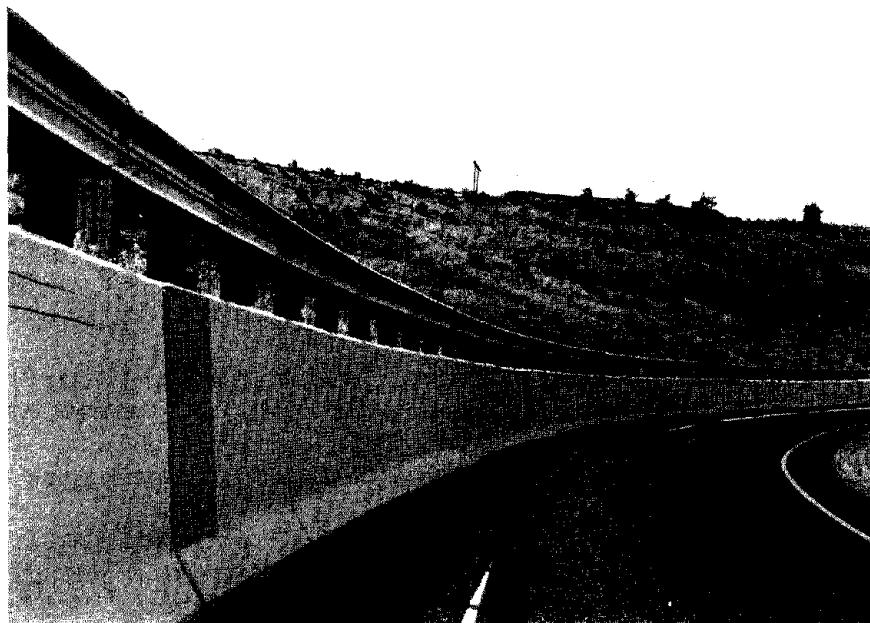
FIGURE 43: Some scrapes can be seen on barrier near center of photograph.

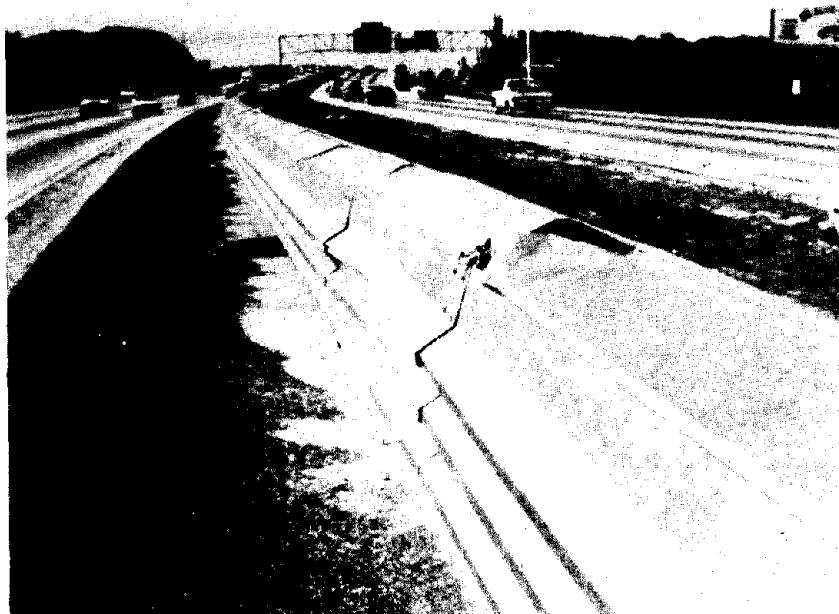
- A. **Minor Impacts**, which have resulted in dents and/or scraping of the galvanized coating. These can be repaired with the use of one of the many commercially-available field applied zinc-rich paints which would prevent corrosion.
- B. **Heavy Impacts**, which result in major distortion of the impacted face panel without reduction of the structural integrity of the barrier. These can be repaired with "cover panels" designed to be installed over the damage for esthetic reasons. Figure 48 shows the type of damage resulting from a heavy impact.

FIGURE 48: This type of damage would not require repair except for esthetic reasons.
