# Rock Cut Blasting Aesthetics Best Management Practices Phase II

1. Report No. CDOT-2021-02	2. Government Accession No.	3. Recipient's Catalog No.	
4. Title and Subtitle <b>ROCK CUT BLASTING AESTHETICS BEST MANAGEMENT PRACTICES PHASE II</b>		5. Report Date June 2021	6. Performing Organization Code

7. Author(s) Thomas Allen, Richard Andrew, Sylvia White		8. Performing Organization Report No.	
9. Performing Organization Name and Address Yeh and Associates, Inc. 2000 Clay Street Suite 200 Denver, CO 80211		10. Work Unit No. (TRAIS)	11. Contract or Grant No. 219.10

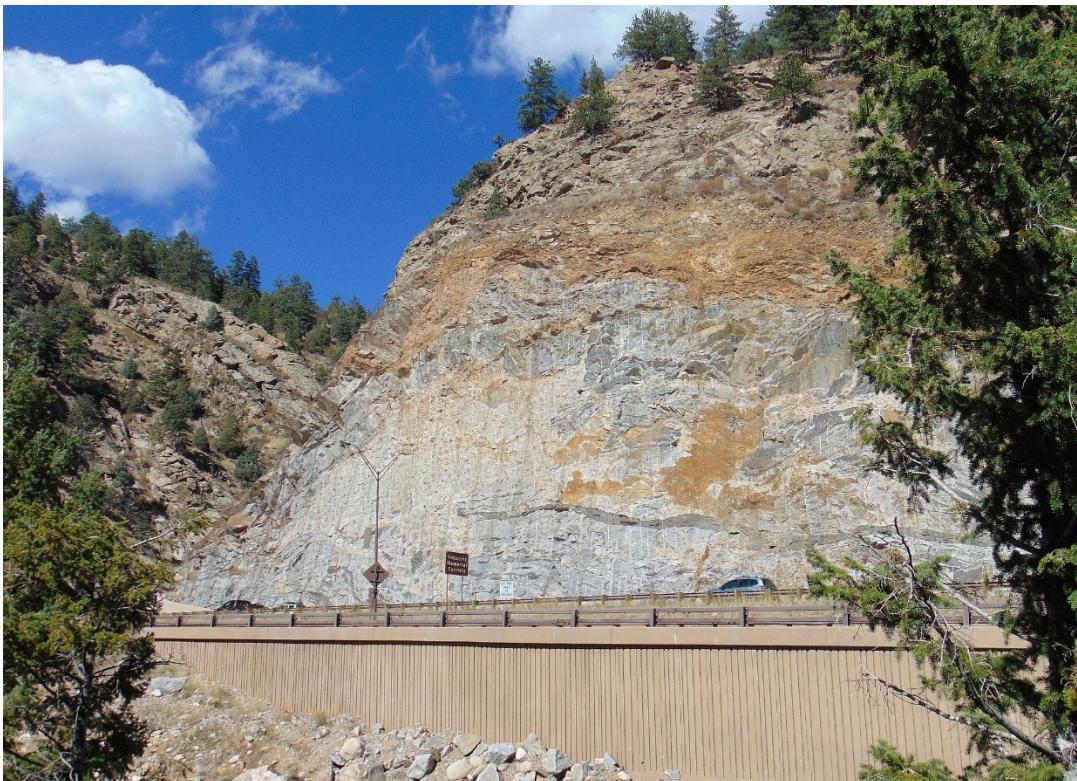
**Figure 7. I-70 MP 242, Veterans Memorial Tunnels**

control overbreak and blast damage to the final rock face, most of the rock was blasted using conventional presplitting and production drilling techniques. Because the cut was excavated in a very steep natural slope, horizontal drilling and blasting was used to develop access to the top of the cut for conventional drilling equipment. The blast holes were drilled parallel to the roadway alignment in a fan shaped pattern. As a result of the horizontal drilling, some blast damage did occur to the slope face and many of the blasts led to an uncontrolled quantity of material falling from the slope during the shots. Expanded slope rounding was used to remove the overshot material and highly weathered rock at the top of the cut to blend the final cut face into the natural rock slope. Draped wire mesh was installed to control rockfall because the ditch width was reduced for road widening in the steep canyon setting. Figure 7 shows the site.

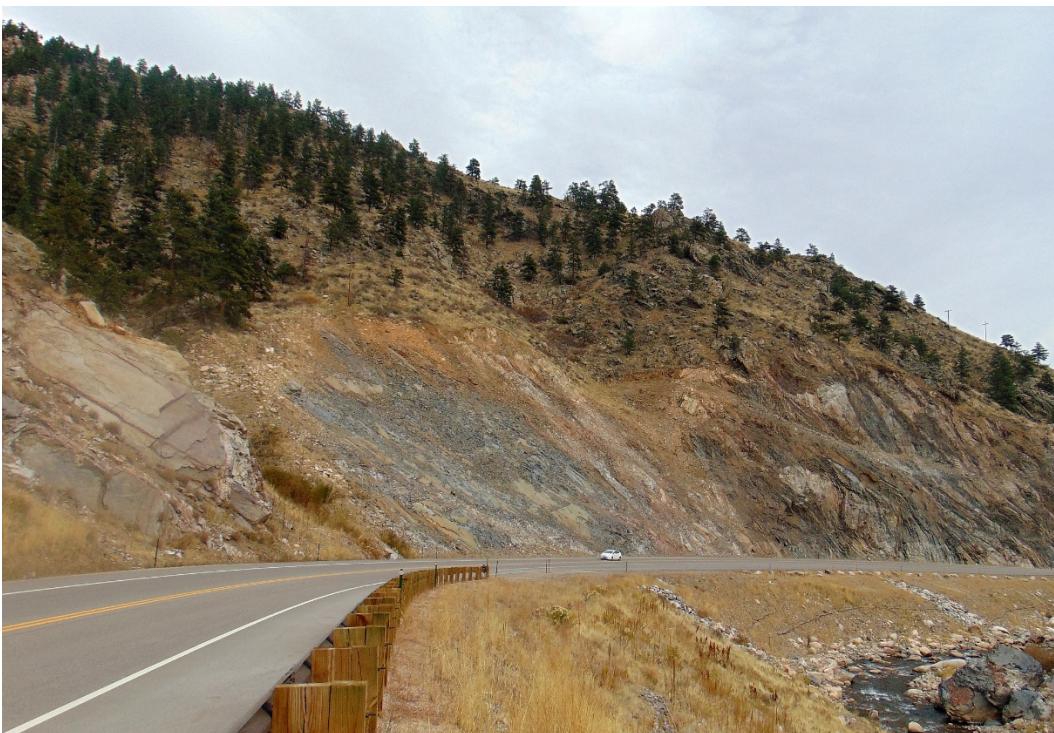
**Figure 11. US 34 MP 77.5**

plane that became the face of the cut. The foliation plane is visible in Figure 11. Additional rock excavation was needed to remove unstable materials following the rockslide and the result was an overrun in plan quantities. Use of advanced bedrock mapping techniques, seismic surveys and subsurface exploration at the top of the cut may have provided sufficient geologic information during the design phase to accurately predict the occurrence of the natural failure zone. The designers could have used this knowledge to plan the excavation and save costs. At other locations along the route, the joint patterns in the foliated rock were favorable to excavation and tended to obscure the half casts from presplit blasting.

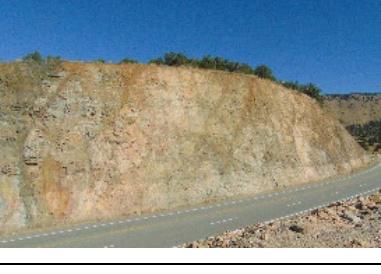
Granodiorite with foliated biotite gneiss xenoliths/inclusion, spheroidally weathered outcrops	Height: 35 to 40 ft Length: 650 ft 65-70 degree southeast facing slope	Westbound 44 seconds; Eastbound 20 seconds; static view from pullout SE side of road across from cut, SE end	Controlled blasting using pre-split blasting and cushion blasting techniques. Scaling, rock dowels and draped wire mesh rockfall mitigation.	Rock excavation to limits shown on the plans left a narrow ridge of highly fractured and jointed bedrock near the east end of the project, south side. This ridge was deemed unstable and additional blasting was required to remove the hazard.

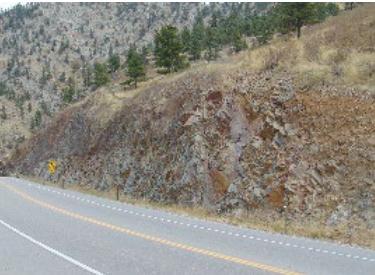
Gneiss, schist, some garnetiferous, possible metaconglomerate	Height: 35 to 40 ft Length: 650 ft 70 degree southwest facing slope	Westbound 14 seconds; Eastbound 17 seconds; static view from fishing access west of and below cut	Presplit blasting along the final face with production blasting. Half-casts from the presplitting were mitigated with rock staining. Rockfall mitigation includes dark brown draped mesh and rock bolts. Rock bolts used to stabilize large blocks are colored dark brown to blend with the rock face.	ROW acquisitions allowed for an adequate rockfall catchment ditch and allowed the draped mesh to terminate 20+ feet above the roadway, lessening the visual impact of the mesh. Rock staining following excavation provided a weathered look to the rock and masked the presence of the half-casts.

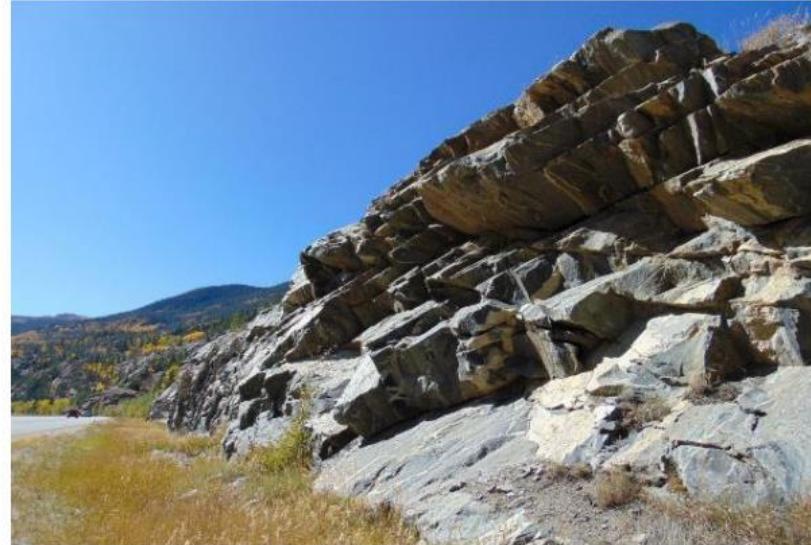
Joint planar surface dip toward roadway

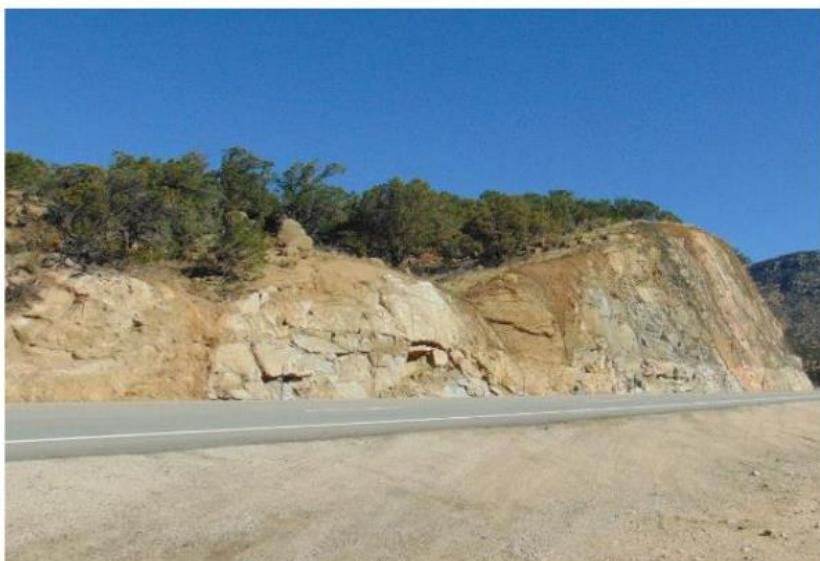
View to northeast, rock wedge missing

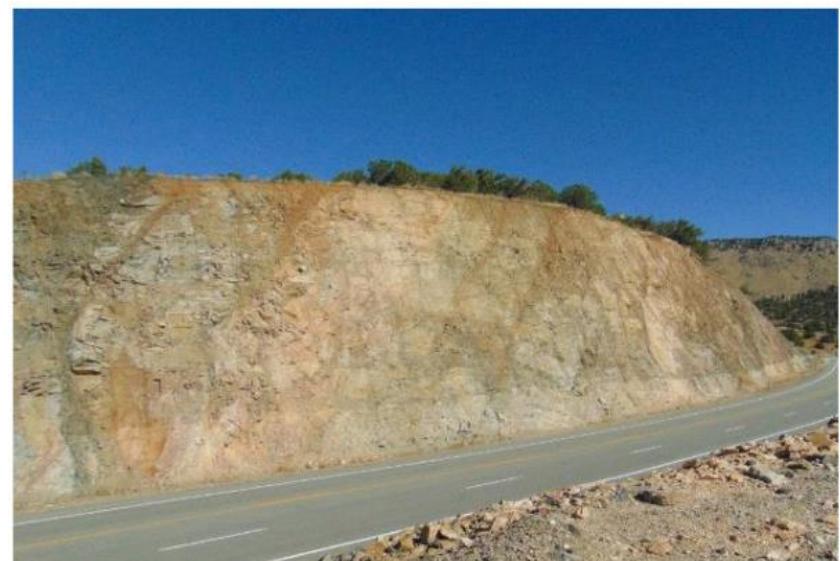
View to north, draped mesh, foliation angle

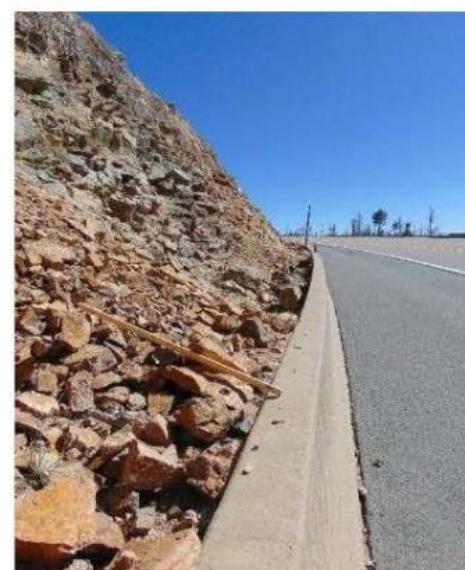
Rock filling behind barrier

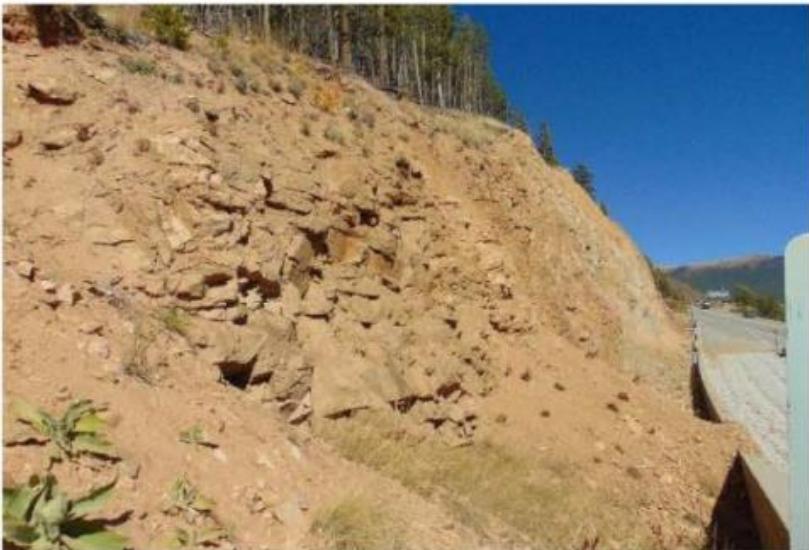
Fractured rock and loose rock on slope and behind barrier, view to east-northeast

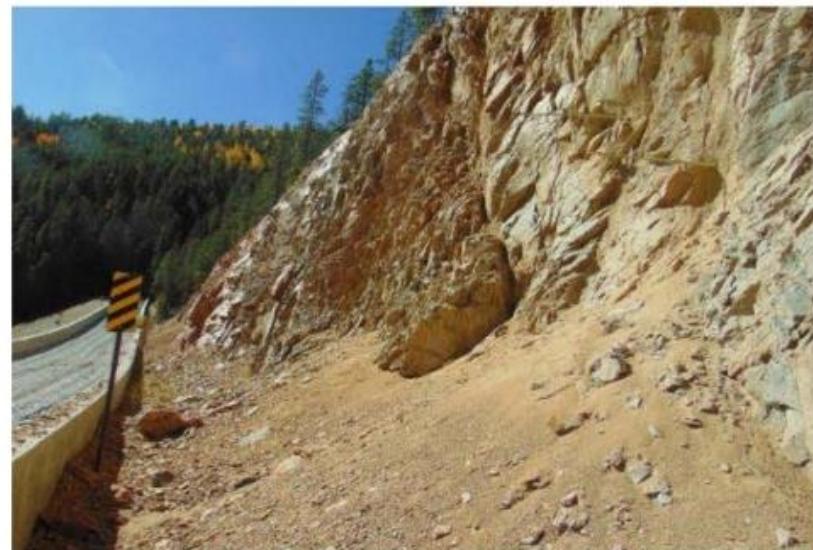
Failed rock bolts at right side photo, view to west-southwest

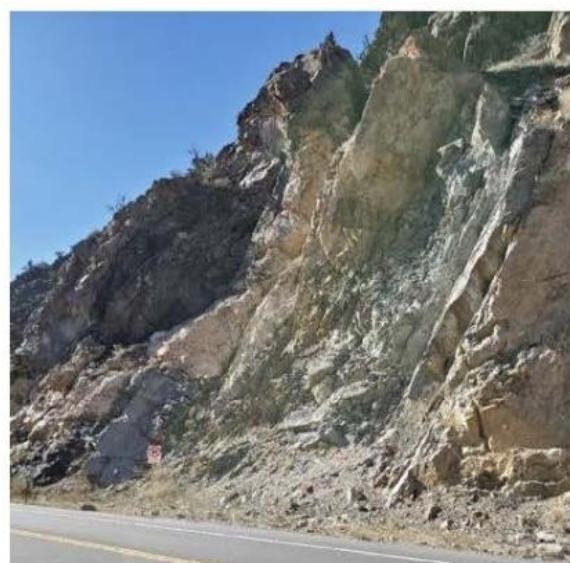
Looking south at loose rock on slope, boulder in ditch

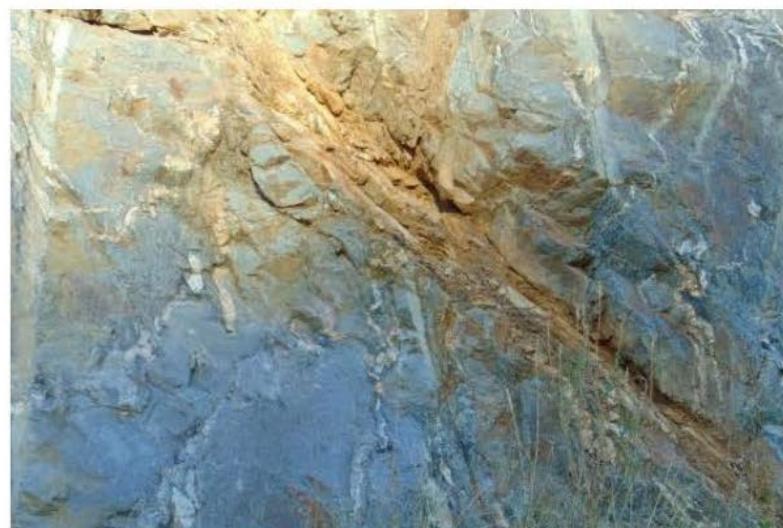
Foliation/fractures with weathered zones

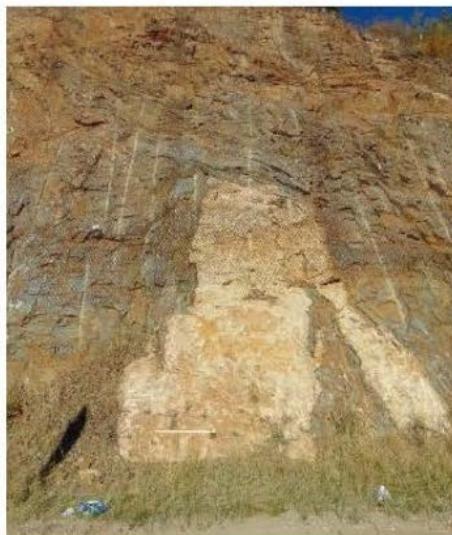
Draped mesh over half cast blast features
