# STATE HIGHWAY 9 WILDLIFE CROSSINGS MONITORING – YEAR 2 PROGRESS REPORT

*December 2015 through April 2017*

March 2018

Report to the Colorado Department of Transportation  
Applied Research and Innovation Branch

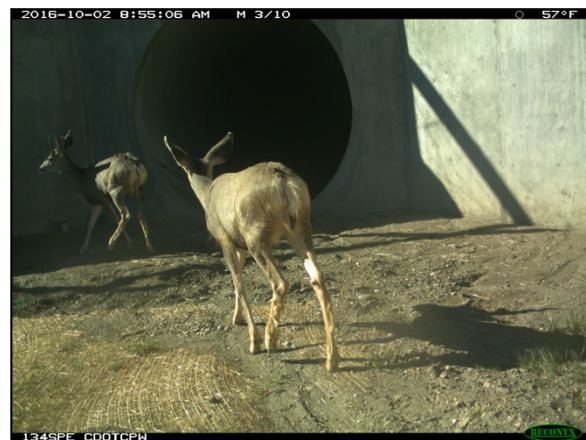
Figure 28. Mule deer repelling at the BVR Pipe Culvert.

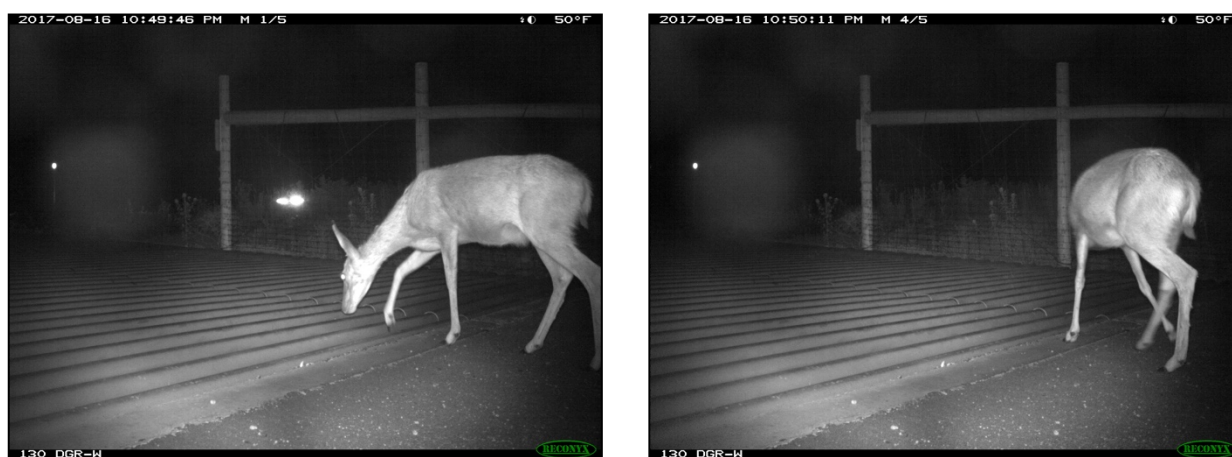
In general, deer guards deterred ungulates from entering the fenced right-of-way 77% of the time. Across monitoring locations, mule deer were most commonly photographed approaching the guards. The breach rate for mule deer at round bar guards was 13% compared to a breach rate of 29% for deer at flat bar guards (Fig. 29). Elk repelled from both types of guards at a rate of 85% (n=13). The only elk to approach to a round deer guard resulted in a breach, which it made by jumping rather than walking on top of the bars. Moose repelled from both guard types 100% of the time (n=6).

Figure 29. Mule deer approaching and ultimately repelling from the round deer guard at County Road 1002.

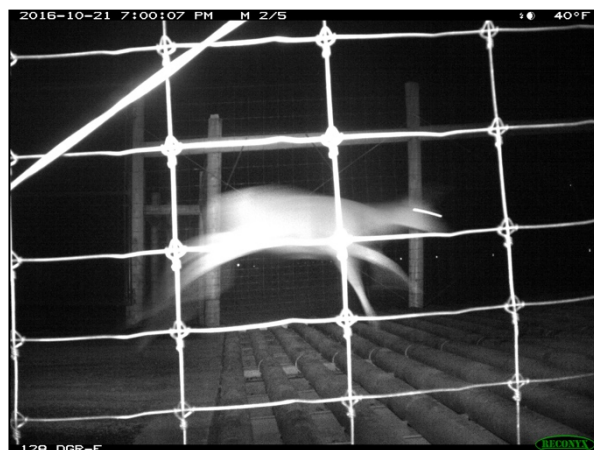
*Figure 30. Mule deer jumping across the Triangle Road round bar deer guard.*

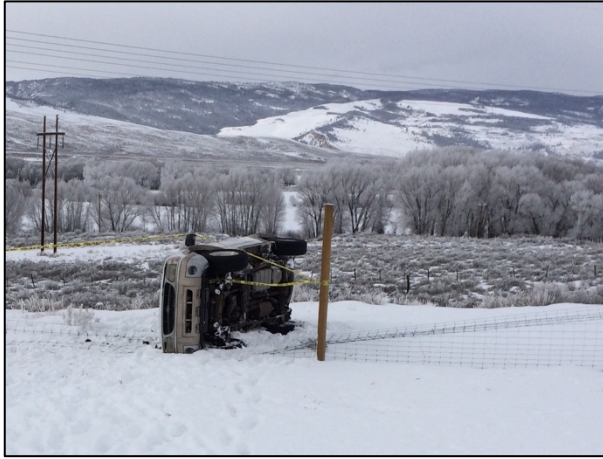
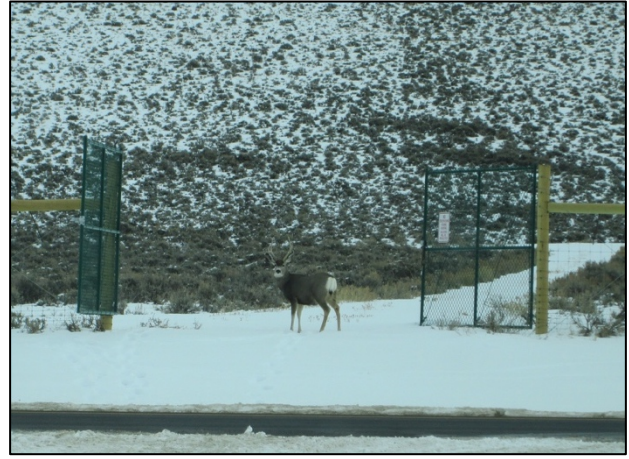
Wildlife exclusion fencing requires ongoing maintenance and a rapid response to fixing holes in the fencing to prevent wildlife incursions through gaps in the fence. Gaps may result from vehicles that run off the road (Fig. 33a), people that cut holes through the fence, wildlife damage, or normal wear and tear. In 2017, three cars ran off the road creating holes in the wildlife fence. Law enforcement, CPW and CDOT are called upon when wildlife incursions occur, requiring extensive labor on the part of these personnel to ensure that wildlife escape back to the habitat side of the fencing and are not involved in a WVC (Fig. 33b).

*Figure 33. a) Gap in wildlife exclusion fence due to a vehicle that ran off the road (left). b) Mule deer exiting through a swing gate left open by CPW to allow the animal to safely exit the fenced right-of-way under their supervision (right).*

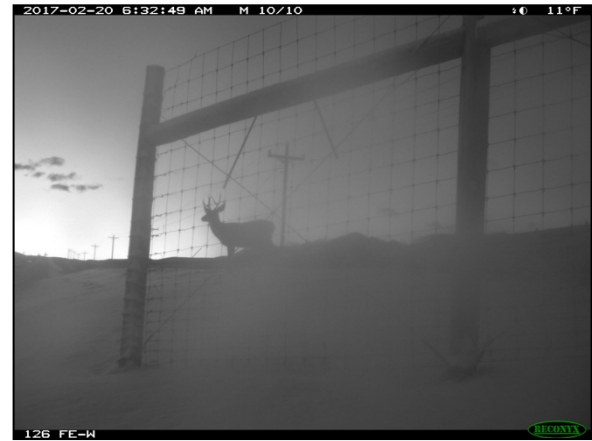
At the south fence end, the vast majority of ungulate movements occurred beyond the fence end (91.6%), that is animals that approached and potentially crossed the highway at-grade without entering into the fenced right-of-way (Fig. 34). Most of these movements were made by mule deer ( $n = 251$ ), although elk were also photographed beyond the fence end ( $n = 22$ ).

*Figure 34. Mule deer buck moving beyond the south fence end.*

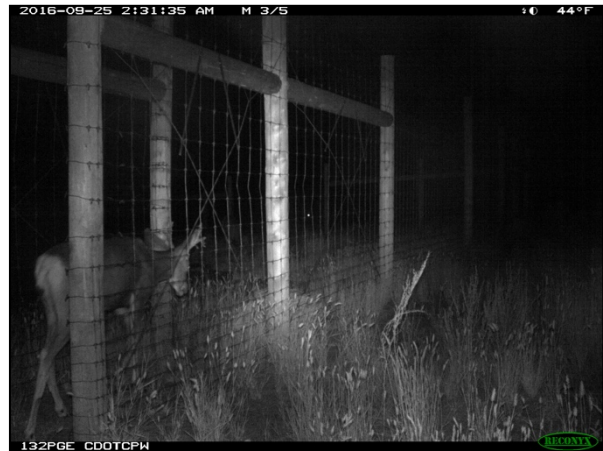
Of animals that investigated a gate, the breach rate for mule deer was 56% and for elk 40%. Overall, breach rates at pedestrian gates were lower for elk than mule deer. Most elk movements were detected at the State Wildlife Area Gate ( $n = 44$ ), whereas no elk were detected at the Summit County Gate. No breach movements by other species of wildlife were documented.

*Figure 35.* Mule deer breach at the BLM Pedestrian Walk-through Gate.
