EVALUATION OF SILICA FUME HIGH DENSITY THIN BONDED OVERLAYS

**Final Report
September 2002**

**Planning & Research Division
Oklahoma Department of Transportation
200 N.E. 21st Street, Room 3A7
(405)522-3794
FAX (405)521-6528**

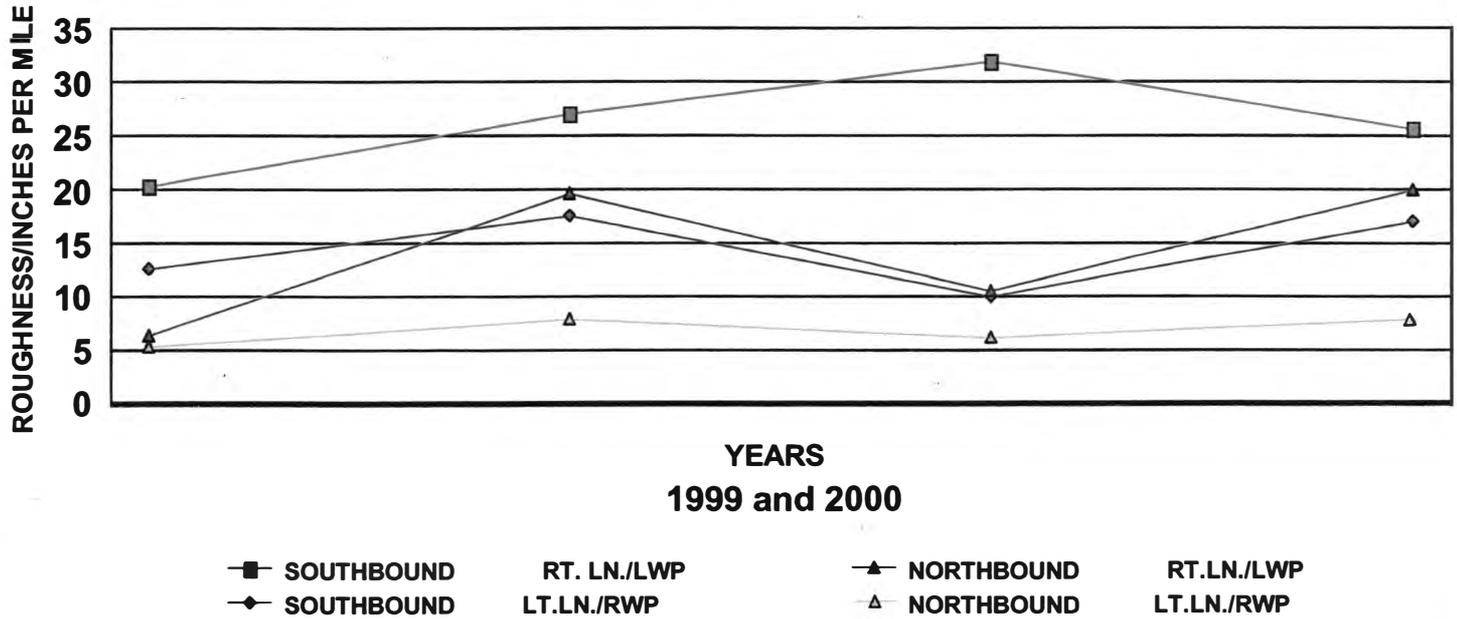
Figure 1. Profilograph testing of the total project which includes 200 ft (61 m) on each side of the bridge deck and on the bridge deck for the years 1999 and 2000. Locations 1 and 3 are results of testing on the bridge decks and locations 2 and 4 results of testing the length of the total project.

According to smoothness measurements shown on the line graph, three out of the four readings show the entire project being slightly rougher than the bridge deck and there was no noticeable increase in roughness for 1999 to 2000. Profilograph testing was not done in year 2001 but the ride quality felt approximately the same as previous years. Both bridges still have smooth riding surfaces.

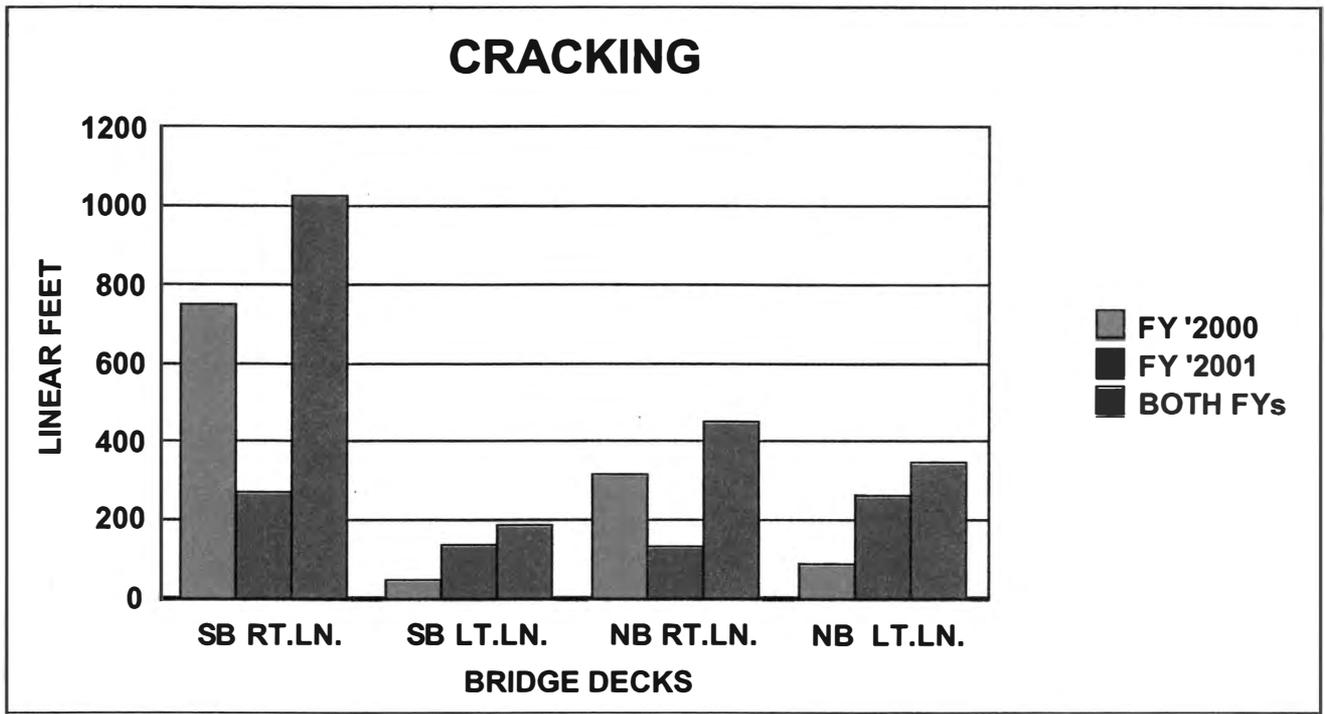
The southbound expressway bridge right lane in year 2000 had 751 ft (226 m)of cracking. Most of this was random cracking, but a construction joint crack of 148 ft (45 m) that runs the length of the bridge deck is included. Year 2001, 274 ft (84 m) of random cracks, in addition to those measured in 2000 were observed. The total amount of cracking for year 2000 and year 2001 is 1025 ft (312 m). Cracking in the left lane has the smallest amount. In the year 2000, the linear feet of cracking was 48 ft (15 m) and it increased to 138 ft (42 m) in the year 2001.

Cracking in the northbound lane has been less severe. In year 2000, the right lane cracking totaled 263 ft (80 m). Of that, 124 ft (38 m) was a longitudinal construction joint crack that runs the length of the bridge deck. Left lane cracking has been moderate. In year 2000, 86 ft (26 m) of random cracks were recorded. Two hundred and sixty three feet (80 m) of cracking was measured in 2001. Both construction joint cracks had a width opening of 1/4 in (6 mm) and the random cracks are still hairline size (2). The linear feet of cracking is graphed in figure 2. from the years 2000 and 2001, the graph shows the new cracking observed each year and a combined amount from both years. Each year, chain-drag testing was performed on both bridge decks and no delimitations were found.

Figure 2. Bar graph of linear feet of cracking on the bridge decks in the years 2000 and 2001 in both lanes.

Cracking continues to be a major concern which could affect the life of this project. It has increased each year and should continue to be observed and evaluated to determine its rate. Although the ride is currently smooth, and the overlays are performing well, an additional three years of investigation to observe cracking, ride quality and surface distress is recommended.

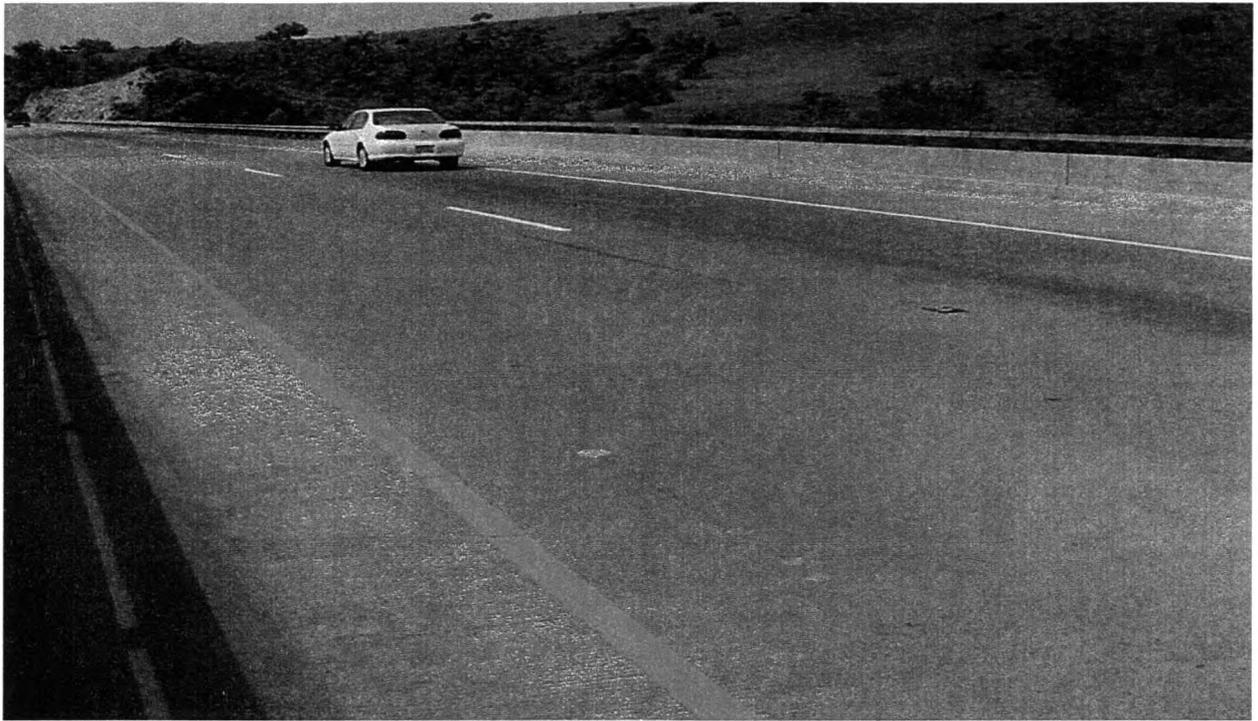
Figure 3. Photograph Of Entire Bridge, Showing Overlay 3 years After Placement.

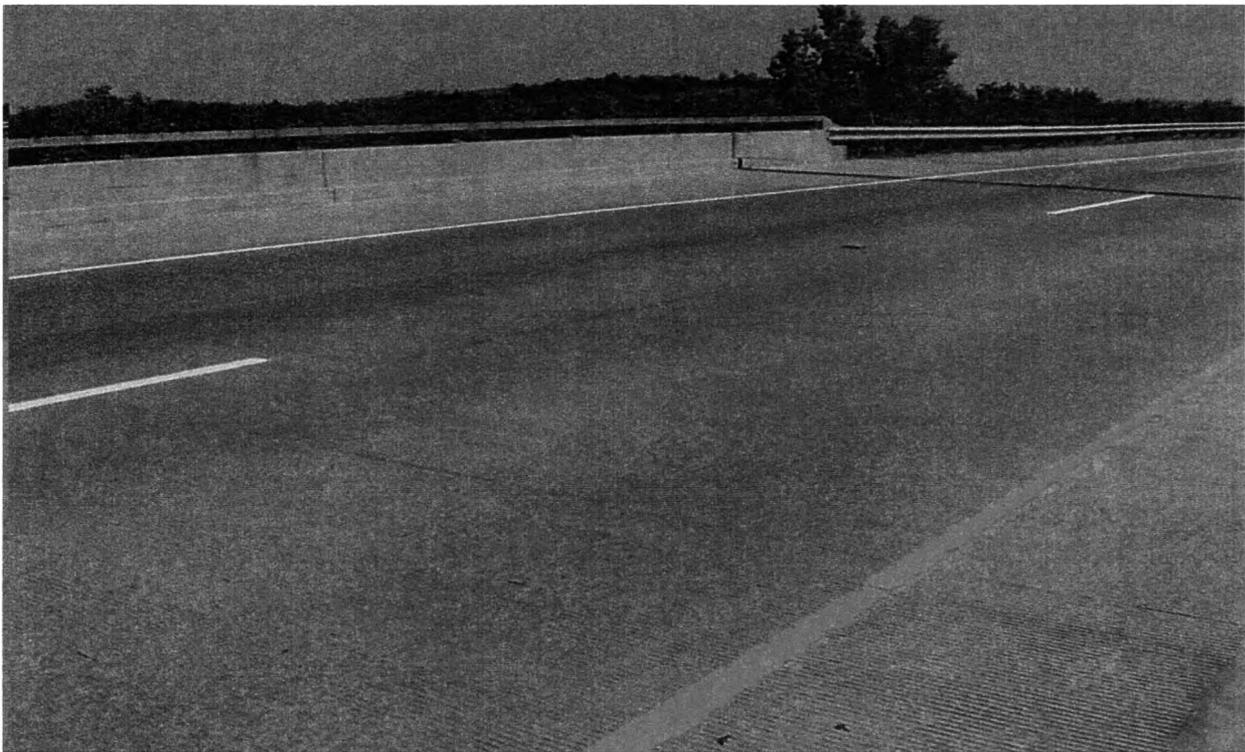
Figure 4. Overlaid Deck, No Distress Present Other Than Cracking.

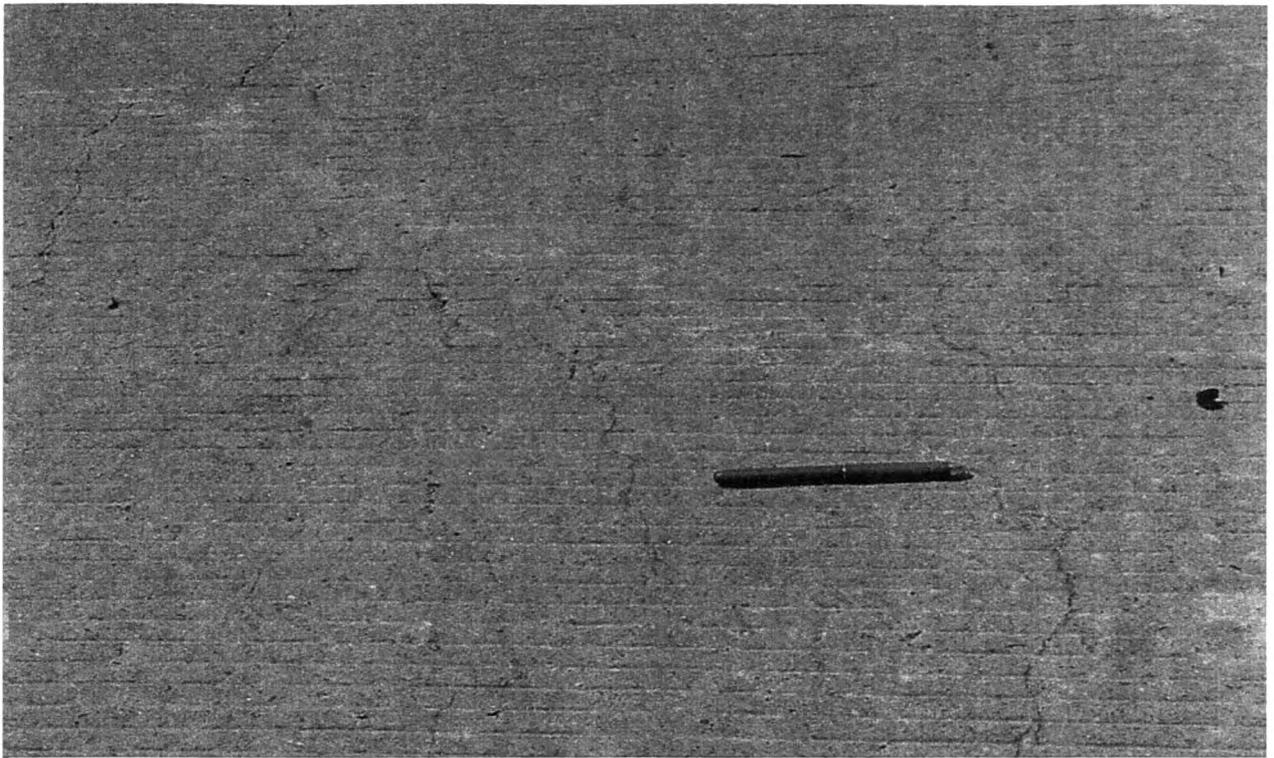
The October 2000 survey showed hairline cracking as the major distress found on both bridge decks. Approximately 10% of the northbound bridge deck had random hairline size cracks while the southbound bridge deck had similar distress over approximately 25%. No delaminations were detected during chain-drag testing. All half cell readings were in the lowest potential class (ASTM C 876). The southbound bridge had only 7% and the northbound bridge had 2.9% class "A" range readings. Skid values were measured on the southbound right lane at 43 and 52, and the northbound right lane at 42 and 46, which indicates good skid resistance. See Figure 1 for a graph of the profilograph test results from 1999 to 2000.

Figure 5. Hairline Size Random Cracks.

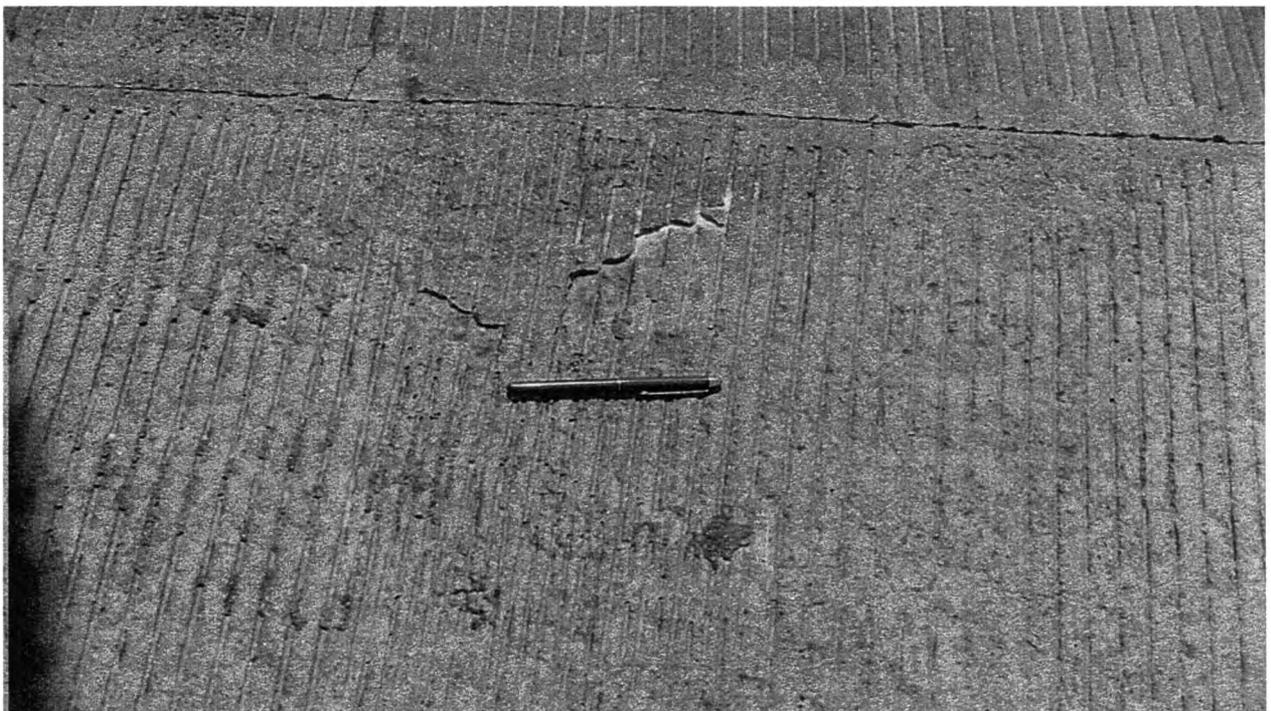
Figure 6. Longitudinal Construction Joint Crack.
