parts return program

U.S. DEPARTMENT OF TRANSPORTATION • NATIONAL HIGHWAY TRAFFIC SAFETY ADMINISTRATION

Vol. 2, No. 2

August, 1976

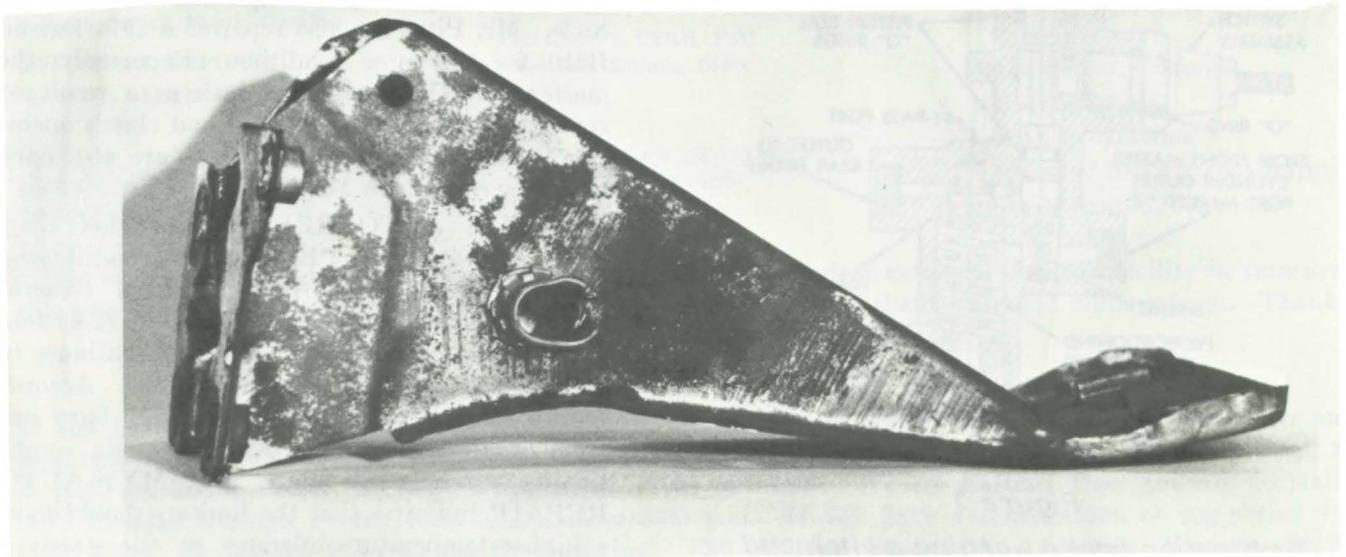
Figure 1

The PRP has received a brake pedal support bracket from GUS COOPER SERVICES, INC., Seattle, Washington. This part, which attaches to the firewall and dash support, was removed from a 1967 Ford Mustang with a mileage of 62,000. The vehicle was equipped with power brakes and an automatic transmission.

The bushing which supports the brake pedal swing shaft on the right side of this bracket is elongated and split (see figure 1). The hole in the bracket thru which the bushing fits is also elongated, approximately $\frac{3}{8}$ of an inch, and the bracket has a light coating of rust. Reportedly, the failed bushing can prevent the brake pedal from returning, possibly resulting in brake lock-up, or cause enough resistance to require excessive effort to apply the brakes.

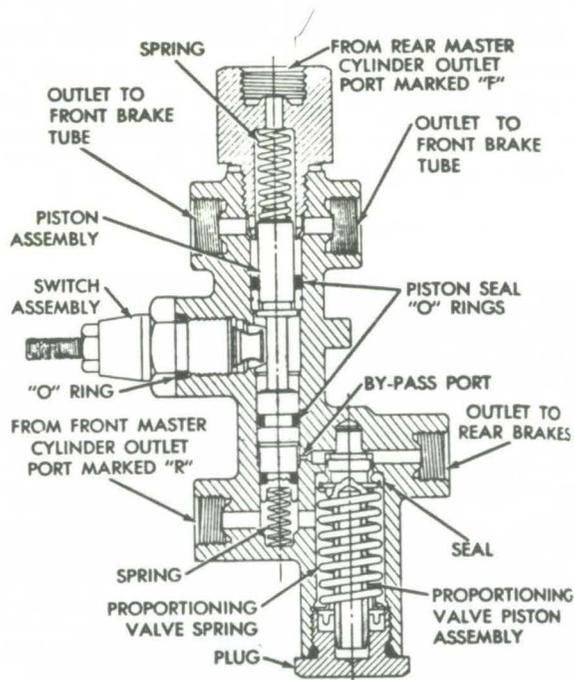
Figure 2

A warning system consists of an illuminated "brake" display sign in the vehicle's instrument panel, a special switch, and a proportioning valve. The switch is operated by *differential* pressure on the ends of a sliding rod. When the brake pedal is pressed and one of the brake lines is open, the rod will be forced to move. It is designed to provide cam operation of the switch which operates the brake warning light (see figure 2).

Combination brake warning switch and proportioning valve assembly (sectional)
