## parts return program

# news

U.S. DEPARTMENT OF TRANSPORTATION • NATIONAL HIGHWAY TRAFFIC SAFETY ADMINISTRATION

December 1976

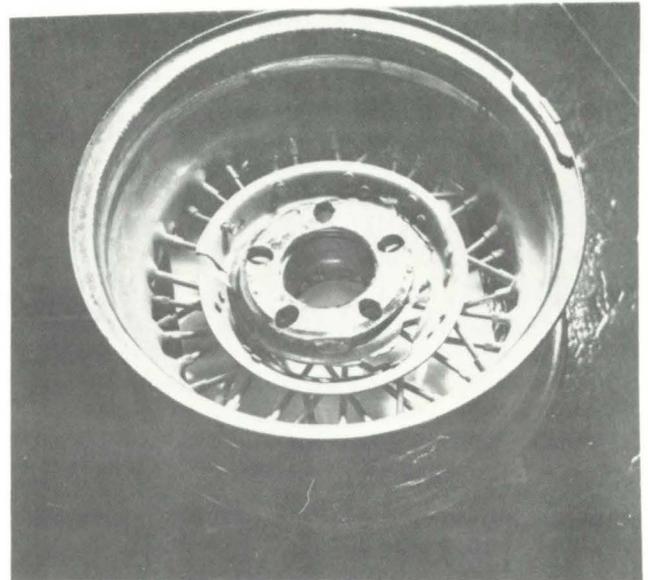
The March 1976, issue of the PRP News contained an article about a Tru-Spoke wire wheel that had been returned to the PRP by DICK JORDAN'S STANDARD SERVICE STATION in Clayton, Missouri. As indicated in the photograph, the inner disc of the wheel is broken around  $\frac{2}{3}$  of its circumference. The wheel had been removed from a 1975 Cadillac Coupe De Ville with approximately 5,000 miles on it. At about the same time, the National Highway Traffic Safety Administration (NHTSA) received some other related inputs concerning Tru-Spoke wheels, including information from ABBCO SAFETY CENTERS, Detroit, Michigan.

After discussions with the NHTSA's Office of Defects Investigation, the manufacturer, Wheel Specialties Company, initiated a safety recall campaign involving 3,268 of these wheels for a potential defect. The wheels may become structurally unsound when used on a vehicle with a gross weight of 5,000 pounds or more. Wheel specialties is notifying involved owners of this potential defect and will replace the wheels free of charge.

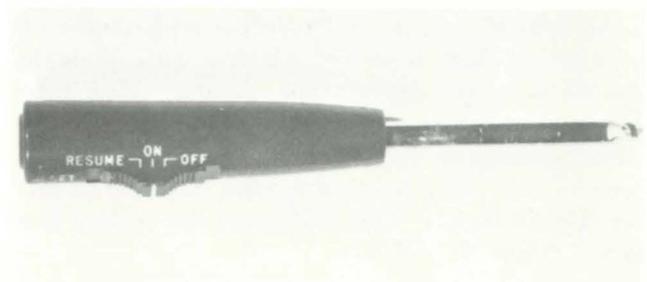
FELD GARAGE, INC. in Kenosha, Wisconsin has returned a turn signal lever that was removed from a 1975 Matador 2 door coupe with a mileage of 11,097. The lever, which includes a speed control device (see photo), broke off at the steering column. The signal cancelling device in the column was still in good condition. Please notify the PRP if you are aware of similar failures.

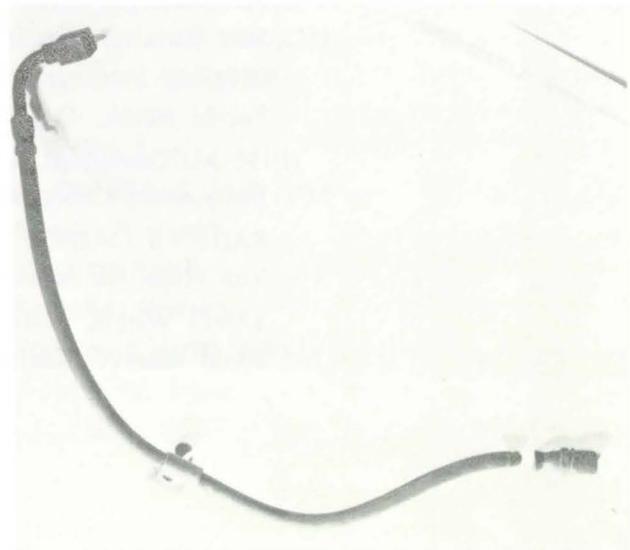
Mr. T. C. Duff at BELOIT FRAME AND AXLE in Beloit, Wisconsin has sent the PRP a front brake hose which is shown here. The hose was removed from a 1973 GMC  $\frac{3}{4}$  ton pick-up truck with a mileage of 23,500. Reportedly, the hose rubber cracked and frayed at the fitting causing a brake fluid leak. The hose separated when the shop removed it from the vehicle. Mr. Duff reported that several  $\frac{3}{4}$  ton GMC trucks have been repaired in his shop for this type of failure.

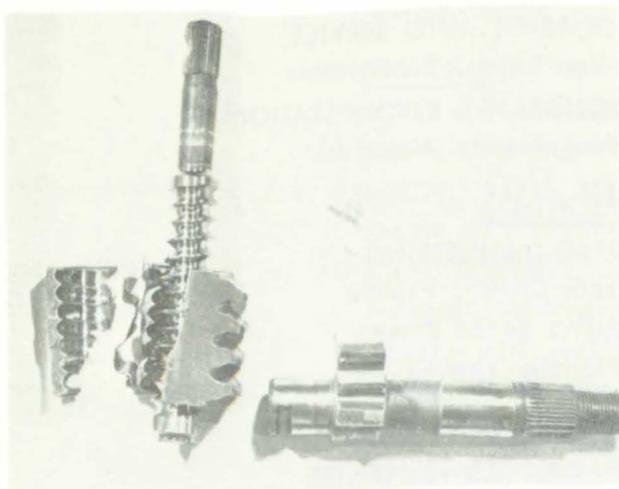
AUTO BRAKE CORP. in Norfolk, Virginia has sent the PRP some components that were removed from the manual steering gear box of a 1975 Chevrolet Series 30 Step Van with 21,696 miles. The steering reportedly failed while the driver was making a turn. No accident occurred as a result. Upon inspection, the shop found that the pitman shaft showed wear marks, bearings were worn, and the ball nut for the worm shaft was cracked in two. The pitman shaft, worm shaft, and ball nut are shown here. The shop states that the possible cause of the failure was lack of lubricant in the gear box. AUTO BRAKE CORP. also reports finding several other trucks, primarily Ford models between six months and two years old, with a lack of lubricant in the steering gear box. If your shop encounters similar conditions on any vehicle make, please let the PRP know. Thanks.

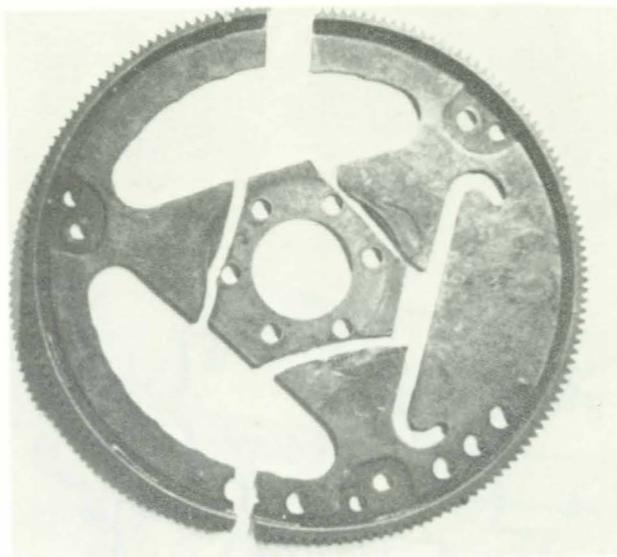
J. GARTNER'S AUTO SERVICE in Chicago, Illinois has returned a converter flex-plate that was removed from a 1973 Buick Century station wagon with a mileage of 49,548. The vehicle was equipped with a 350 CID engine and a 350 Turbo Automatic transmission. The hub apparently broke out of the flex-plate, suddenly, while the vehicle was being driven on the highway. As shown in the photograph, the outer mounting holes of the plate are elongated and worn, and the hub is broken away from the spokes. The part was too large to fit in a PRP mailbag, so the rim has been cut in two. The driver of the car reportedly experienced loss

of drive power as a result of the failure. The vehicle was allowed to coast to the side of the road and out of the path of traffic. Special thanks to J. GARTNER'S for sending in the part. If your shop has encountered a similar failure please let the PRP know.
