parts return program

U.S. DEPARTMENT OF TRANSPORTATION • NATIONAL HIGHWAY TRAFFIC SAFETY ADMINISTRATION

Vol. 2, No. 5

November 1976

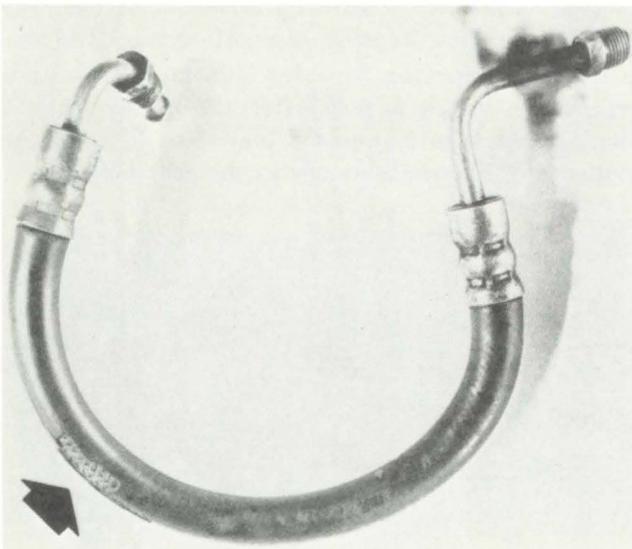
Figure 1

POWER STEERING HOSE FAILS

The high pressure power steering hose that is shown was sent in by WINSLOW'S MOBILE STATION in Gorham, Maine. The hose was removed from a 1975 AMC Hornet Sportabout with a mileage of 35,070. As indicated in the photograph, a two inch section of the rubber surface on the hose has cracked and fallen off. This reportedly resulted in a loss of power steering. The NHTSA has received two other similar reports involving 1975 AMC Hornets. In those two cases engine compartment fires were reported as a result of hose deterioration and power steering fluid leakage. The NHTSA is analyzing the reports. If your shop knows of similar failures, the PRP would like to hear from you.

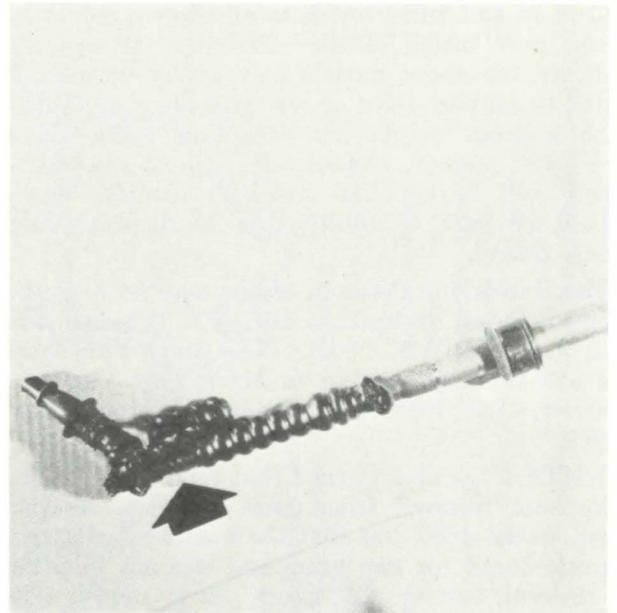
Figure 2

STEERING COLUMN FAILS

The photograph below shows a steering column, lower shaft assembly that was removed from a 1971 Ford Pinto. Vehicle mileage was 61,174. The assembly was sent to the PRP by ROEHL'S BEE LINE BRAKE and ALIGNMENT in Appleton, Wisconsin. The flexible portion of the shaft consists of twined metal wire covered by a rubber boot. In the area shown on the photograph some of the wire strands are unraveled and broken. The

failure reportedly resulted in complete loss of steering. There is no evidence of rust or corrosion. If your shop knows of any similar failures, the PRP would like to hear from you.

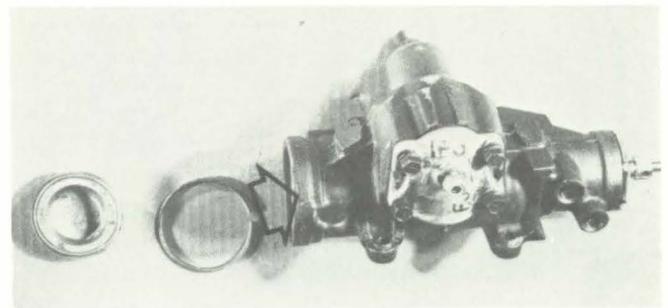
Figure 3

POWER STEERING GEAR CRACKS

BEACON AUTO BODY in Pennsauken, New Jersey sent in the power steering gear that is shown. The gear was removed from a 1976 Oldsmobile Delta Royals with mileage of 7,413. As indicated in the photograph, the end of the gear housing is cracked. The crack extends about $\frac{1}{3}$ of the way around the gear housing circumference. The end plate and snap ring are also shown. The vehicle reportedly struck a pole after the owner made a sharp right turn to avoid a bicyclist. There is no evidence of external damage to the gear housing.
