LIBRARY
MEDICALparts
return
program

U.S. DEPARTMENT OF TRANSPORTATION • NATIONAL HIGHWAY TRAFFIC SAFETY ADMINISTRATION

Vol. 3, No. 2

August 1977

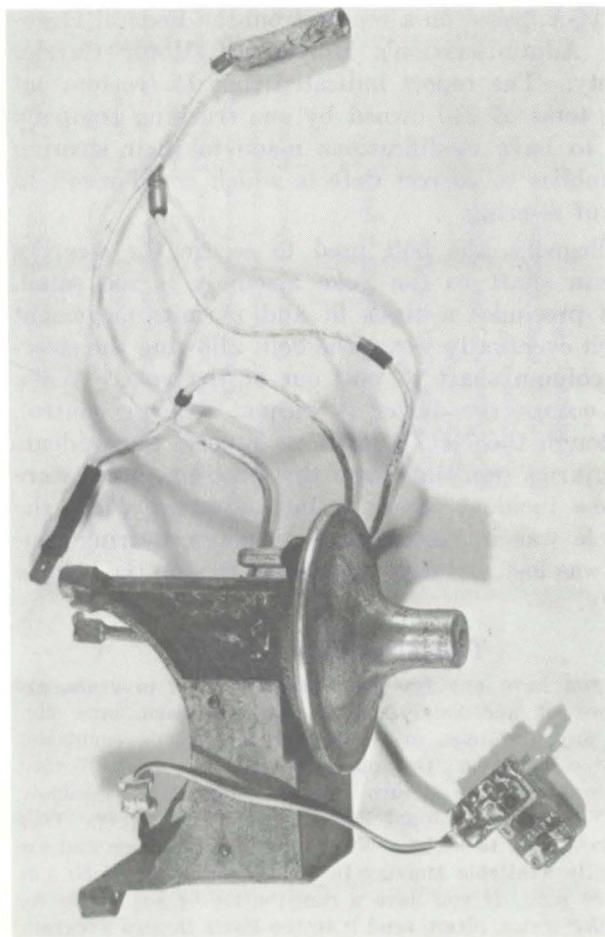
IGNITION AMPLIFIER
1975 Triumph TR-7

The Parts Return Program has received three ignition amplifier units, one of which is depicted below, from A. RUTH GARAGE, Colonie, New York. The unit shown was removed from a 1975 Triumph model TR-7. Vehicle mileage was 28,534. The other two units were removed from a 1976 MGB and a 1975 MG Midget.

mal defect investigation on this subject (Case No. C7-31). This case involves 1975-77 Spitfire, TR-7, MGB, MG Midget, Jaguar XJ6 vehicles, and 1971-77 Jaguar XJ12 vehicles for reported failures of the ignition amplifier. The failures allegedly cause the cars to misfire, stall in traffic, and fail to restart. At the time the case was initiated, the NHTSA had received at least 67 complaints either directly from owners or forwarded from British Leyland in response to inquiries. To date there have been no accidents reported.

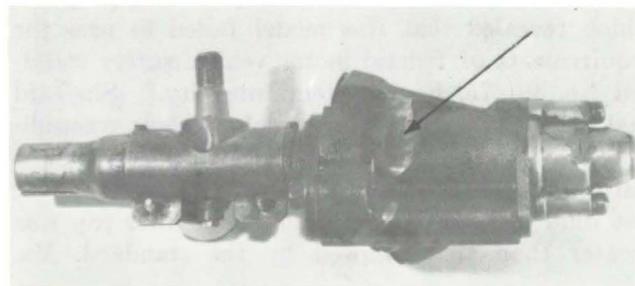
POWER STEERING CONTROL VALVE
1977 Mercury Monarch

The photograph below illustrates a power steering control valve that was submitted by BOB CHESTER'S AUTO SERVICE of Arlington, Texas. The component was removed from a 1977 Mercury Monarch with a vehicle mileage of 20,179. As the arrow indicates, a groove has been worn in the valve body and a small hole is present at the center of the groove. The hole and resulting power steering fluid leak reportedly caused a loss of power steering assist. Note the groove at the valve body end cap as well.

According to the shop, the vehicle owner brought the car in before any repairs were made. The shop reportedly found one of the tie rod adjusting sleeve

clamps positioned such that it had been rubbing the valve body, causing the damage. The vehicle owner reported that the car had never received a front wheel alignment, and that the tie rod adjusting sleeve was apparently installed this way when new.
