parts  
return  
program

# news

September 1977

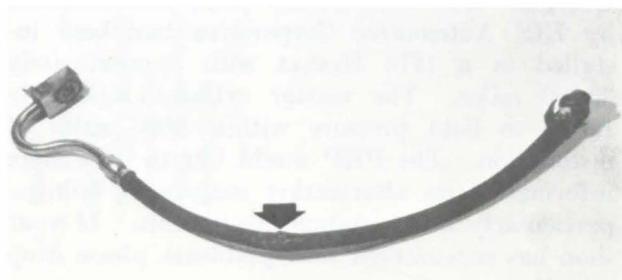
FRONT BRAKE HOSE  
1977 Ford F-350 Pick-up

D & Z AUTO SERVICE in Cornwell Heights, Pennsylvania sent in the front brake hose shown in the photograph. The hose was removed from a 1977 Ford F-350 pick-up with 23,462 miles. As indicated, the hose is worn through the cord at midpoint. This was reportedly caused by contact with a front tire on the vehicle. According to the shop, the vehicle was equipped with the original wheels and tires. The leaking hose reportedly allowed the brake pedal to be depressed to the floor, when the owner was backing the vehicle up with a fully loaded horse trailer. The shop believes that the hose may have been installed incorrectly at the factory. Special thanks to D & Z AUTO SERVICE for this information. If your shop finds a similar problem, please let the PRP know.

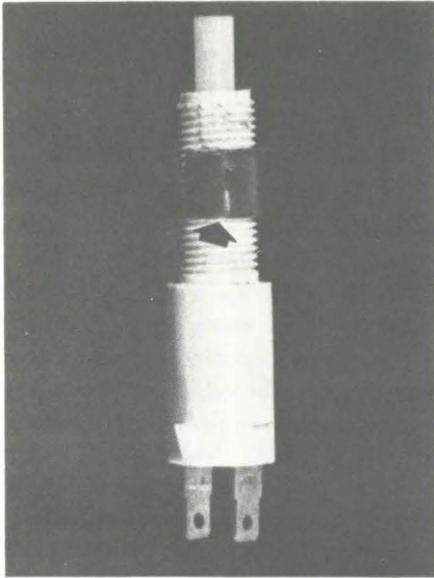
BRAKE LIGHT SWITCH  
1977 Chevelle

The photograph shows a brake light switch that was removed from a 1977 Chevrolet Chevelle with 7,032 miles. The switch was returned by ART'S SERVICE in Minneapolis, Minnesota. The metal collar and plastic threads on the switch casing reportedly failed to hold the switch in place under the vehicle's dash, allowing the switch to become misaligned. This in turn caused the vehicle's brake lights to stay on. The switch serves as a stop when the brake pedal is released. Special thanks to ART'S SERVICE for returning the switch. If your shop finds a similar problem, please let the PRP know.
