parts
return
program

news

U.S. DEPARTMENT OF TRANSPORTATION • NATIONAL HIGHWAY TRAFFIC SAFETY ADMINISTRATION

July 1978

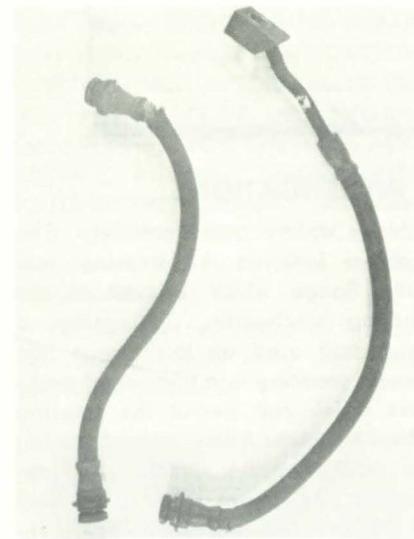
PLYMOUTH/DODGE BRAKE HOSE CRACKS

Based upon a large number of parts received from PRP members, the NHTSA has recently opened an engineering analysis into brake hoses on Chrysler Corporation vehicles. The analysis involves brake hoses from 1973 and 1974 Plymouth Valiants and Dodge Darts. The hoses allegedly develop cracks and splits near the fitting.

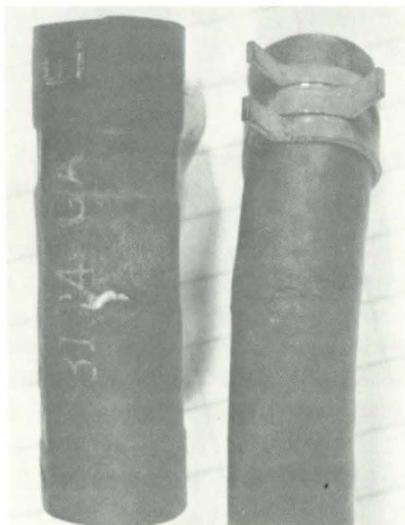
CRACKED, SPLIT AND LEAKING FUEL HOSES: Seen Any Lately?

The PRP has received a number of cracked fuel hoses from members over the past year, most of which were leaking fuel at the time they were removed. Hoses have been received from Ford, Chevrolet, Oldsmobile and Fiat vehicles. The most serious failure was reported in 1976 by **VANOWEN BRAKE AND WHEEL**, North Hollywood, California. Allegedly, a cracked fuel hose leaking at the carburetor end on a 1973 Ford caused an engine compartment fire which led to loss of vehicle control and a subsequent accident.
