parts return program

U.S. DEPARTMENT OF TRANSPORTATION • NATIONAL HIGHWAY TRAFFIC SAFETY ADMINISTRATION

Vol. 4, No. 5-6

November-December 1978

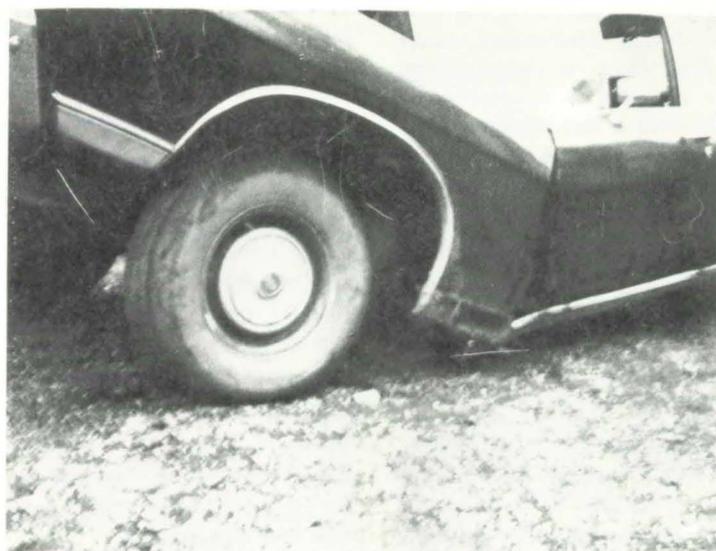
Recently, the PRP received a letter from Frank Hornyak, a former director of the Ohio Chapter of the Independent Garage Owners of America, Inc., (IGO). Mr. Hornyak, who has retired from the service industry, provided us with photographs and information concerning corrosion damage to the under-carriages of vehicles exposed to salt and other ice preventive road additives. The photograph shows a vehicle which reportedly came apart at the front door posts as it was hoisted on a front end lift. Hornyak commented that this is a common hazard particularly where salt and other chemicals are utilized for ice and snow removal. With winter on the move, all PRP members should be aware of potentially dangerous corrosion situations.

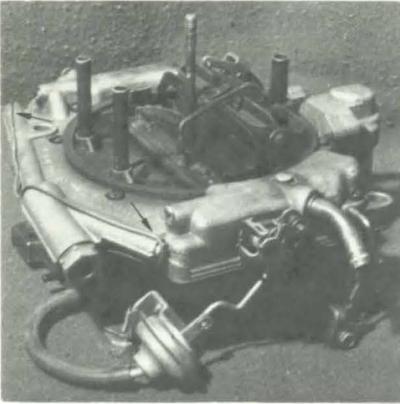
CITY OF SAN JOSE POLICE PATROL FIRE

The City of San Jose has submitted to the PRP information and photos of a 1976 Dodge Monaco Police Patrol vehicle which had been destroyed by an engine compartment fire. The 440 cid engine, was equipped with a Carter Thermoquad four barrel carburetor in which an unsecured tapered plug had come out, allowing gasoline to flood over the engine. The vehicle was still parked with the engine running when the plug reportedly came out and started the fire.

The officer immediately left the vehicle, but the running engine caused more fuel to be continually pumped out, feeding the fire and ultimately destroying the vehicle.

The San Jose maintenance department is now installing safety wires to secure these plugs in place, as shown in the photo. The PRP would be interested in any information concerning similar experiences from other program members.
