parts return program

news

Vol. 4 No. 3

September 1978

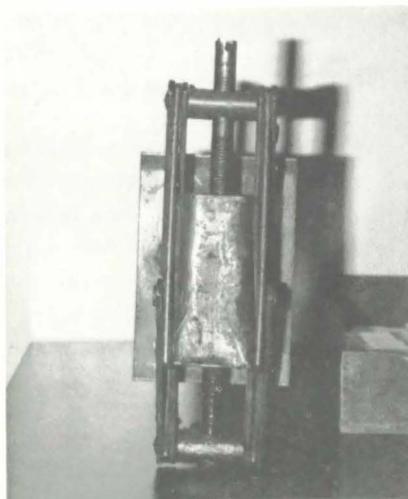
In response to an article concerning scissors jack failures in the May, 1978 PRP News, RIVERSIDE AUTO PARTS, Macon, Georgia, has forwarded information on a similar failure. The Hein Werner 1½ ton scissors jack pictured here reportedly collapsed after its handle broke off while a vehicle was being jacked up. The shop states that with this design, once the handle breaks off, there is nothing left to hold the jack, resulting in complete collapse.

Photograph of failed Hein Werner scissors jack submitted by RIVERSIDE AUTO PARTS.
