parts  
return  
program

U.S. DEPARTMENT OF TRANSPORTATION • NATIONAL HIGHWAY TRAFFIC SAFETY ADMINISTRATION

Vol. 5 No. 2

August 1979

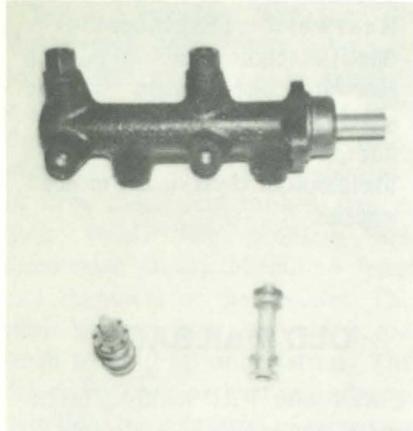
The PRP is interested in gathering information on brake master cylinders from various VW vehicles as reported in past issues. Several PRP members have contributed parts and information concerning brake master cylinders during recent months.

The contributing shops reported similar accounts of sudden partial loss of the vehicles' braking ability. Upon inspection, it was discovered that the seals in the master cylinders had worn out, allowing internal leakage of the brake fluid. Because of this, pressure may be applied to only one set of brakes in the tandem system. No external loss of brake fluid has been reported. Also, many reports have been received indicating the primary and secondary braking systems fail simultaneously, resulting in the brake pedal traveling to the floor with little or no braking action.

One shop noted that during assembly of the master cylinders, the seals, in order to fit tightly in

place, must be stretched over a pronged retainer. This can reportedly result in damage to the seals in the form of tears and small nicks. Premature failure can result, with the seal lasting as little as 30,000 miles.

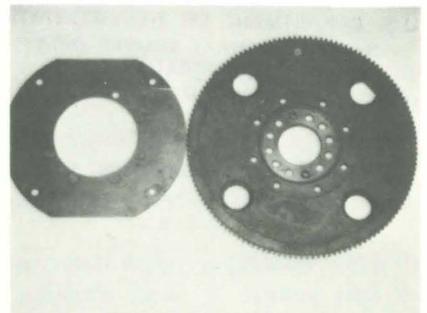
Pictured is the other flywheel submitted by **Automatic Transmission**

**Service** of San Diego, California. This flywheel was removed from a 1974 Jaguar XJ6. As seen in the photo, the flex plate broke free from the flywheel. The shop states that this is a fairly common problem among late model Jaguar XJ6's.
