parts return program

news

U.S. DEPARTMENT OF TRANSPORTATION • NATIONAL HIGHWAY TRAFFIC SAFETY ADMINISTRATION

January 1979

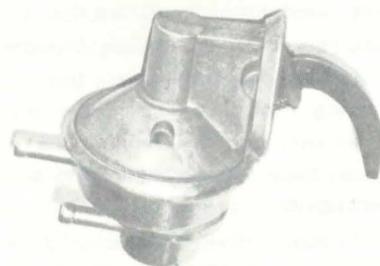
Fuel pumps for the Triumph TR-7, as shown in the picture, are designed to be assembled by crimping the pump cover to the main housing. Tim's reports that this does not make a seal sufficient enough to prevent fuel leakage.

According to the shop, through normal use, the crimped seal of the pump can work loose, creating an

intermittent leak. At times, there will be no leaking, but at other times fuel will spray out into the engine compartment.

Besides creating abnormal engine operation, whenever a situation involving fuel leakage occurs, there is a potential fire hazard. Because the pump is crimped together, there is nothing to tighten to prevent or eliminate the leak and the entire pump must be replaced. Any information of similar failures in TR-7's, should be forwarded to the PRP.
