parts
return
program

news

U.S. DEPARTMENT OF TRANSPORTATION • NATIONAL HIGHWAY TRAFFIC SAFETY ADMINISTRATION

May 1979

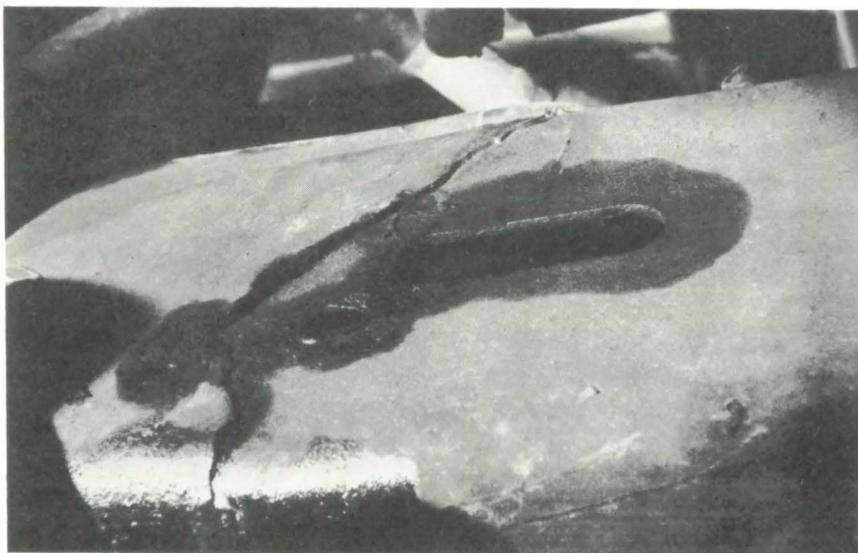
The above photo shows a 1977 Dodge B300 Van with 52,000 miles experiencing cracking of the frame. The information and photo was submitted by the **City of Phoenix** in Phoenix, Arizona. The problem started as a small crack where the steering gear box is attached by

bolts and welding to the frame. As seen in the photo the crack has grown considerably. This fleet has also had several 1978 models with 12-15,000 miles experience similar cracking. Reports of a similar problem were noted in the PRP News of February-March, 1979.

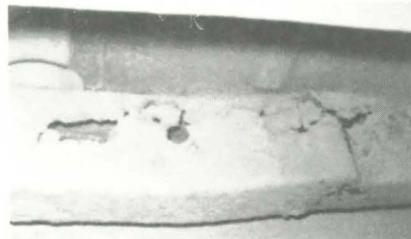
John's Body Shop in Binghamton, NY reported seven vehicles from various domestic manufacturers all experiencing severe rust

problems primarily in the vehicle's undercarriage and frame.

The information, supported with photographs, clearly shows the problem. The vehicles involved were one 1971 International truck, two 1972 Mercurys, a 1968 and 1975 Chevrolet, a 1970 Duster and a 1968 Pontiac: Pictured is the rusted frame from one of the 1972 Mercury vehicles.

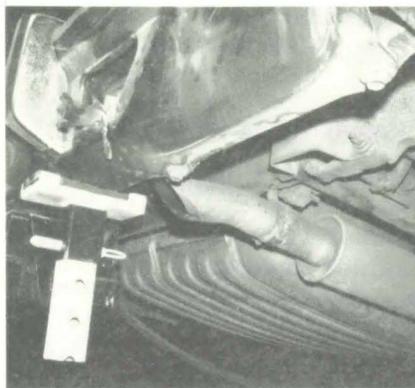
As shown in the picture, the **Village of West Milwaukee, Wis.** reports a mis-aligned exhaust system tailpipe on a 1977 Plymouth Fury Coupe with 36,712 miles. The alignment allowed gases to accumulate on the inside of the rear bumper. Reportedly, the resulting heat was intense enough to melt the plastic back-up lamp lens and cage. In addition, Lt. Springer of West Milwaukee reports that the gasoline tank filler pipe is less than 12 inches from the melted lens, creating a potential fire hazard.
