parts
return
program

news

U.S. DEPARTMENT OF TRANSPORTATION • NATIONAL HIGHWAY TRAFFIC SAFETY ADMINISTRATION

September 1979

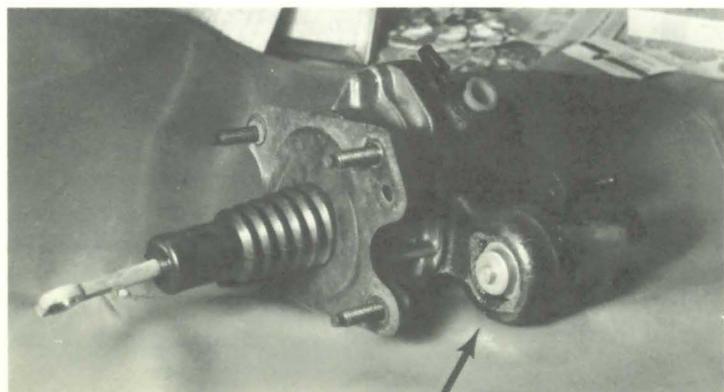
The NHTSA is currently looking into allegations of Hydro-boost failures on late model domestic vehicles allegedly due to casting failures which result in a loss of pressure to the power brake and steering system.

In a Hydro-boost system, power steering and power brakes are interdependent, utilizing one hydraulic pump to pressurize both. Reports of system failures include total loss of power assist steering and brakes, self-actuation of brakes upon executing a turn, and contamination of the brake fluid with power steering (automatic transmission) fluid.

The photo below, taken from a 1977 Ford LTD station wagon, illustrates casting failure of the Hydro-boost in the area of the accumulator, resulting in a sudden total loss of power assist to both the steering and brakes.

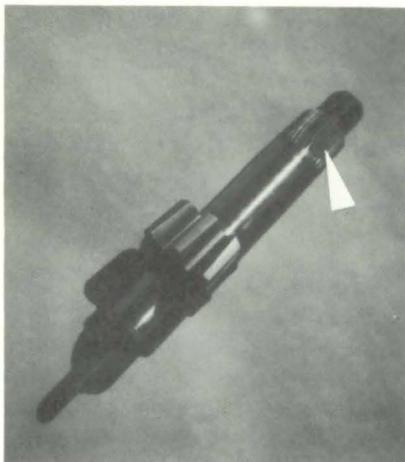
The steering sector shaft shown in the accompanying photo, was submitted to the PRP by **Art Dell's Garage** in Rensselaer, New York. It was removed from a 1977 Chevrolet

Impala with 22,329 miles. As indicated by the arrow in the photo, the shaft has several cracks and twisted threads at the point where it meets the steering arm. The result is an unstable connection between the two and potential loss of steering control. Any further information on this type of problem would be appreciated.
