# parts return program

U.S. DEPARTMENT OF TRANSPORTATION • NATIONAL HIGHWAY TRAFFIC SAFETY ADMINISTRATION

Vol. 6 No. 4

## CHEVROLET REAR BRAKE PROBLEMS REPORTED

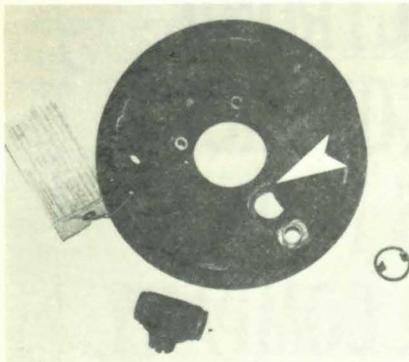
The reported problem is centered around the brake backing plate, pictured above. On this vehicle the wheel cylinder fits through an irregularly shaped hole on the backing plate, which is designed to prevent the wheel cylinder from rotating. The wheel cylinder is held against the backing plate by a spring clip also pictured above, on the rear of the backing plate, as opposed to being held by bolts.

According to the shop, there is enough "free play" between the backing plate slot and the wheel cylinder body to allow slight rotational movement of the wheel cylinder as the brakes are applied. With use, the wheel cylinder rotates back and forth in the hole, enlarging it. Finally, there is enough wear so

that as the brakes are applied in a normal fashion, the wheel cylinder "cocks" and the wheel cylinder push rods wedge themselves against the brake shoe holding the brakes on. The wheel cylinder push rods are pictured below.

The shop also reports a theory that one of the push rods can drop out of the wheel cylinder and cause a complete loss of rear brakes. The failure seems to occur at around 40,000 miles and has been noticed on eight of their vehicles.

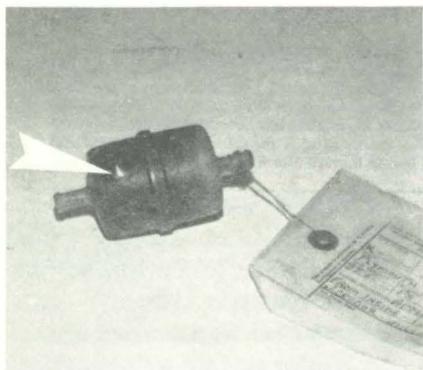
The **COUNTY OF HENRICO, VA** near Richmond submitted the fuel filter pictured below, removed from a 1978 Plymouth Volare with 18,000 miles.

As can be seen, the plastic filter case has become discolored and distorted around the area where a pinhole exists (arrow). It is possible that the combination of heat from the exhaust manifold fuel pressure acting on the inside wall of the fuel filter contributed to the failure. When the filter failed, raw fuel was spilled onto the hot intake manifold and cylinder head. Fortunately, the leak did not result in fire.
