COLORADO
Department of Transportation

CDOT Office of Applied Research

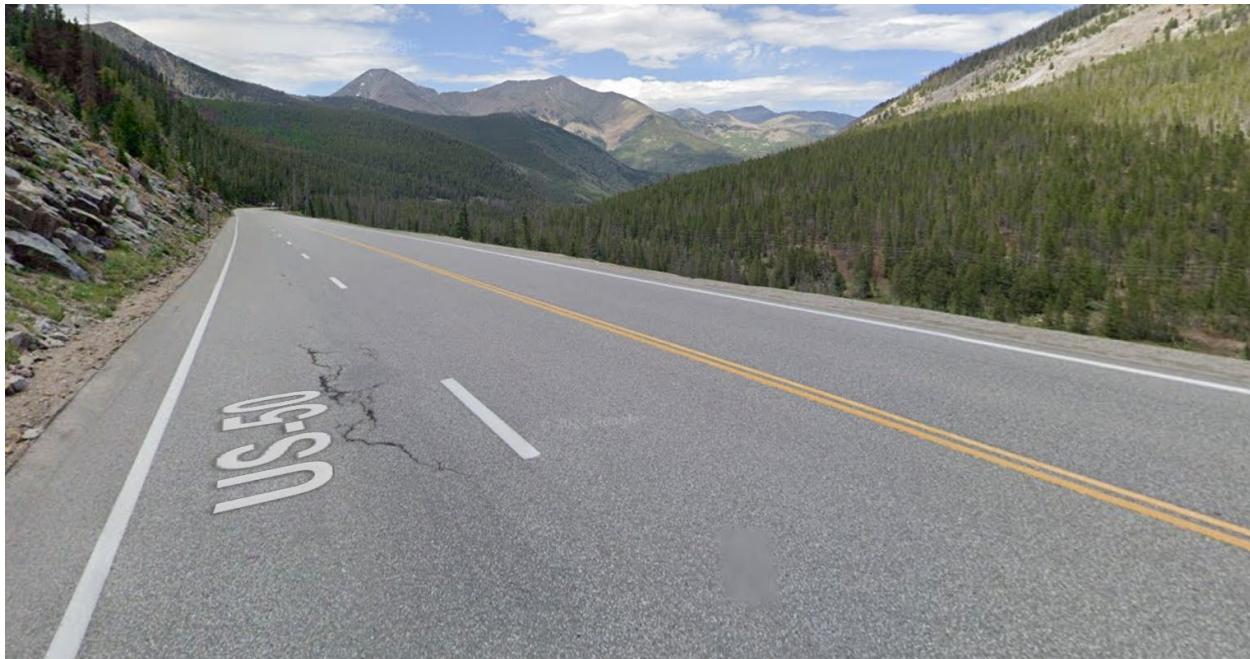
Figure 4-34: View of MP 201.80 Commercial Vehicle Crash Location, Jul. 2022

- The third injury crash, at MP 201.80 is somewhat of an outlier in that the records show the precipitating factor was that the vehicle "accelerated without explanation into the opposing lane," and it was not related to an overtaking maneuver. This portion of the study corridor is on a clear downgrade, and so one possible explanation for the sudden acceleration might be brake failure. Furthermore, the eastbound side of the road is unprotected by guardrail in this location and the maneuver into the westbound lane may have been to avoid rollover down the steep embankment (Figure 4-34).

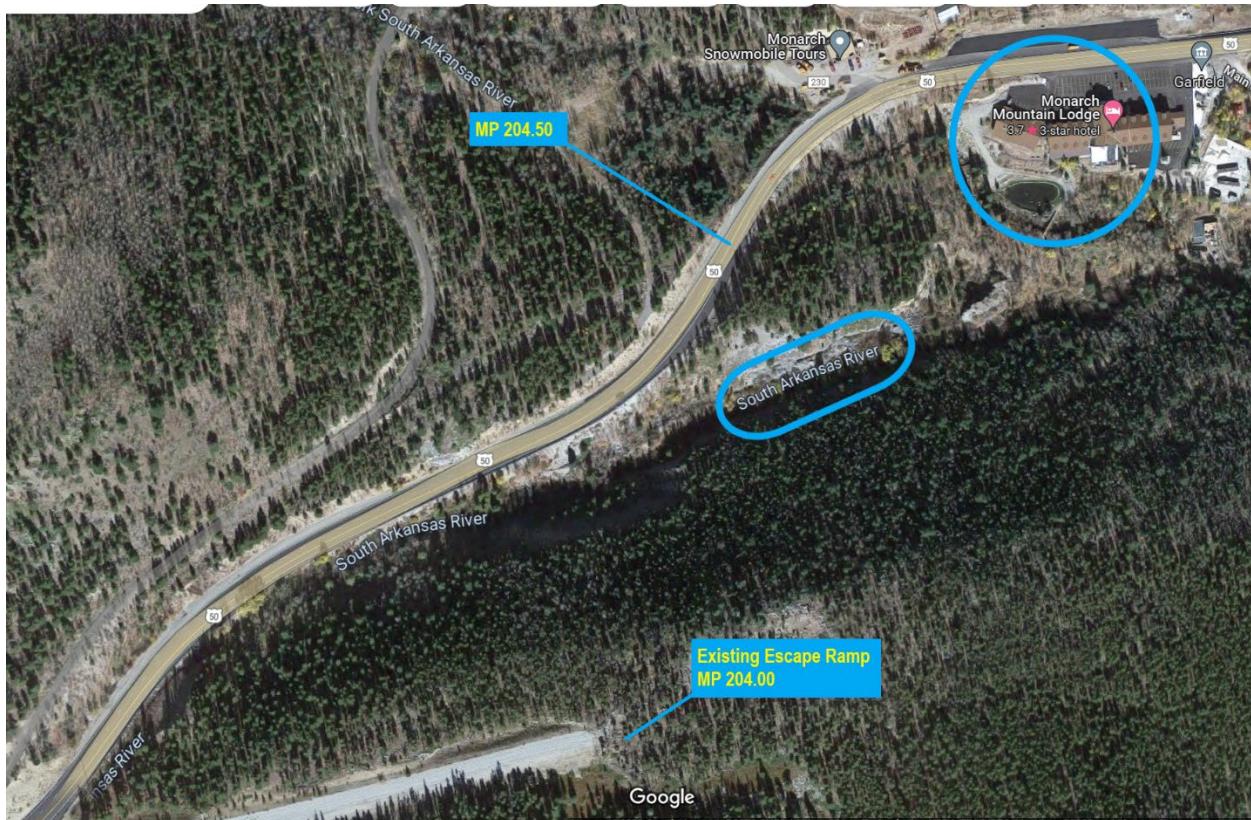
Figure 4-39: Aerial View of Curve near EB US50 MP 204.50

When we consider those truck crashes which resulted in run-off-the-road collisions, and in particular those severe level truck crashes described earlier, it might be considered if the truck ramp would have been better placed in advance of MP 204.00, closer to MP 203.50, or further downstream closer to MP 204.50 where crash clusters are seen. However, in the case of the latter location, there are narrow shoulders, a river and a hotel on the east side (Figure 4-39).

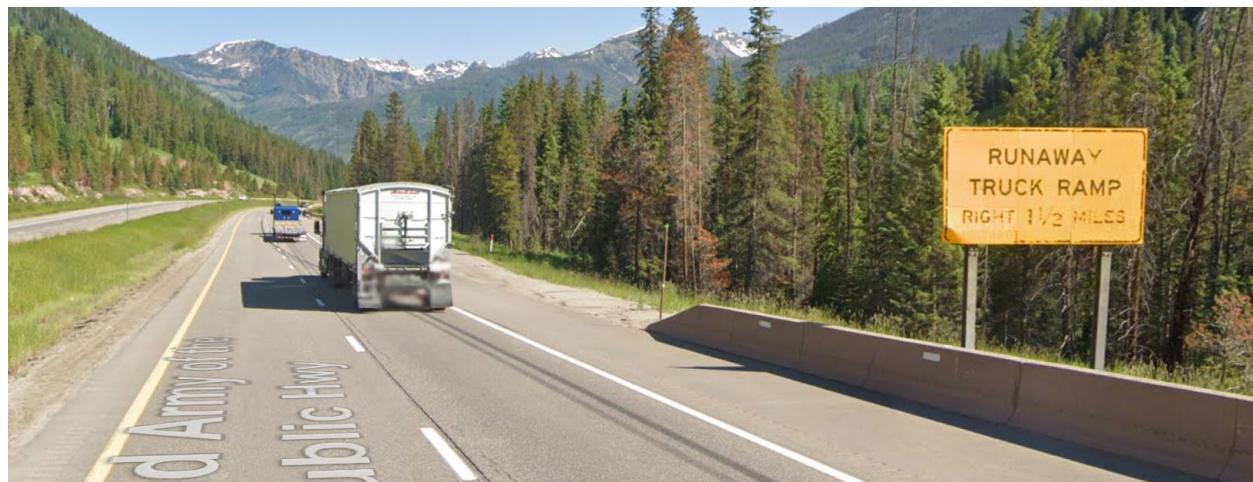
Figure 4-52: WB I-70 MP 183.72 Escape Ramp Advance Warning (Faded), Jul. 2023

ramp could have potentially been used but a combination of driver inexperience and inadequate signing may have contributed to it not having been.

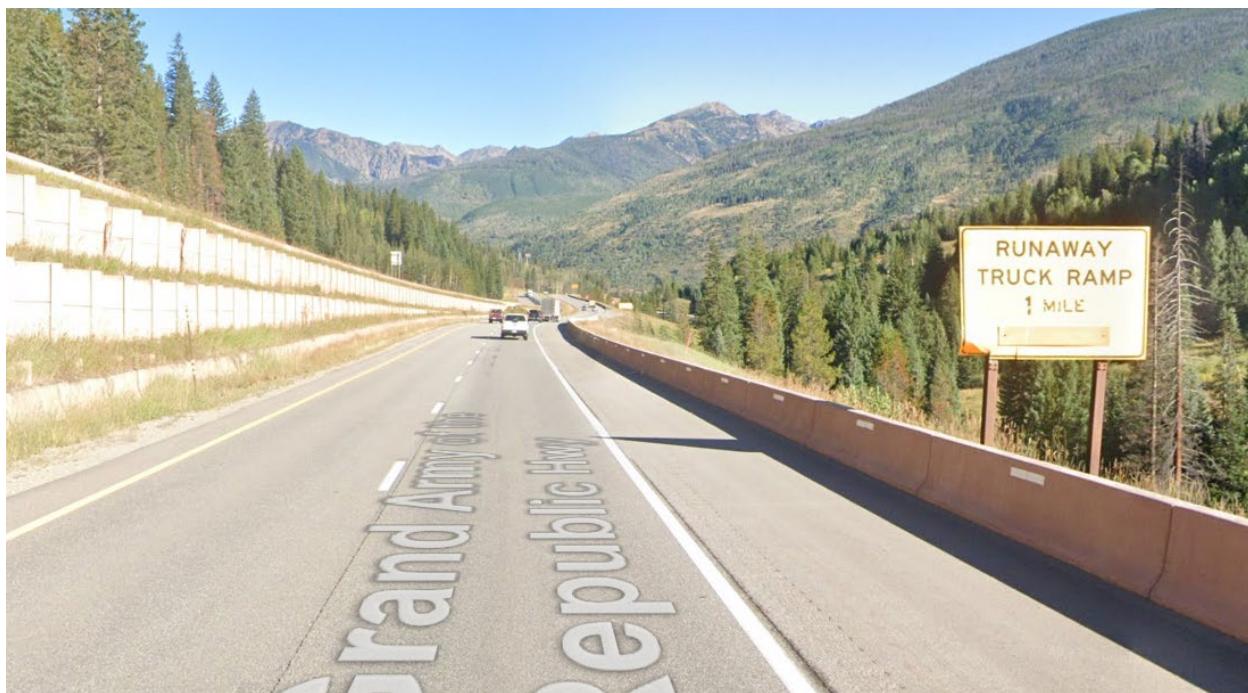
Figure 4-53: WB I-70 MP 183.24 Escape Ramp Advance Warning (Faded), Sept. 2023

3. On 5/24/19 near MP 182.30 a truck crash due to brake failure was recorded. This was an Injury level crash occurring on-grade. The truck went off the road to the right for 237 feet before colliding with a tree. The driver was unfamiliar with the area. The date of the crash puts it in the timeframe when the advance warning sign 1.5 miles in advance of the Lower ramp would have been faded. Additionally, imagery indicates that for the '1 Mile' advance warning sign near MP 183.24, it appears to be faded (**Figure 4-53**). It may be that it was very unlucky that the truck's brakes failed just at the escape ramp, not allowing the driver enough time to use the ramp. It might also have been that the brakes failed prior to the ramp and the driver attempted to use the ramp but was unsuccessful, and the crash was recorded at the location of the ramp. Inadequate signing regarding the exact distance to the ramp would not have served to assist a driver unfamiliar with the area.

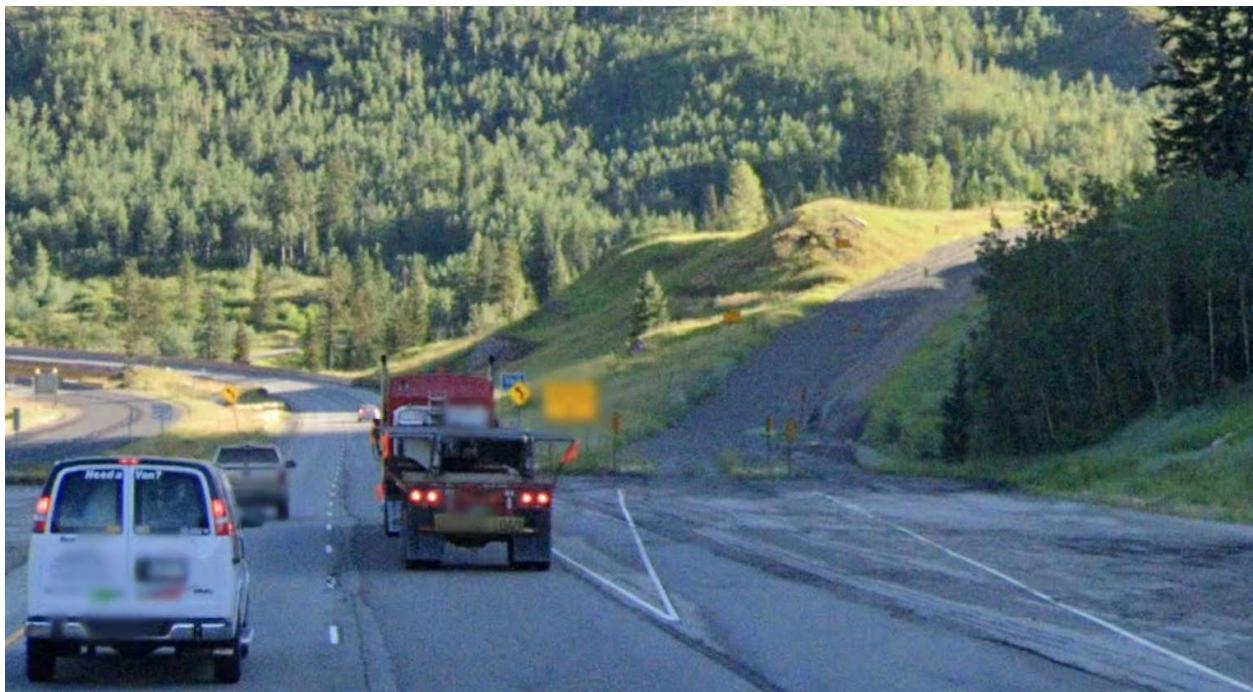
Figure 4-54: Lower Truck Escape Ramp (MP 182.36), Aug. 2019

7. On 6/23/21 there was a recorded use of the Lower escape ramp. This was a PDO crash on grade in dry conditions. Driver inexperience was a factor. The crash record narrative states that after traveling 1,000 feet along the ramp the truck exited the right side of the ramp and collided with a sign, then used the emergency side road, colliding with trees, before driving off a cliff. This is the 3rd recorded use of the Lower escape ramp where drivers were noted to have collided with signs while using the ramp and deviated in some way along or from the arrester bed. Cases like this may make truck operators hesitant to utilize escape ramps for fear of overshooting or overturning. **Figure 4-54** shows the Lower escape ramp in August of 2019. It is clear the ramp curves away to the right, out of the field of view of an approaching driver, this configuration could be off-putting for truck operators, particularly the inexperienced operator who may be less confident in their ability to successfully guide the vehicle along a curved ramp. While gravel arrester beds are intended to have the wheels of a truck sink in order to arrest the moment of the vehicle, this also creates a situation where steering becomes more difficult. While this may have more minimal effects during the use of ramp which is in a straight alignment, on a curved ramp such as this, it could cause deviations from the arrester bed, as has been seen in a several cases.

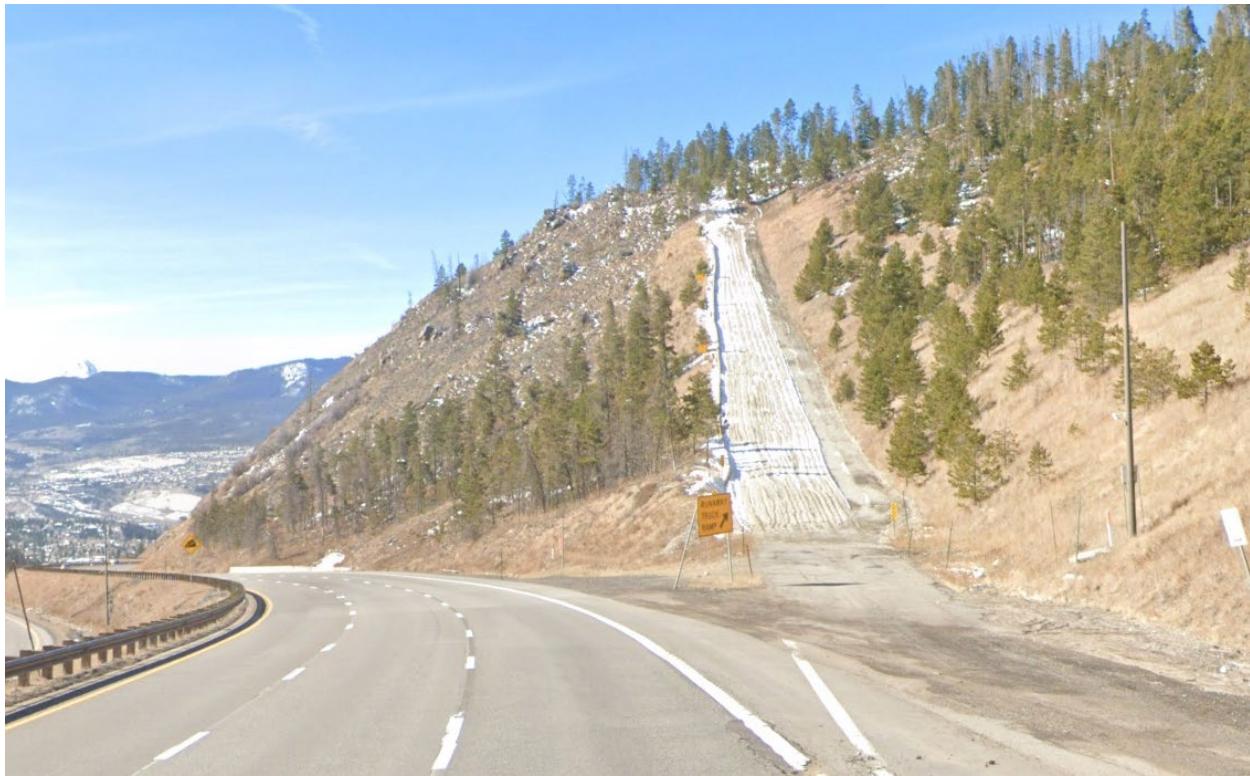
Figure 4-82: Lower Escape Ramp Entrance, Nov. 2023

In **Figure 4-82** recent Streetview imagery shows the sign at the entrance to the ramp has been damaged and faces away from oncoming drivers. CDOT is advised to repair the sign if this has not already been completed.

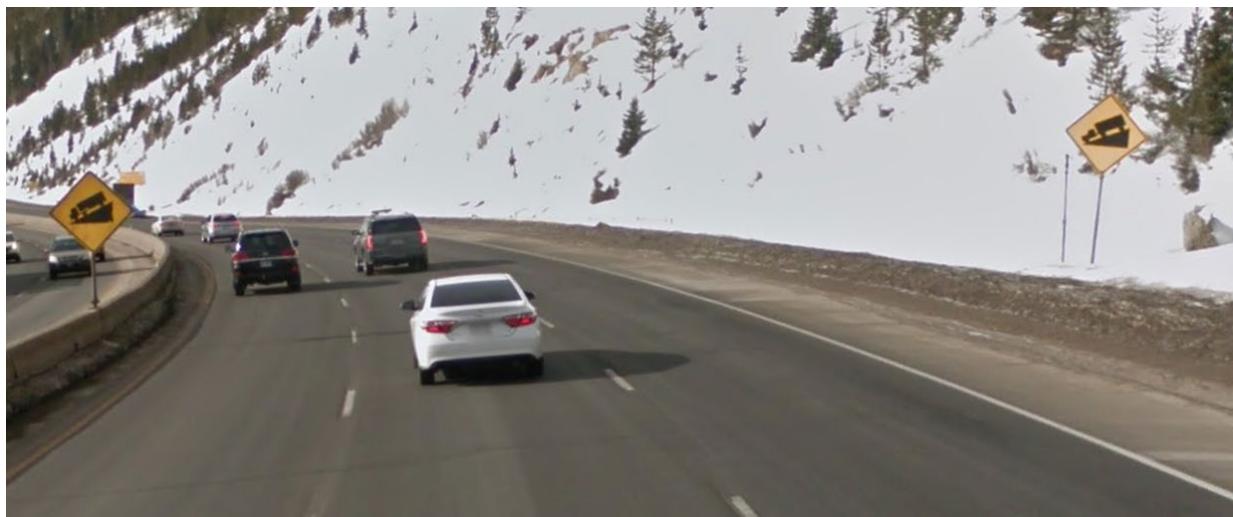
Figure 4-85: W7-1 Signs, WB I-70 MP 211.57, Dec. 2018

These signs are also supplemented with gated steep grades warning signs for trucks (MUTCD W7-1) near MP 211.57 and MP 208.65. However, Streetview imagery indicates that one of the signs at the former location is twisted away from oncoming traffic since sometime following 12/2018 and at least August 2023 (see **Figure 4-85** through **Figure 4-87**). If not already addressed, CDOT is advised to repair this sign so that it faces oncoming westbound traffic.
