DOT HS 813 734

**Special Crash Investigations:
On-Site Ambulance Crash
Investigation;
Vehicle: 2019 Ford E-350 Type III
Ambulance;
Location: Georgia;
Date: November 2022**

Special Crash Investigations
On-Site Ambulance Crash Investigation
Case Number: CR22017
Vehicle: 2019 Ford E-350 Type III Ambulance
Location: Georgia
Crash Date: November 2022

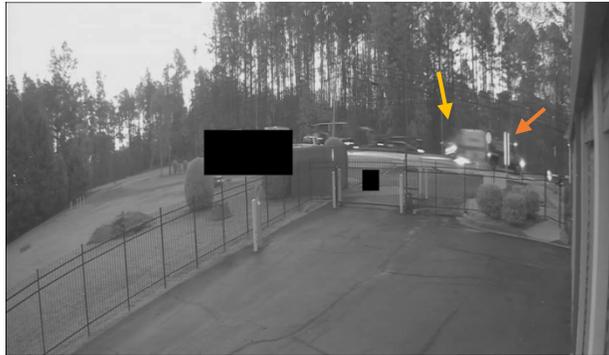
The front of the Mustang struck the left and center aspects of the ambulance front plane (Event 1, Figure 6). The ambulance's left front wheel assembly was crushed rearward into the toe pan as the ambulance ramped up the Mustang (Figure 7). The Mustang's momentum was redirected, and it began to rapidly rotate counterclockwise. The ambulance overturned one-quarter turn onto its right side (Event 2), sliding approximately 44 m (144 ft) from the initial impact area to rest in the center two-way left turn lane facing east.

Figure 6. Looking south from camera 2 and viewing the ambulance vs Mustang crash (Event 1). Yellow arrow shows ambulance and Mustang. Red arrow shows the box truck.

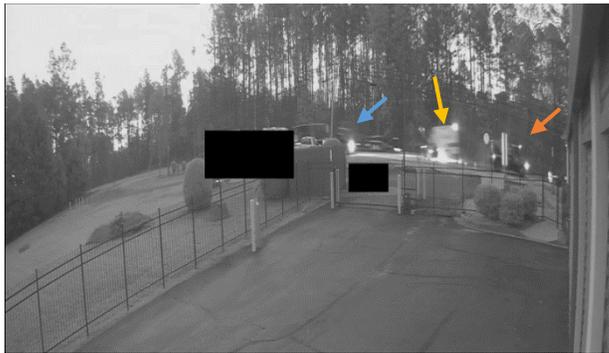
Figure 7. Looking south from camera 2 and viewing the ambulance ramping over the Mustang and initiating the rollover Event 2 (yellow arrow). The Dodge comes into frame (blue arrow) and the box truck (red arrow).

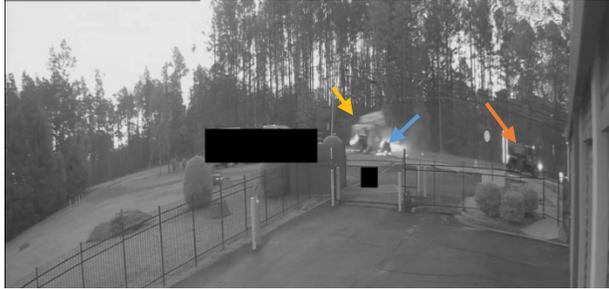
The redirected Mustang rotated approximately 180° counterclockwise. The Dodge Ram then struck the right side of the Mustang. The Mustang came to final rest against the Ram in the west right-turn lane (Event 3, Figures 8 and 9).

Figure 8. Looking south from camera 2 and viewing the ambulance in the rollover event (yellow arrow) and the Dodge striking the right side of the Mustang (blue arrow) and the box truck (red arrow).

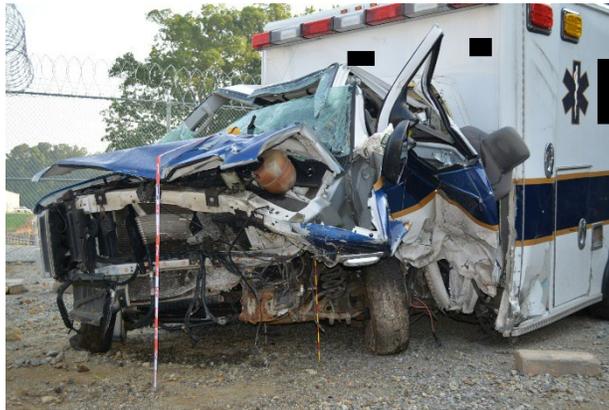
The ambulance sustained severe damage to the front plane as a result of the initial impact with the Mustang (Event 1). The ambulance's front stainless steel wraparound bumper separated at impact and was missing at the time of the SCI investigation. Damage measurements were taken across the lower radiator support bar. Direct damage started at the center line of the radiator and extended 66 cm (26.0 in) to the left corner with a maximum crush of 81 cm (31.9 in). The left front axle was crushed rearward 130 cm (51.2 in) causing severe intrusions to the driver's toe pan area (Figures 11 and 12). The driver's door and sill were driven upwards as the ambulance ramped over the Mustang causing the upper portion of the door to be separated away from the roof rail. The residual crush was measured at the lower radiator support bar with a total station and the resultant profile was: C1= 81 cm (31.9 in), C2= 65 cm (25.6 in), C3= 42 cm (16.5 in), C4= 17 cm (6.7 in), C5= 30 cm (11.8 in), C6= 19 cm (7.5 in). The GVWR of the ambulance exceeded the 4,535 kg (10,000 lb) limit and analysis was outside of scope of the WinSMASH program. For comparative purposes, the damage profile was run through the barrier algorithm. The barrier equivalent speed of this crush profile was calculated as 52 km/h (32.3 mph). The Truck Deformation Classification (TDC) assigned to this damage pattern was 12FYEW5.

Figure 11. Damage to the front end from the initial impact with the Mustang

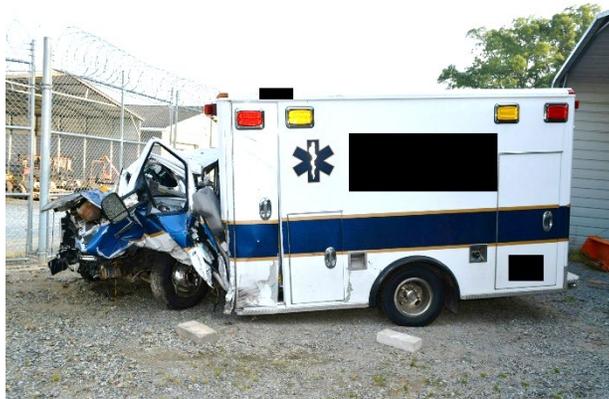
Figure 12. Viewing the left side of the ambulance

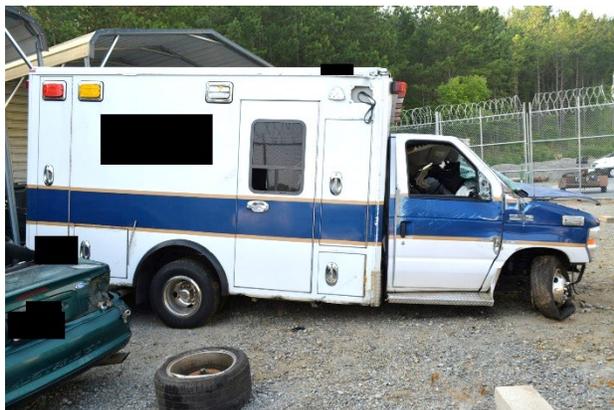
The ambulance sustained minor damage during the rollover (Event 2, Figure 13) that consisted of minor abrasions along the right side. As the ambulance came down onto the ground, the already compromised cab separated from the patient compartment causing a 23 cm (9.1 in) gap between the left B-pillar and the front of the patient compartment (Figure 14). The TDC assigned to this event is 33RDAO1.

Figure 13. Viewing the right side of the ambulance

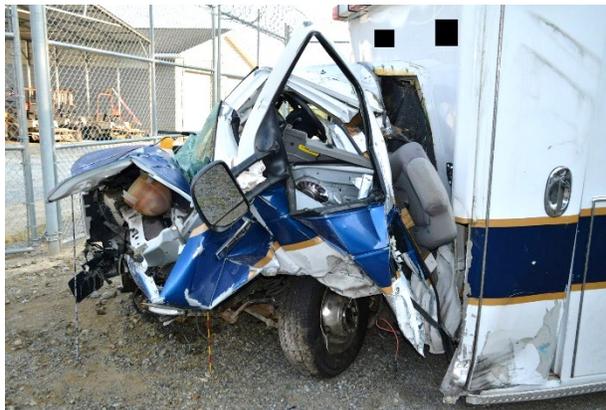
Figure 14. Viewing the damaged left side of the cab

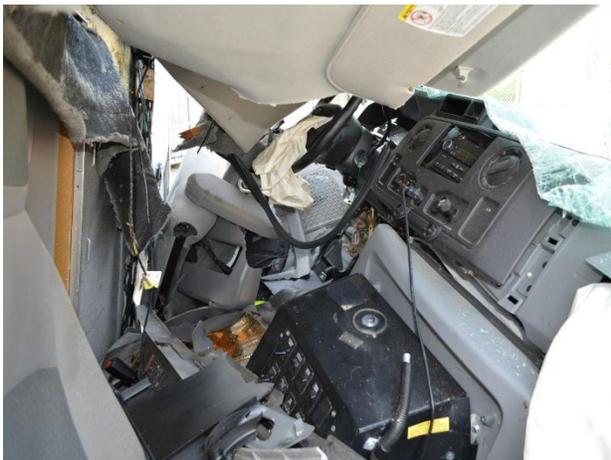
The interior damage to the ambulance cab was severe (Figure 15). The driver's floor/toe pan was intruded 25 cm (9.8 in) vertically and 20 cm (7.9 in) longitudinally into the occupant space from contact with the deformed left front wheel assembly (Figure 16). Based on these intrusions it is likely the driver's lower extremities were pinned between the toe pan and the knee bolster. The instrument panel was intruded 5 cm (2.0 in) longitudinally into the driver's space. The driver's door was fractured in several points and was laterally intruded into the driver's space by 19 cm (7.5 in). The center console was pushed 15 cm (5.9 in) right of the cab's center line and into the front passenger's seat base. The roof was damaged post-crash during the mechanical extrication of the occupants.

Figure 15. Looking across the front row from the right side

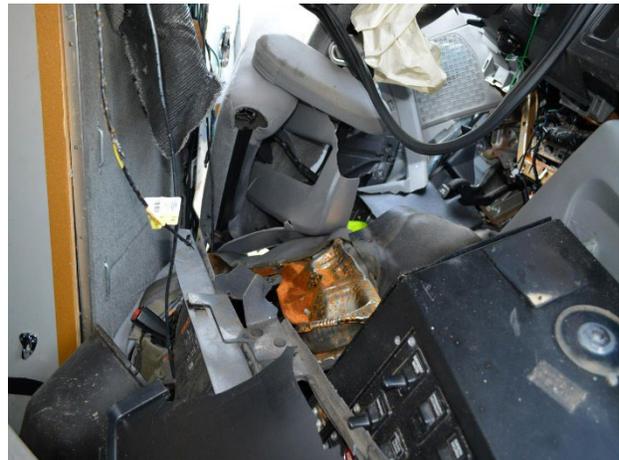
Figure 16. Viewing the intrusion and driver's seat

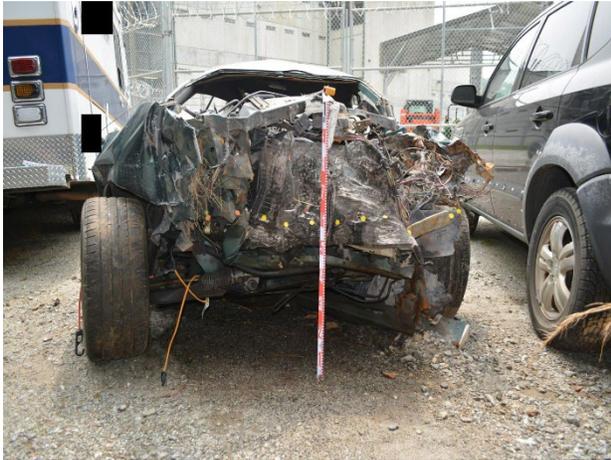
The Mustang sustained moderate damage to its front plane at impact and to its left side as it disengaged from the ambulance (Figure 18). The front bumper bar reinforcement separated during the impact and was missing. The direct damage measured 109 cm (42.9 in) along the radiator support plane with a maximum crush of 66 cm (26.0 in) at the left front corner. As the ambulance ramped over the front of the Mustang and began to disengage, the left door panel was ripped away leaving the mid-door support bar intact (Figure 19). The frontal impact caused

severe interior damage. The steering wheel with the deployed hub-mounted air bag was found in the driver's seat and was attributed to post crash extrication. The residual crush for Event 1 was measured with a total station and the resultant profile was: C1= 66 cm (26.0 in), C2= 49 cm (19.3 in), C3= 46 cm (18.1 in), C4= 48 cm (18.8 in), C5= 45 cm (17.7 in), C6= 32 cm (12.6 in). A barrier equivalent speed for this crush profile was estimated by the WinSMASH program as 62 km/h (38.5 mph). The collision deformation classification (CDC) assigned to the damage pattern for Event 1 is 12FDEW3.

Figure 18. Damage to the front end of the Mustang from Event 1

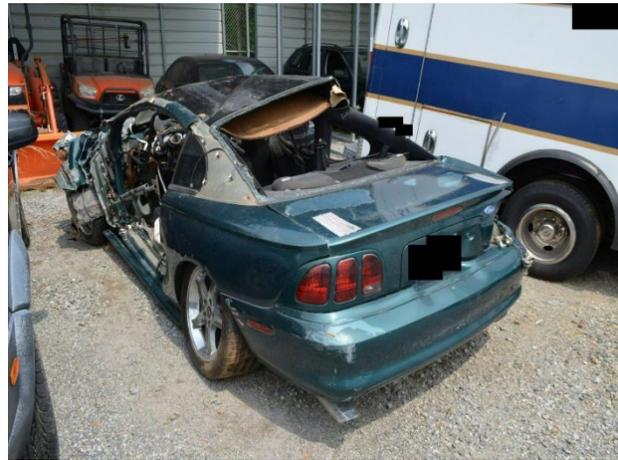
Figure 19. The left rear oblique view of the Mustang and damage along the left side

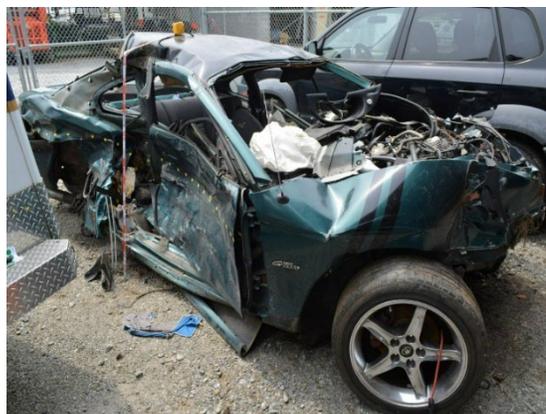
The Mustang then rotated approximately 180° counterclockwise facing east when the following Dodge Ram struck the right side of the Mustang (Event 3). The direct damage began at the right rear corner and extended forward 256 cm (100.8 in, Figure 20). The impact of the Dodge caused a severe 30 cm (11.8 in) intrusion of the right B-pillar into the occupant space. The maximum crush of 41 cm (16.1 in) was measured at the rear of the right B-pillar, 96 cm (37.8 in) rear of the right vehicle center line. A barrier equivalent speed for this crush profile was estimated by the missing vehicle algorithm of the WinSMASH program as 23 km/h (14.2 mph). The CDC assigned to the damage pattern was 03RZAW3.

Figure 20. Damage to the right side of the Mustang from Event 3
