# Effect of Y-cracking on CRCP Performance

## **ANNUAL REPORT FOR FY 2011**

ODOT SPR ITEM NUMBER 2230

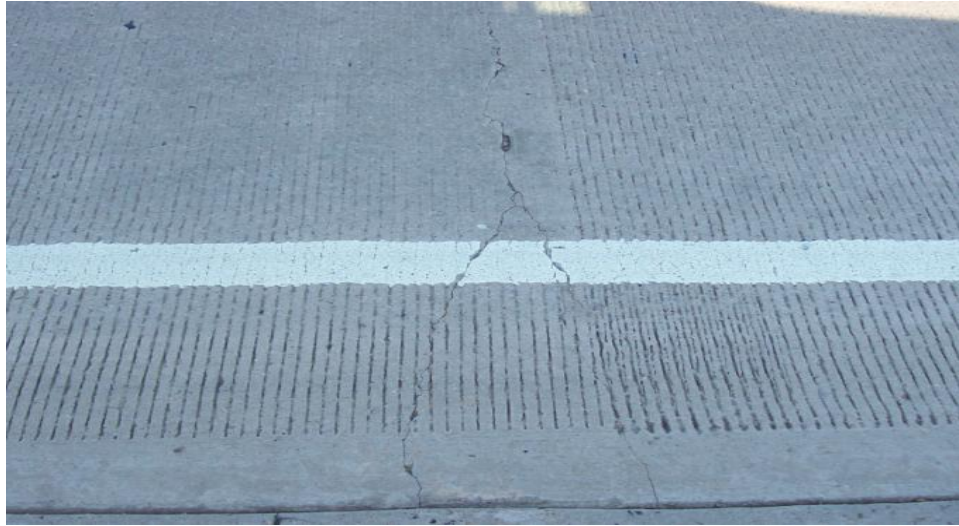
These types of cracks could severely decrease the performance and life of the CRCPs. Figure 2.2 is a picture of Y-cracking in an Oklahoma CRCP. Y-cracking is easily categorized by its very unique shape. There is a single crack, or “trunk” crack, which splits into two other cracks, called the “branch” cracks. It is not known how the crack propagates, whether the branches form and converge into one crack or the trunk forms and branches into the other two cracks.

**Figure 2.2 - Y-cracking example**

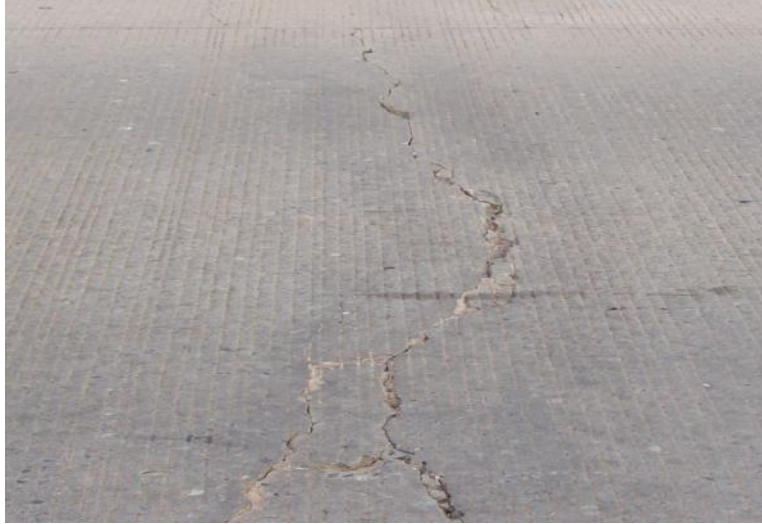
Spalling is defined as “the cracking, breaking, or chipping of the slab edges within 2 feet of the crack” (Choi & Chen, 2005). Normal CRCPs are designed with tight cracks that help resist spalling. Transverse crack spacing and crack width have been associated with controlling the resistance to spalling in CRCPs (Kohler and Roesler 2004). Spalling can be caused by excessive crack widths, which causes excessive stresses at the cracks. These stresses are from water infiltration, expansion of slabs, and traffic loading (Choi & Chen, 2005). An example of spalling in Oklahoma can be seen in Figure 2.3.

**Figure 2.3** - Example of spalling

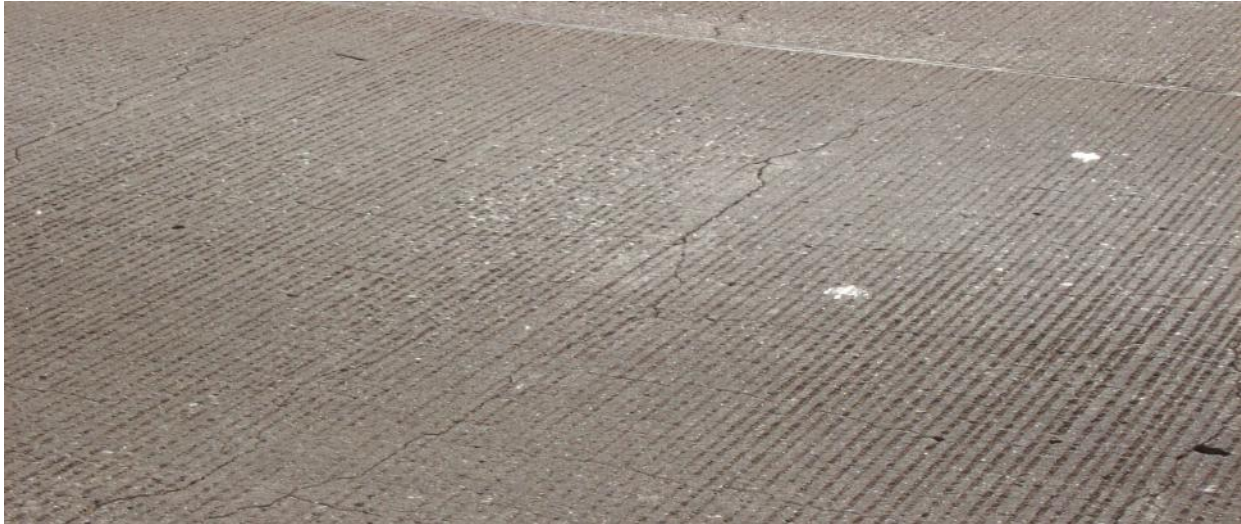
The south bound lane of this project had several more distresses and failures than the north bound lane. The south bound lane had several large areas of map cracking as seen in figure 3.2. The lane also exhibited multiple Y-cracks, or transverse cracks with several branching cracks, shown in figure 3.3 below.

**Figure 3.2** – Photo shows transverse cracks with inter-connecting longitudinal cracks.

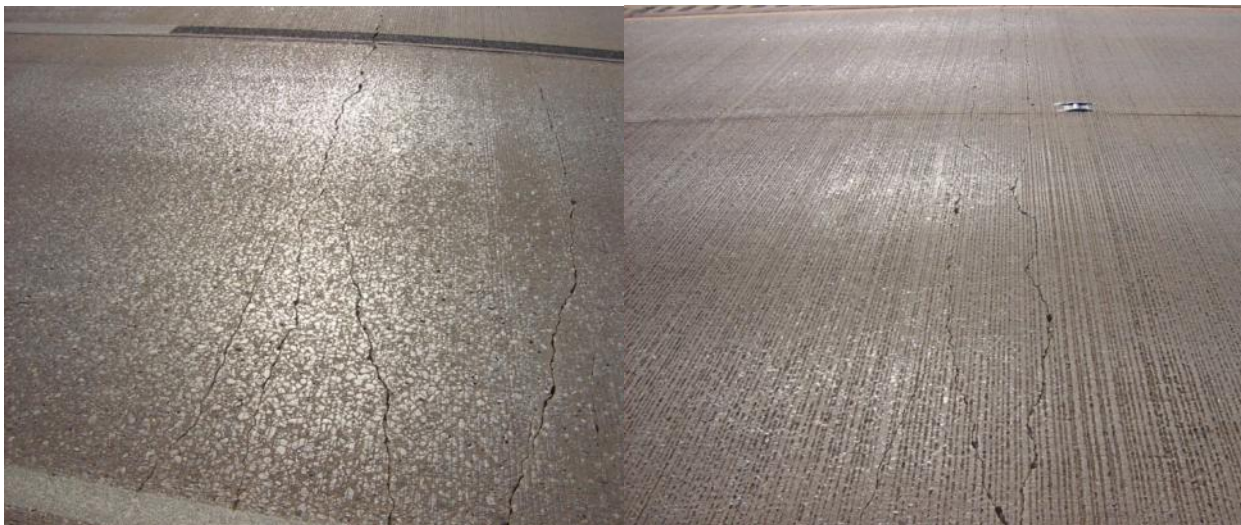
**Figure 3.3** – Photo shows Y-cracks with multiple branches

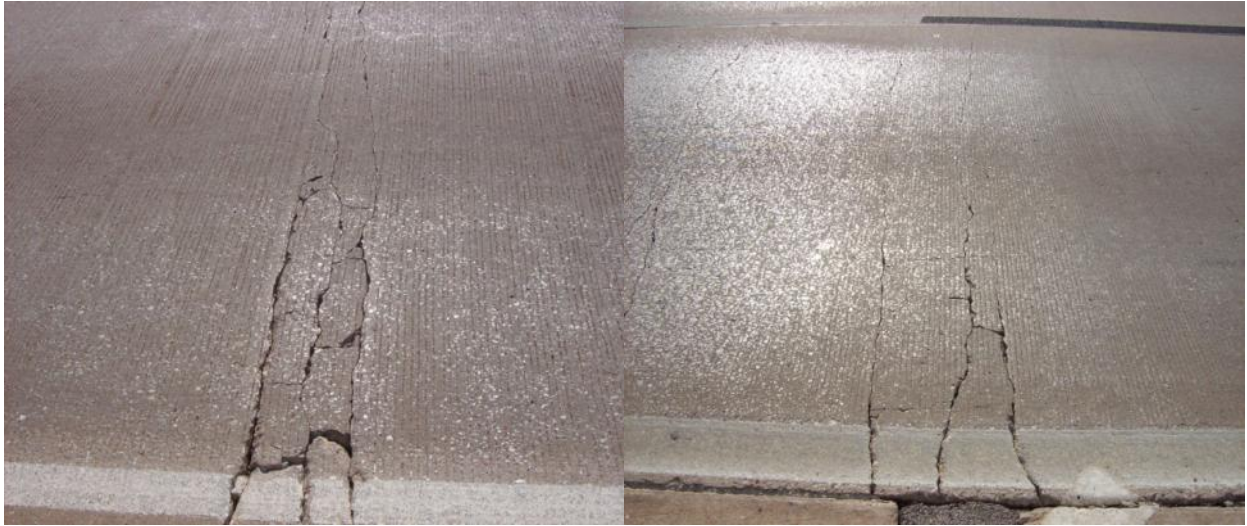
The overall crack spacing in the south bound lane was fairly irregular. Cracks seemed to range in spacing from two to ten feet. There were several instances of close transverse cracks (less than one foot) starting to break up, by way of longitudinal cracks, shown in figure 3.4. During the south bound lane inspection it was noted that areas with deeper tines made it more difficult to count Y-cracks, but seemed to make the cracks meander less.

**Figure 3.4** – Photo showing closely spaced transverse cracks developing into punch-outs

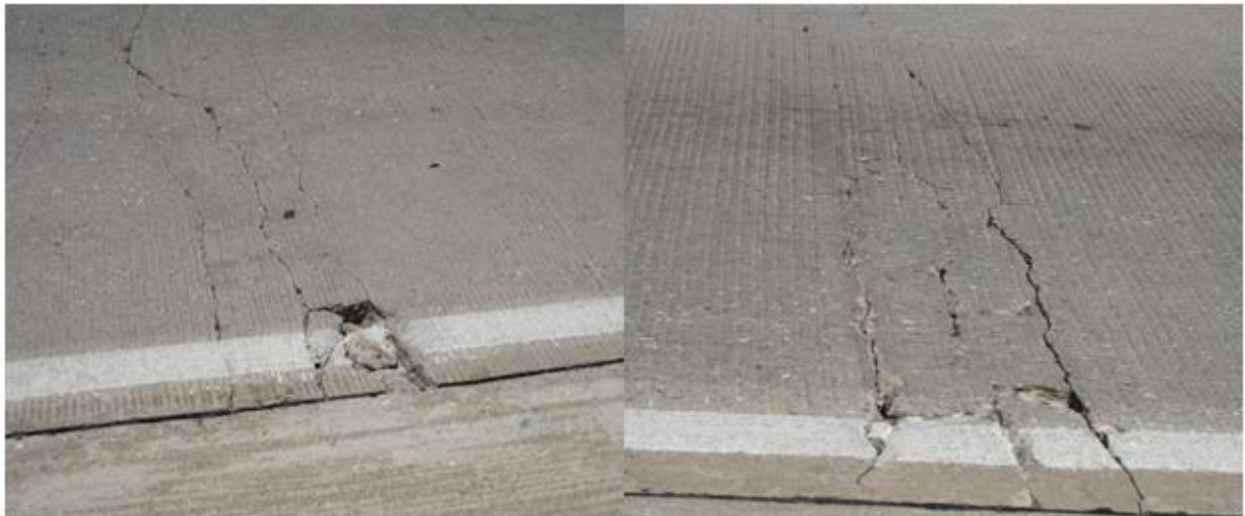
The north bound lane also exhibited irregular crack spacing, with cracks ranging from three to eight feet in spacing. There were a few developing punch-outs that had not been patched (figure 3.5); however, these appeared to be close transverse cracks and not Y-cracks. Many of the Y-cracks had spalling along their length. It was noted during the inspection that Y-cracks seemed to be spaced far apart and in clusters. In areas of increased crack spacing, such as eight to ten foot, Y-cracks were scarce.

**Figure 3.5** – Developing punch-out between two close transverse cracks

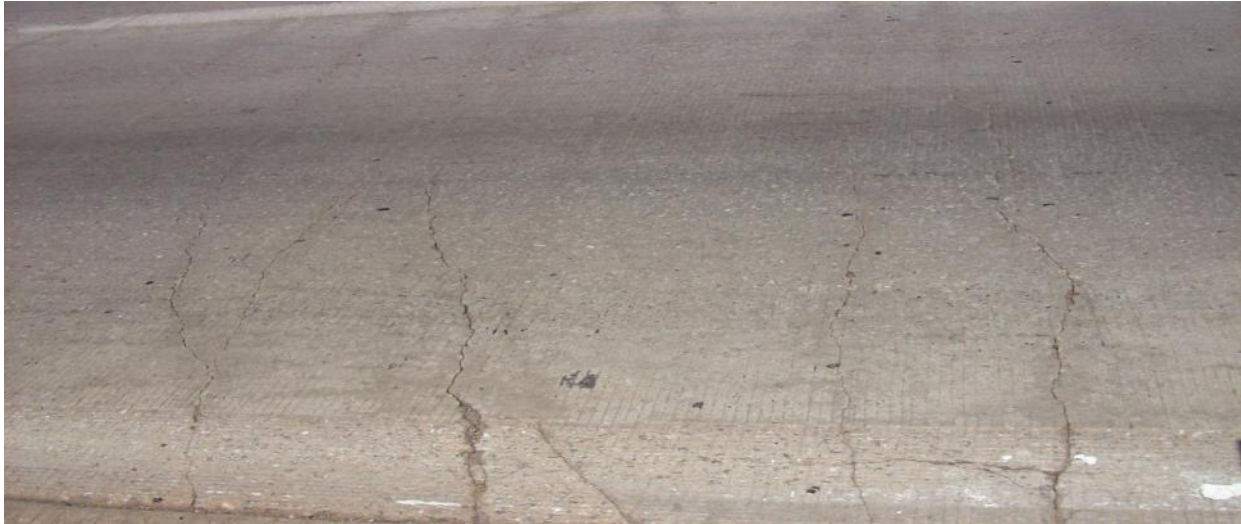
The north bound lane of this project had isolated areas of heavy Y-cracking and closely spaced transverse cracks connected by longitudinal cracks (see figure 3.7). It was noted that the crack width seemed to be very small, with a crack spacing of eight to ten feet between clusters of cracks.

**Figure 3.7** – Closely spaced transverse connected by longitudinal cracks

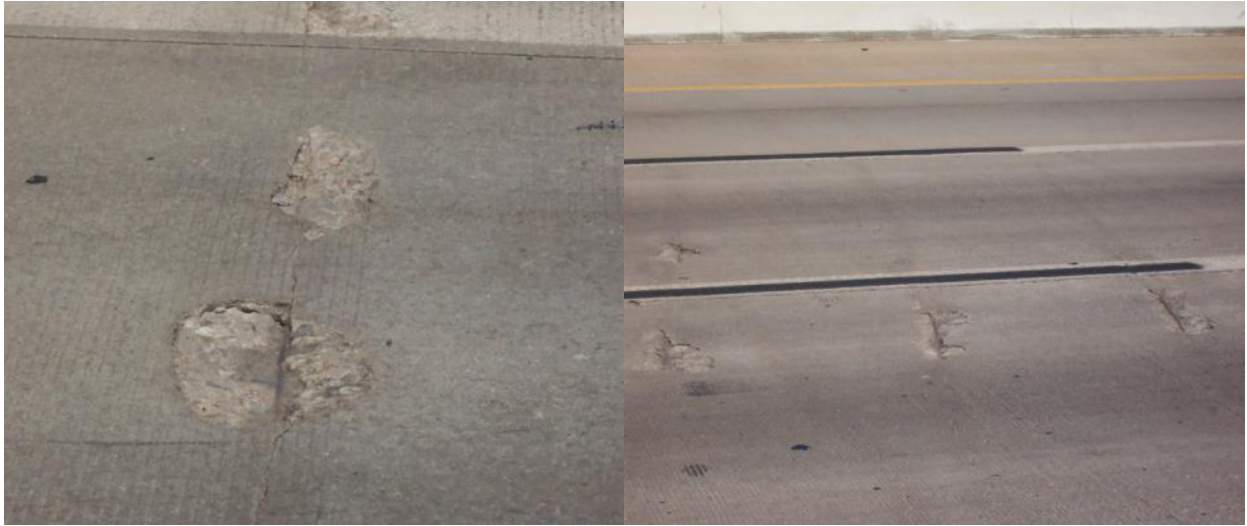
Before the project was inspected, ODOT commented that they had a particular concern within mileposts 124.1 and 124.2. Figures 3.8 and 3.9 show the distresses in this particular region. The transverse steel in this region appears to be high in the pavement, leaving only  $\frac{3}{4}$ -1 inch of concrete cover over the bar. It was also noted that the transverse steel in this region does not appear to be perpendicular to the direction of traffic. Chris Westlund, an ODOT employee, said that the steel on this project was placed with a machine during the paving process and he recalled that the machine was having problems. Nevertheless, the distresses in this section of pavement seemed to be caused by inadequate steel cover and not related to Y-cracking, or any other cracking patterns. None of the distresses caused by the transverse steel have been patched in the north bound lane. The north bound lane also exhibited several stretches where the road surface was extremely worn. The tines in the wheel paths were barely visible. Several stretches of pavement had to be skipped while performing the visual inspection due to exits, entrances, and barrier walls not providing a shoulder to conduct the inspection.

**Figure 3.8** – Distresses in ODOT’s region of concern

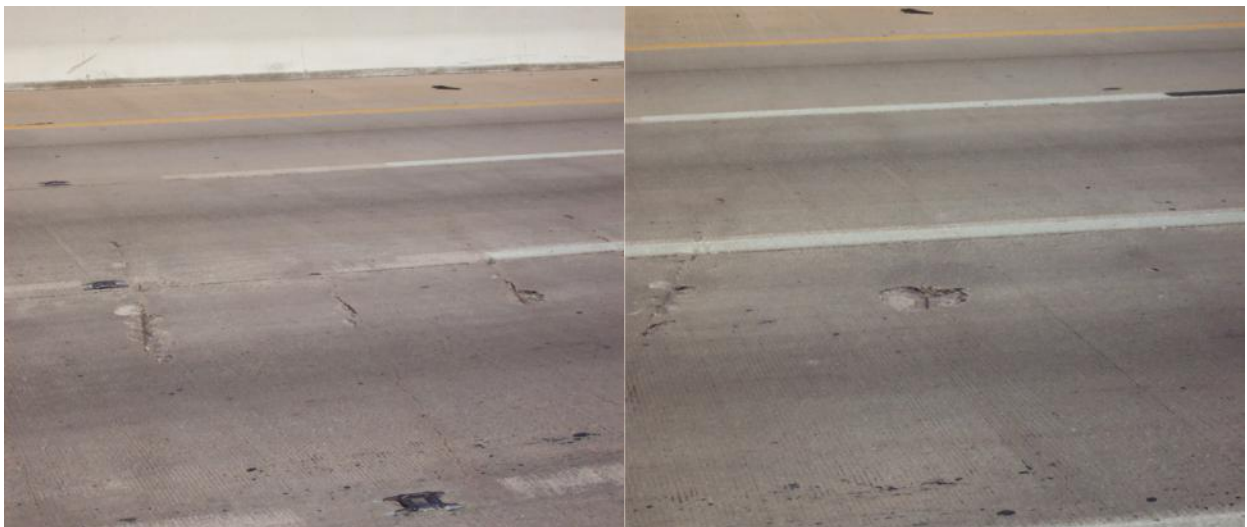
**Figure 3.9** – More distresses in ODOT’s region of concern

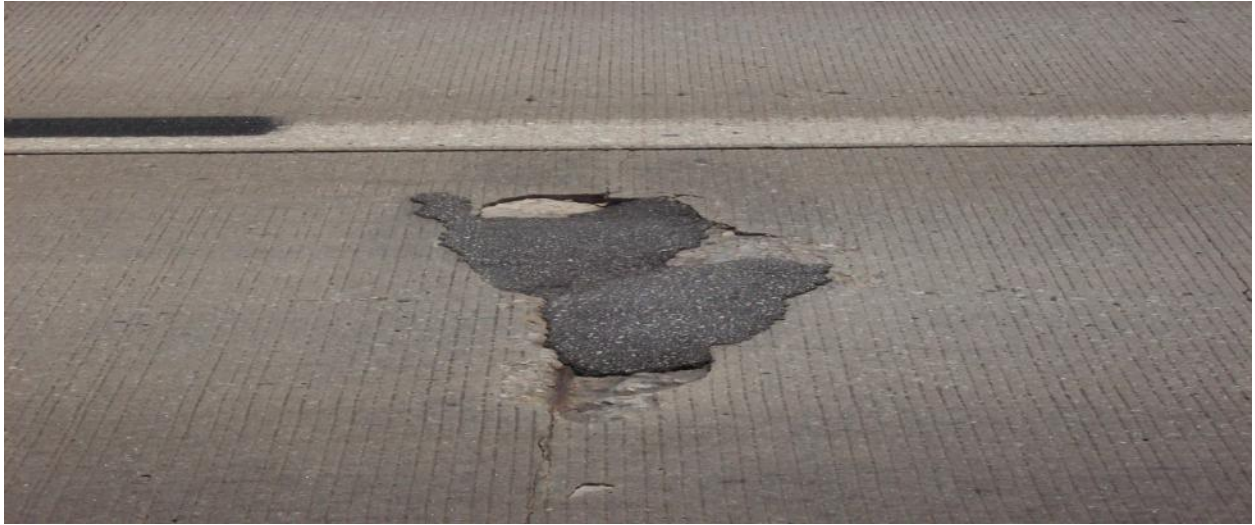
more likely to be the cause of the distress, not the Y-crack. Ignoring the steel placement issues, the pavement appeared to be in good shape with a low number of Y-cracks observed and no Y-crack related distresses.

**Figure 3.10** – AC patch over a distress with exposed transverse steel

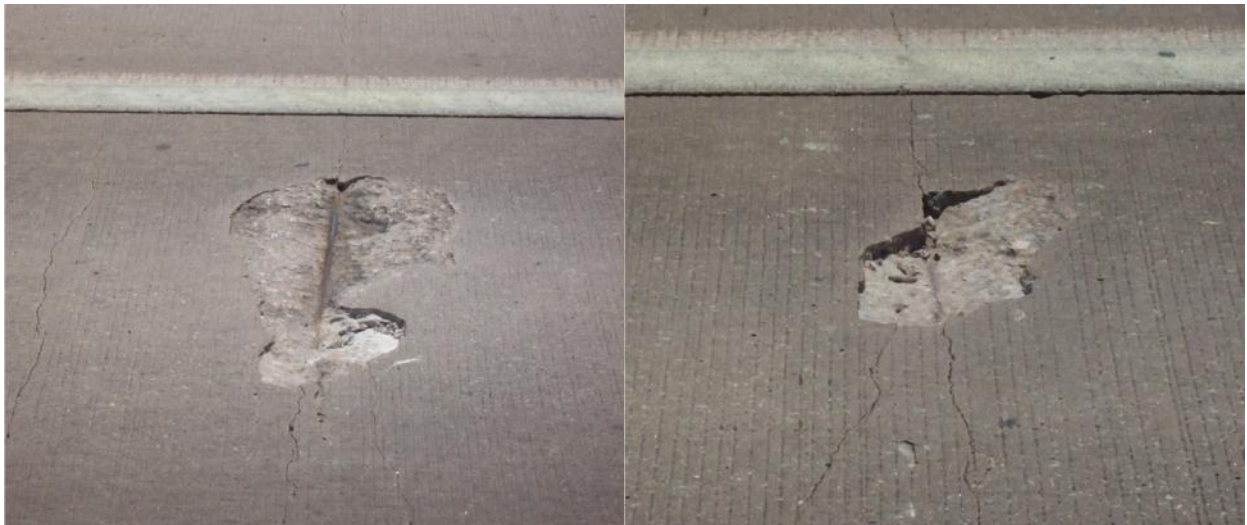
**Figure 3.11** – Possible Y-crack over shallow transverse steel

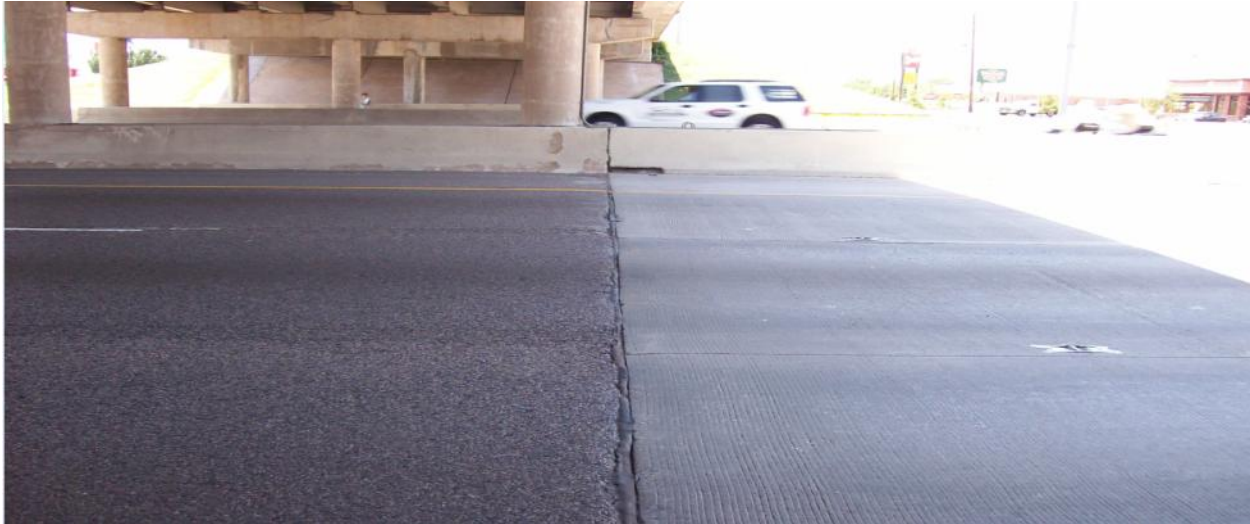
**Figure 3.13** – Joint at the Southern end of North bound lane

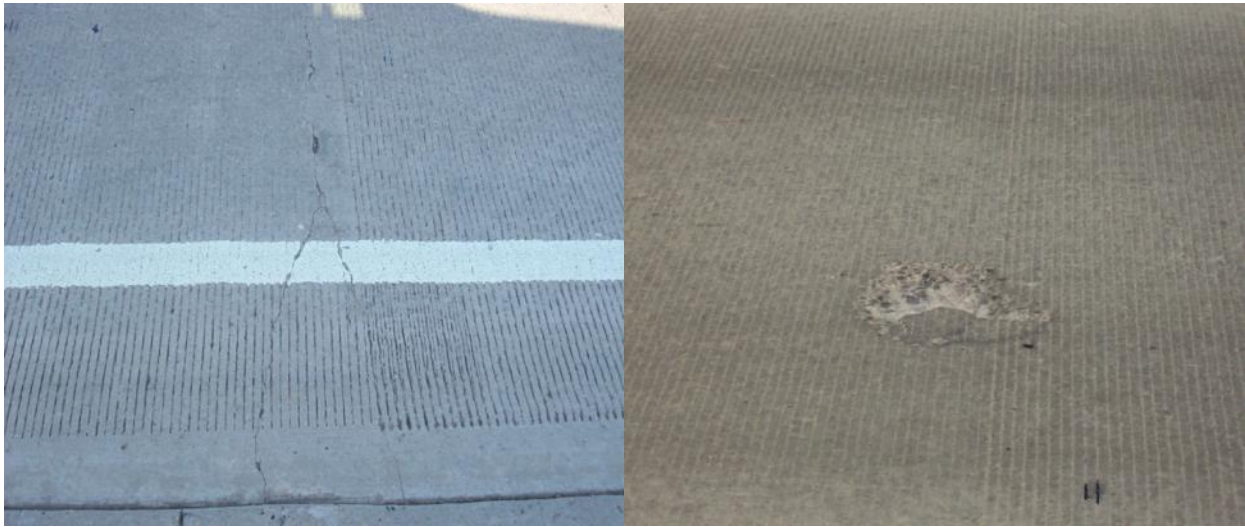
left and spalled circular area on the right. The Y-crack shown in figure 3.15 seemed to be the most common, it was noted during inspection that there were multiple Y-cracks at the pavement edge with several of them being outside the white line (approximately 40%). This was especially noticed between mileposts 125 and 126. Figure 3.16 shows two construction joints that display signs of raveling. Despite the occurrence of Y-cracks (see figure 3.17 left), more potential for distresses to develop were found by closely spaced transverse cracks (see figure 3.17 right). These cracks displayed spalling and in several instances were connected by longitudinal cracks.

**Figure 3.15** – (Left) Typical Y-crack for the region, (right) circular spalled area

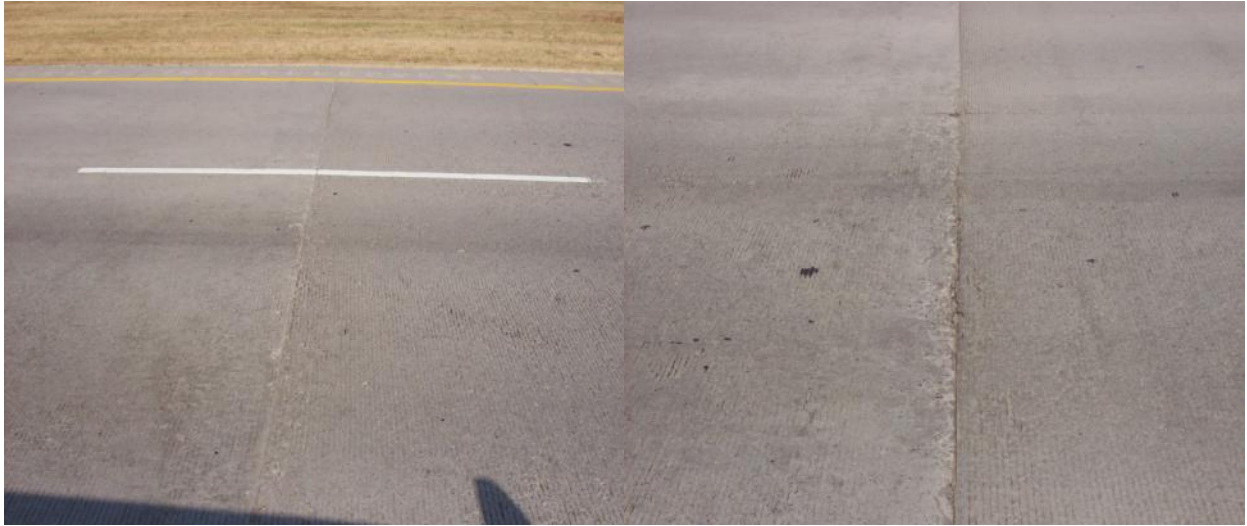
**Figure 3.16** – Two construction joints displaying signs of spalling

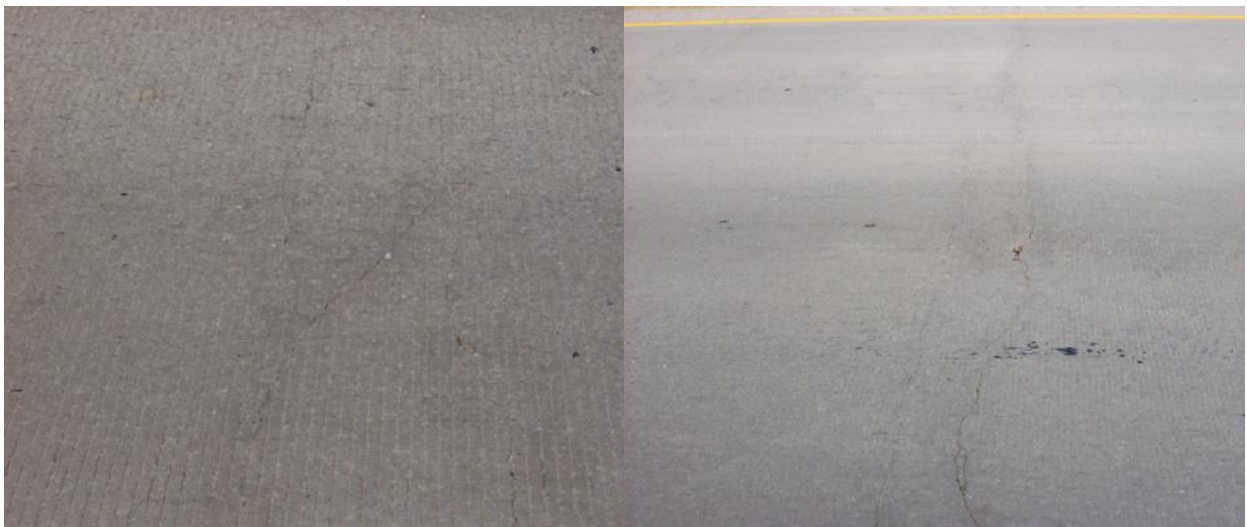
**Figure 3.17** – (Left) Y-crack located in the region; (right) two close transverse cracks showing distress

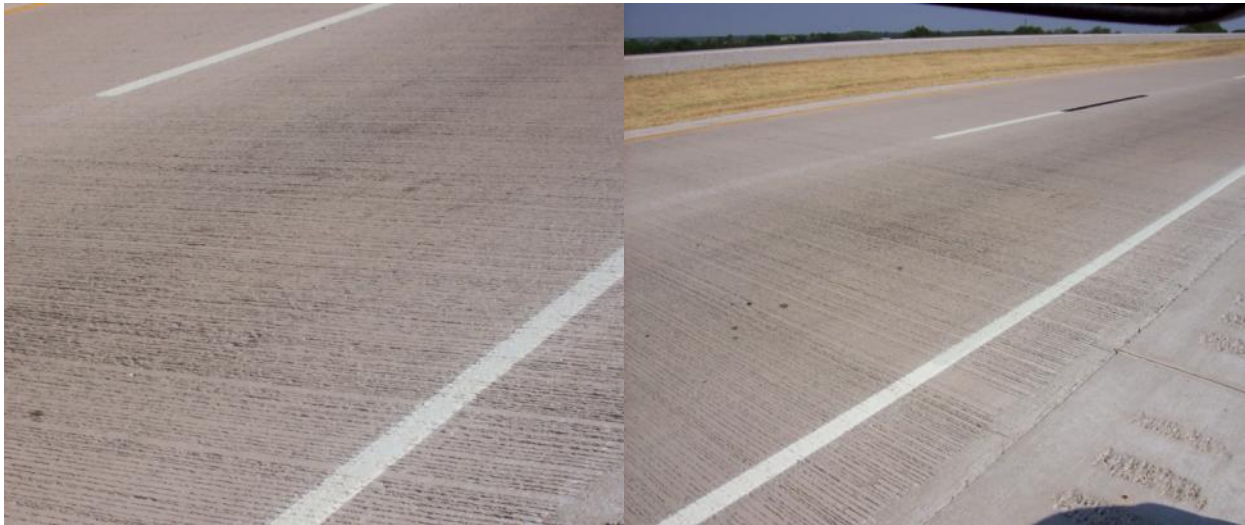
Due to curiosity, approximately ½ mile of this project was inspected in both the north and south bound directions. Figure 3.18 shows images of the pavement. The roadway displays a grey/silver color, possibly due to curing compound, while the surface appears to be in good shape with virtually no wear.

**Figure 3.18** – Two images showing the glossy pavement surface with little wear

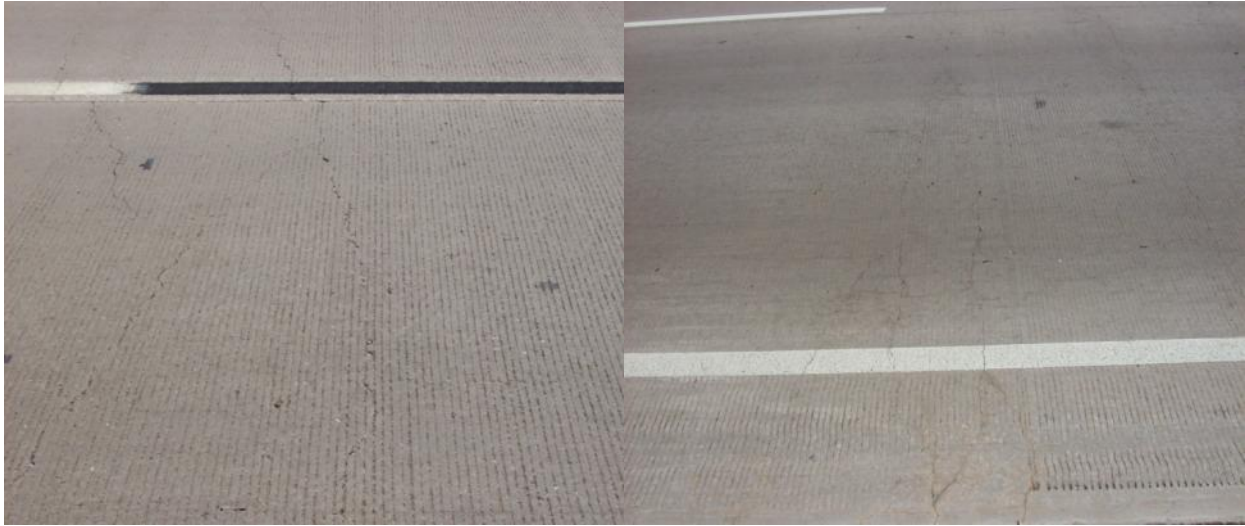
The south bound inspection began at a bridge approach joint 0.16 miles north of mile post 29. The first 0.64 miles inspected were part of the project IMY-35-1(145)029. This area of pavement displayed a low number of Y-cracks. The south bound lane appeared to be more worn than the north bound lane, and its appearance was not as glossy. The south bound lane of the original project of interest displayed various forms of Y-cracking as seen in figure 3.19. However no patches or punch-outs were documented.

**Figure 3.19** – Two different forms of Y-cracking

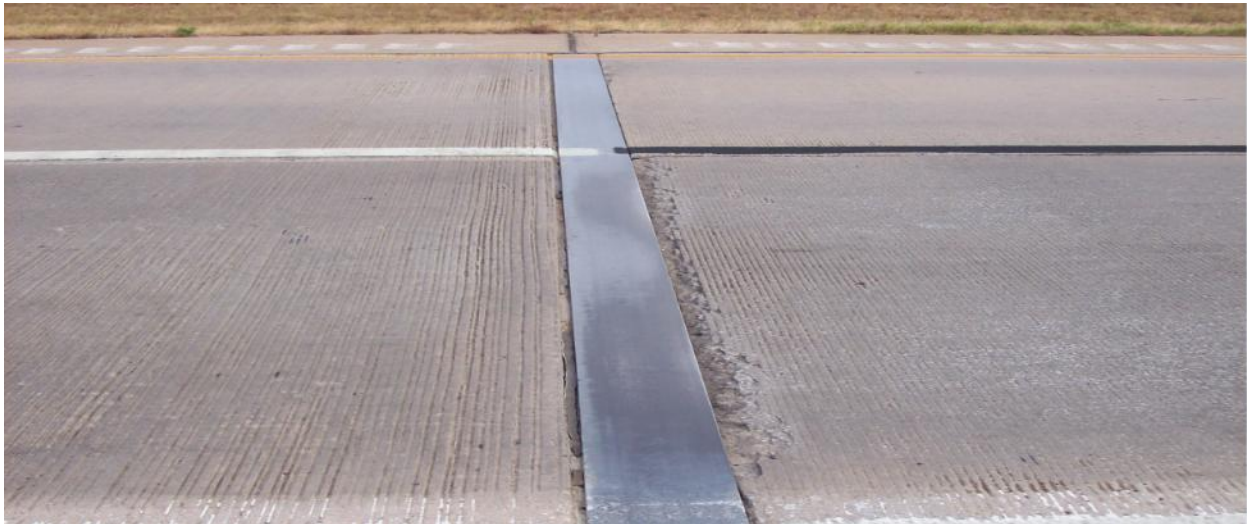
The inspection began in the east bound direction; figure 3.21 shows the terminal joint at the project beginning. The terminal joint has some signs of deterioration. The east bound direction contained several types of Y-cracks (figure 3.22), but seemed to have many places where the transverse cracks were close together. Figure 3.23 shows a place where five transverse cracks all occurred within an eight foot section of pavement. Figure 3.22 right does contain a Y-crack on the far left, but in most cases the closely spaced transverse cracks did not consist of Y-cracks, and in most cases the close transverse cracks did not show signs of punch-out or failure. However, a few did, as shown in figure 3.23.

**Figure 3.21** – Deteriorated terminal joint at project beginning

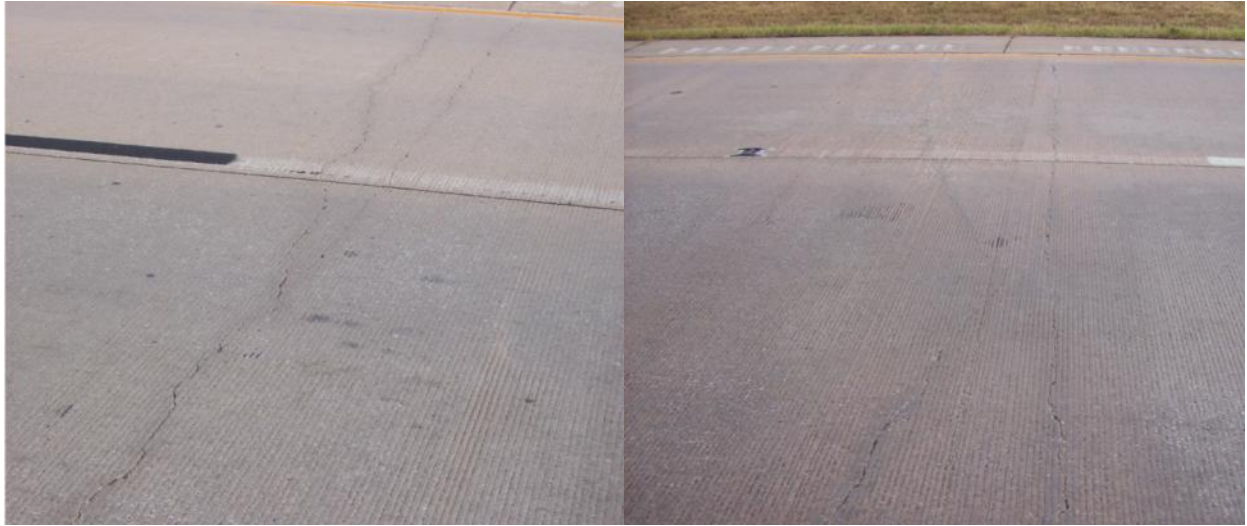
**Figure 3.22** – Two different types of Y-cracks found in the area

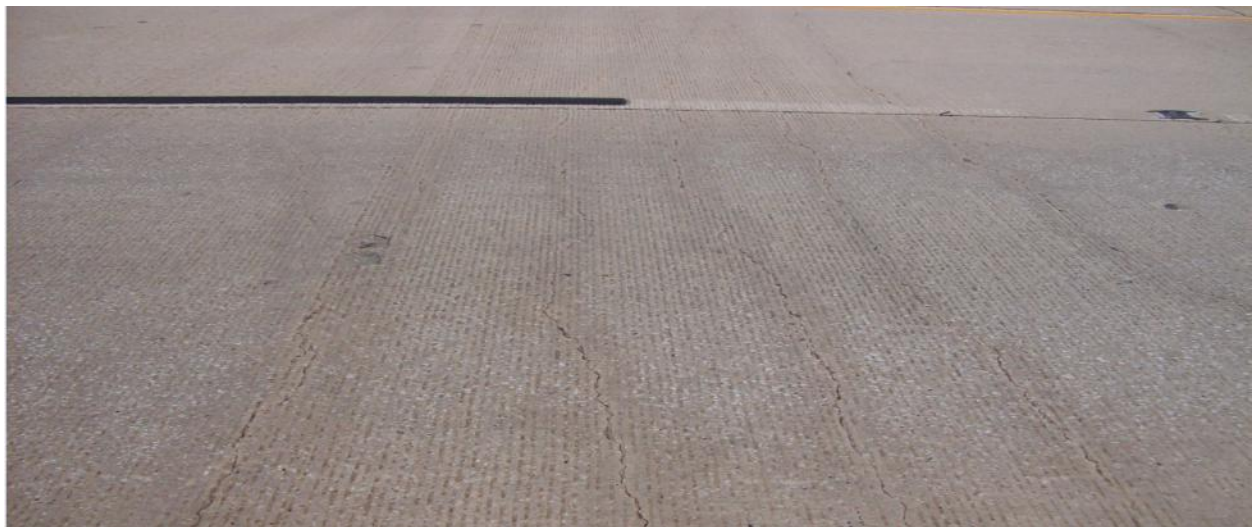
**Figure 3.23** – Closely spaced transverse cracks

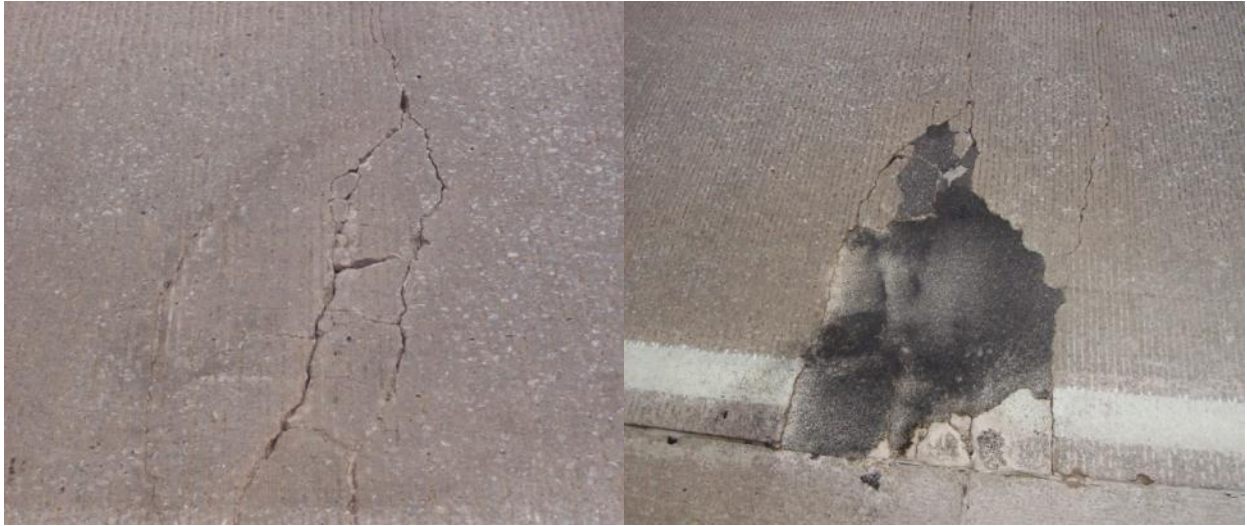
This pavement showed the first signs of a Y-crack leading to a punch-out (see figure 3.24). However, the majority of failures that were not patched seemed to be caused by closely spaced transverse cracks with intersecting longitudinal cracks, as shown in figure 3.25. Overall the east bound lane was in poor shape with thirty-three patches in the outside lane alone over the length of the project.

**Figure 3.24** – Two instances where a Y-crack seemed to be developing into a punch-out

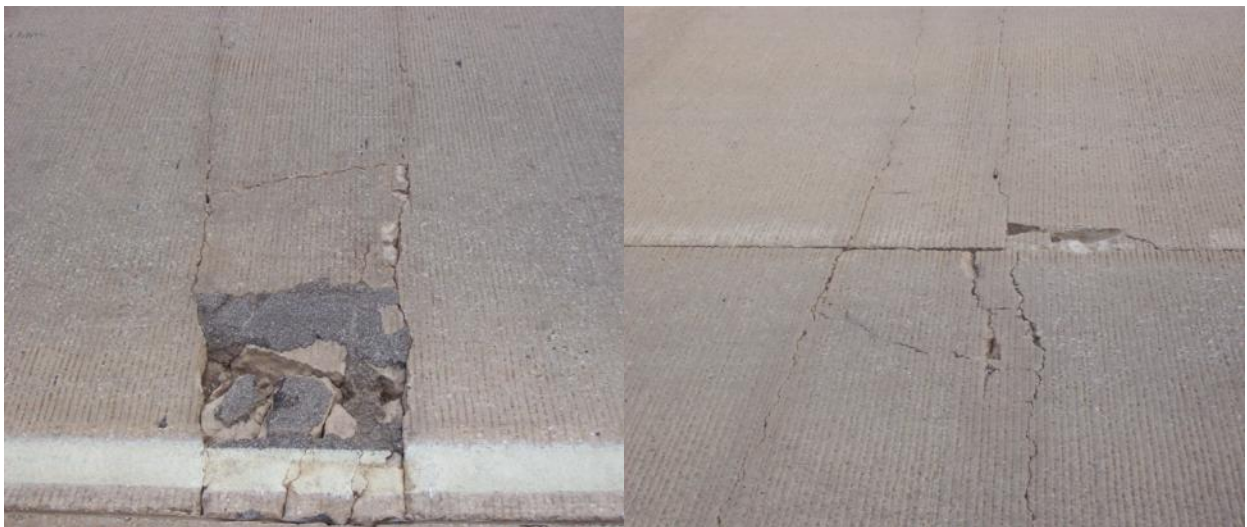
**Figure 3.25** – Punch-outs forming between closely spaced transverse cracks

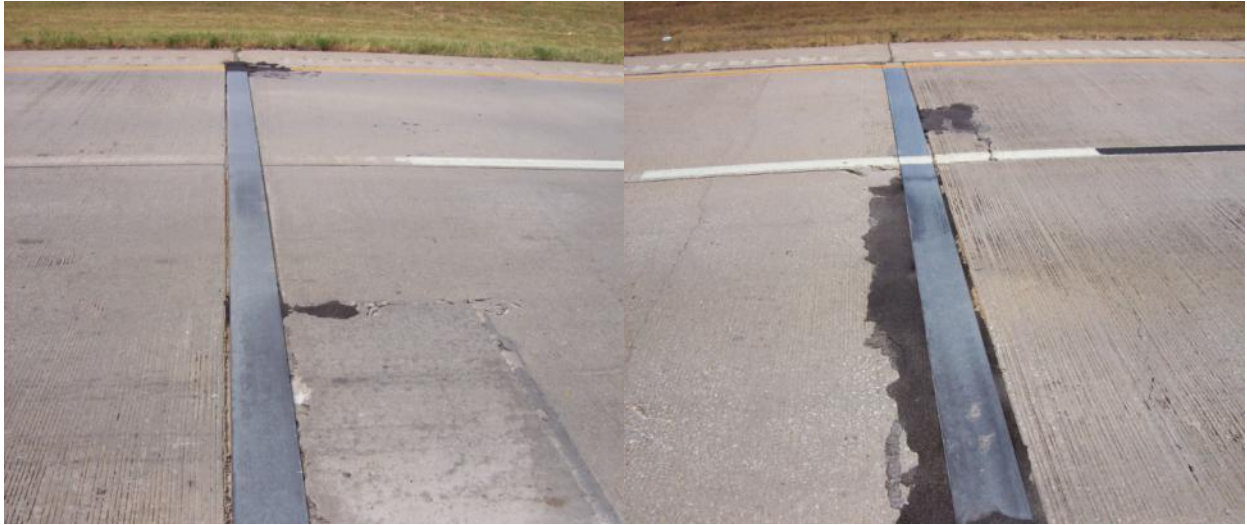
**Figure 3.26** – (left) Terminal joint at west bound beginning, (right) terminal joint at west bound end

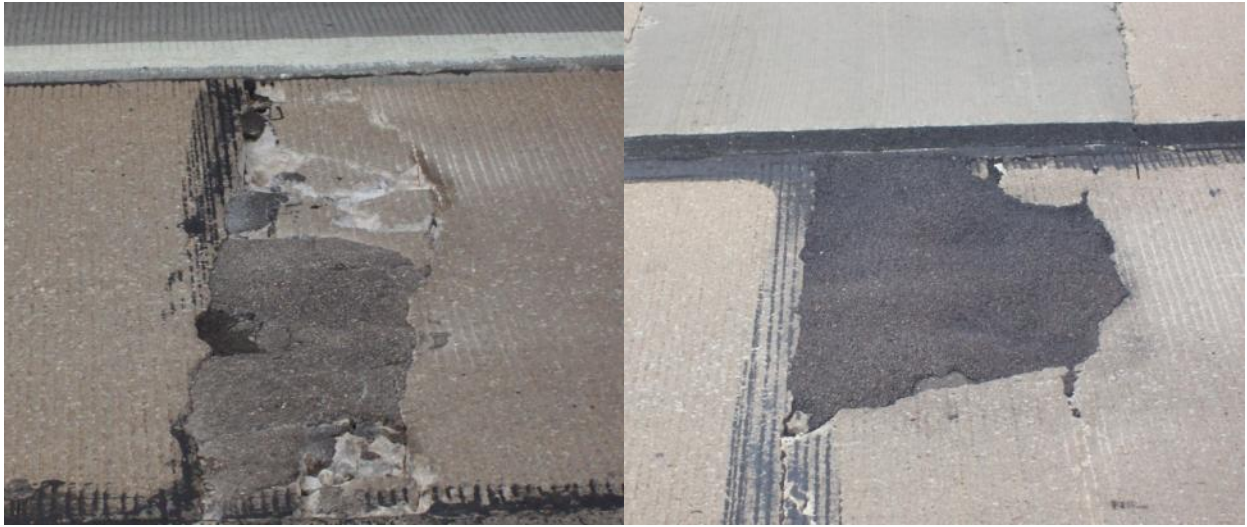
figure 3.28. By observing the west bound lane it was clear that along with the numerous patches, asphalt joint sealant had been applied to many of the transverse cracks along the roadway, see figure 3.29.

**Figure 3.28** – Patches caused by closely spaced transverse cracks

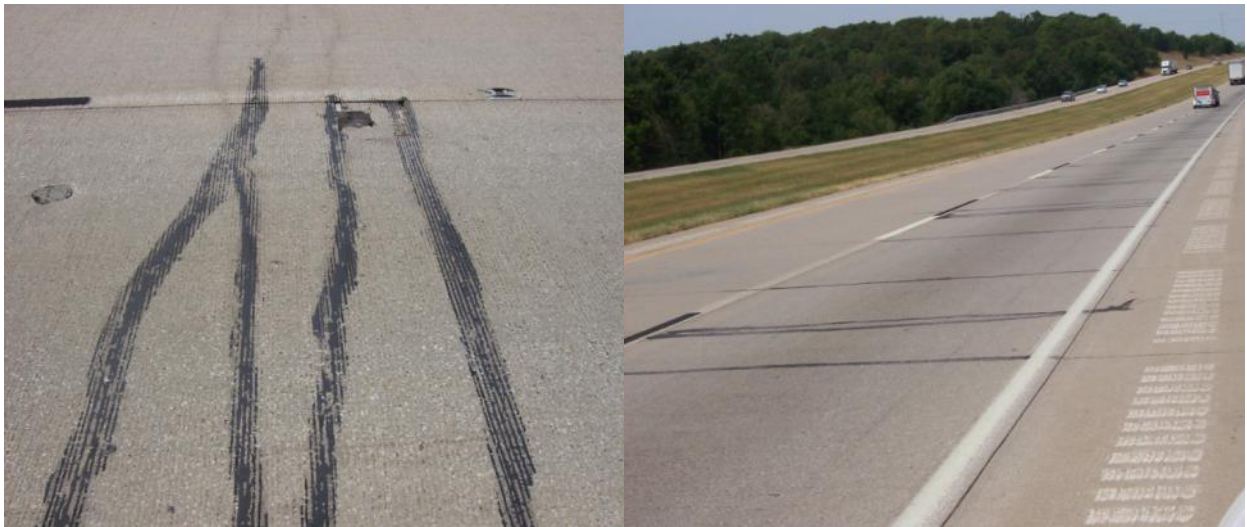
**Figure 3.29** – Transverse cracks sealed with an asphalt joint sealant

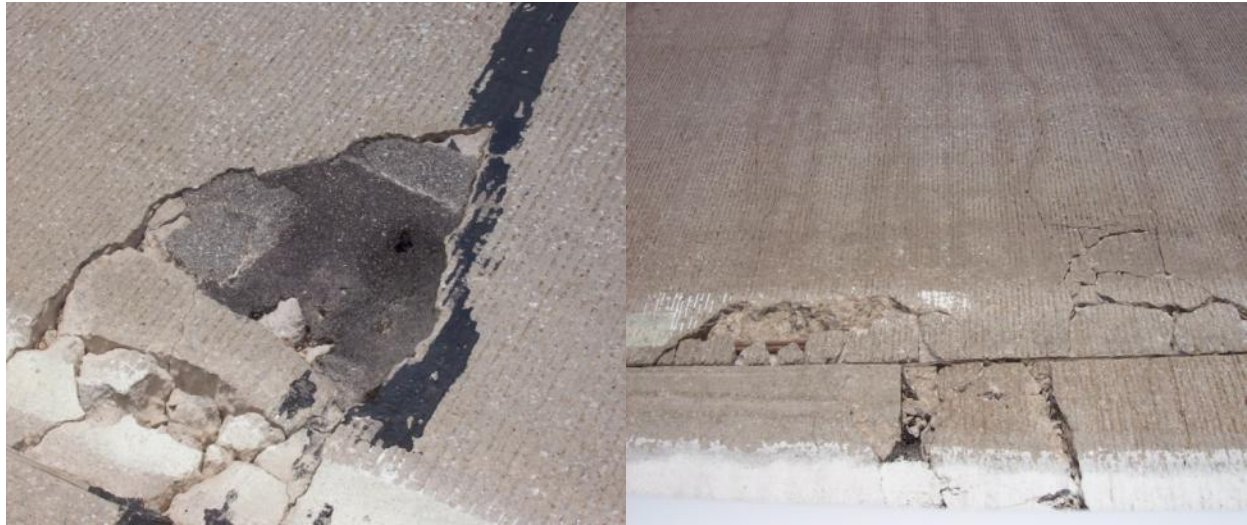
was also noted that the image in figure 3.30 (right) showed a longitudinal steel splice. The steel appeared to be approximately two inches from the concrete surface.

**Figure 3.30** – (left) Y-crack breaking up, (right) distress caused by close transverse cracking

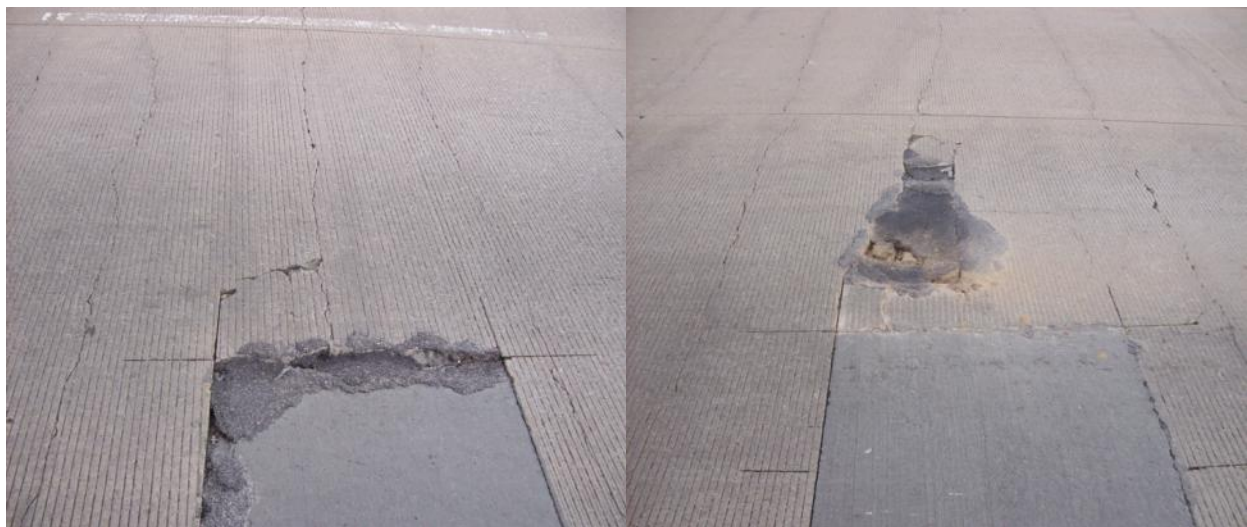
The pavement in the north bound lane inspection contained several patches. Many of these patches were not full lane patches and punch-outs had developed near the patch (figure 3.32 right), while some patches showed signs of distress (figure 3.32 left). Most of the w-shaped beams used at terminal joints showed signs of deterioration. Signs of deterioration were spalling of the CRCP, AC patching, and missing sections of the w-shape, see figures 3.33 and 3.34.

**Figure 3.32** – Small patch with distress developing close by

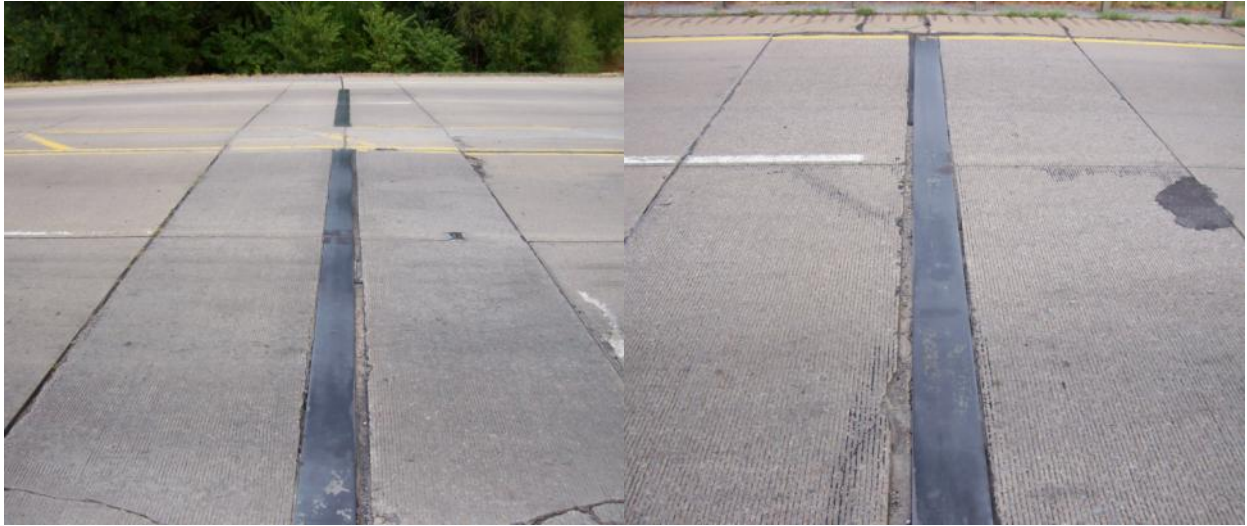
**Figure 3.33** – Terminal joints showing signs of spalling

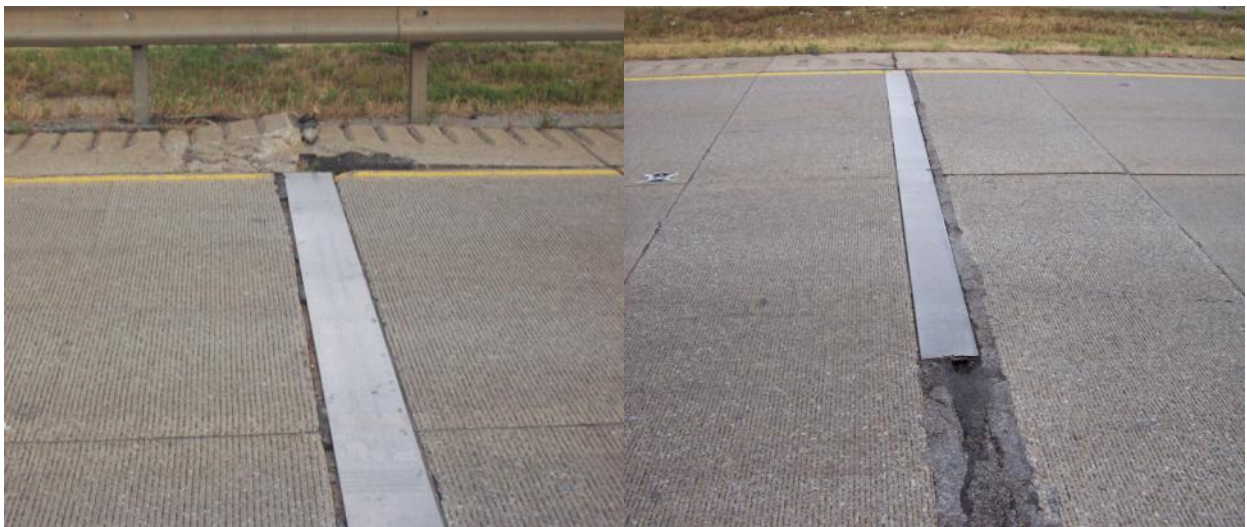
**Figure 3.34** – Terminal Joints with different kinds of distress

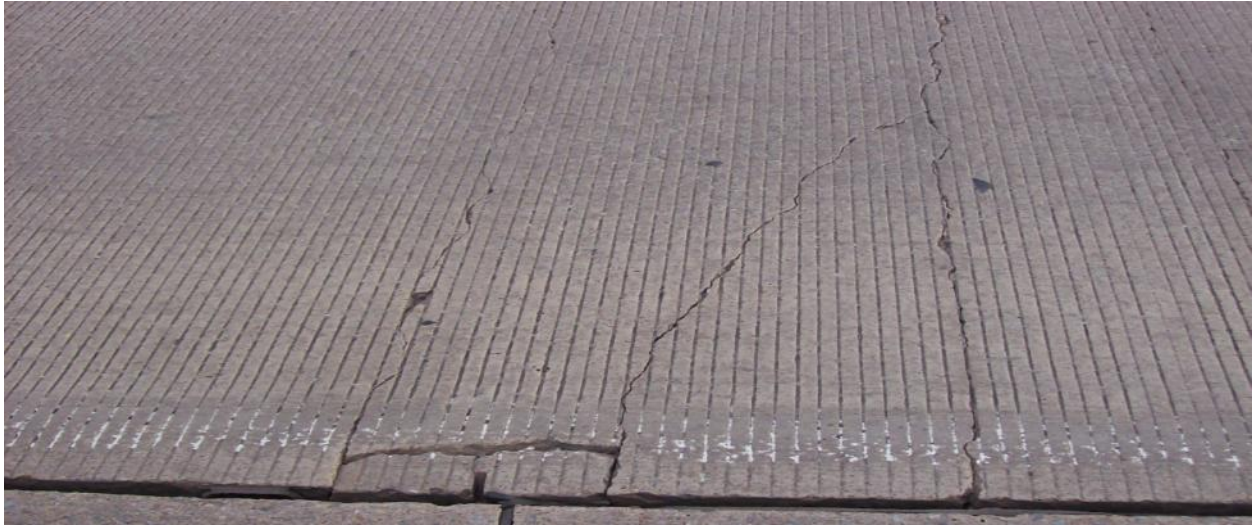
**Figure 3.35** – Typical Y-crack for the area

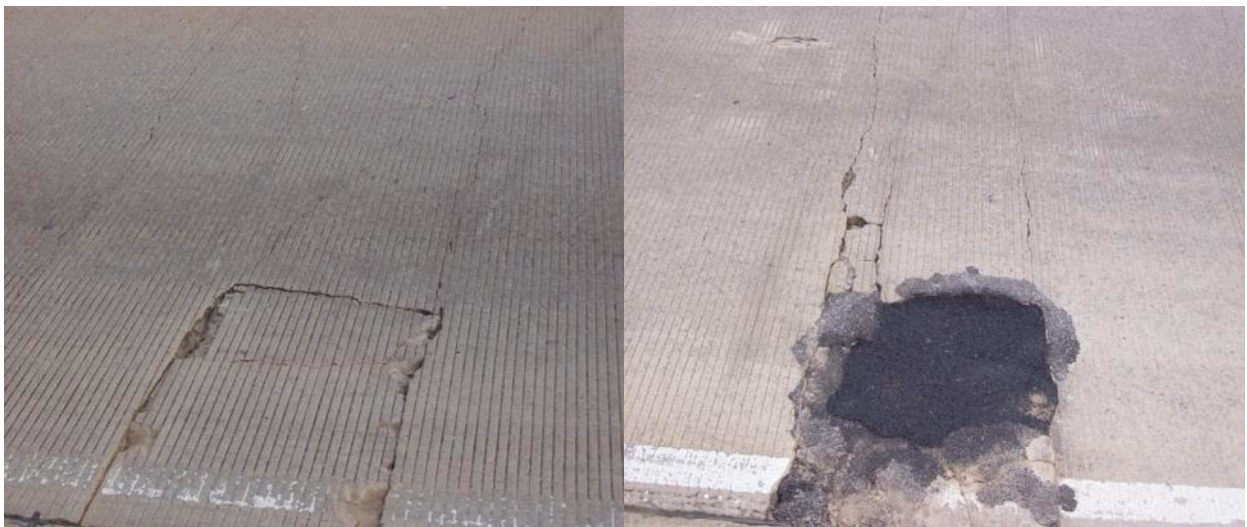
**Figure 3.36** – Y-cracks leading to punch-out and eventually failure
