# Effect of Y-cracking on CRCP Performance

## **ANNUAL REPORT FOR FY 2011**

ODOT SPR ITEM NUMBER 2230

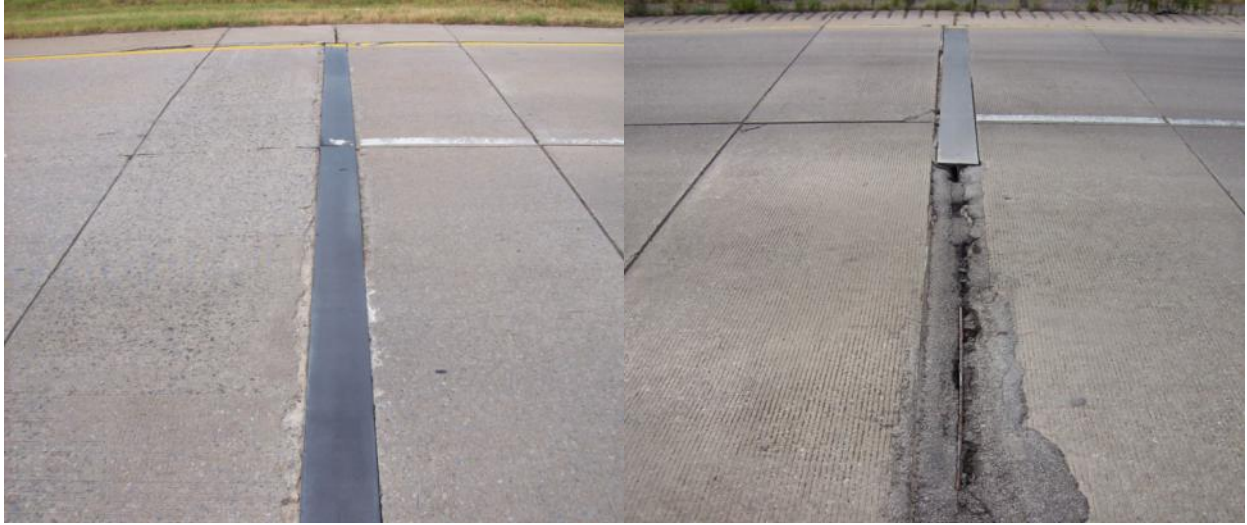
**Figure 3.37** – Terminal joints showing distress

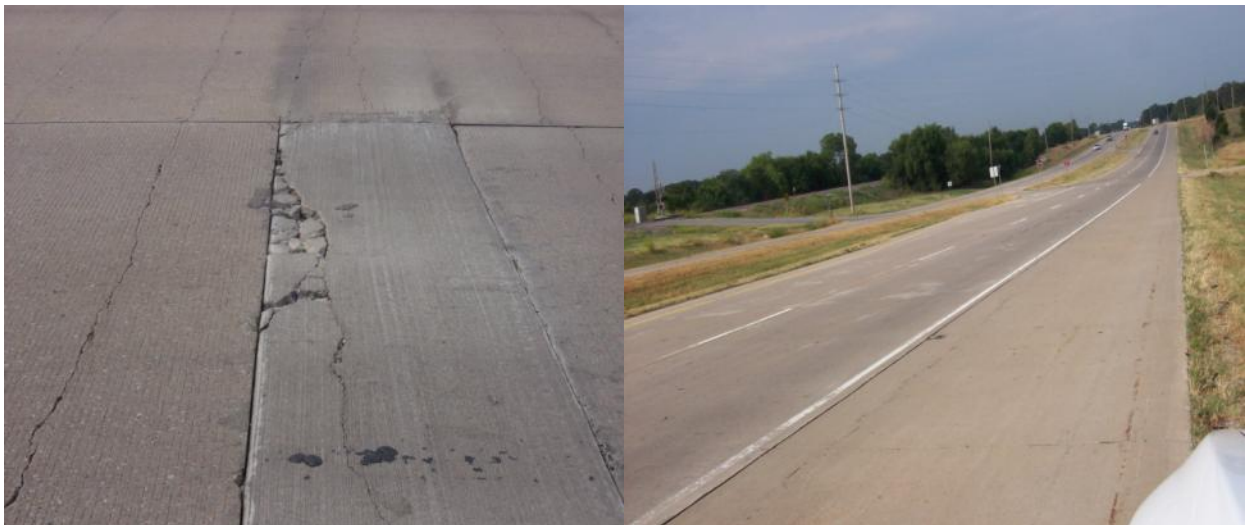
**Figure 3.38** – (left) patch showing signs of distress (right) area of road where crack survey was taken

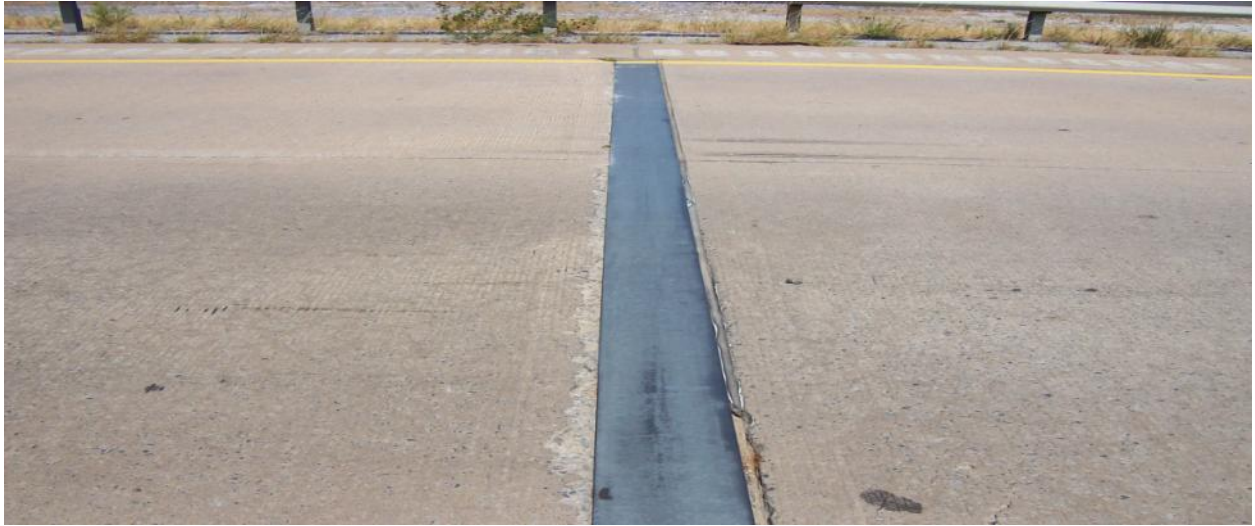
**Figure 3.39** – Spalled terminal joint with worn roadway surface

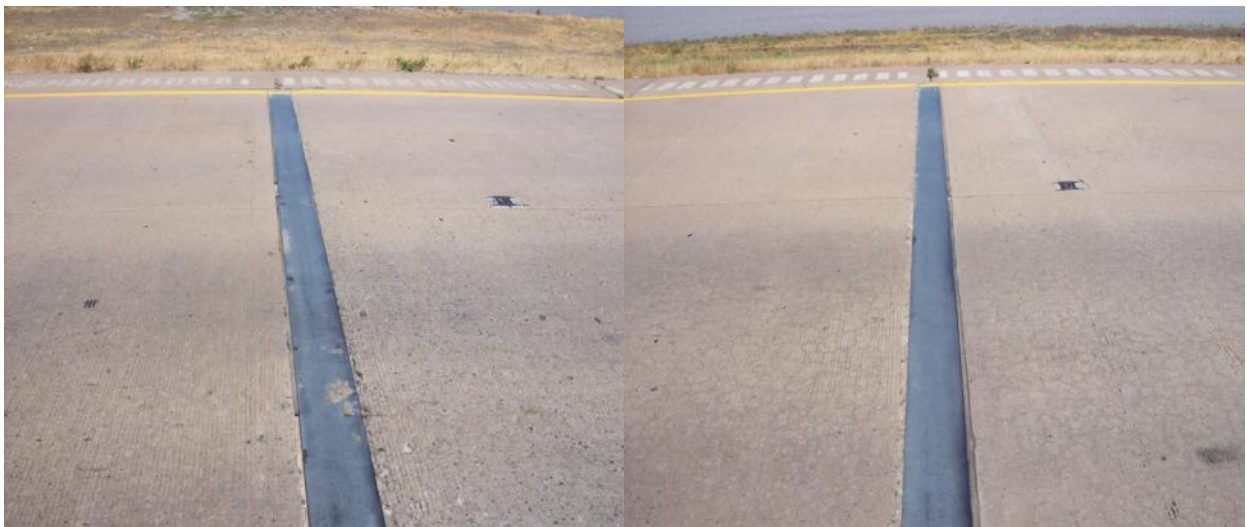
**Figure 3.40** – Spalled terminal joints, with the (right) displaying map-cracking

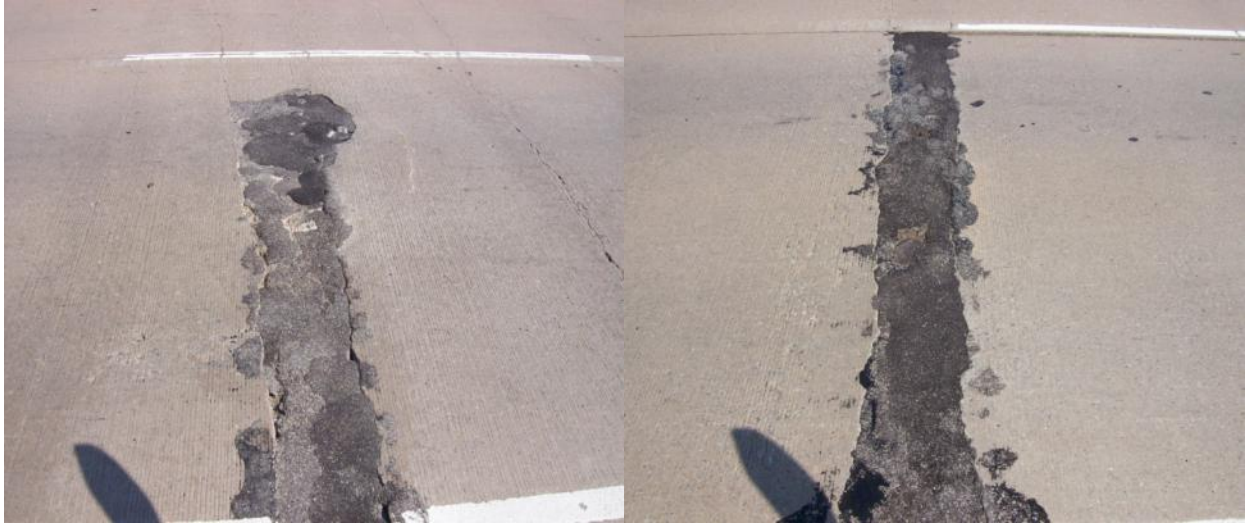
**Figure 3.41** – Patches caused by closely spaced transverse cracks

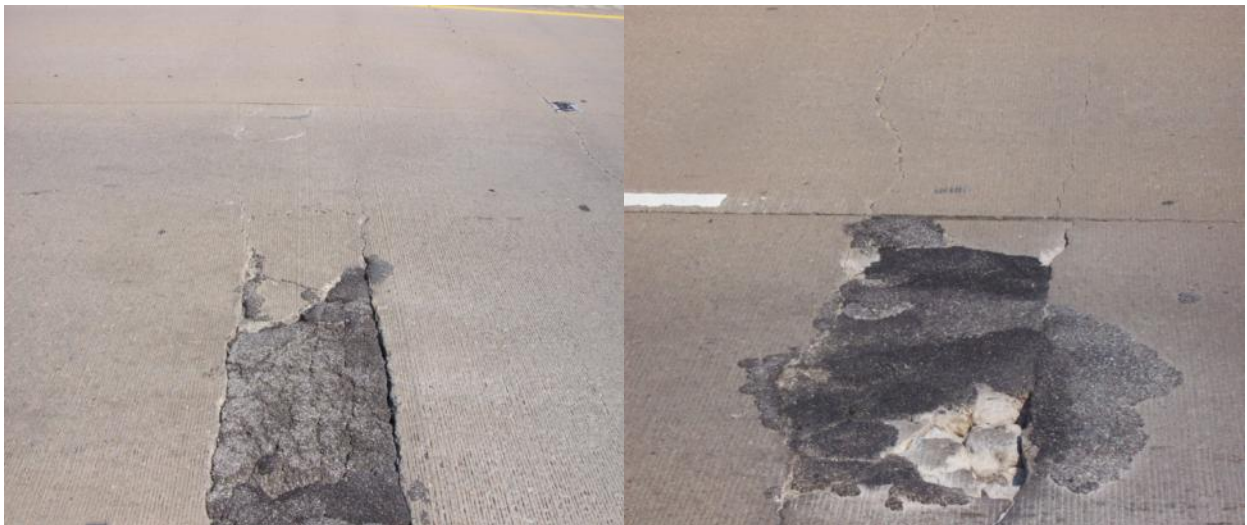
**Figure 3.42** – More patches cause by closely spaced transverse cracks

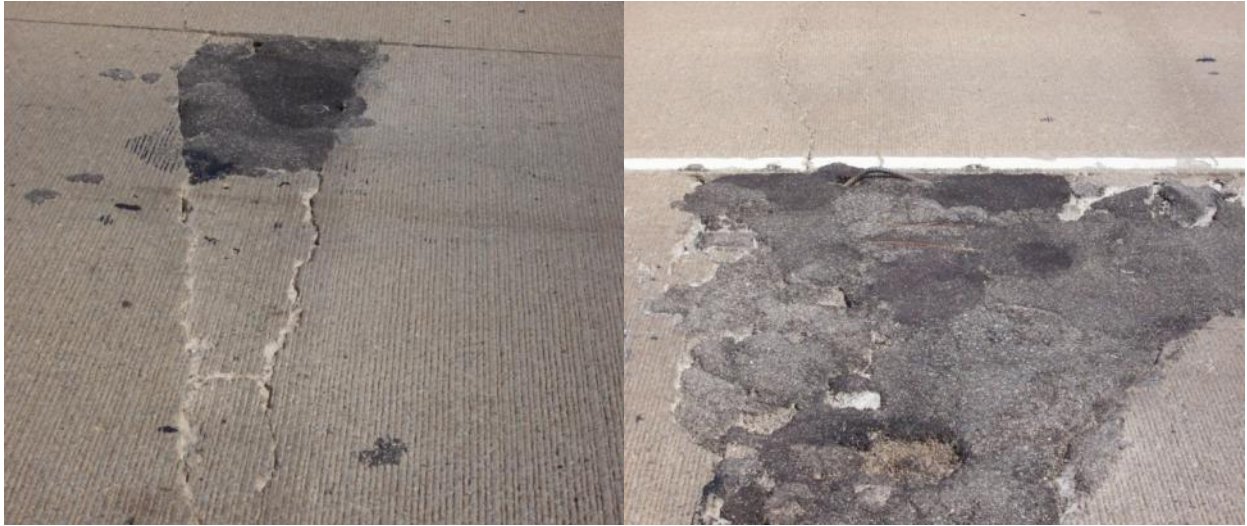
**Figure 3.43** – (left) Patch caused by a Y-crack (right) patch with steel protruding through

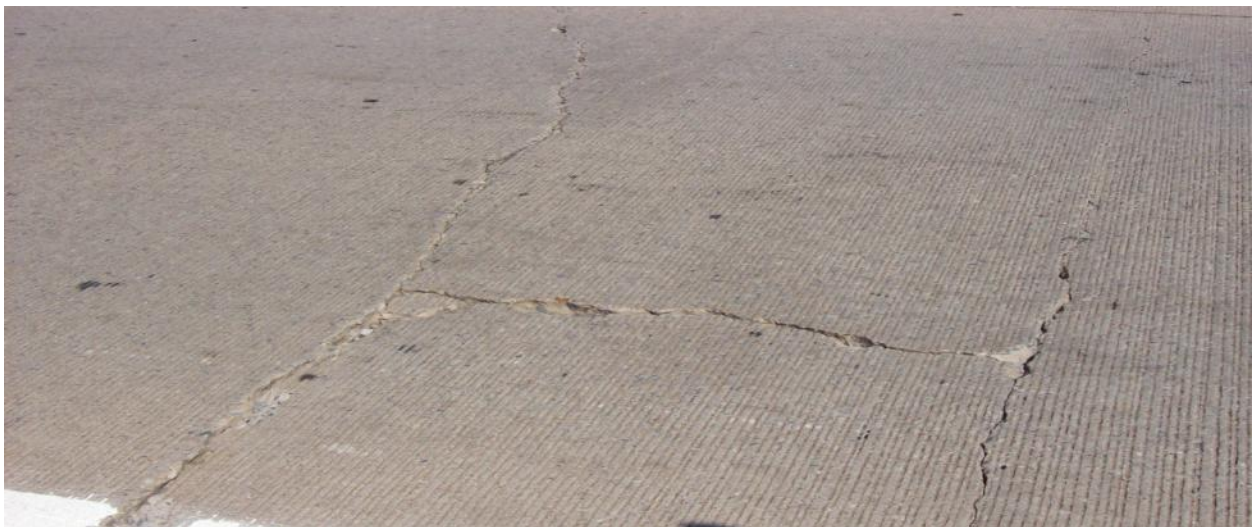
**Figure 3.44** – Two transverse cracks intersected by a longitudinal crack

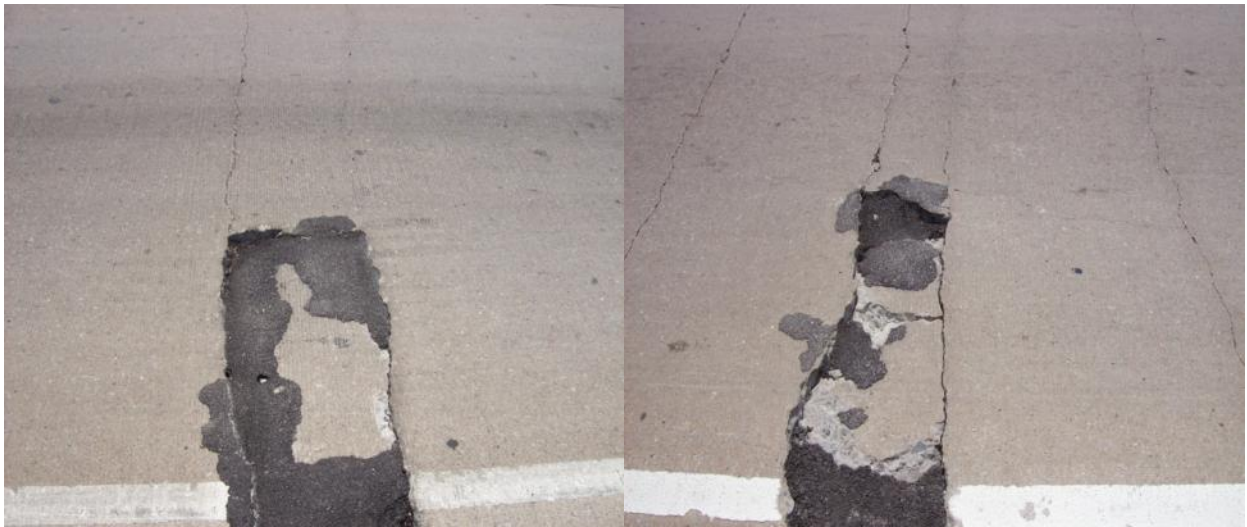
**Figure 3.45** – Transverse cracks intersected by longitudinal cracks

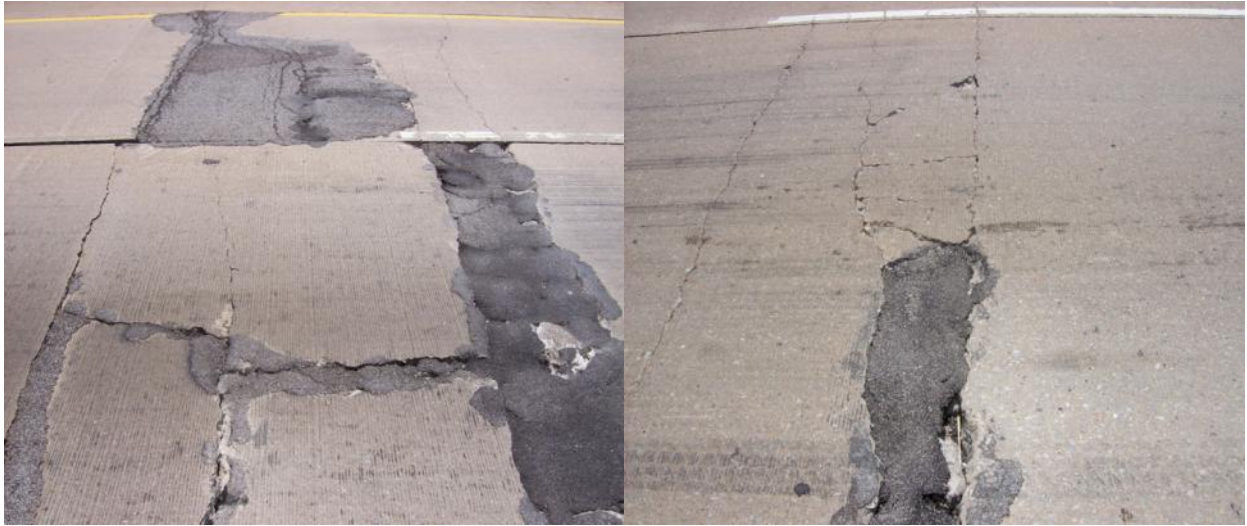
**Figure 3.46** – Transverse cracks intersected by longitudinal cracks

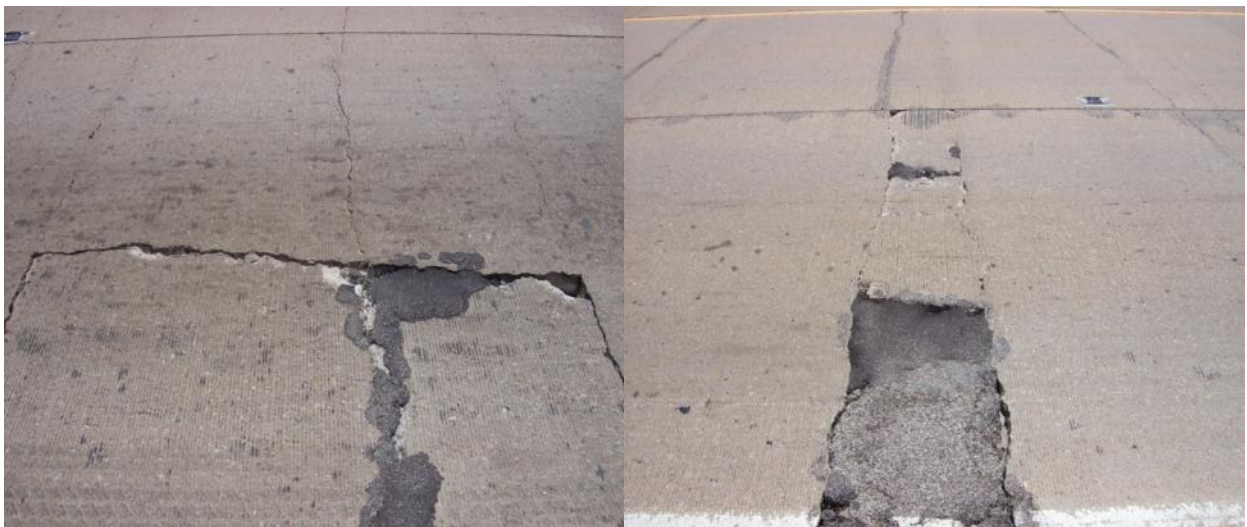
**Figure 3.47** – Transverse cracks intersected by longitudinal cracks

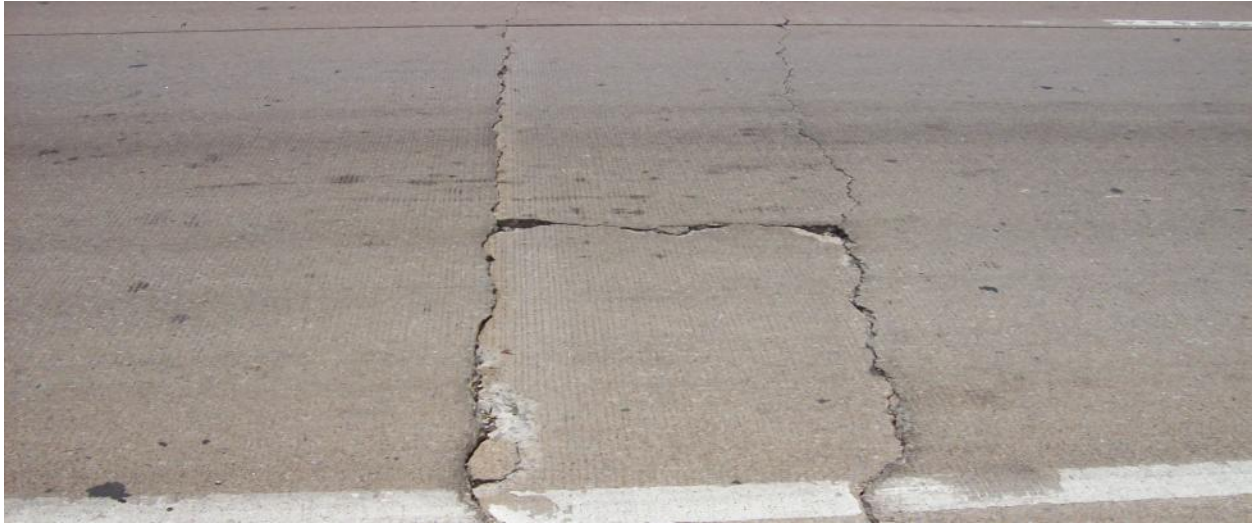
**Figure 3.48** – Two transverse cracks intersected by a longitudinal crack

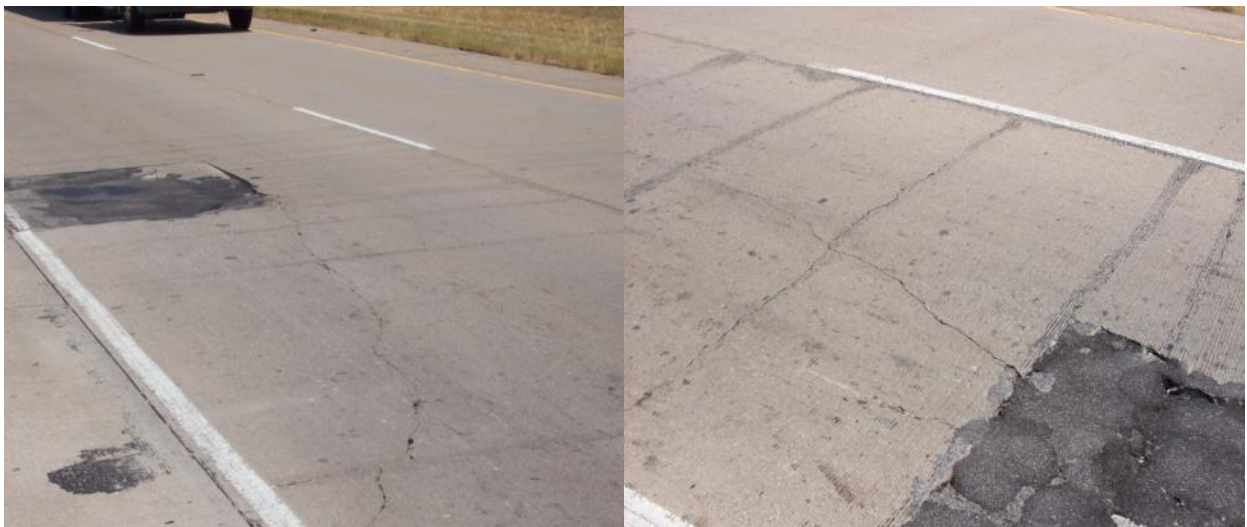
**Figure 3.49** – Multiple transverse cracks intersected by a longitudinal crack

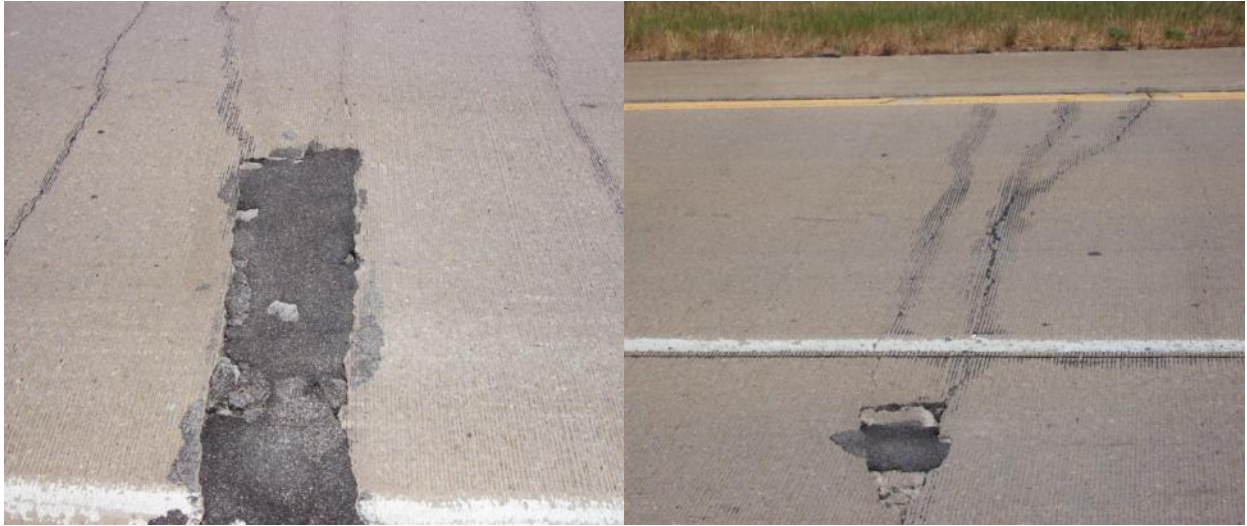
**Figure 3.50** – Patches that appear to be the result of a failed Y-crack

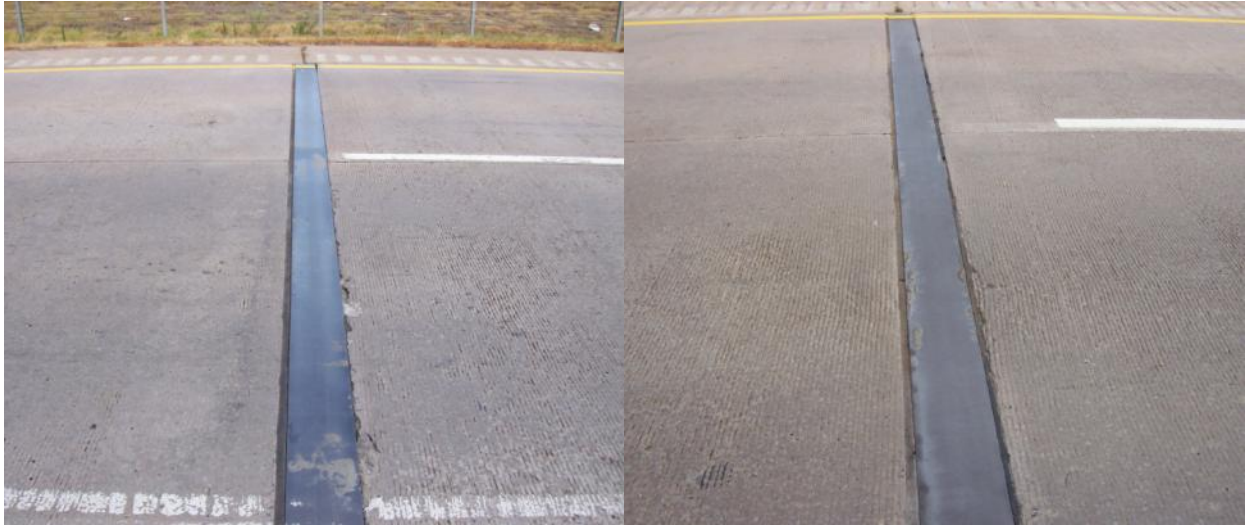
**Figure 3.52** – Terminal joints at north bound beginning and end

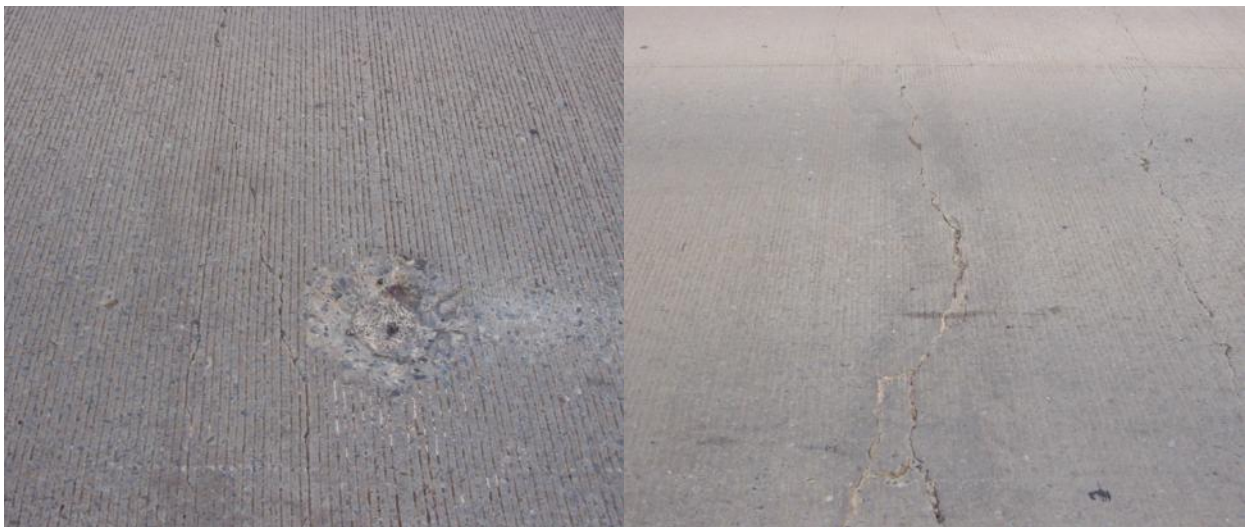
**Figure 3.53** – (Left) Large circular distress, (right) Spalled Y-crack beginning to break up

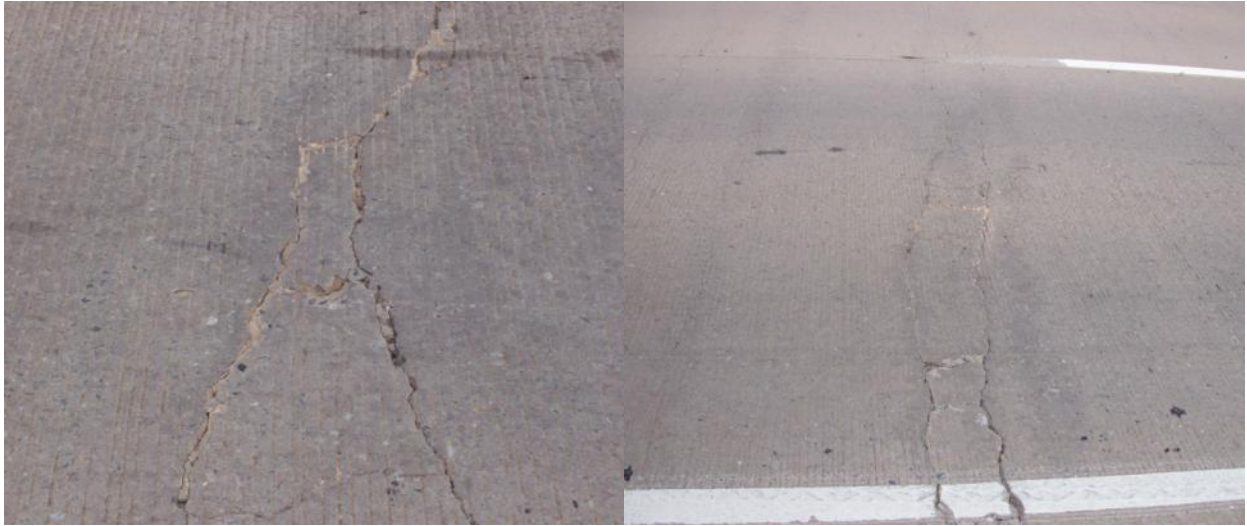
**Figure 3.54** – Two developing punch-outs

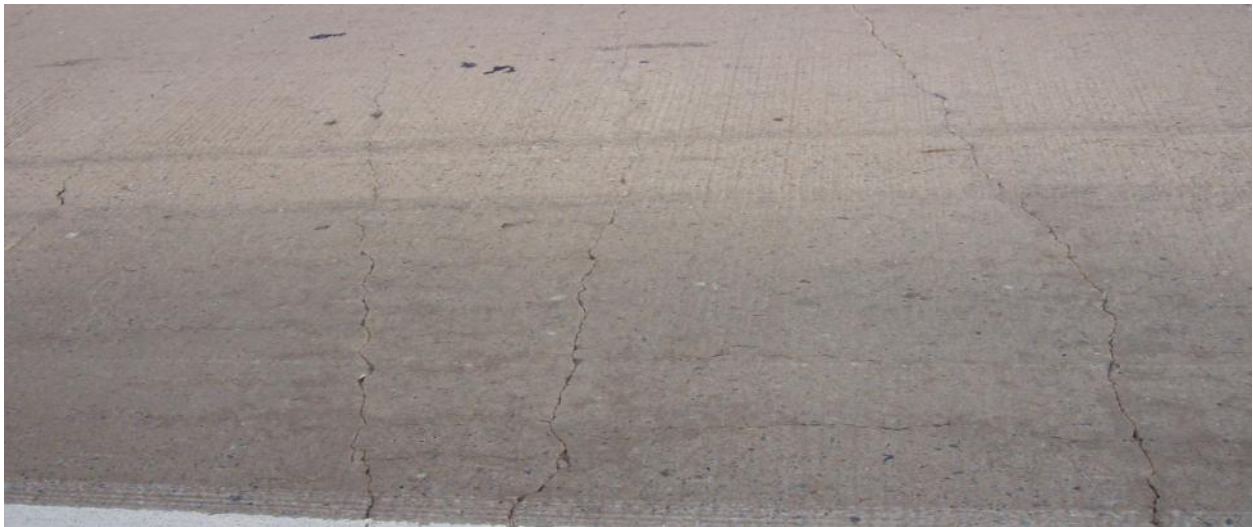
**Figure 3.55** – Stretch of pavement showing signs of map-cracking

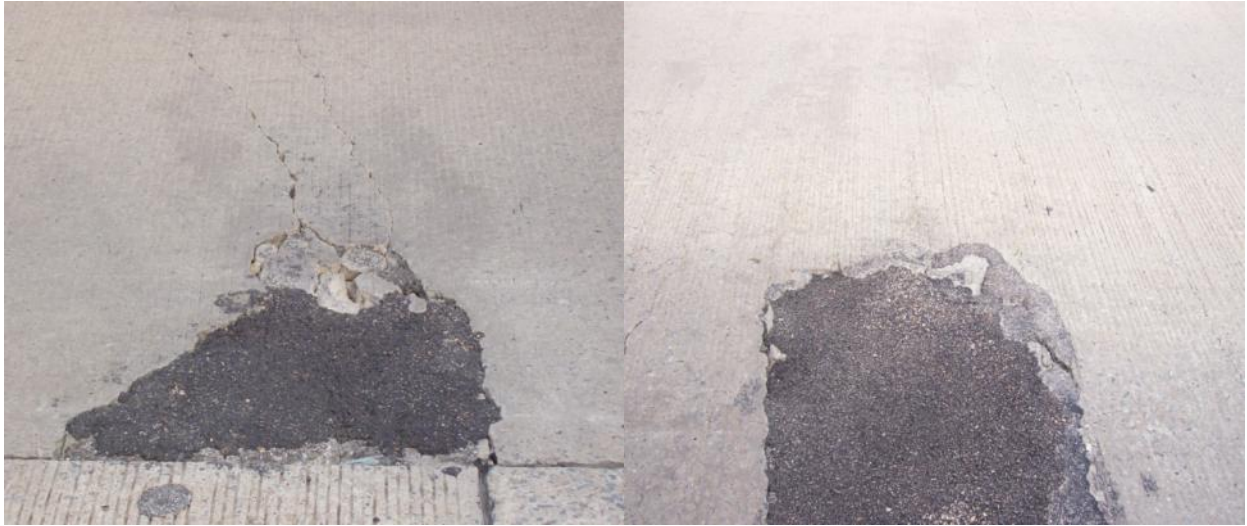
**Figure 3.56** – The two patches in the north bound lane

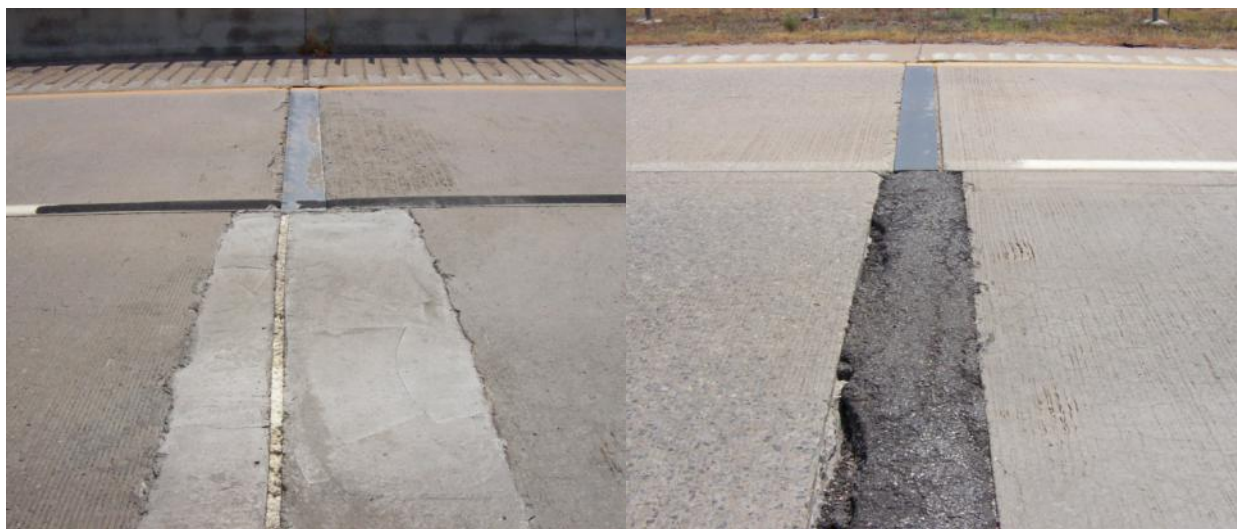
**Figure 3.59** – Terminal joints at the beginning and end of the project

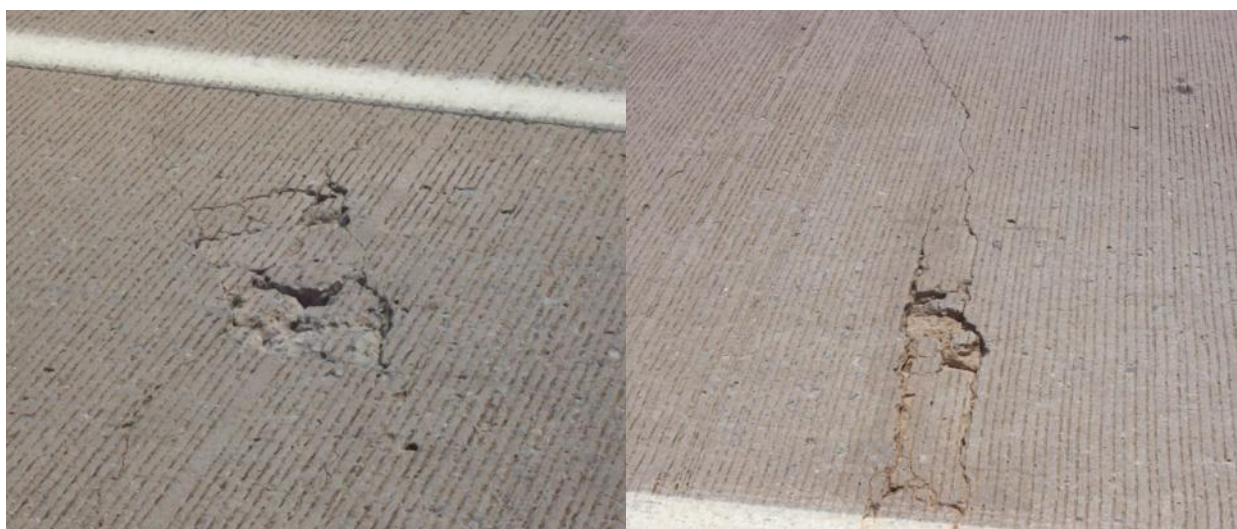
**Figure 3.60** – (left) Two closely spaced transverse cracks, (right) Y-crack developing into a punch-out

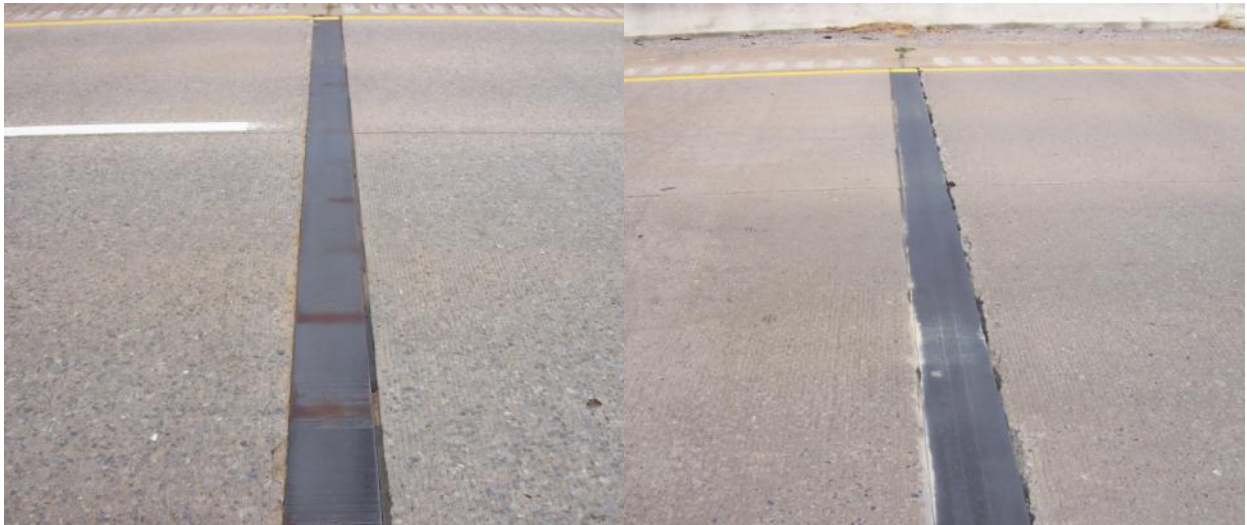
**Figure 3.61** – Terminal joints on each end of the project

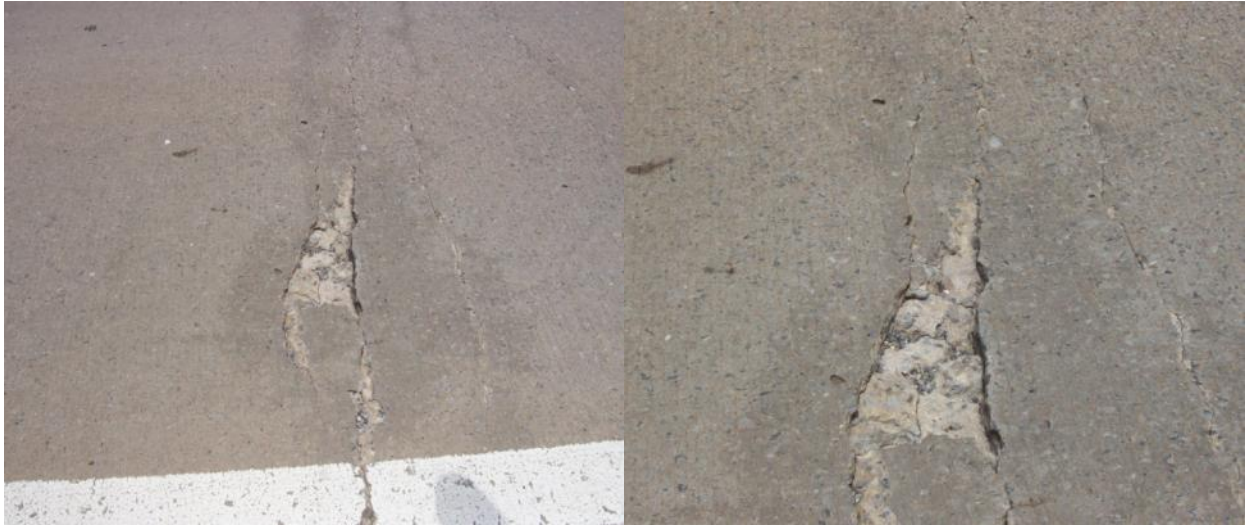
**Figure 3.62** – Y-crack developing into a punch-out

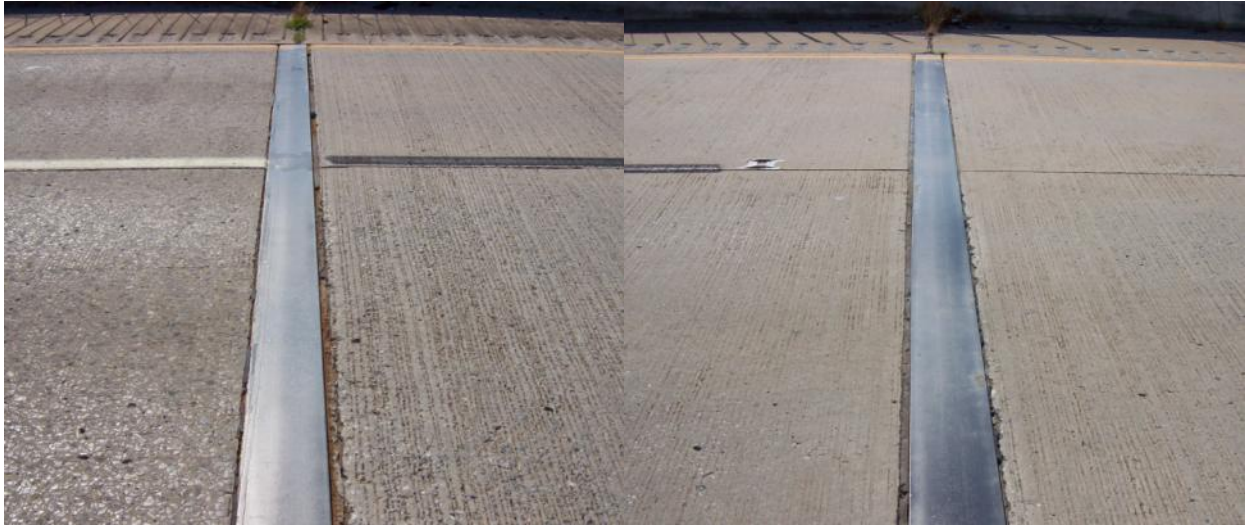
**Figure 3.63** – Terminal joints at the project beginning and end

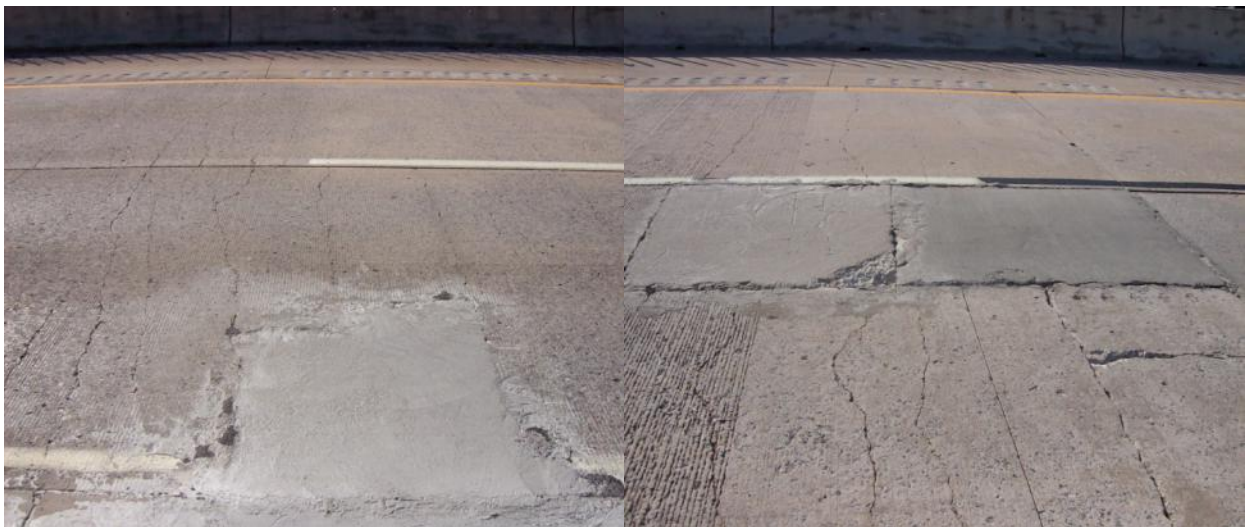
**Figure 3.64** – Patches formed near closely spaced transverse cracks

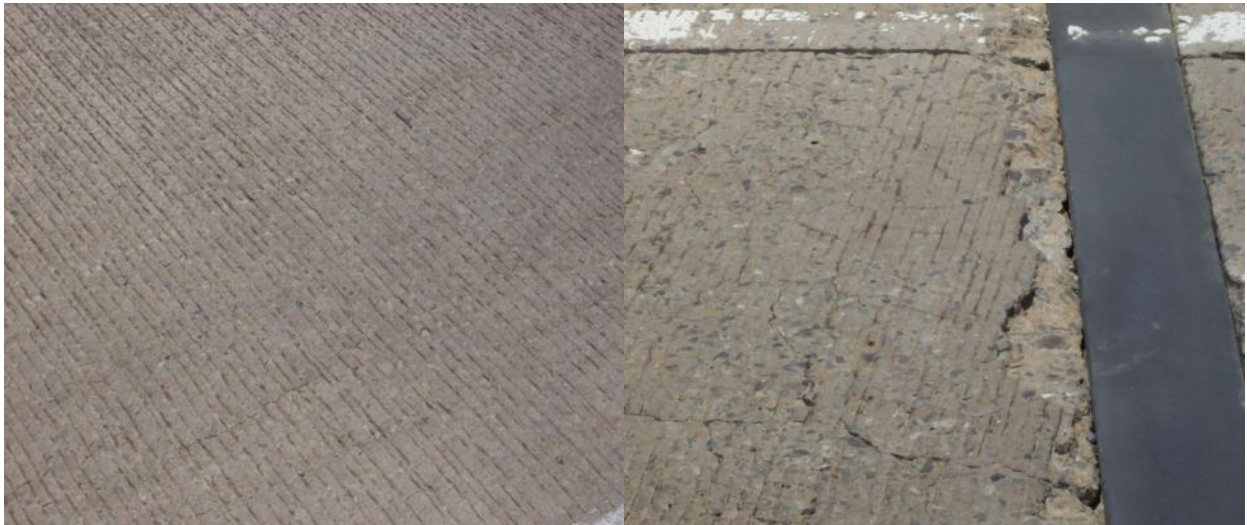
**Figure 3.65** – Close ups showing map-cracking

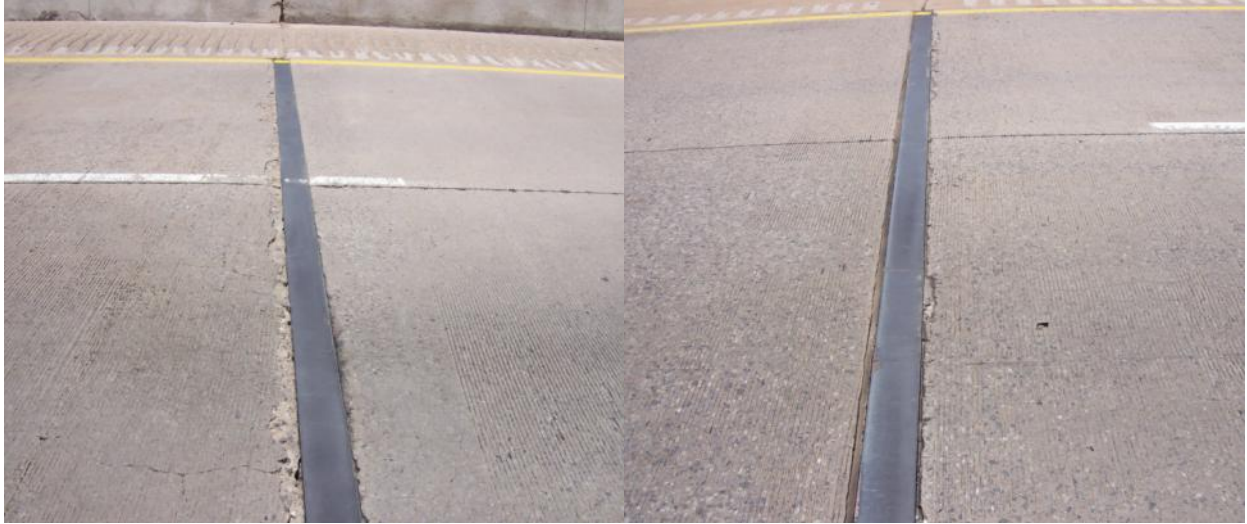
**Figure 3.66** – Terminal joints at project beginning and end

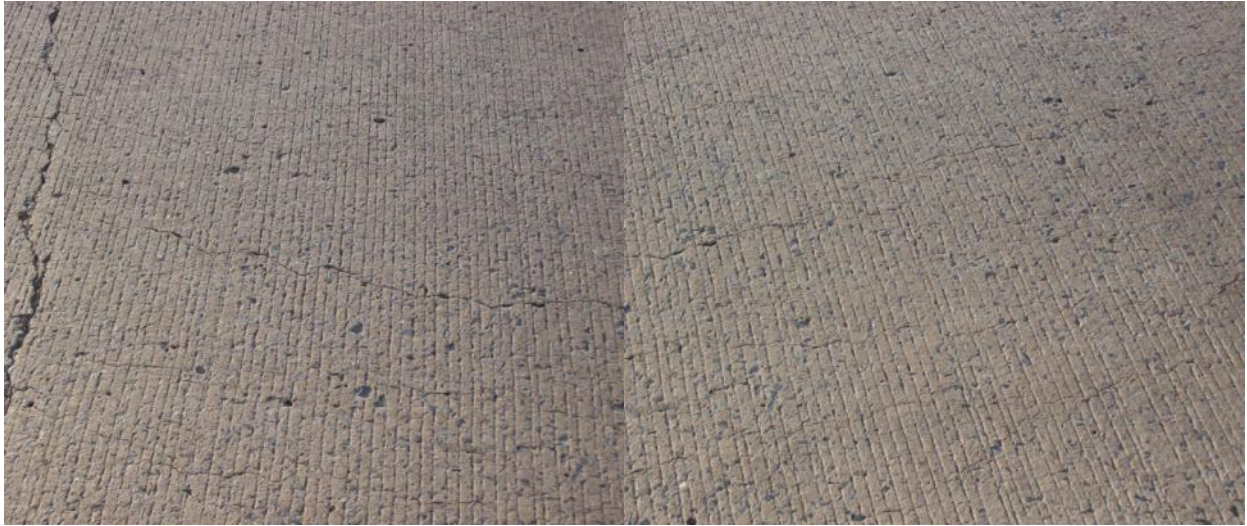
**Figure 3.67** – Map cracking in the south bound lane

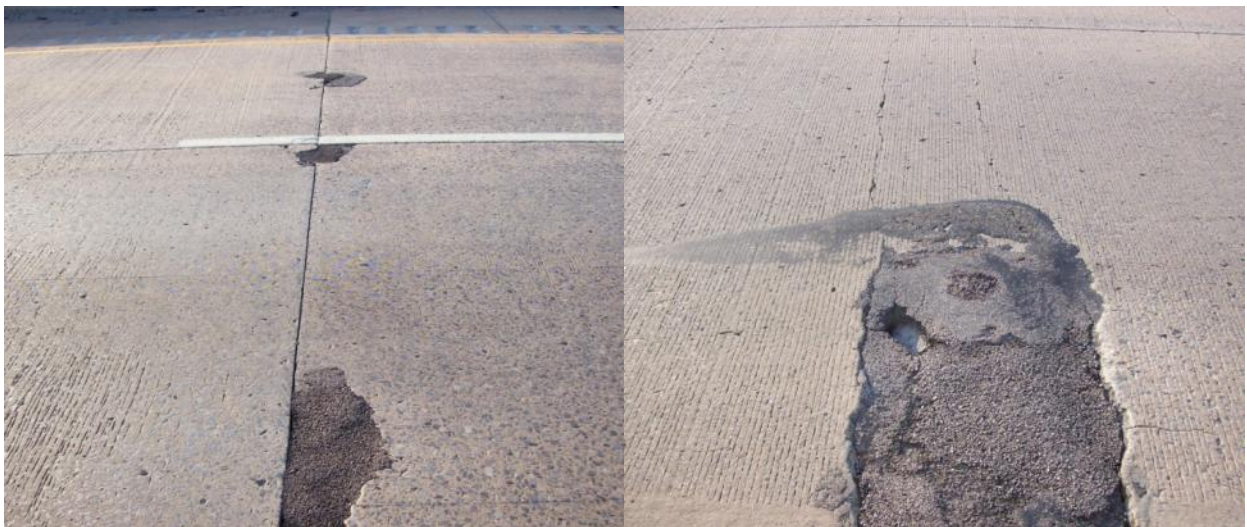
**Figure 3.68** – Patches in the south bound lane

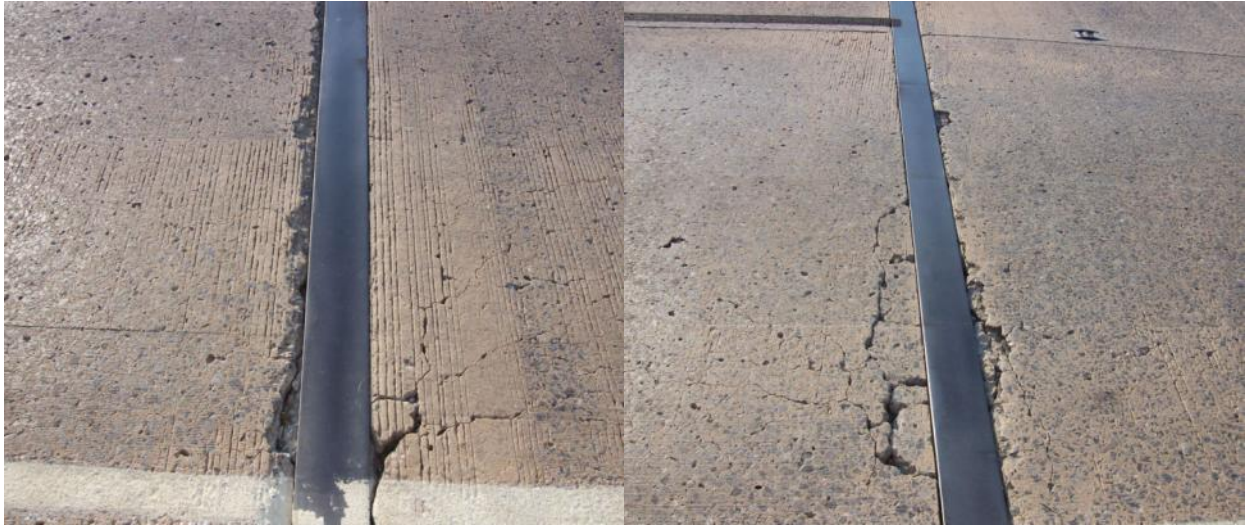
**Figure 3.69** – Terminal joints at the beginning and end of the project
