FIELD PERFORMANCE EVALUATION OF SELF-LEVELLING SEALANTS DOW CORNING 888-SL AND 890-SL

Gary G. Williams, P.E.
Research Project Manager

April, 1995

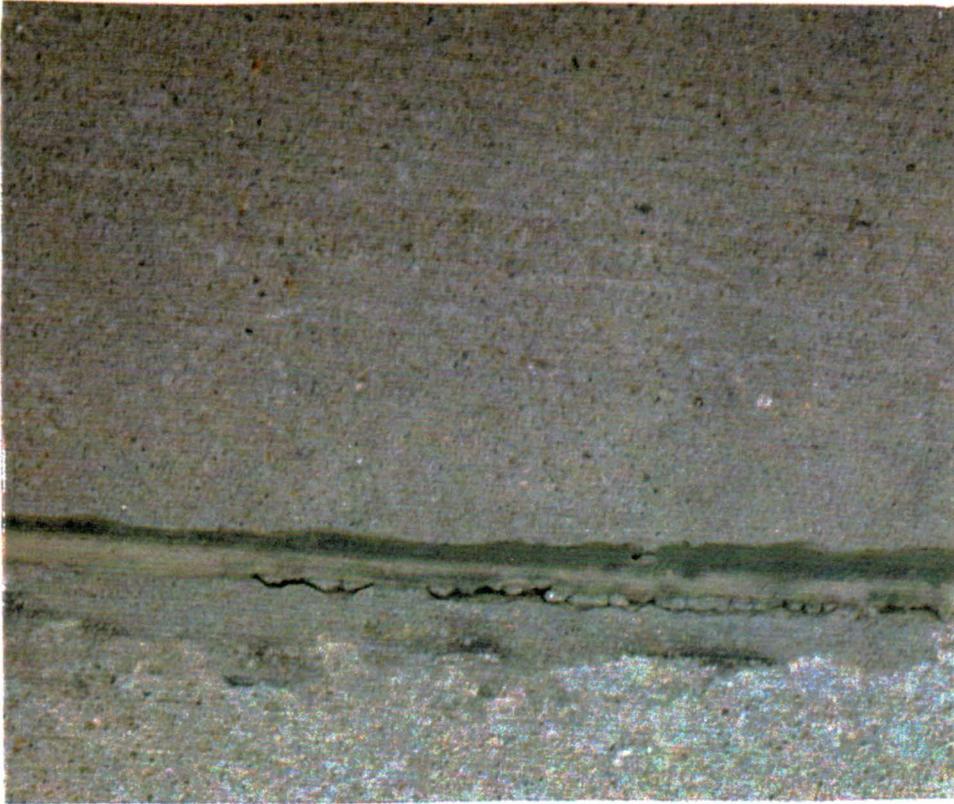
The formation of small cracks, with spalls along the sawed joints (Figure 8), was a common condition on this project. The cracks extended below the sealant, causing the joints to be unsealed where this occurred. The sealant was generally in good condition and adhering to the concrete in these cases.

Figure 8. Crack next to Joint, Leaving an Unsealed Joint with no Sealant Failure.

8. All projects in the study had numerous areas where small cracks formed parallel to joints or where small amounts of concrete spalled off of the edge of the saw cut. Where these conditions occurred, their effect was the same as that of sealant failure.

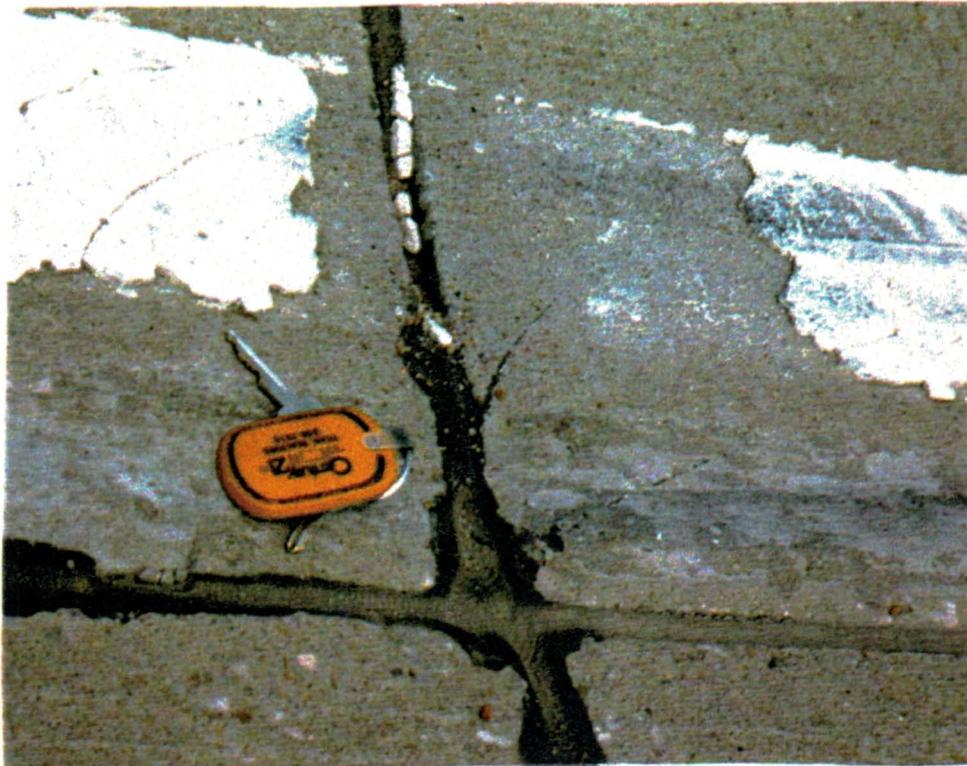
At the time of the final survey on this project (June 3, 1994), this section had seven adhesion failures (no other types of failure observed). Lengths of failures ranged from one inch to six inches. Four of these had failed on both sides of the sealant. This allowed the sealant to drop down into the joint in the failed area (Figure 13). All of the failures in this section were in locations where thermoplastic striping crossed a sealed joint (Figure 14). The failures were first observed when the sealant had been in service three and one half years.

Figure 13. Sealant Dropped into Joint Due to Adhesion Failure on Both Sides.

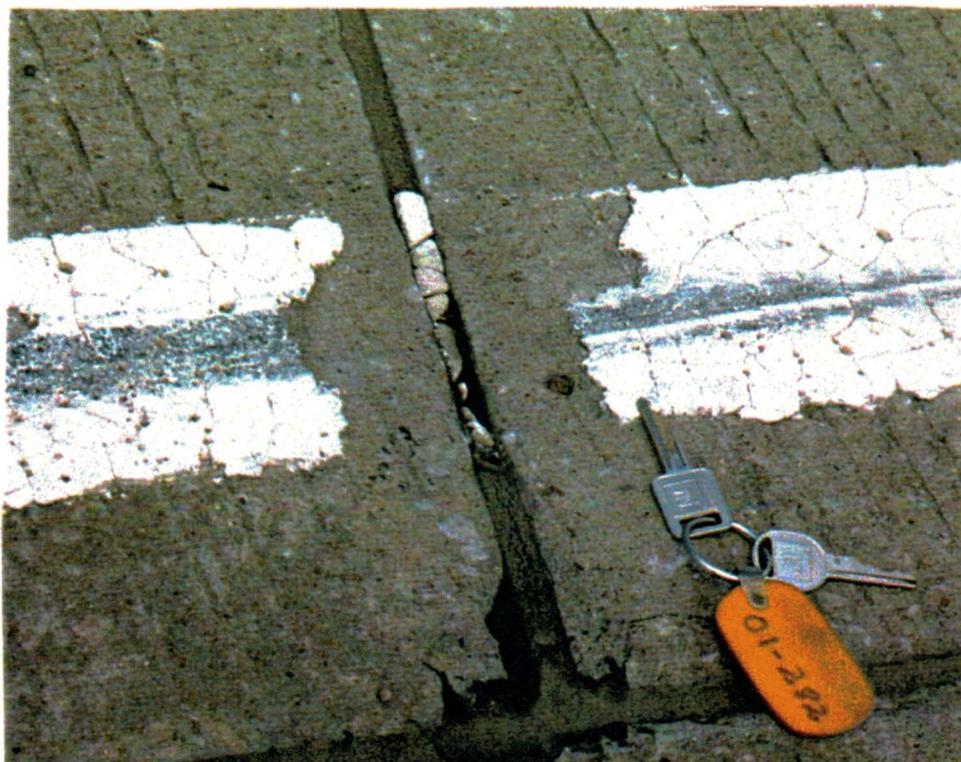
Figure 14. Adhesion Failure Where Thermoplastic Striping Crosses Joint Sealed with 890-SL.

1. On Project MAF-521(035), numerous failures occurred where Thermoplastic traffic striping crossed joints sealed with 890-SL. This was most common, and the effects most severe, where the outside edge stripe crossed transverse joints.

It may be possible to reduce the number of failures of the type involving thermoplastic striping. This could possibly be done by temporarily covering the part of the joint that will be crossed during striping with some type of fabric cover material. Another possibility would be scheduling striping to be done before joint sealing. Further research would be required to determine the effectiveness of actions of this type, and what effect they might have on construction operations.

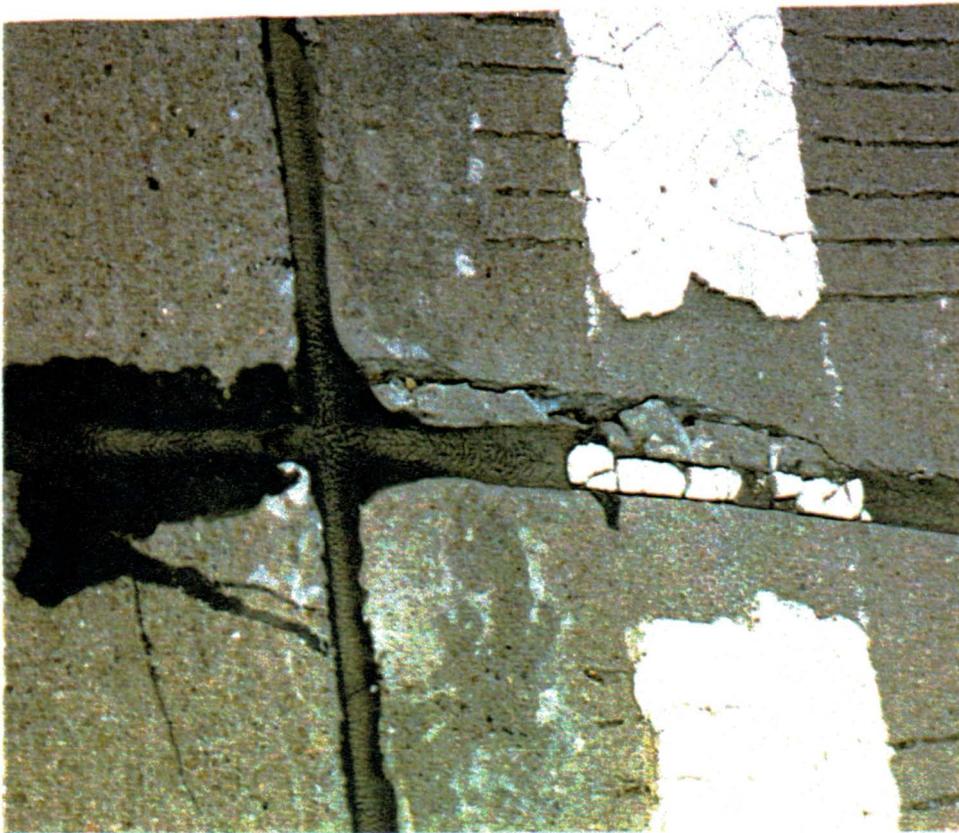
Eleven failures had occurred in this section by the time of the final survey. Five of these were cohesion failures, appearing as 3/8 inch (0.9525 cm) diameter holes through the sealant). All of the failures of this type occurred at the intersection of transverse joints and longitudinal edge line joint. One failure was a three-inch-long cohesion failure that had the appearance of a split in the sealant. The other three were adhesion failures occurring where thermoplastic striping crossed joints (Figure 15).

Figure 15. Adhesion Failure Where Thermoplastic Striping Crosses Joint Sealed with Accepted Sealant.

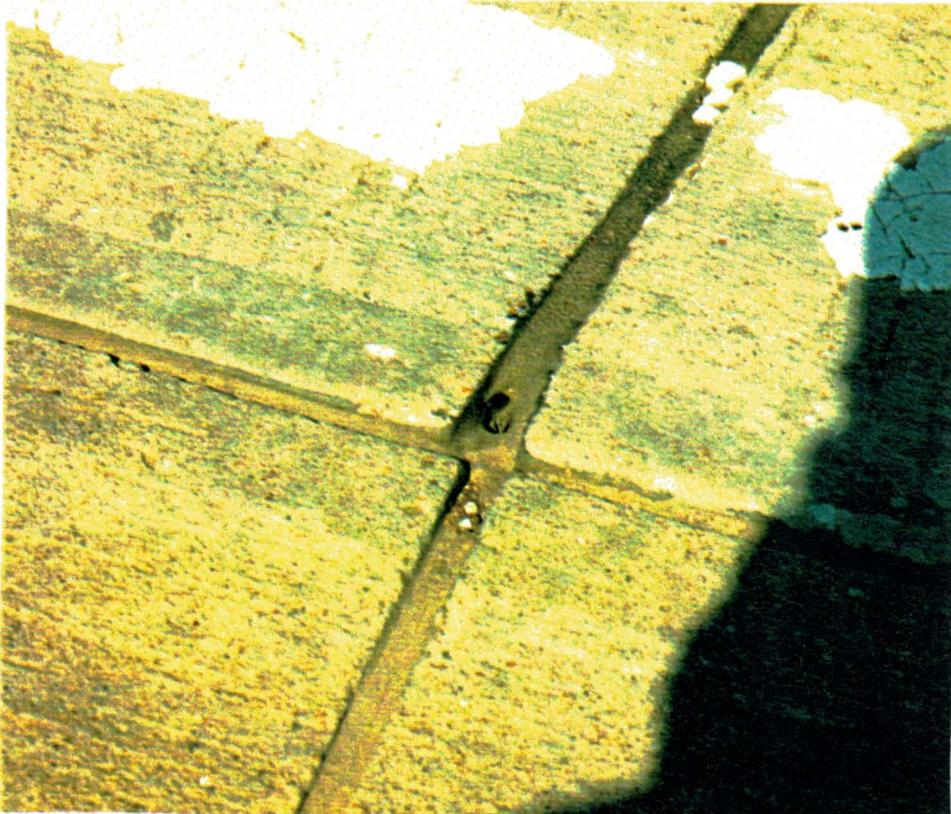
Figure 16. Cohesion Failure Appearing as "Hole" in Sealant.

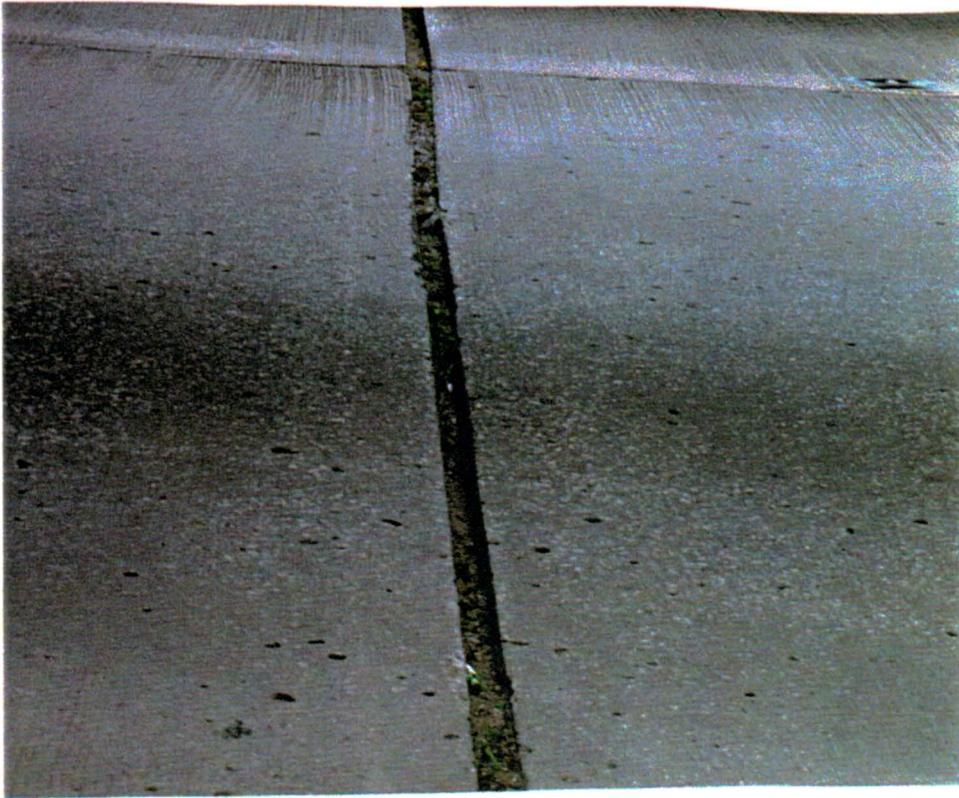
The joint between the bridge and the adjacent approach slab was sealed with hot pour sealant as in Sections 1, 2, and 3. The result was also similar. Only small traces of hot pour sealant remain in the joint. The other two-inch-wide joints, sealed with 890-SL, have adhesion failures in the wheel paths and show "polishing" where the sealant has been pushed up above the roadway surface when thermal expansion closes the joints (Figure 23). There were no failures in the 300-foot CRCP Section.

Figure 18. Expansion Joint Formerly Sealed With Hot Pour Sealant.

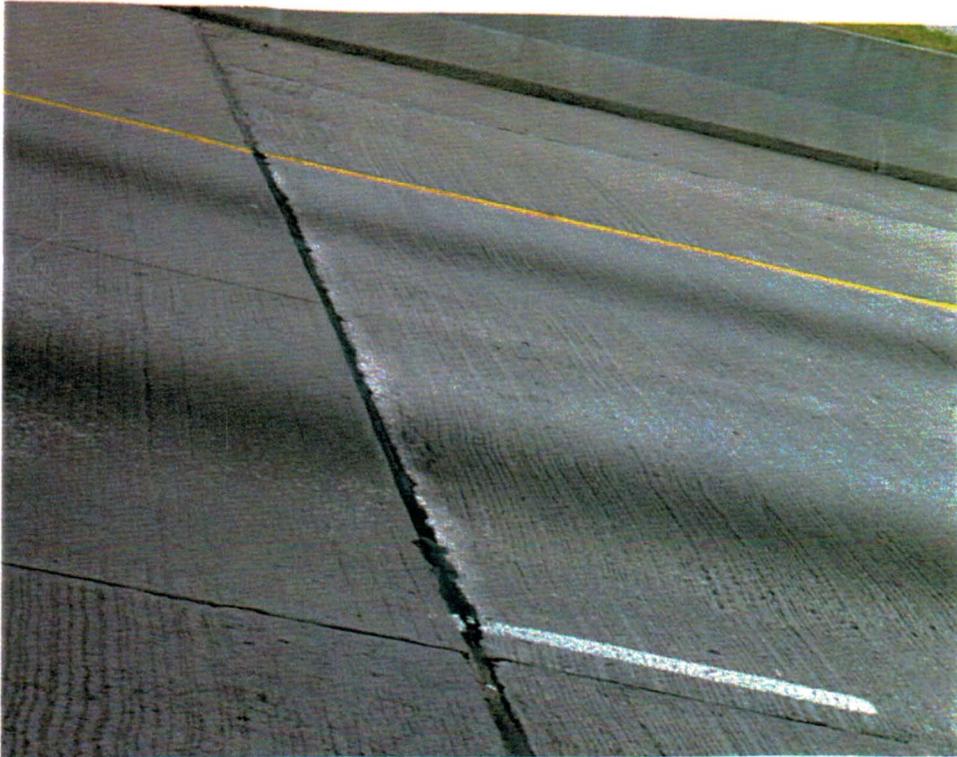
Figure 19. Expansion Joint Sealed with Self-Levelling Sealant.

Where self-levelling sealants were used to seal 1 1/2 inch (3.81 cm) wide expansion joints on Project MAF-521(075), they were considerably more successful than the hot pour sealant that they replaced.

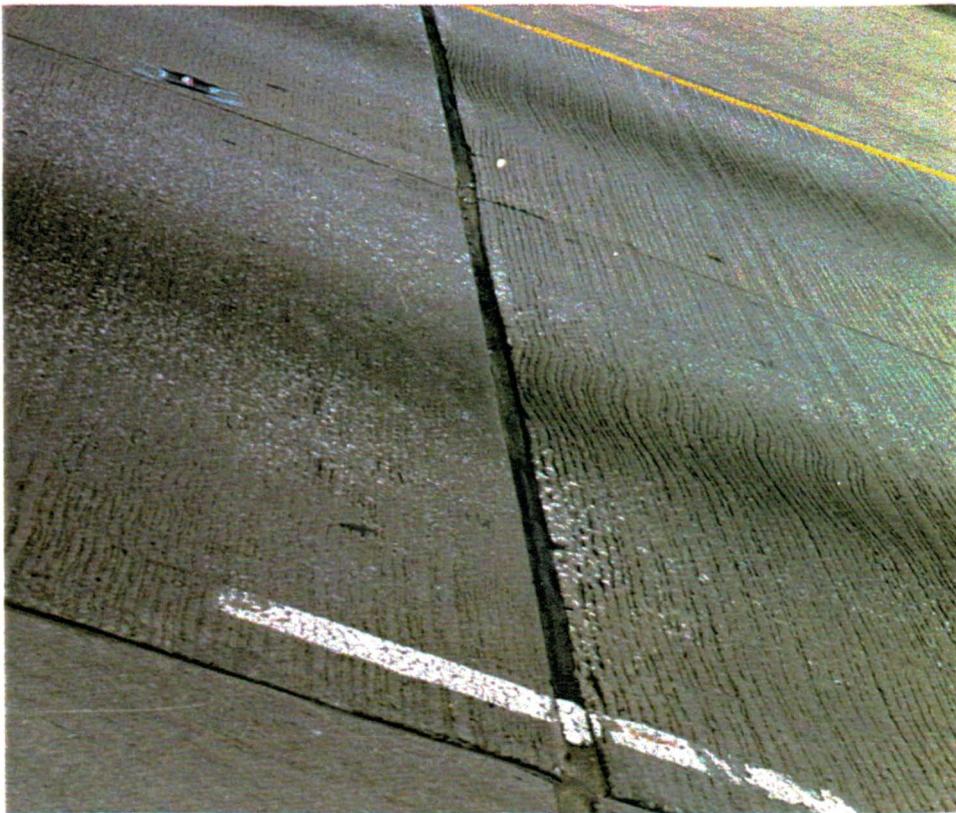
Figure 20. Expansion Joint Sealed with 890-SL with Adhesion Failures in Wheel Paths.

10. The self-levelling sealants used to reseal the 1 1/2 inch (3.81 cm) expansion joints on Project MAF-521(075) were installed so that the top of the sealant was 1/2 inch below the roadway surface. This recess distance appears to be inadequate, since sealant "polishing" in the wheel paths indicates that the sealant is being forced above the roadway surface during joint closure from thermal expansion of the deck. Installing sealant during hot weather, when joints are in a relatively closed position, would be another possibility for preventing this.
11. Results of this Field Performance Evaluation indicate that both 888-SL and 890-SL should be accepted for use on ODOT Projects.

1. Both self-levelling sealants (888-SL and 890-SL) should be accepted for use on ODOT projects.
2. Where joints are to be resealed with self-levelling sealants the old sealant should be completely removed and joints thoroughly cleaned.
3. Further research should be done on protecting self-levelling sealants from damage where thermoplastic traffic striping is applied over the sealant.
4. Where self-levelling sealants are used to seal 1 1/2 inch (3.81 cm) wide expansion joints, the distance the sealant is recessed below the roadway surface should be increased (beyond the 1/2 inch (1.27 cm) distance now used).

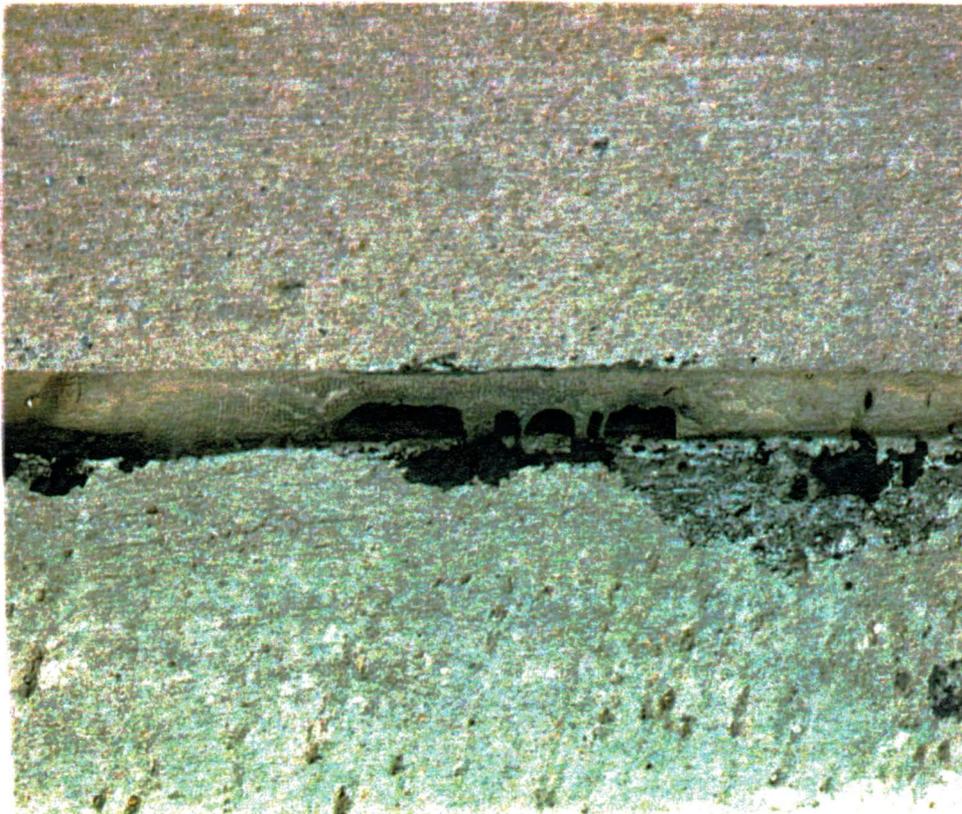
This test section had two failures in the sealed edge joint, and five in the two sealed terminal joints at the ends of the 51st Street overpass. The failures in the edge joint were cohesion failures consisting of series of connected "holes" (Figure 21). The sealant on both sides of these failures was intact and adhering to the pavement. The hot pour sealant originally used in the 1 1/2 inch joint between the bridge deck and the first slab had completely failed. Only small traces of it could be found in the joint (Figure 18). The next 1 1/2 inch wide joint was sealed with 890-SL. That seal was in good condition (Figure 19). South of this, there is another 30 foot long approach slab and another 1 1/2 inch wide joint, sealed with 890-SL. This joint has one six inch long adhesion failure at the outside edge line stripe.

Figure 21. Cohesion Failures in Edge Line Joint.

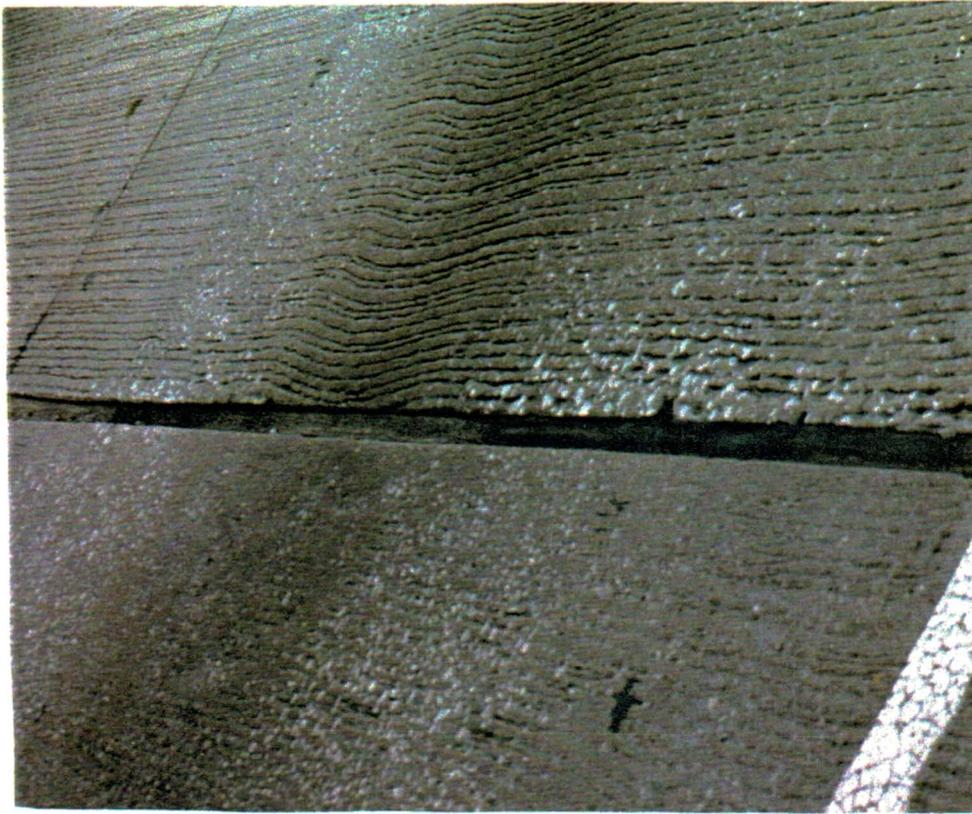
Figure 22. Adhesion Failures Occurring Where Wheels Contact Sealant.

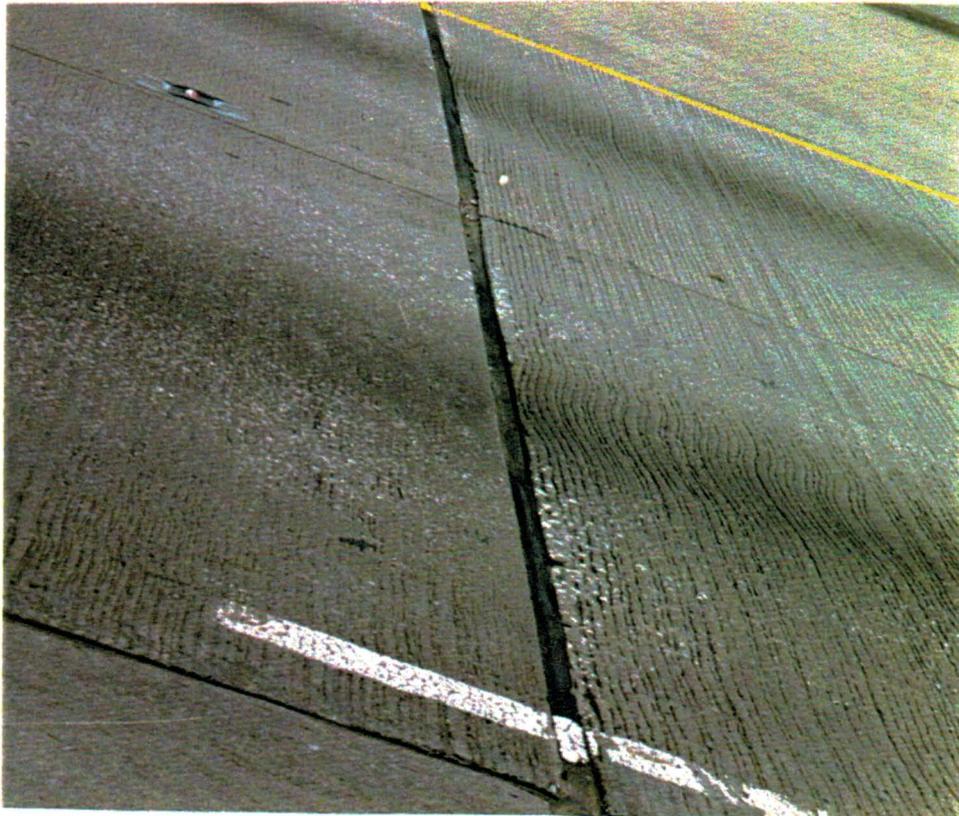
Figure 23. "Polished" Sealant in Wheel Path.

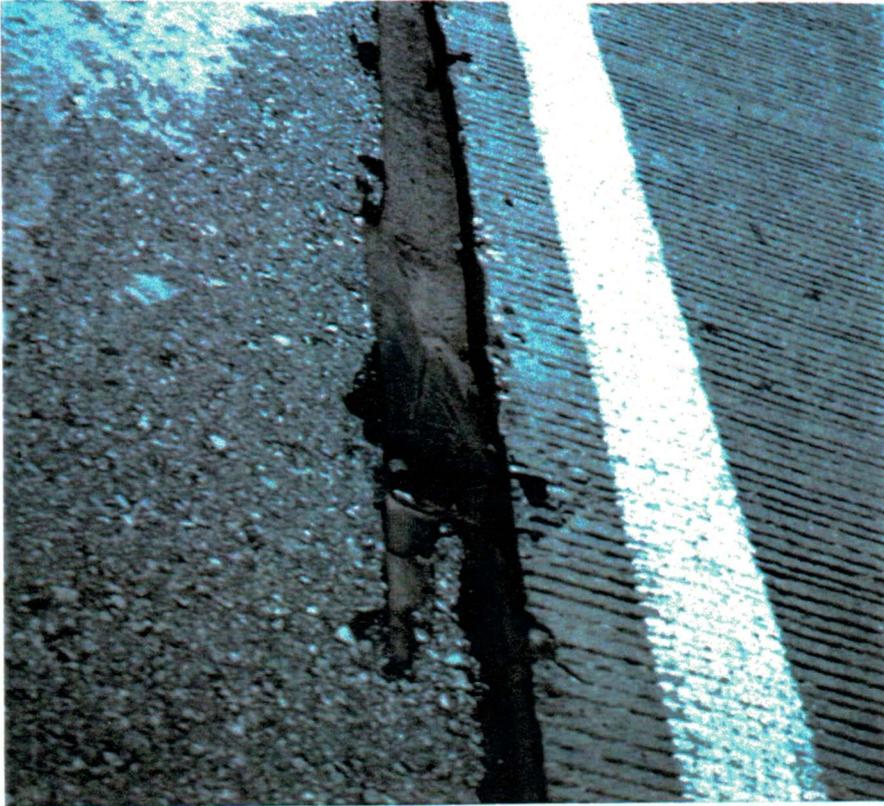
Prior to the demonstration, the the original joint sealant was removed by sawing it out of the joints. The joints were then cleaned by sandblasting. Removal of the old sealant and joint cleaning was done by ODOT Maintenance Forces. It is difficult to completely remove old sealant in this manner. In numerous locations, small amounts of the old sealant remained on the joints. The saw cut between the roadway and the shoulder varied in width from 1/2 inch (1.27 cm) to 2 inches (5.08 cm) (Figure 26). Also, the elevation of the shoulder varied from being flush with the roadway to as much as 1 inch (2.54 cm) below it. (Figure 27). Most of the failures at this location were related to these conditions.

Figure 26. Sawed Joint Between PCC Roadway and AC Shoulder.

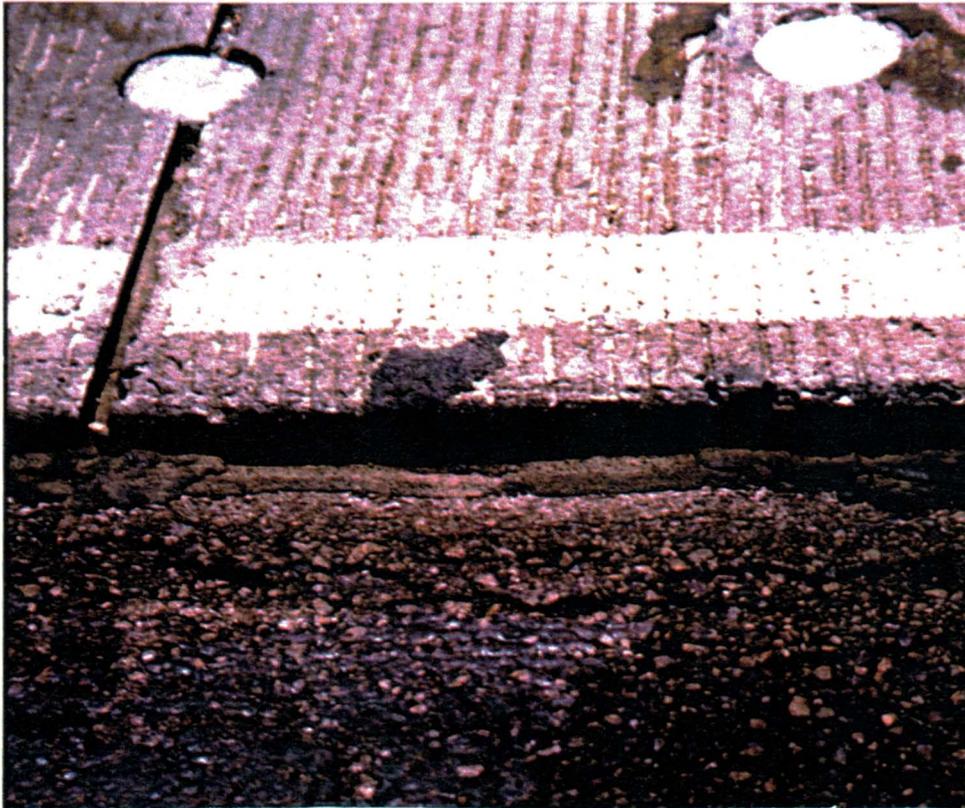
Figure 27. Difference in Elevation Between PCC Roadway and AC Shoulder.
