# KOCH BRIDGE JOINT SYSTEMS

## FINAL REPORT

June, 1993

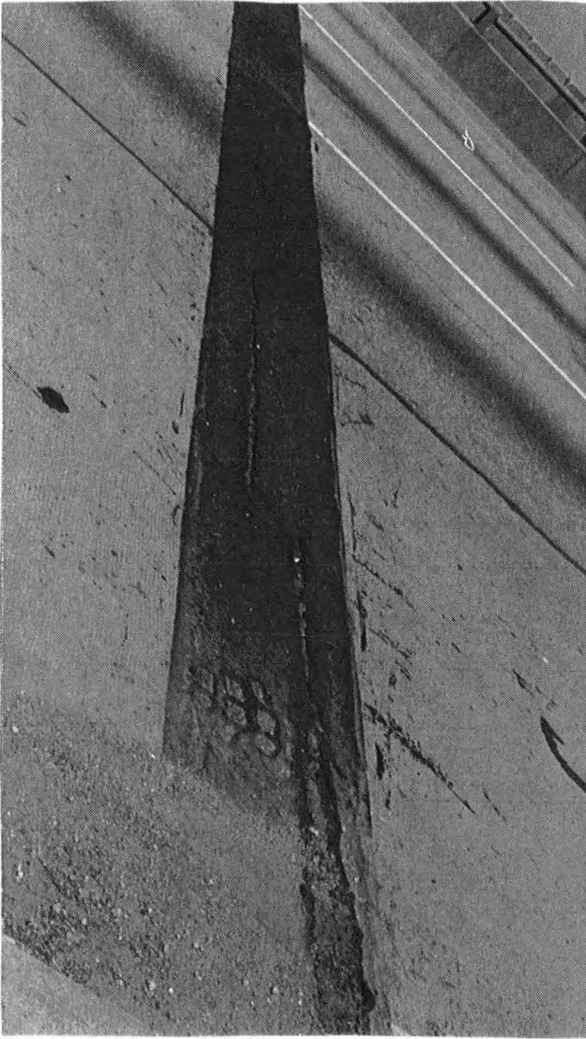
Of the twenty-seven BJS Units, nine (33 percent) had some cracking at the time of this survey (Figures 2 - 4). Crack lengths ranged from half of the bridge width to full width. All of the cracks appeared to be located over the outside edges of the bridge plates. Due to the high ADT in this area, it was not practical to close lanes to test water-tightness of the joints with a water truck. Visual inspection indicated that cracks extended at least down to the bridge plate. The asphaltic plug in the expansion gap is directly below the bridge plate, so there is a possibility that the BJS Units may still have been functioning as water tight seals on the survey date.

Figure 2. Typical Cracks in BJS Units,  
January 9, 1992.

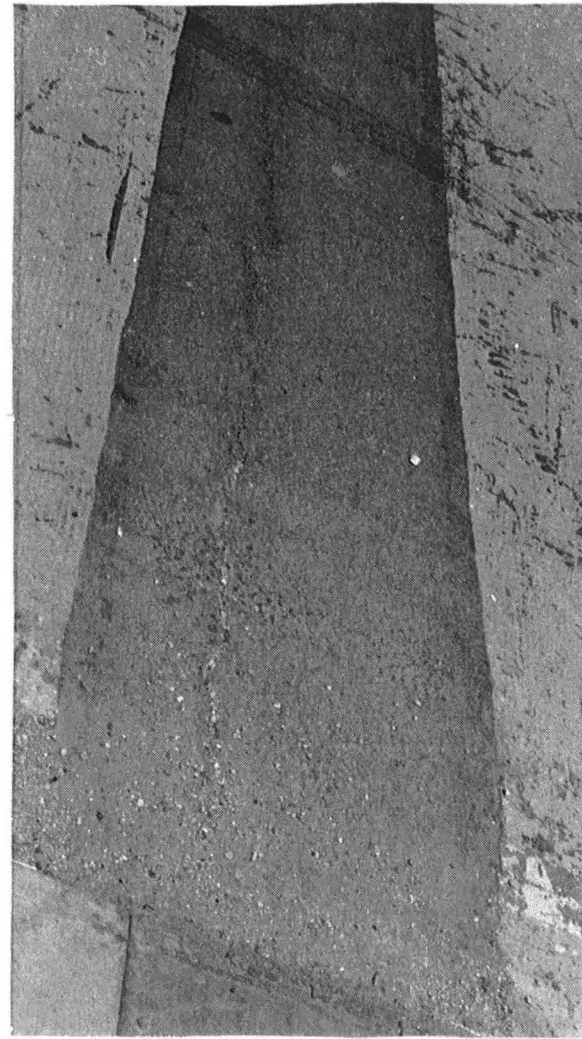
Figure 3. Cracks in BJS Units,  
January 9, 1992.

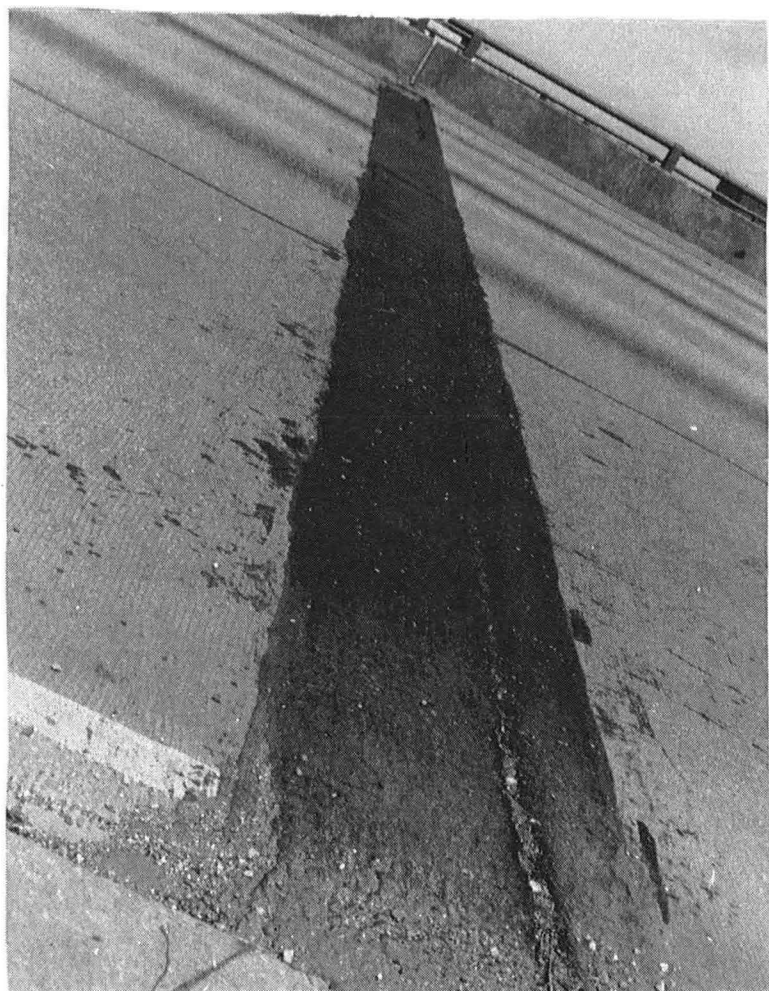
Figure 4. Cracks in BJS Units. January 9, 1992

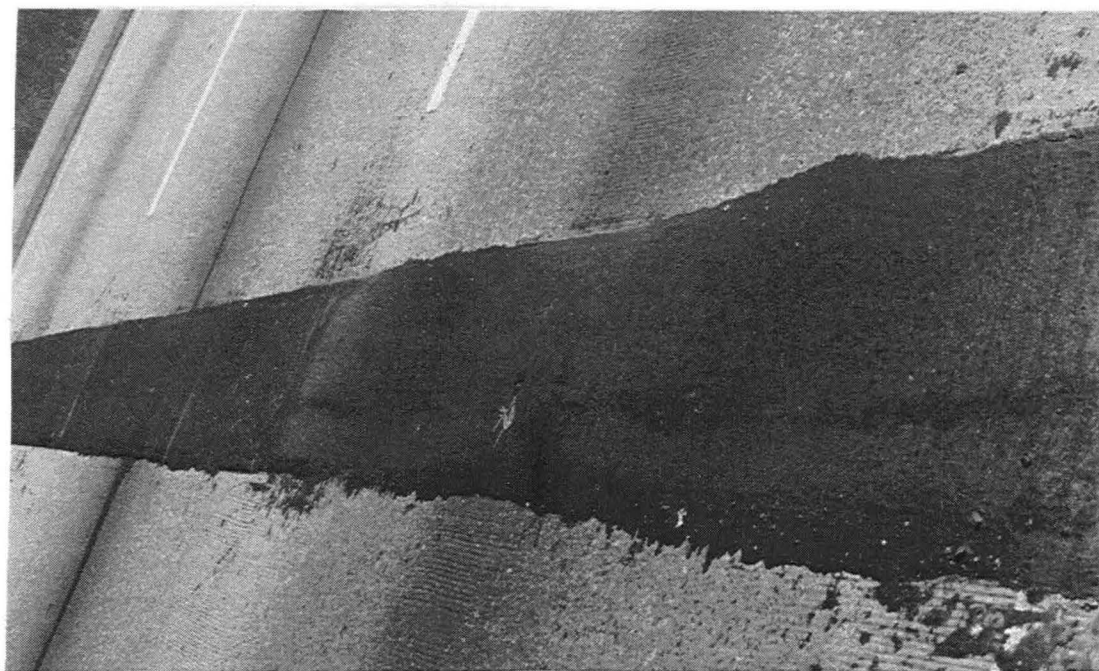
When this survey was done, all but two of the cracks noted during the two previous surveys appeared to have closed. A check with the Oklahoma City Maintenance Branch Manager confirmed that no work had been done on the BJS units, either by ODOT forces or the installation contractor's employees. Temperature at the time of this survey was higher than the previous surveys (Table 4). Because of this, the expansion gaps in the joints were closed relative to the January and April Surveys. The cracks appeared to have "healed". This was probably due to a combination of two actions, the expansion gaps closing and the action of the tires on the BJS units. On some of the units, the previous cracks could be seen as depressed areas (Figure 5). On others, sand, rock, and other foreign material could be seen compressed into the previously cracked area (Figure 6).

Figure 5. BJS Unit with "healed" crack  
(depressed area).

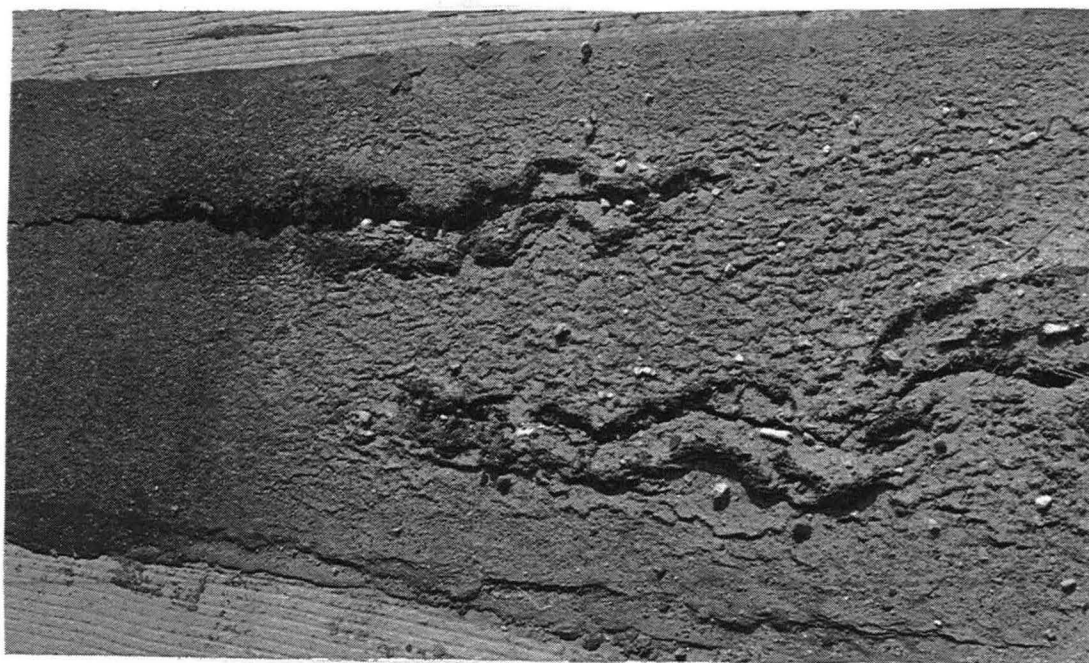
Figure 6. Previously Cracked BJS Unit.  
Rock compressed into crack.

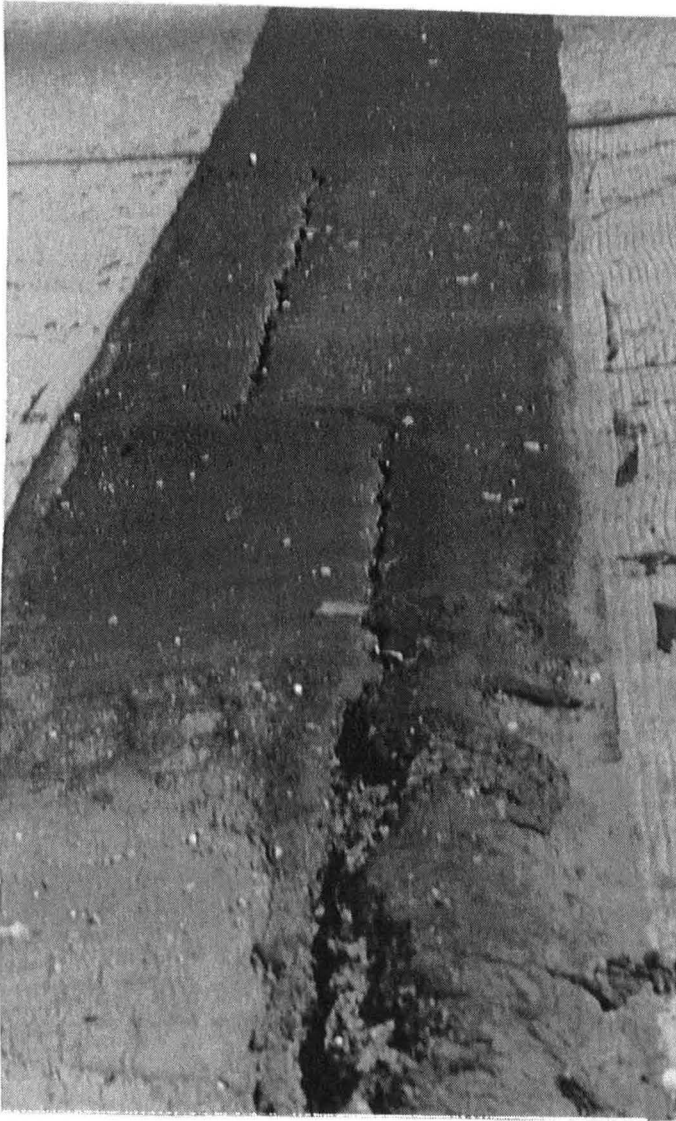
Figure 7. Cracked BJS Unit, 7-10-92.

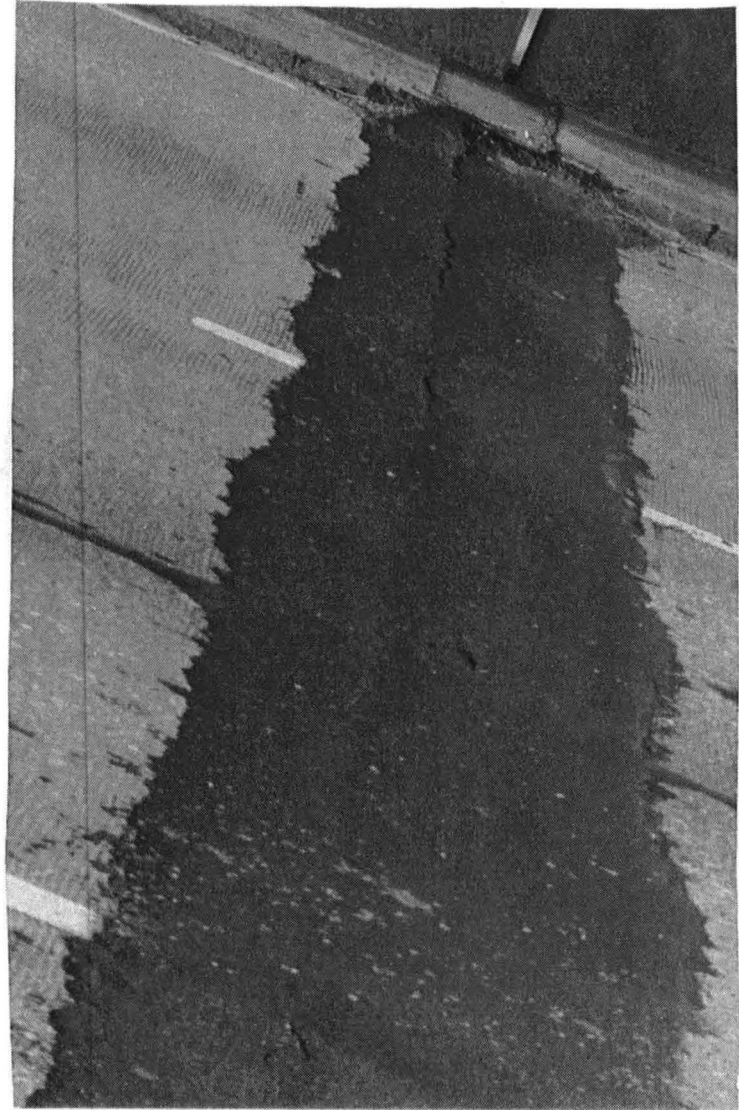
Figure 8. Cracked BJS Unit, 7-10-92.

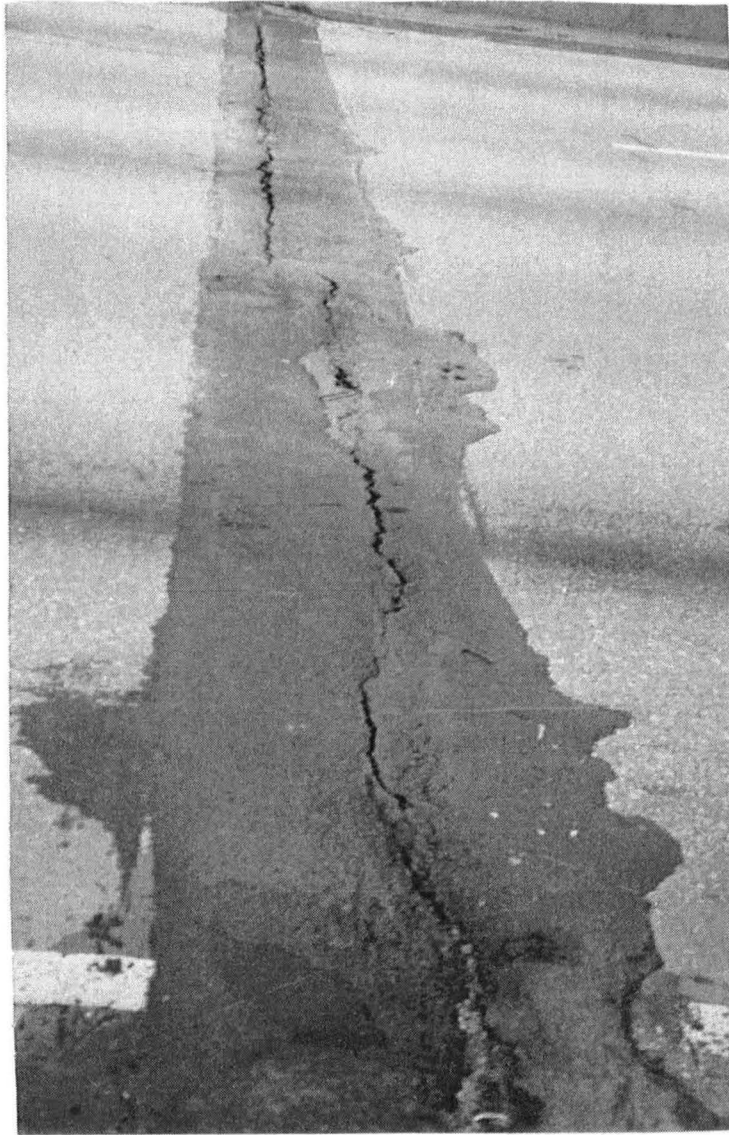
Nineteen of the twenty-seven BJS units (70 percent) were observed to be cracked during the survey. Also, there were two units where the bridge plate was either missing or moved out of position for part of the joint length, resulting in a joint without anything in that part of it (Figure 13). The other 17 cracked joints might (possibly) still be functioning as water-tight joints, but these have definitely failed. Cracking appears to be more severe than in previous surveys. Also, chunks of the KOCH Modified Asphalt Concrete making up the units have spalled along the cracks (Figures 10 and 11). Some spalls were also observed on the outside edges of the units (Figure 12).

Figure 9. Typical cracked BJS Unit, March 4, 1993

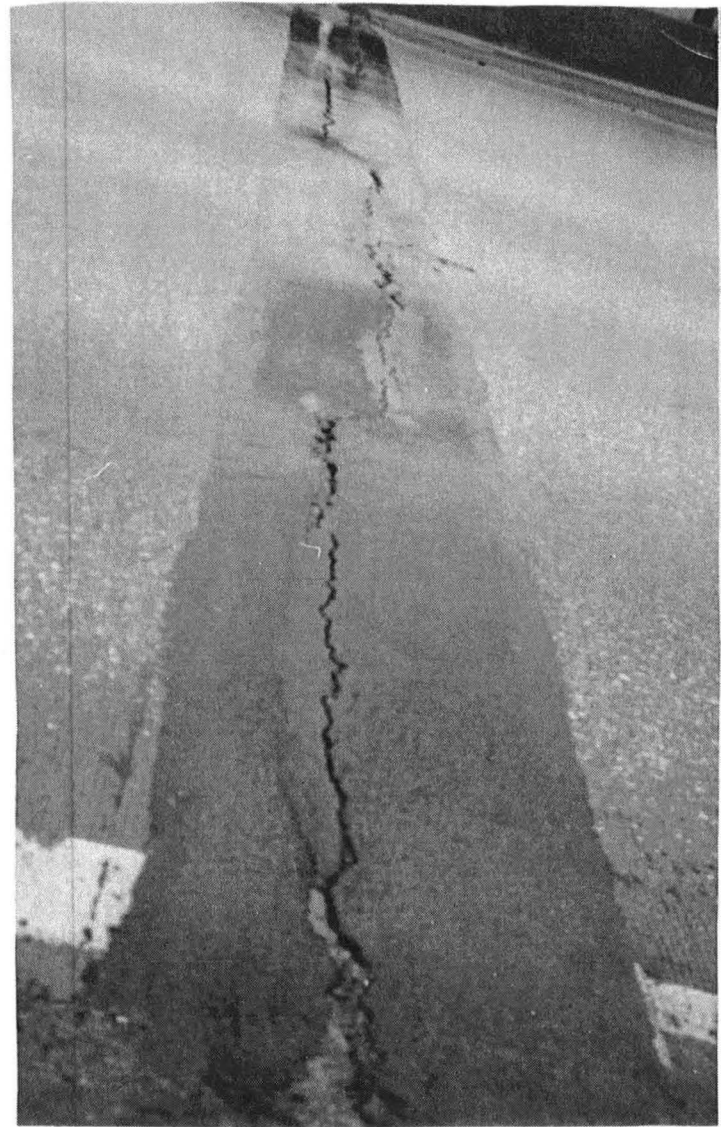
Figure 10. Typical cracked BJS Unit, March 4, 1993

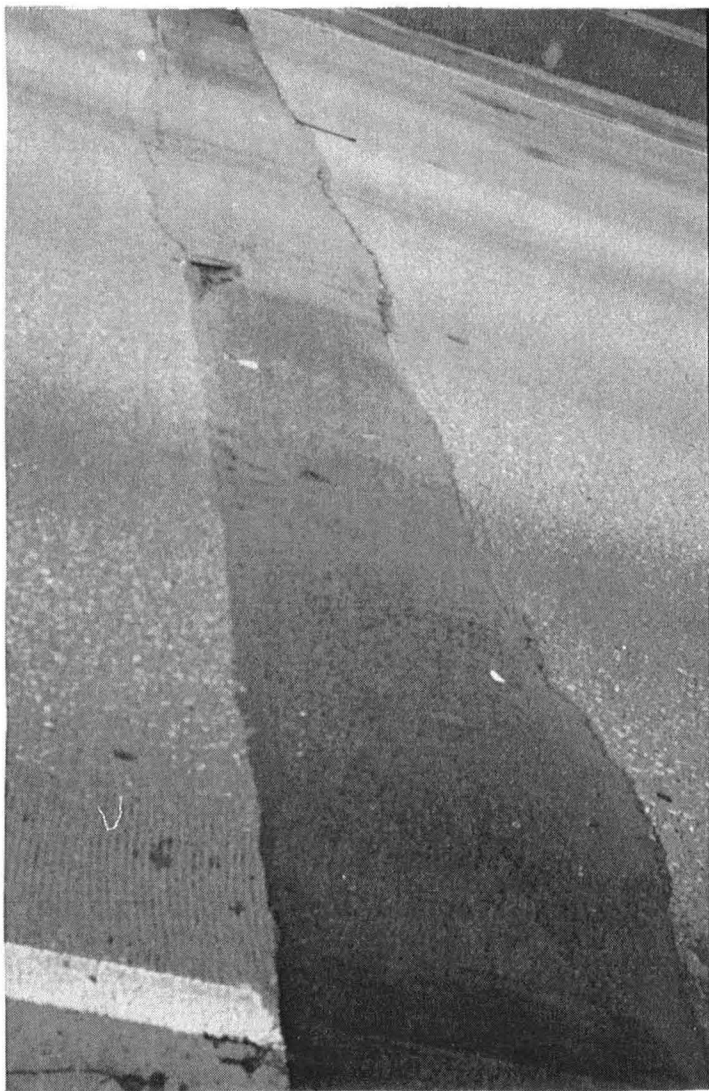
Figure 11. Spalling at edge of BJS Unit,  
March 4, 1993

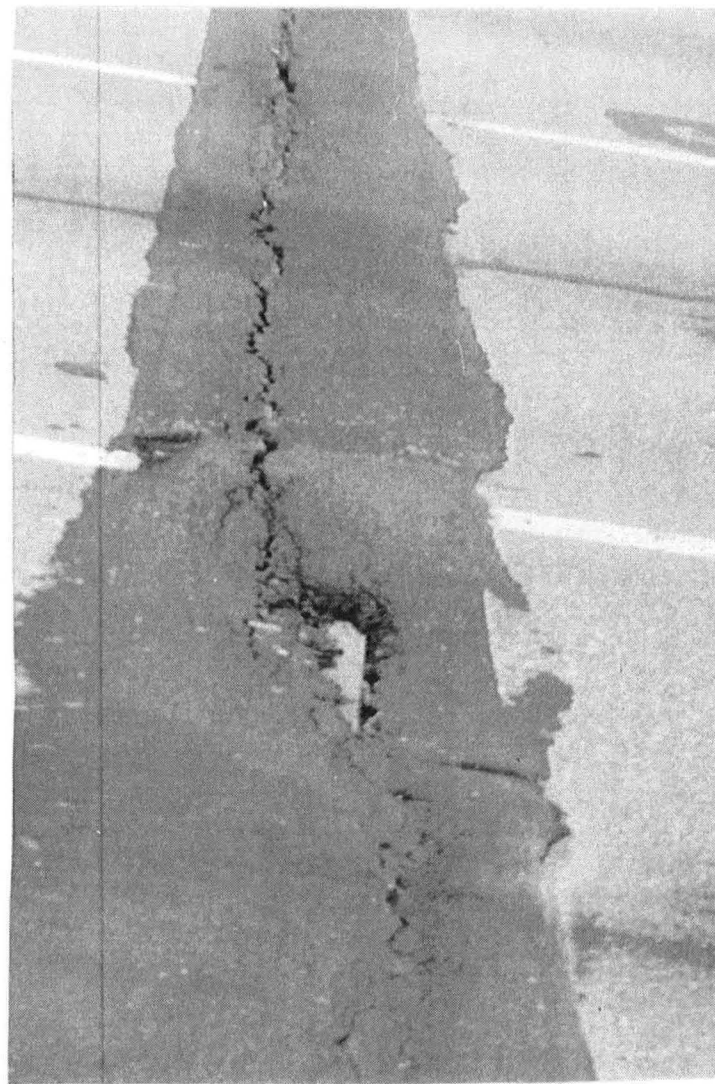
Figure 12. Spalls at Edge of Unit and Along  
Crack, March 4, 1993

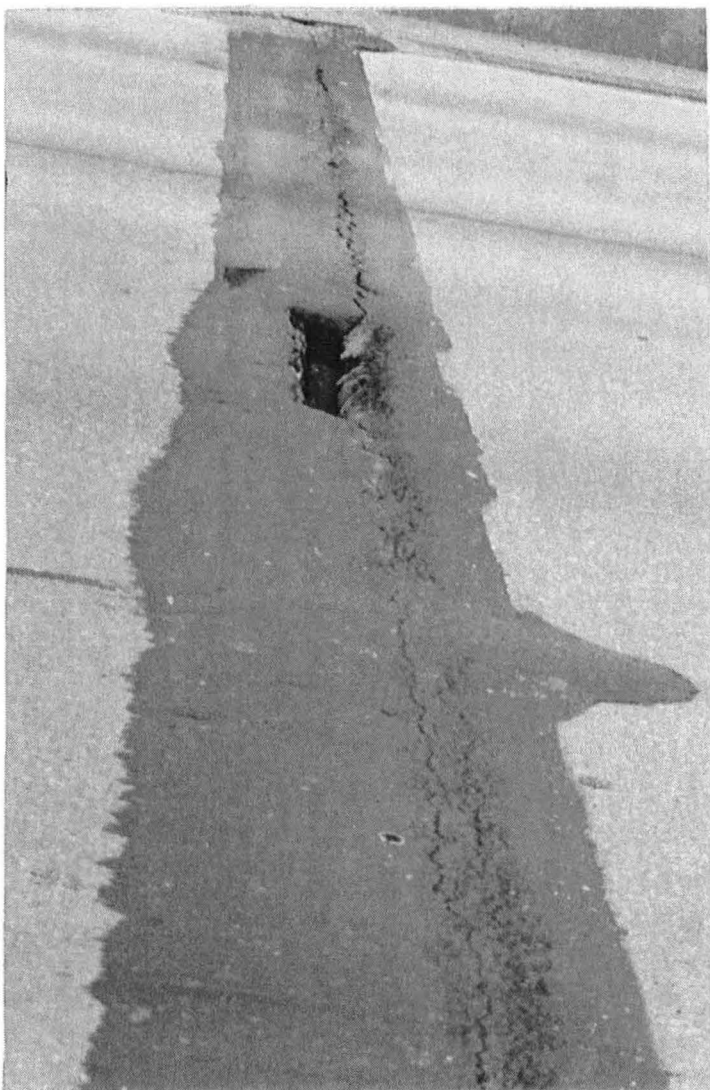
Figure 13. Hole through BJS, Part of Bridge  
Plate Missing, March 4, 1993.
