Bridge Deck Thermography Verification and Policy

WisDOT ID no. 0092-23-04

September 2024

TECHNICAL REPORT DOCUMENTATION PAGE

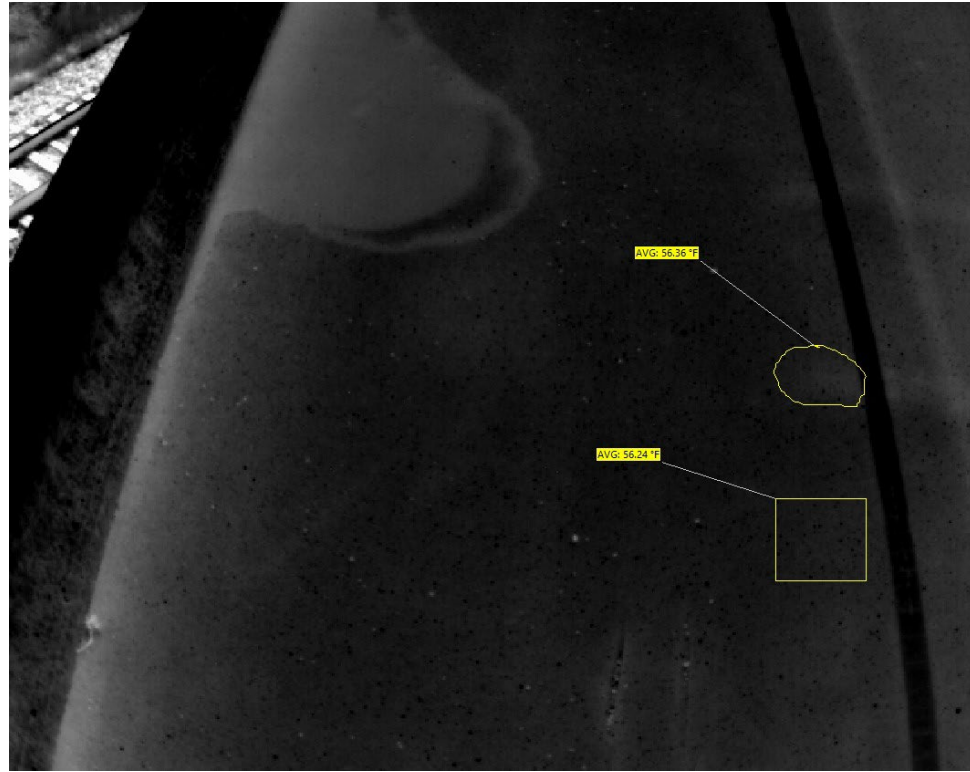
B300048 EB Left Shoulder defect 1

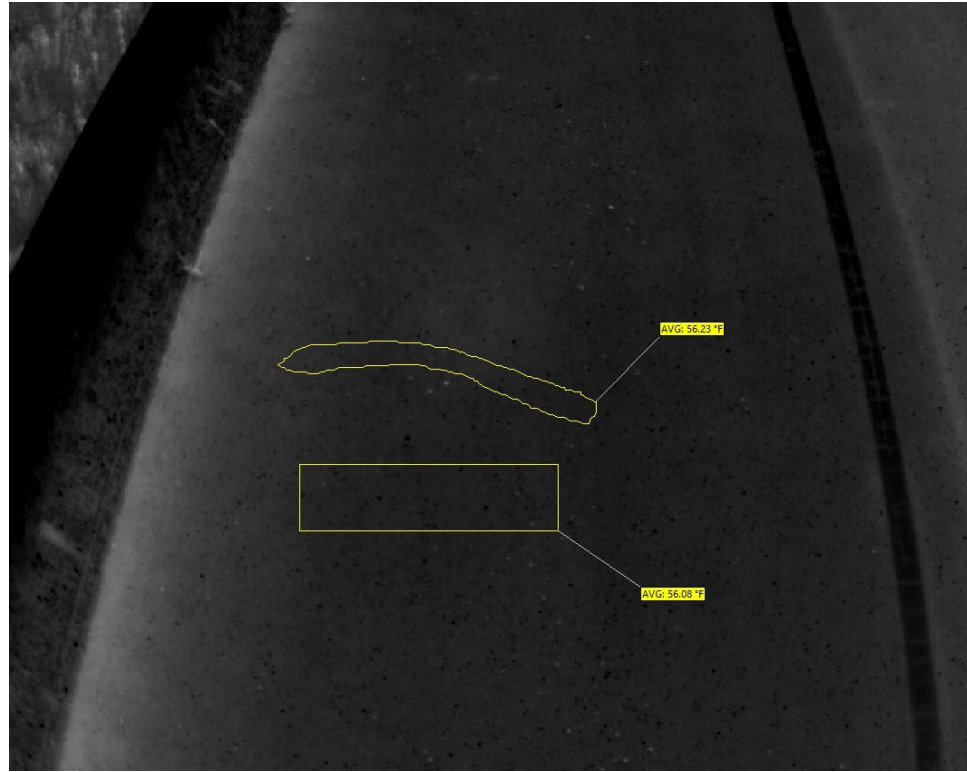
B300048 EB Left Shoulder defect 3

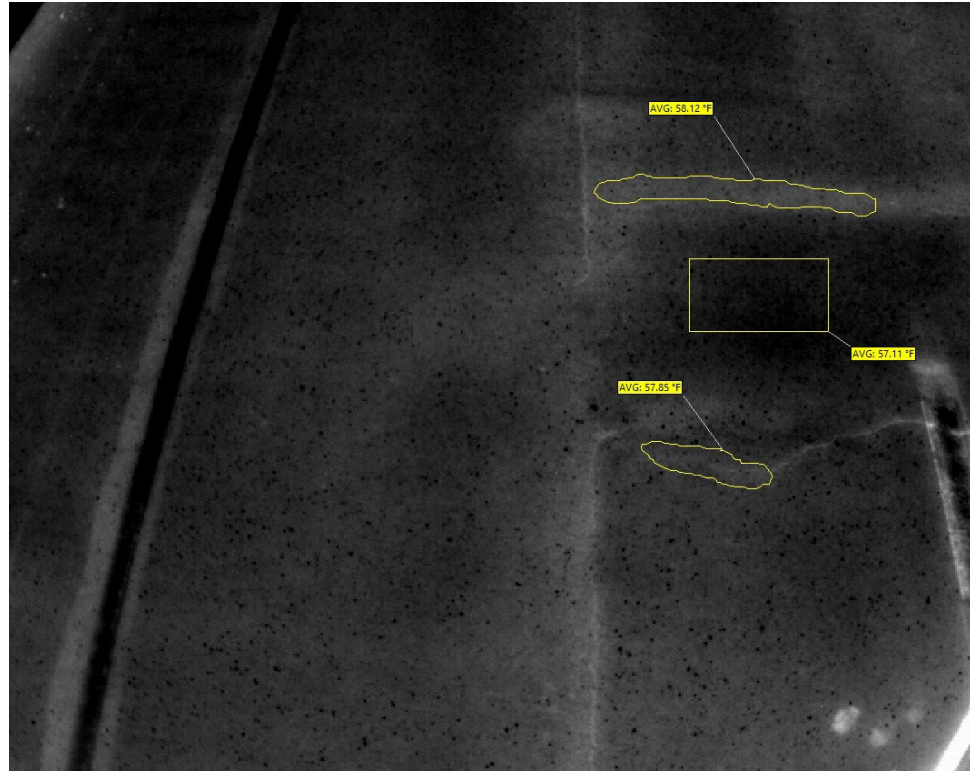
B300058 WB Left Lane defects 1 and 2

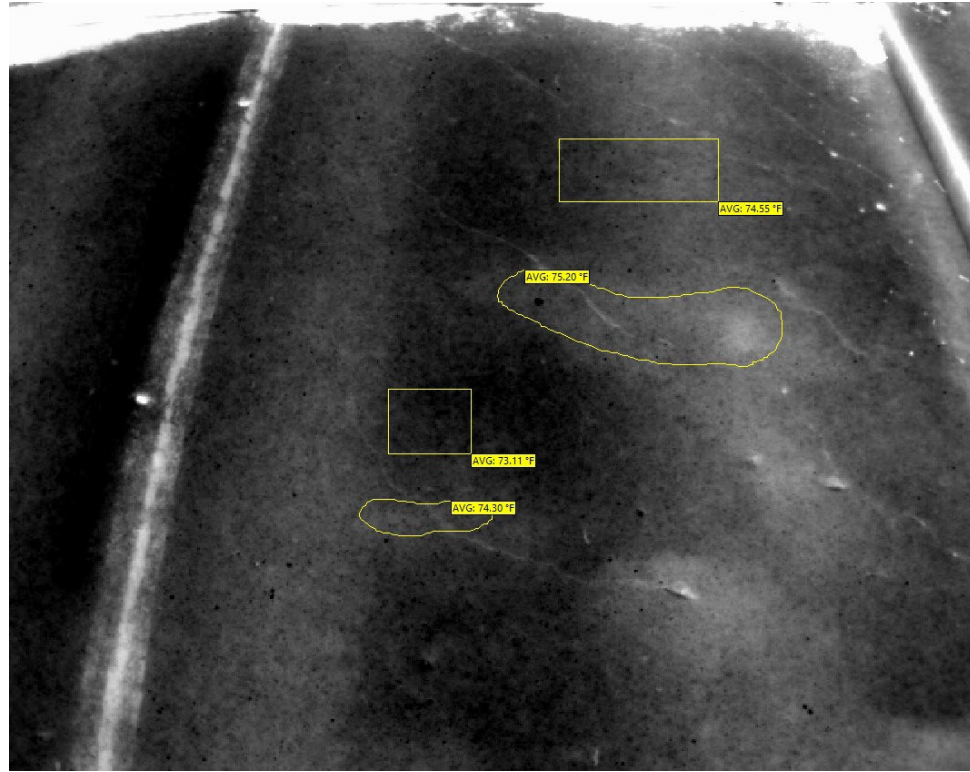
B400519 WB Right Lane defects 2 and 3

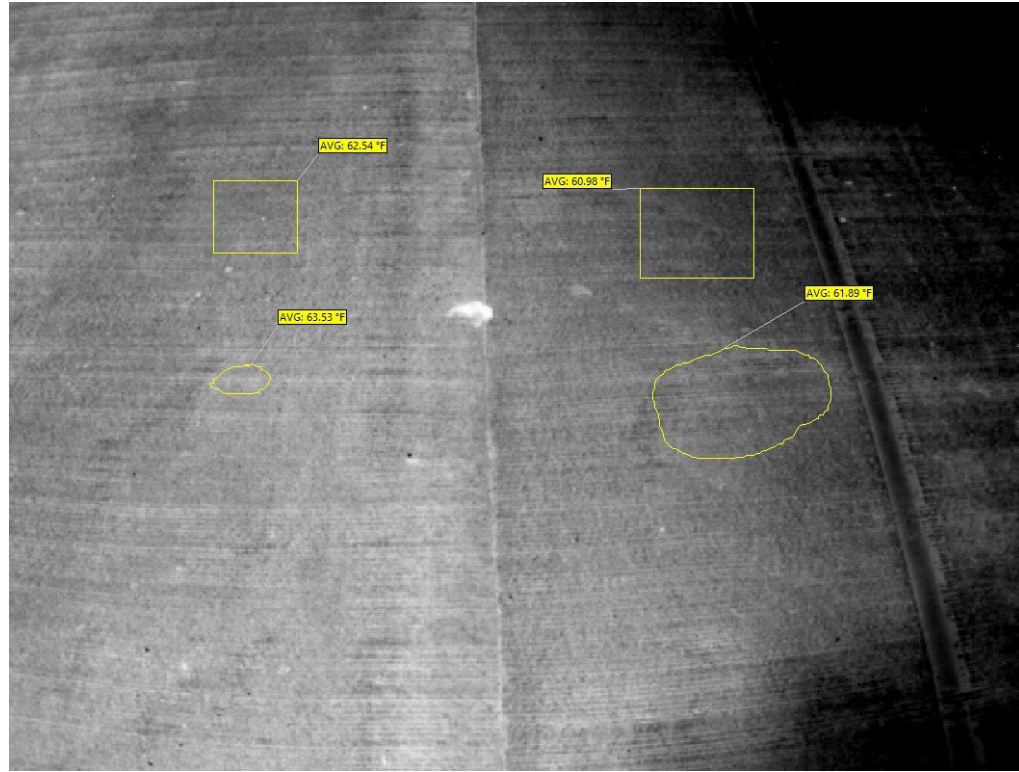
B670152 NB Right Lane defects 2 and 3

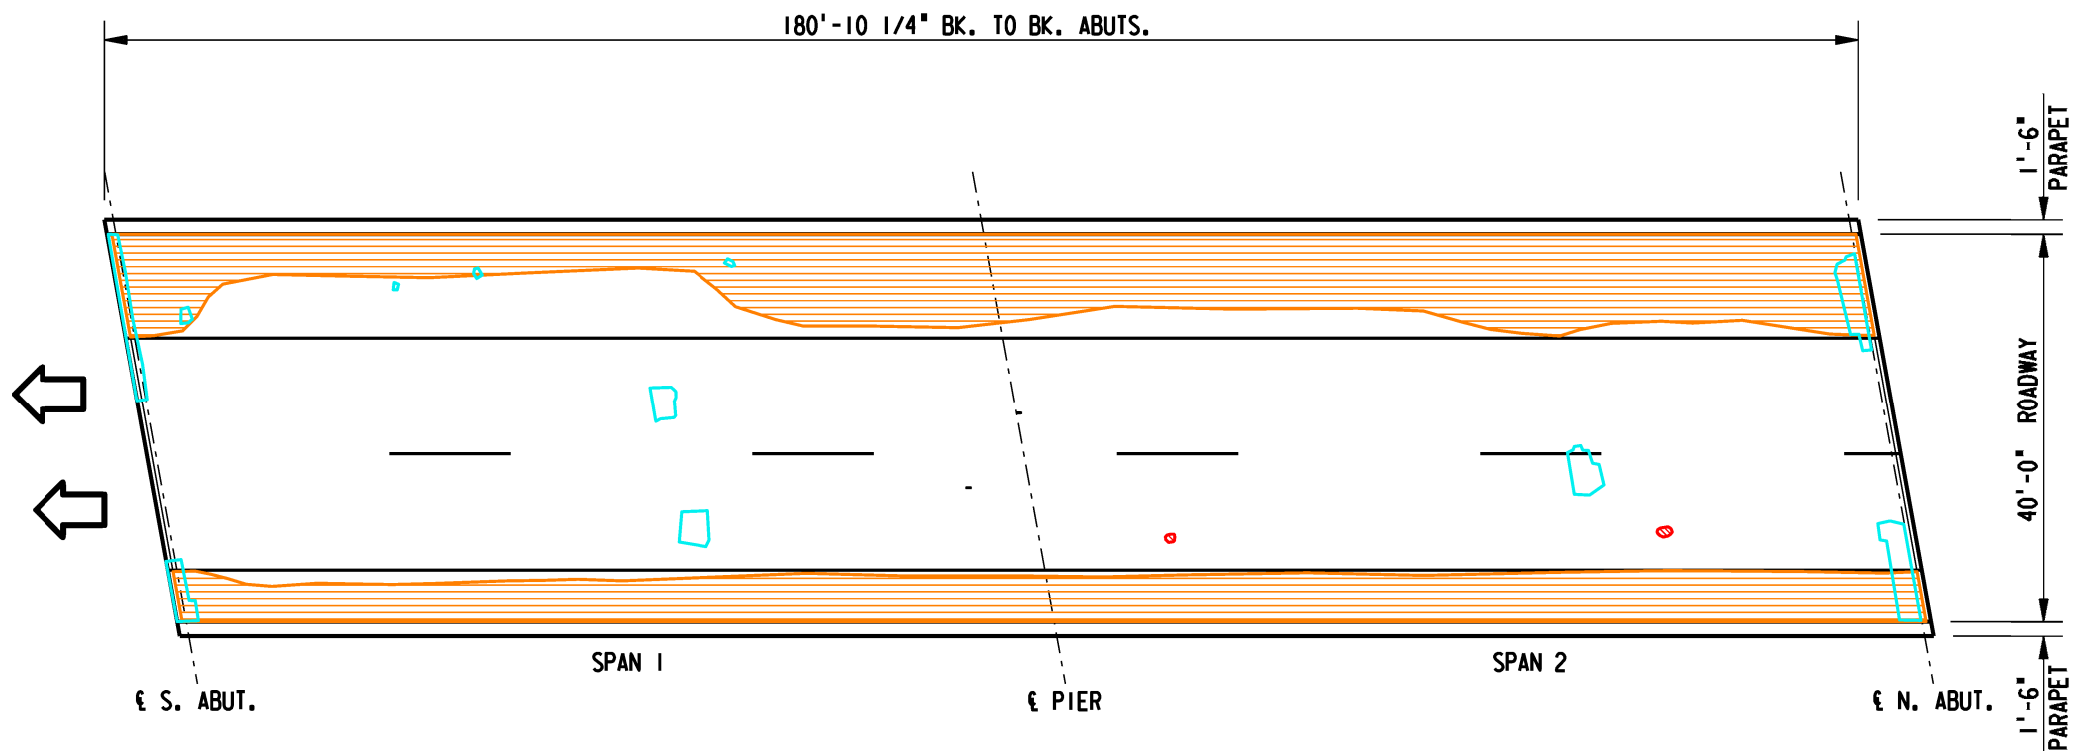
PLAN
B-5-202

DEFECT-REHAB COMPARISON		STRUCTURE NO. B-5-202	
ITEM	UNIT	QUANT.	%
TOTAL AREA	ft ²	7188	
TOTAL DEFECTS*	ft ²	2	<0.1
TOTAL TYPE-1 REHAB	ft ²	104	1.5
DEFECTS/REHAB OVERLAP	ft ²	0	0
IR FALSE POSITIVES	ft ²	2	<0.1
REHAB NOT DETECTED BY IR	ft ²	104	1.5

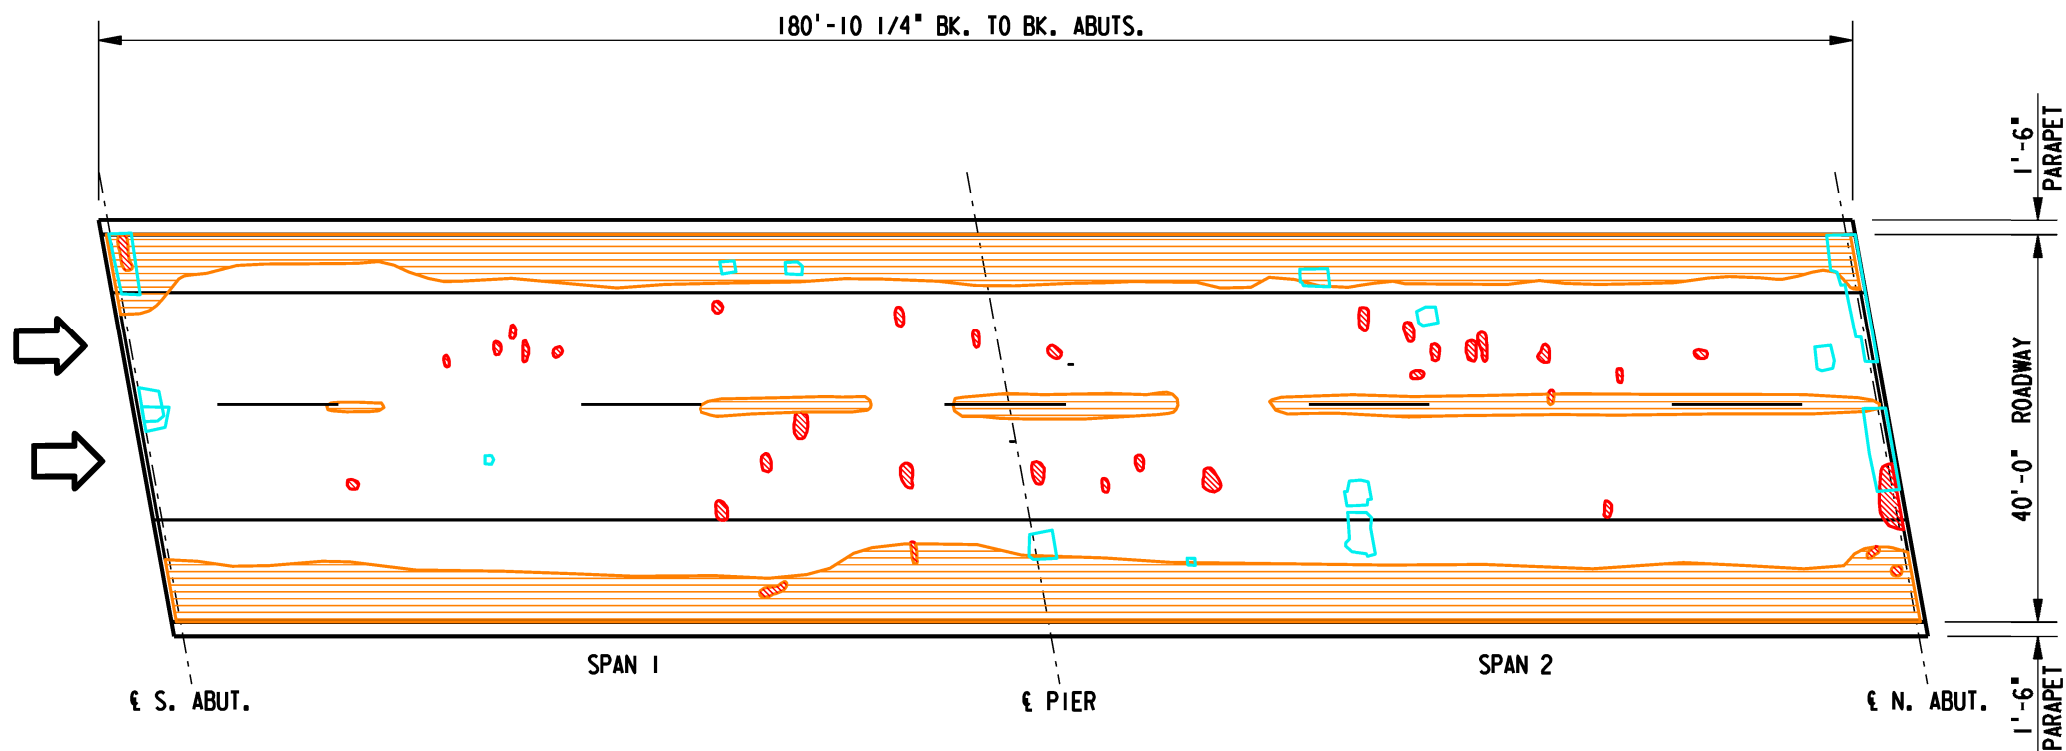
PLAN
B-5-203

DEFECT-REHAB COMPARISON		STRUCTURE NO. B-5-203	
ITEM	UNIT	QUANT.	%
TOTAL AREA	ft ²	7188	
TOTAL DEFECTS*	ft ²	61	0.8
TOTAL TYPE-1 REHAB	ft ²	113	1.6
DEFECTS/REHAB OVERLAP	ft ²	7	0.1
IR FALSE POSITIVES	ft ²	54	0.8
REHAB NOT DETECTED BY IR	ft ²	106	1.5

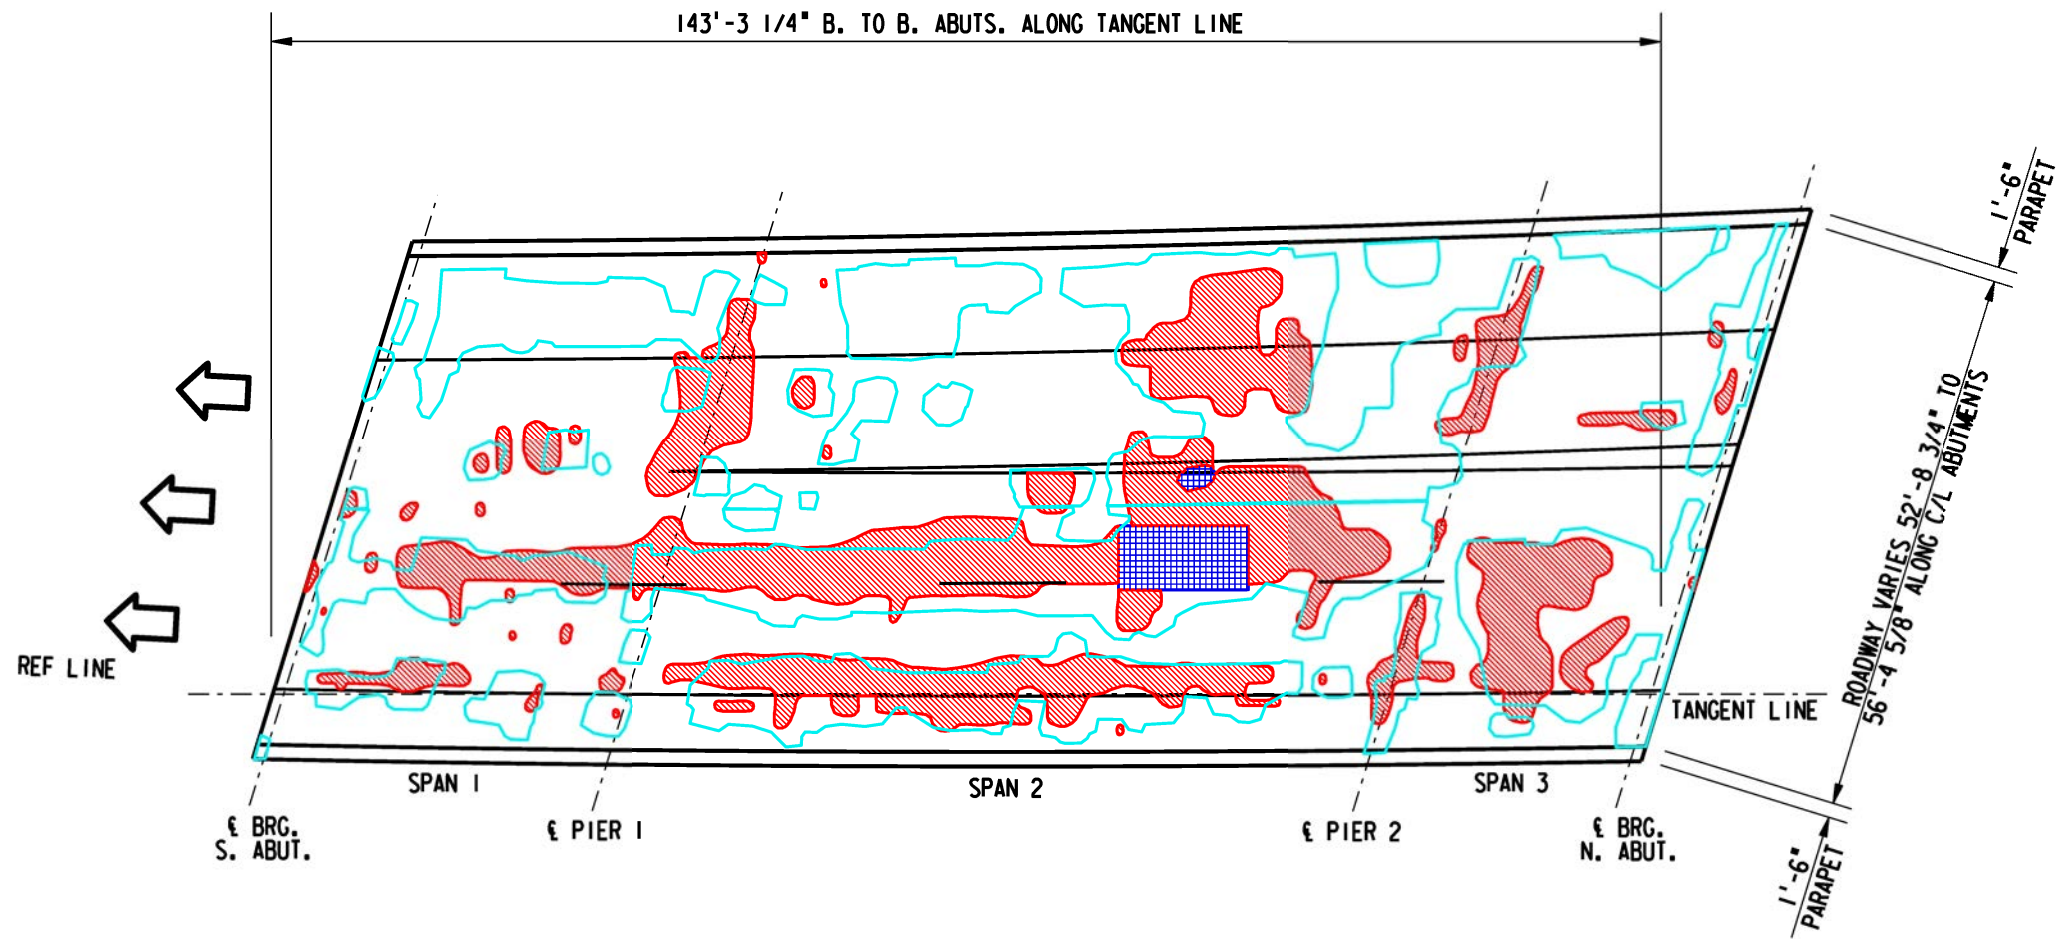
PLAN
B-5-208

DEFECT-REHAB COMPARISON		STRUCTURE NO. B-5-208	
ITEM	UNIT	QUANT.	%
TOTAL AREA	ft ²	7454	
TOTAL DEFECTS*	ft ²	1684	22.6
TOTAL TYPE-1 REHAB	ft ²	3318	44.5
DEFECTS/REHAB OVERLAP	ft ²	1377	18.5
IR FALSE POSITIVES	ft ²	307	4.1
REHAB NOT DETECTED BY IR	ft ²	1941	26.0

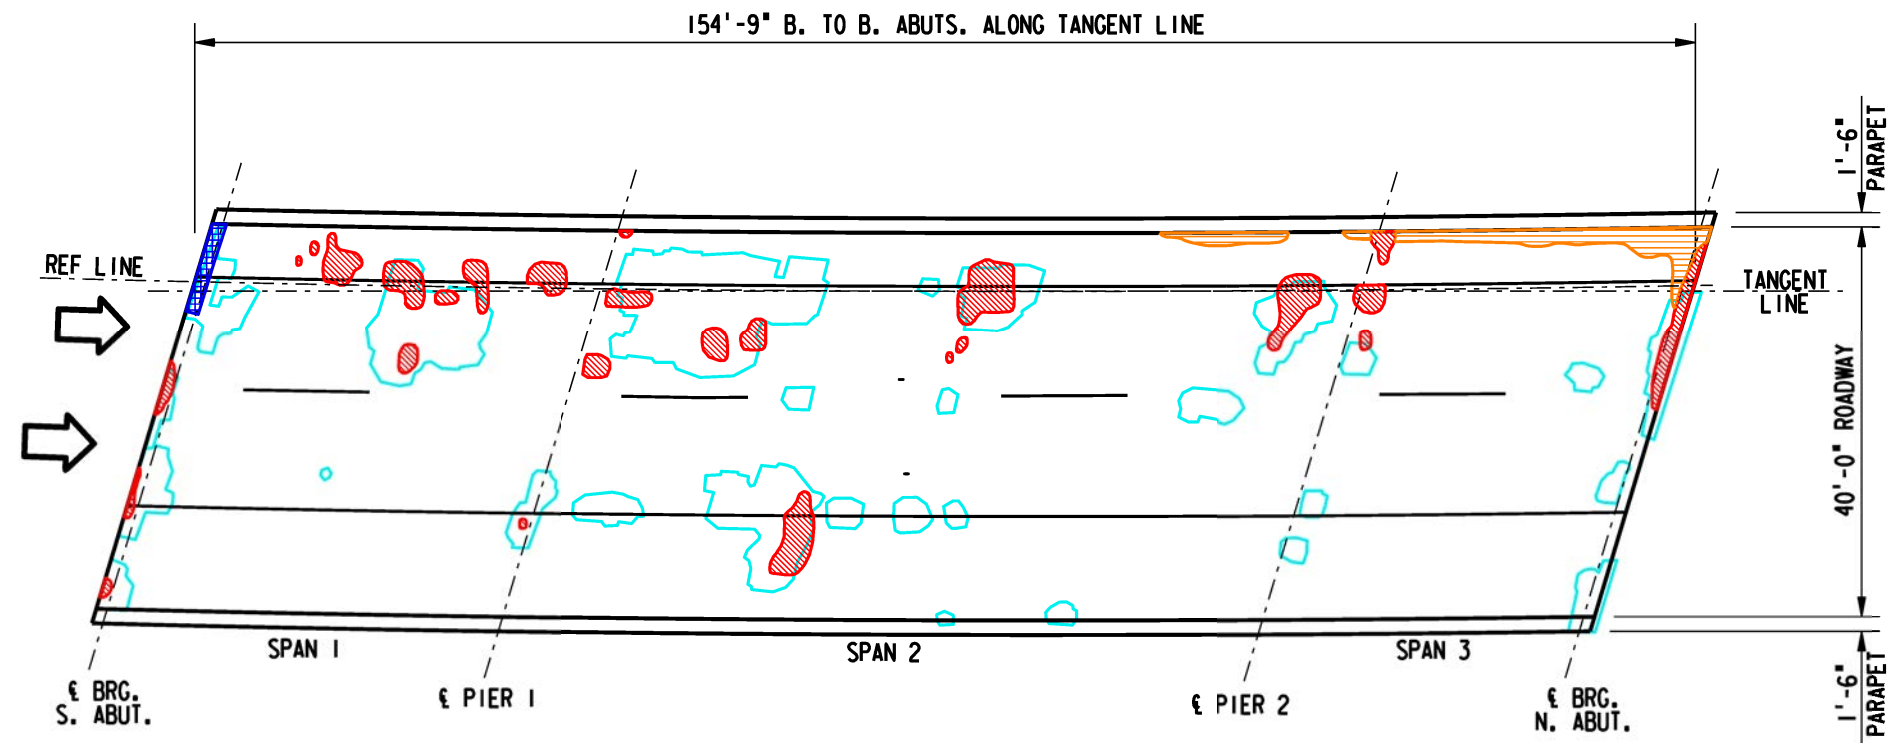
PLAN
B-5-209

DEFECT-REHAB COMPARISON		STRUCTURE NO. B-5-209	
ITEM	UNIT	QUANT.	%
TOTAL AREA	ft ²	6188	
TOTAL DEFECTS*	ft ²	214	3.5
TOTAL TYPE-1 REHAB	ft ²	800	12.9
DEFECTS/REHAB OVERLAP	ft ²	132	2.1
IR FALSE POSITIVES	ft ²	82	1.3
REHAB NOT DETECTED BY IR	ft ²	668	10.8

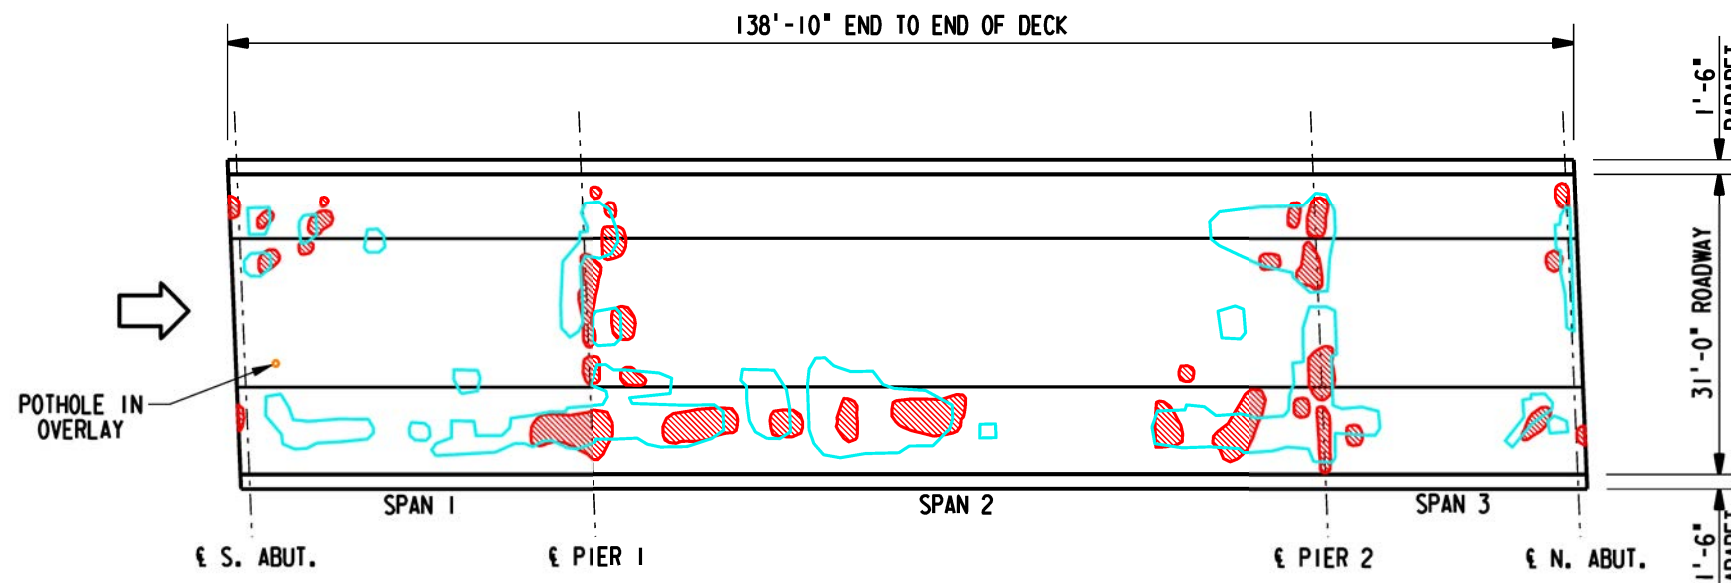
PLAN
B-5-210

DEFECT-REHAB COMPARISON		STRUCTURE NO. B-5-210	
ITEM	UNIT	QUANT.	%
TOTAL AREA	ft ²	4303	
TOTAL DEFECTS*	ft ²	236	5.5
TOTAL TYPE-1 REHAB	ft ²	598	13.9
DEFECTS/REHAB OVERLAP	ft ²	158	3.7
IR FALSE POSITIVES	ft ²	79	1.8
REHAB NOT DETECTED BY IR	ft ²	441	10.2

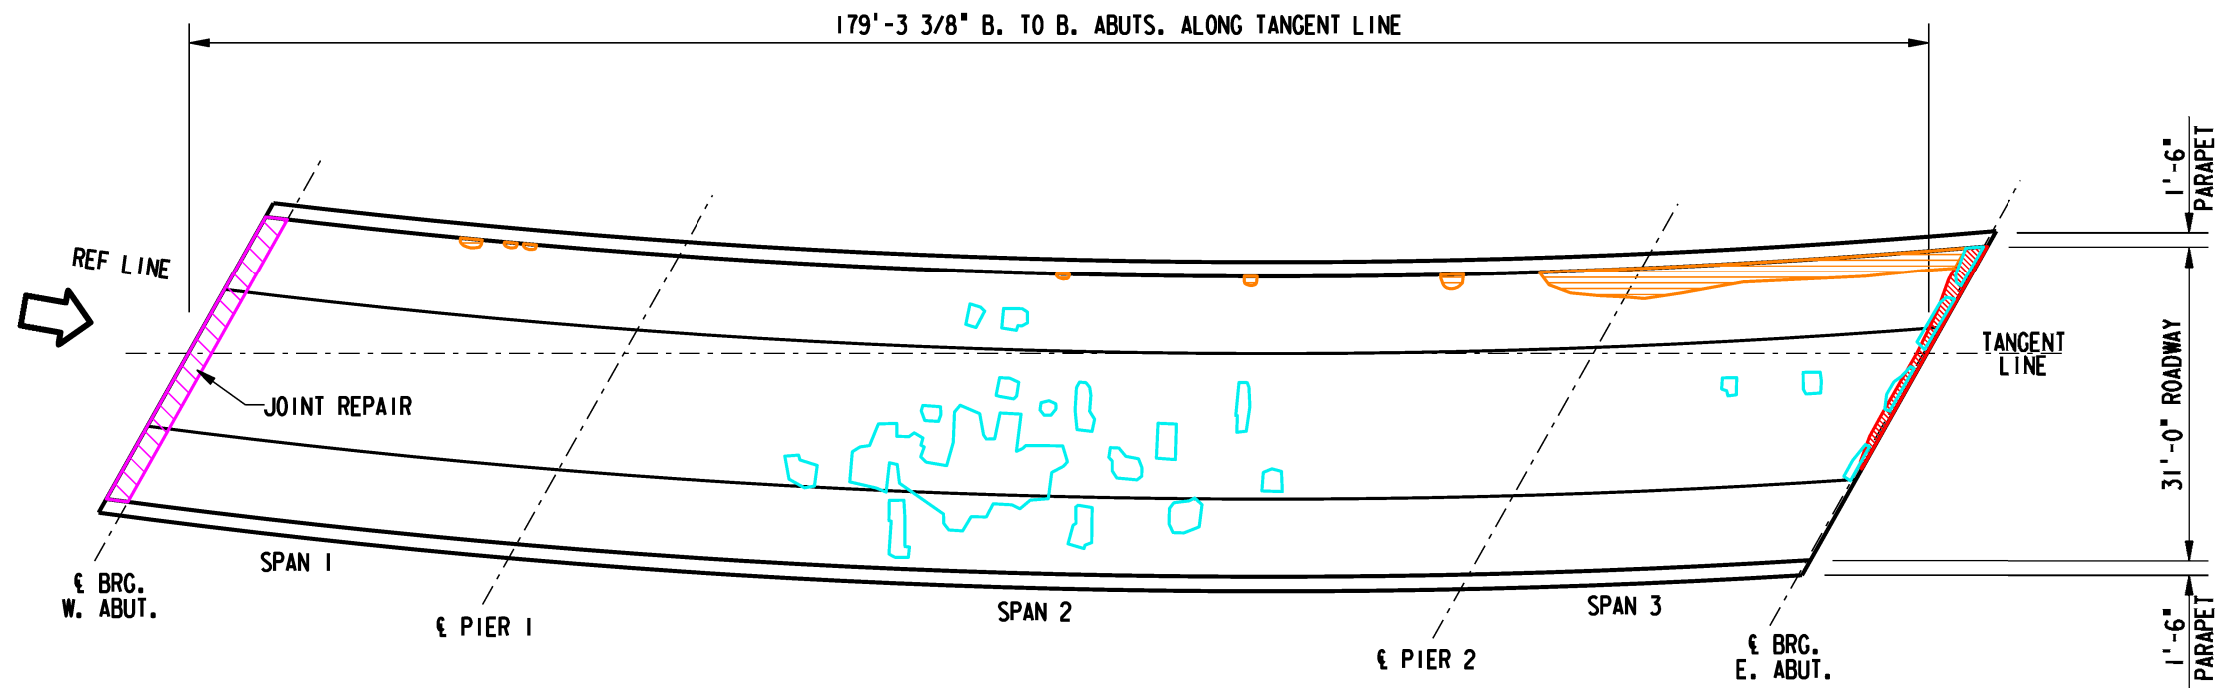
PLAN
B-5-211

DEFECT-REHAB COMPARISON		STRUCTURE NO. B-5-211	
ITEM	UNIT	QUANT.	%
TOTAL AREA	ft ²	5530	
TOTAL DEFECTS*	ft ²	30	0.5
TOTAL TYPE-1 REHAB	ft ²	252	4.5
DEFECTS/REHAB OVERLAP	ft ²	13	0.2
IR FALSE POSITIVES	ft ²	17	0.3
REHAB NOT DETECTED BY IR	ft ²	239	4.3

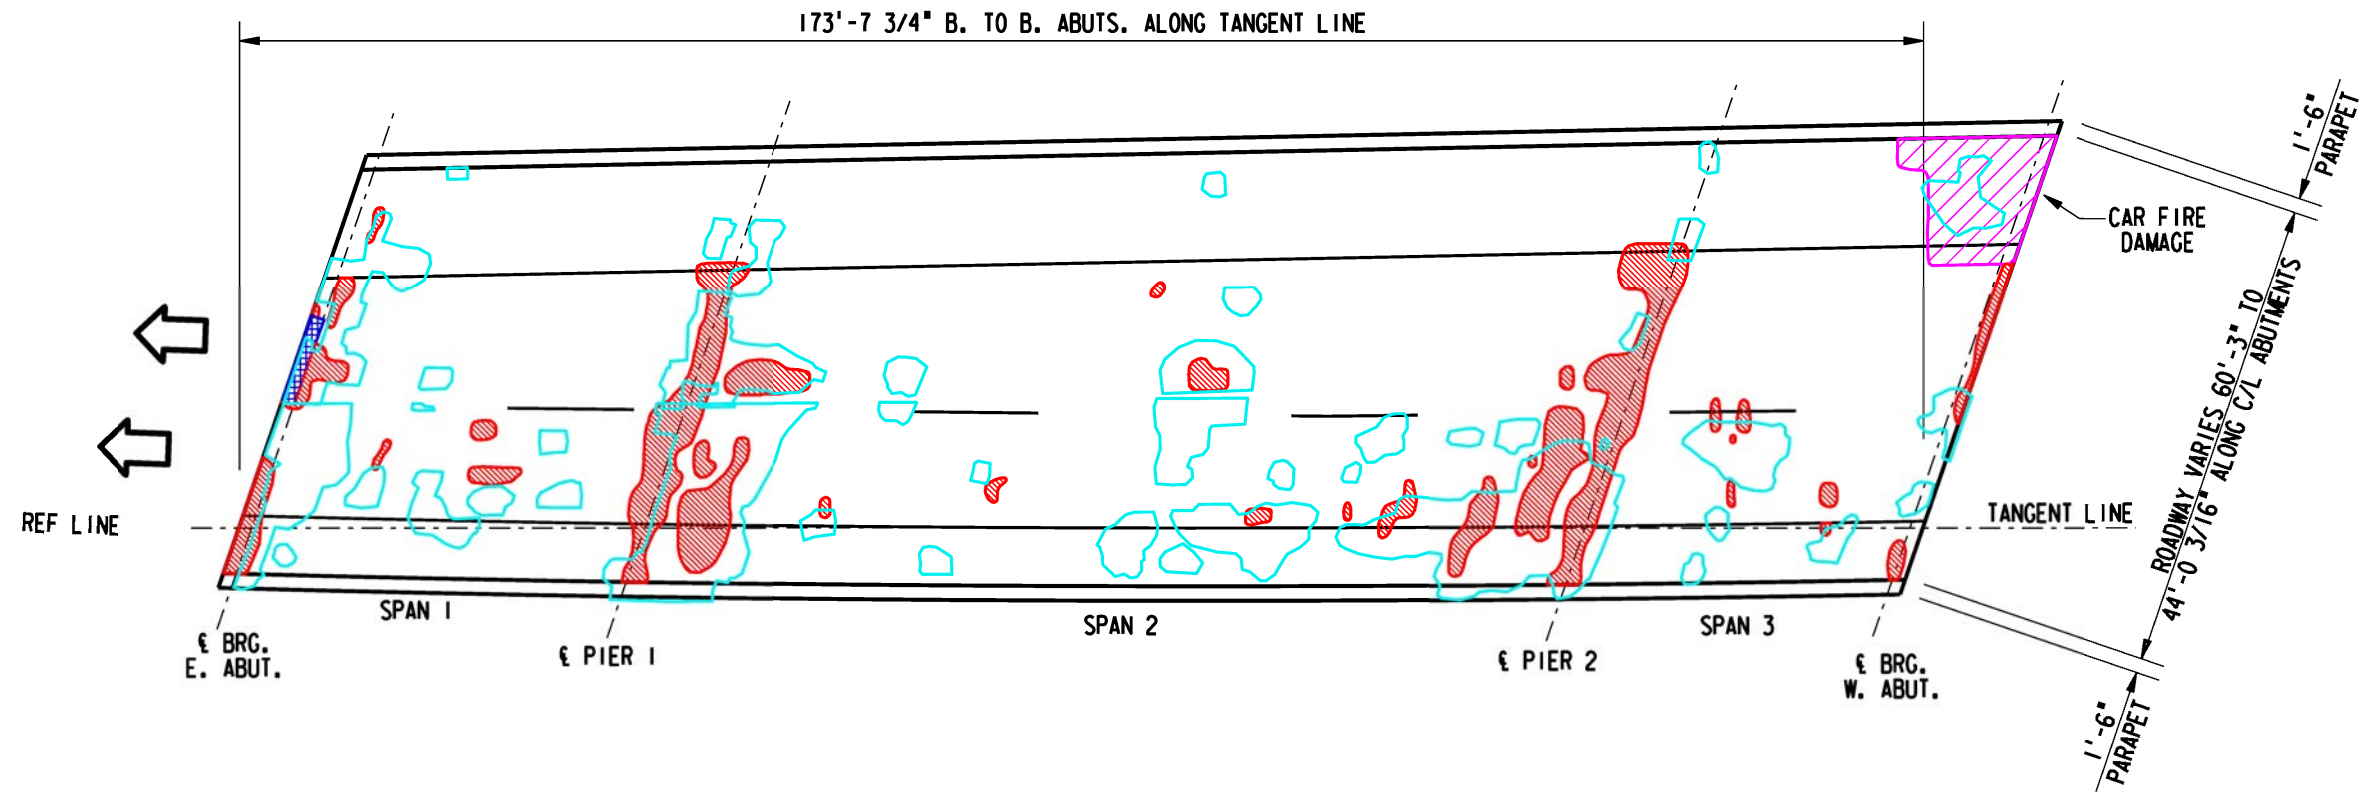
PLAN
B-5-212

DEFECT-REHAB COMPARISON		STRUCTURE NO. B-5-212	
ITEM	UNIT	QUANT.	%
TOTAL AREA	ft ²	7578	
TOTAL DEFECTS*	ft ²	531	7.0
TOTAL TYPE-1 REHAB	ft ²	1359	17.9
DEFECTS/REHAB OVERLAP	ft ²	292	3.9
IR FALSE POSITIVES	ft ²	239	3.2
REHAB NOT DETECTED BY IR	ft ²	1067	14.1

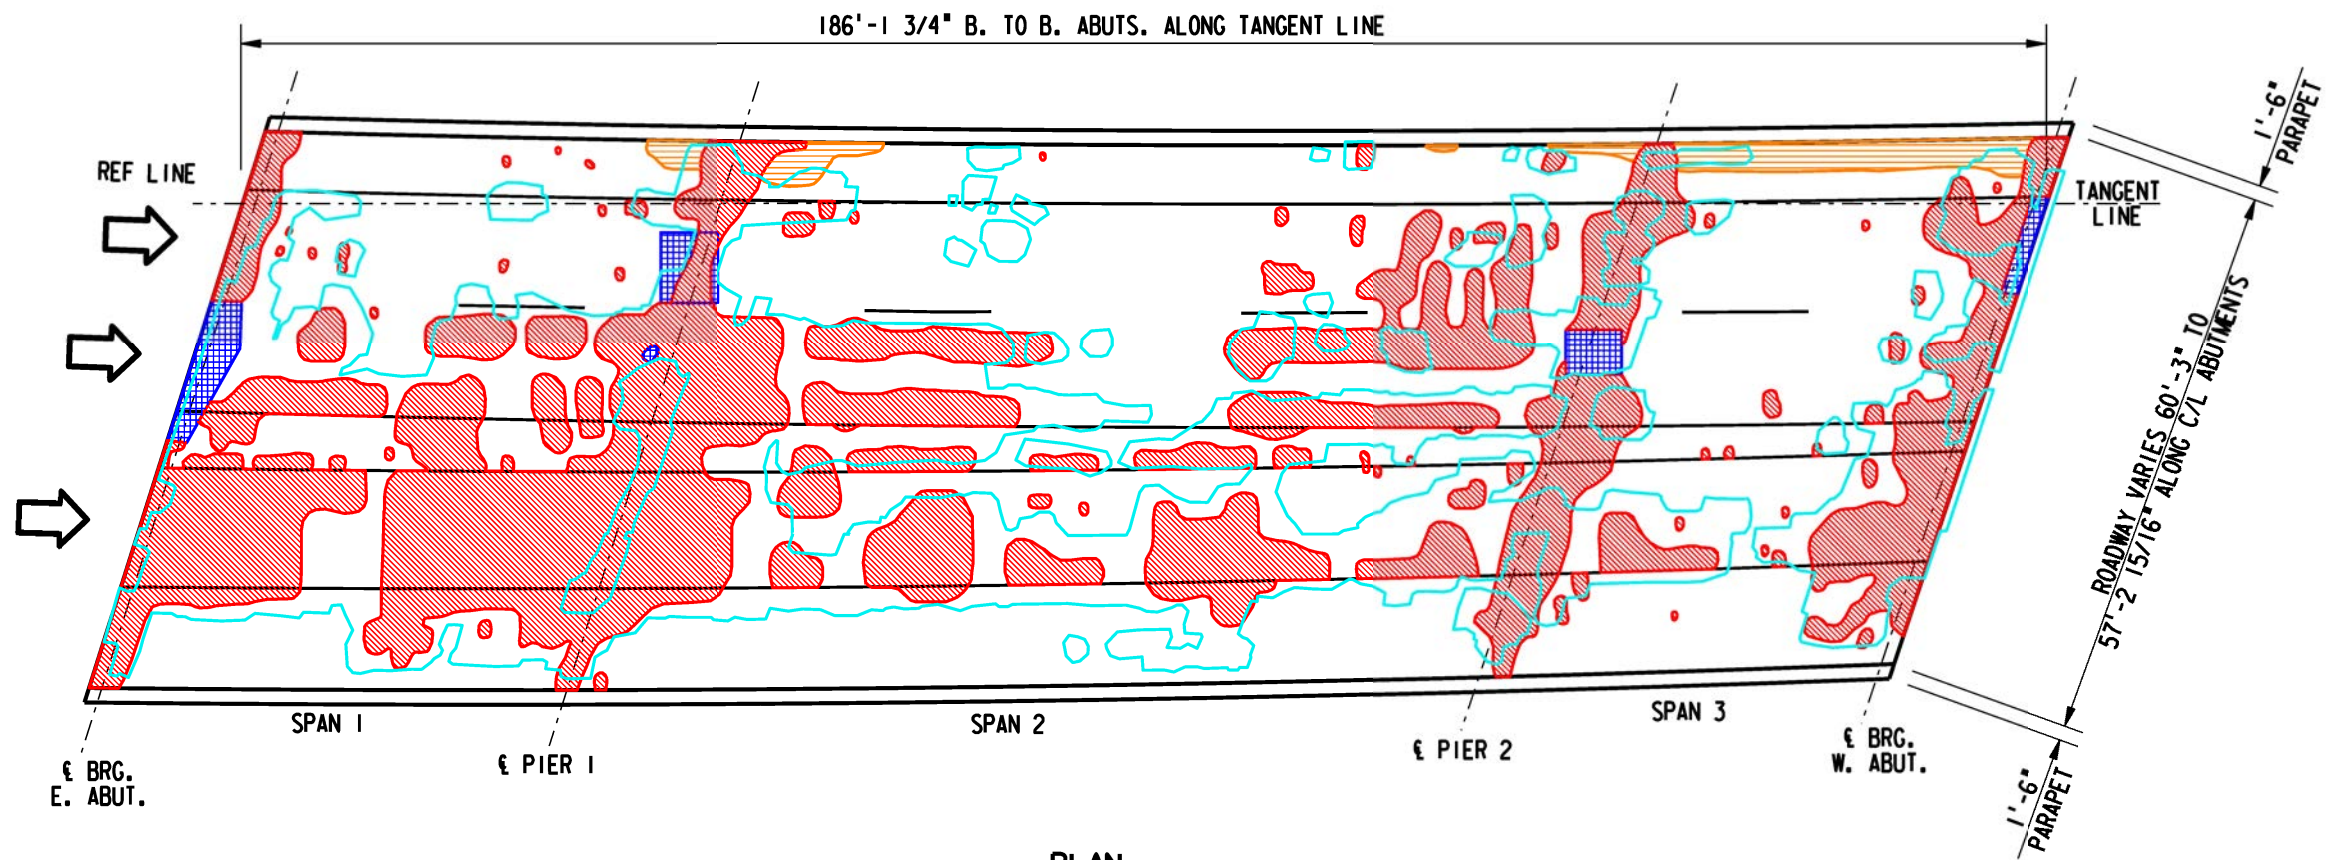
PLAN
B-5-213

DEFECT-REHAB COMPARISON		STRUCTURE NO. B-5-213	
ITEM	UNIT	QUANT.	%
TOTAL AREA	ft ²	10364	
TOTAL DEFECTS*	ft ²	3470	33.5
TOTAL TYPE-1 REHAB	ft ²	4850	46.8
DEFECTS/REHAB OVERLAP	ft ²	2732	26.4
IR FALSE POSITIVES	ft ²	738	7.1
REHAB NOT DETECTED BY IR	ft ²	2118	20.4

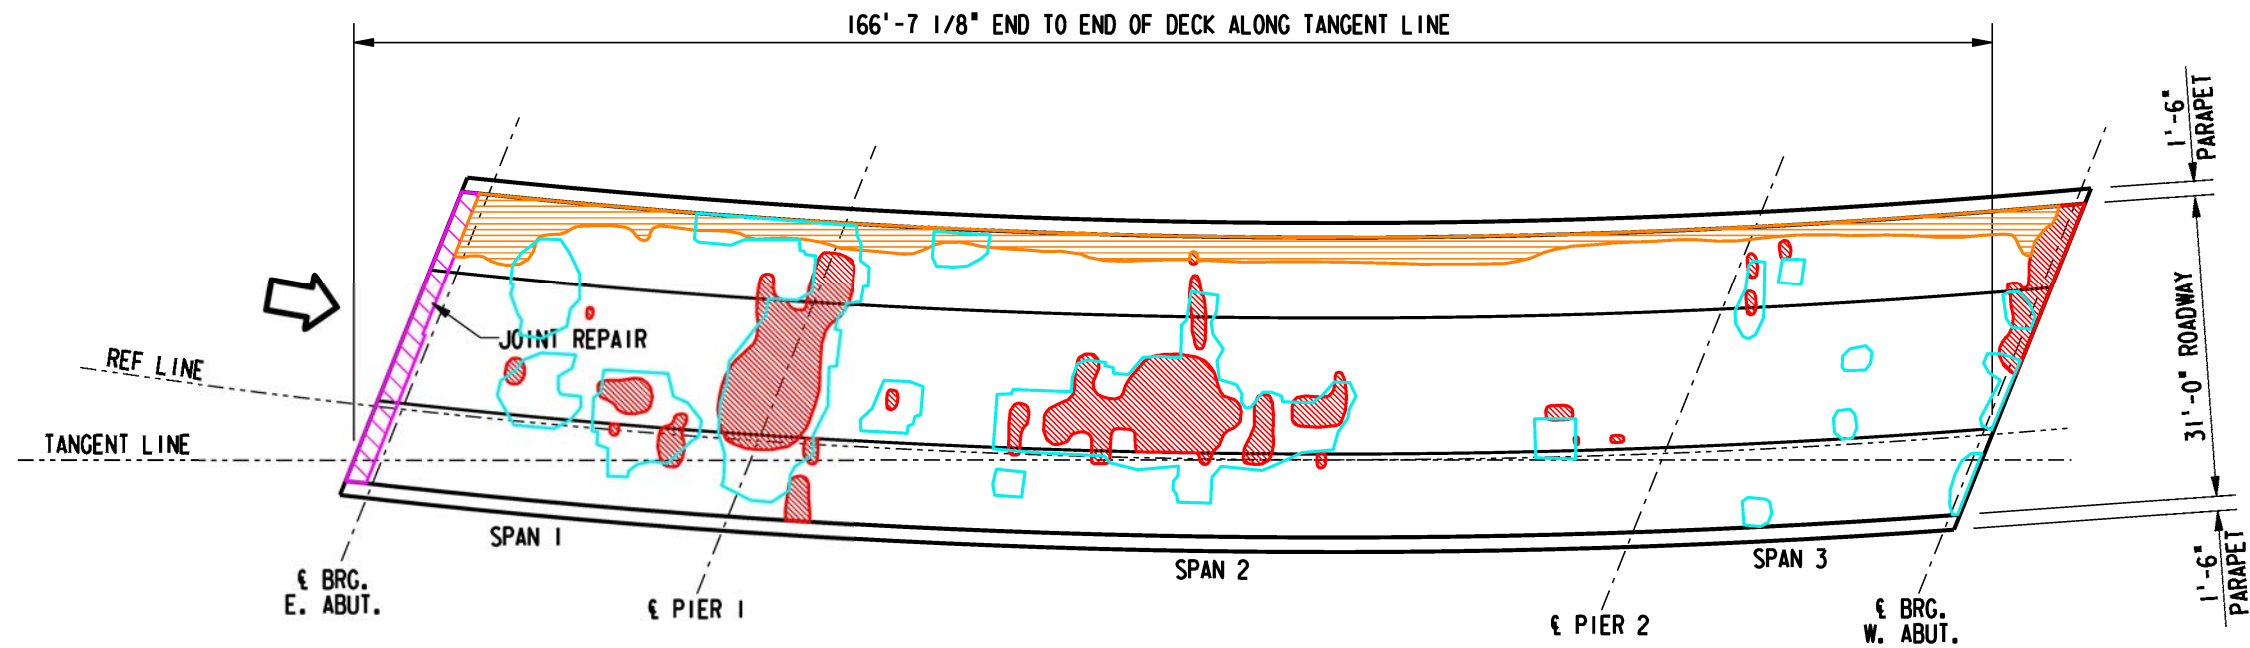
PLAN
B-5-214

DEFECT-REHAB COMPARISON		STRUCTURE NO. B-5-214	
ITEM	UNIT	QUANT.	%
TOTAL AREA	ft ²	5137	
TOTAL DEFECTS*	ft ²	459	8.9
TOTAL TYPE-1 REHAB	ft ²	929	18.1
DEFECTS/REHAB OVERLAP	ft ²	378	7.4
IR FALSE POSITIVES	ft ²	82	1.6
REHAB NOT DETECTED BY IR	ft ²	552	10.7

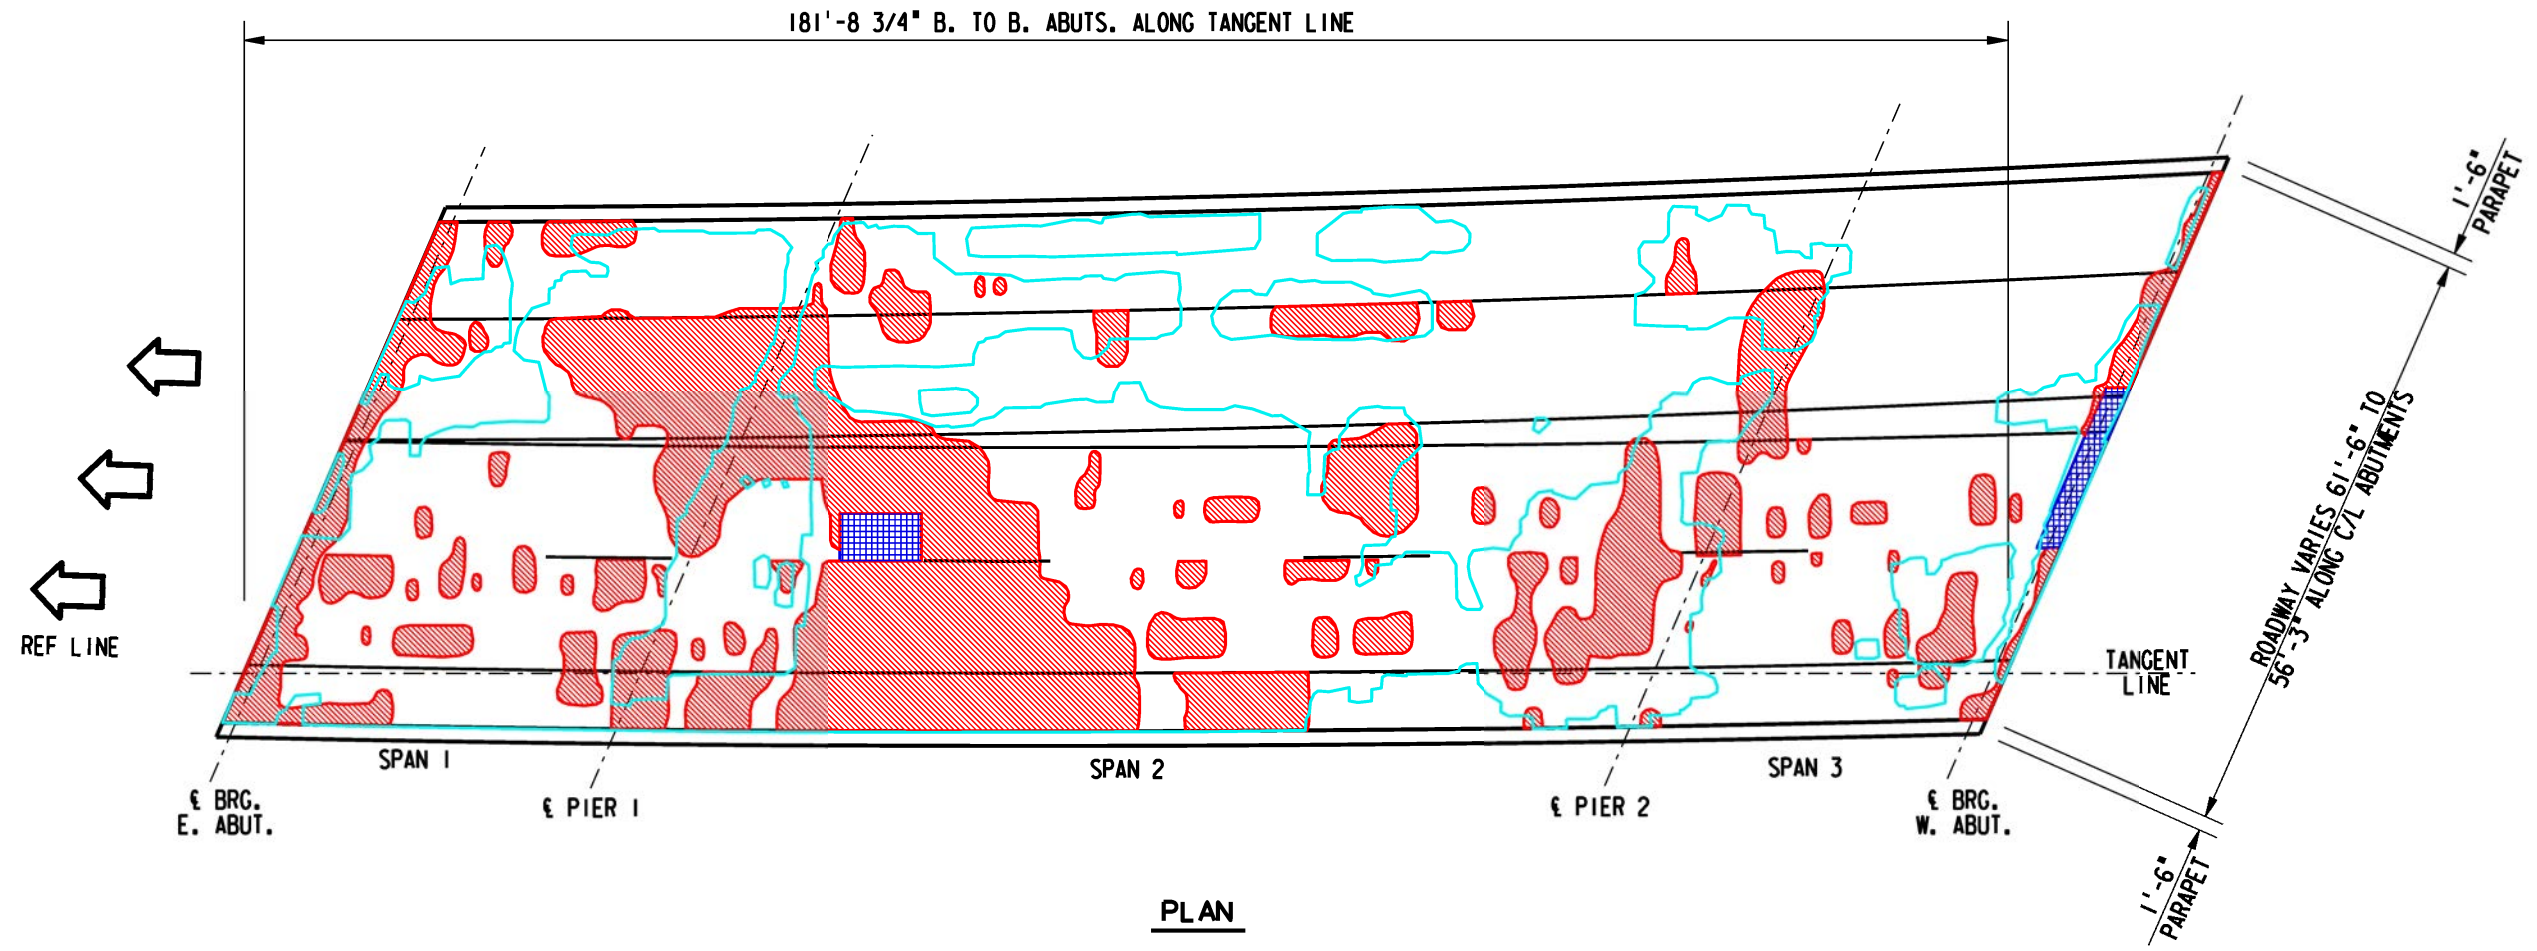
PLAN
B-5-215

DEFECT-REHAB COMPARISON		STRUCTURE NO. B-5-215	
ITEM	UNIT	QUANT.	%
TOTAL AREA	ft ²	9826	
TOTAL DEFECTS*	ft ²	2783	28.3
TOTAL TYPE-1 REHAB	ft ²	5688	57.9
DEFECTS/REHAB OVERLAP	ft ²	2271	23.1
IR FALSE POSITIVES	ft ²	512	5.2
REHAB NOT DETECTED BY IR	ft ²	3417	34.8

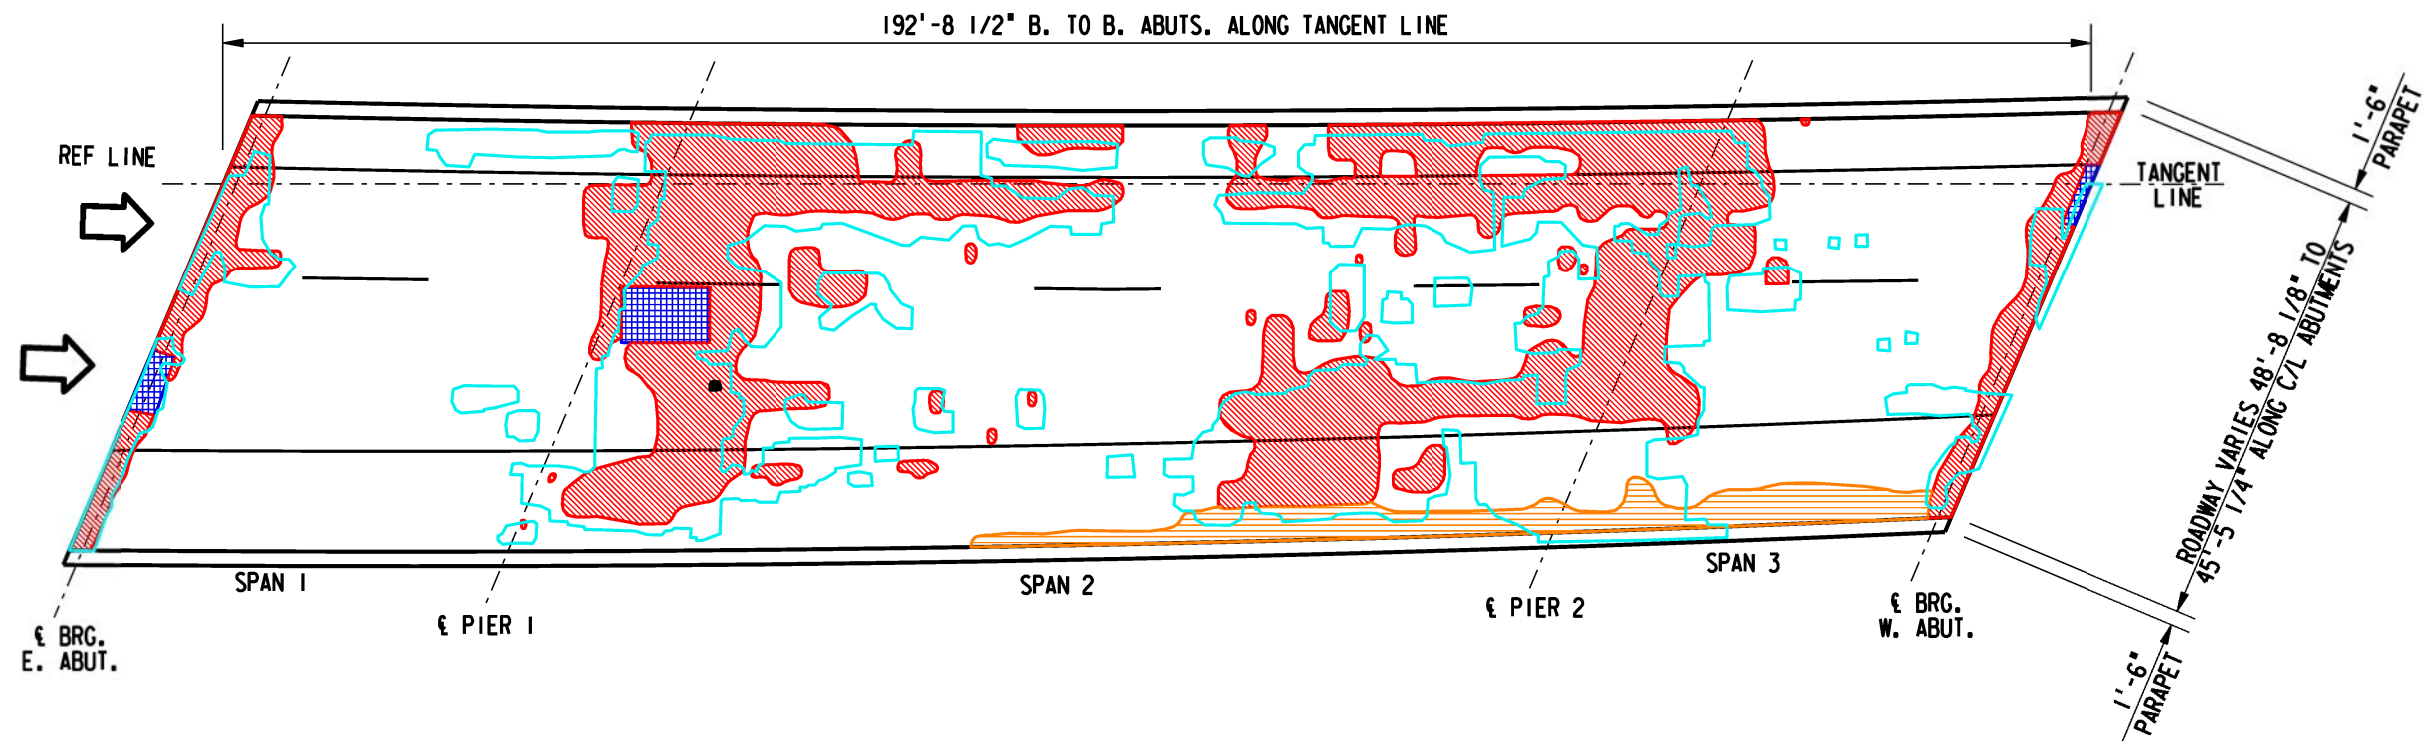
PLAN
B-5-216

DEFECT-REHAB COMPARISON		STRUCTURE NO. B-5-216	
ITEM	UNIT	QUANT.	%
TOTAL AREA	ft ²	8445	
TOTAL DEFECTS*	ft ²	2208	26.2
TOTAL TYPE-1 REHAB	ft ²	2846	33.7
DEFECTS/REHAB OVERLAP	ft ²	1608	19.0
IR FALSE POSITIVES	ft ²	601	7.1
REHAB NOT DETECTED BY IR	ft ²	1238	14.7
