Bridge Deck Thermography Verification and Policy

WisDOT ID no. 0092-23-04

September 2024

TECHNICAL REPORT DOCUMENTATION PAGE

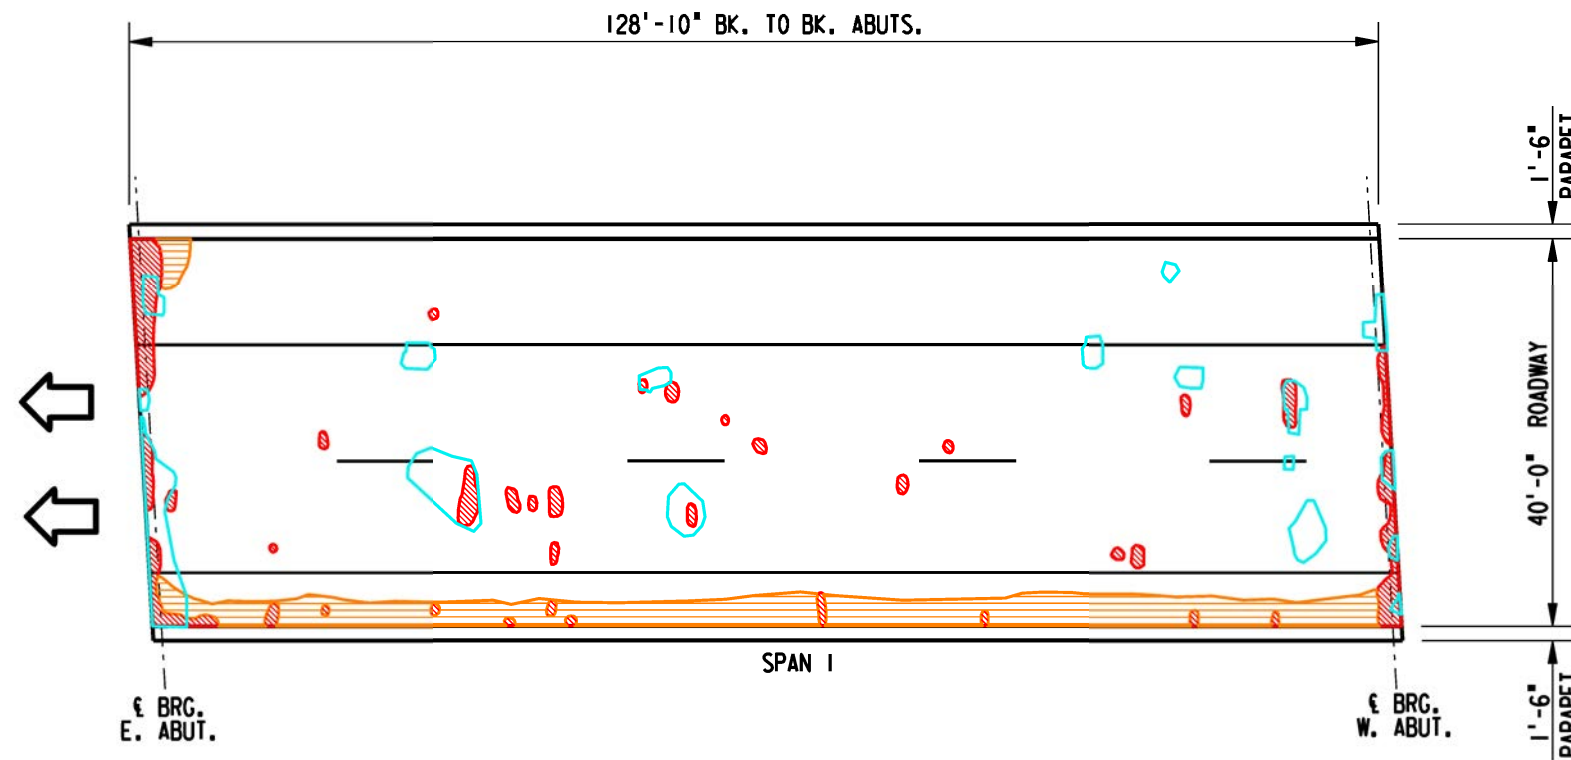
PLAN
B-5-219

DEFECT-REHAB COMPARISON		STRUCTURE NO. B-5-219	
ITEM	UNIT	QUANT.	%
TOTAL AREA	ft ²	5152	
TOTAL DEFECTS*	ft ²	144	2.8
TOTAL TYPE-1 REHAB	ft ²	185	3.6
DEFECTS/REHAB OVERLAP	ft ²	47	0.9
IR FALSE POSITIVES	ft ²	98	1.9
REHAB NOT DETECTED BY IR	ft ²	138	2.7

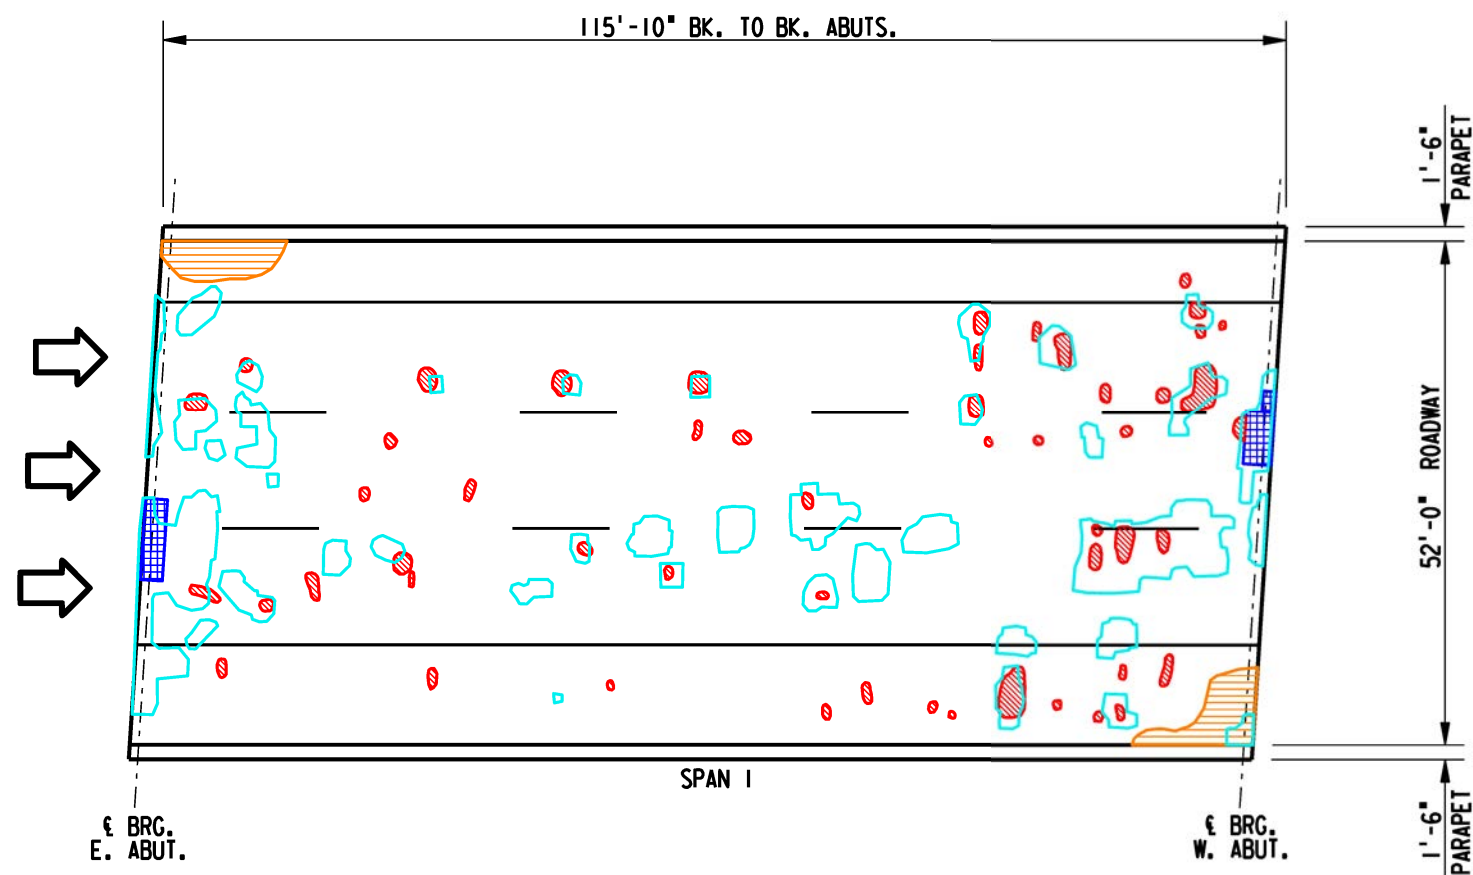
PLAN
B-5-220

DEFECT-REHAB COMPARISON		STRUCTURE NO. B-5-220	
ITEM	UNIT	QUANT.	%
TOTAL AREA	ft ²	6022	
TOTAL DEFECTS*	ft ²	149	2.5
TOTAL TYPE-1 REHAB	ft ²	617	10.2
DEFECTS/REHAB OVERLAP	ft ²	95	1.6
IR FALSE POSITIVES	ft ²	54	0.9
REHAB NOT DETECTED BY IR	ft ²	522	8.7

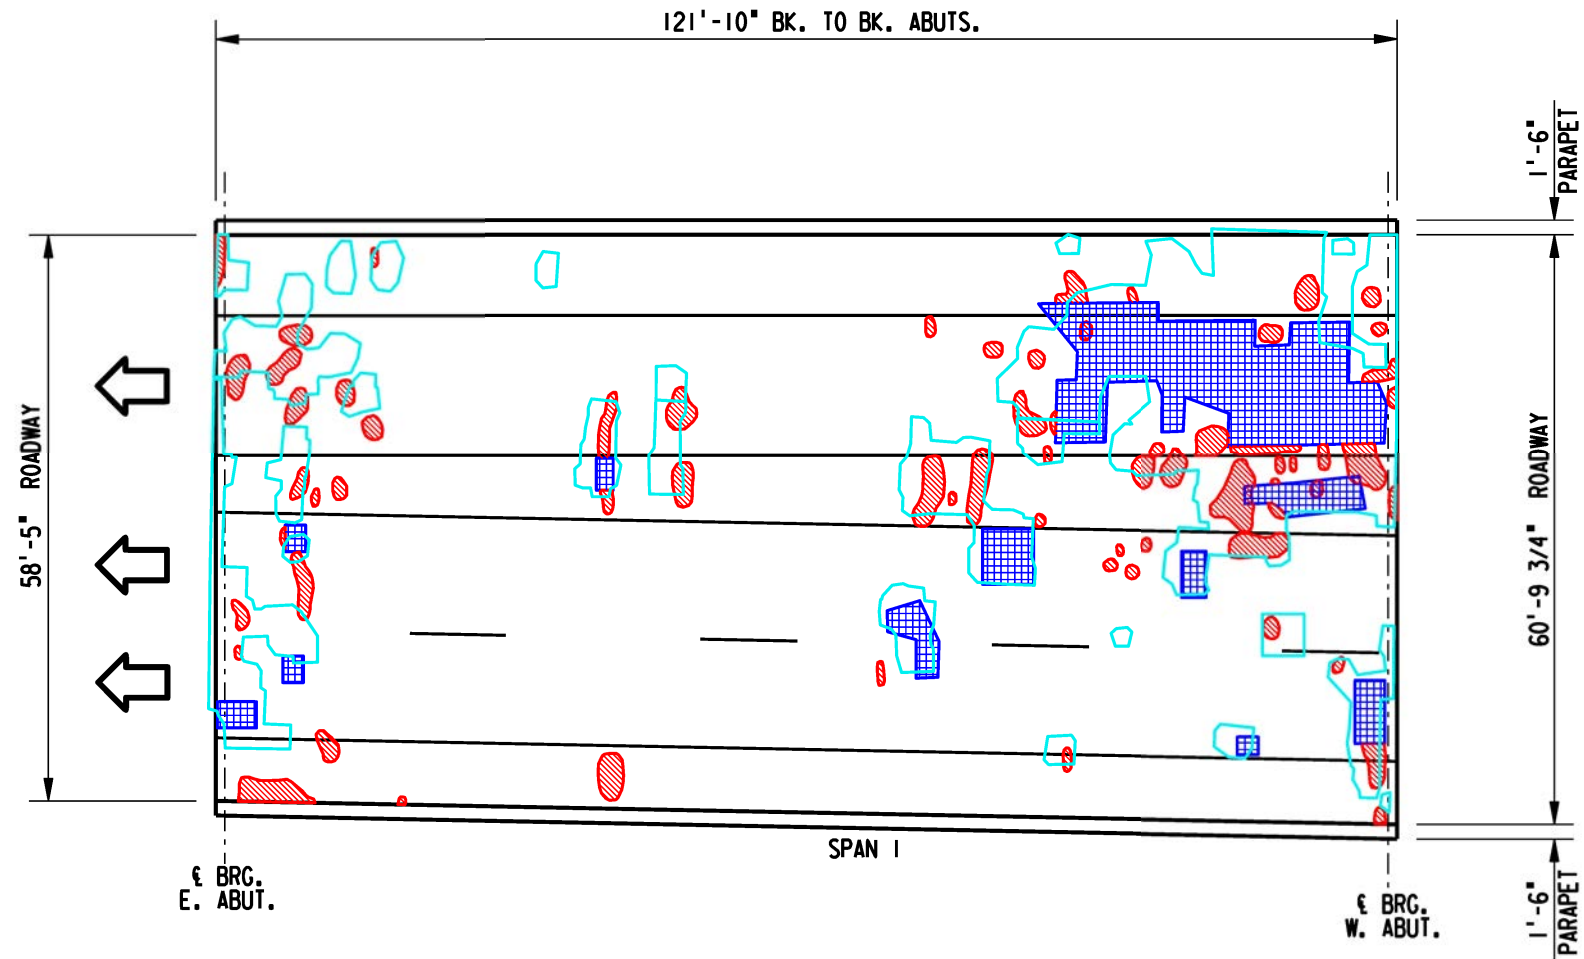
PLAN
B-5-221

DEFECT-REHAB COMPARISON		STRUCTURE NO. B-5-221	
ITEM	UNIT	QUANT.	%
TOTAL AREA	ft ²	7259	
TOTAL DEFECTS*	ft ²	805	11.1
TOTAL TYPE-1 REHAB	ft ²	1586	21.8
DEFECTS/REHAB OVERLAP	ft ²	661	9.1
IR FALSE POSITIVES	ft ²	144	2.0
REHAB NOT DETECTED BY IR	ft ²	925	12.7

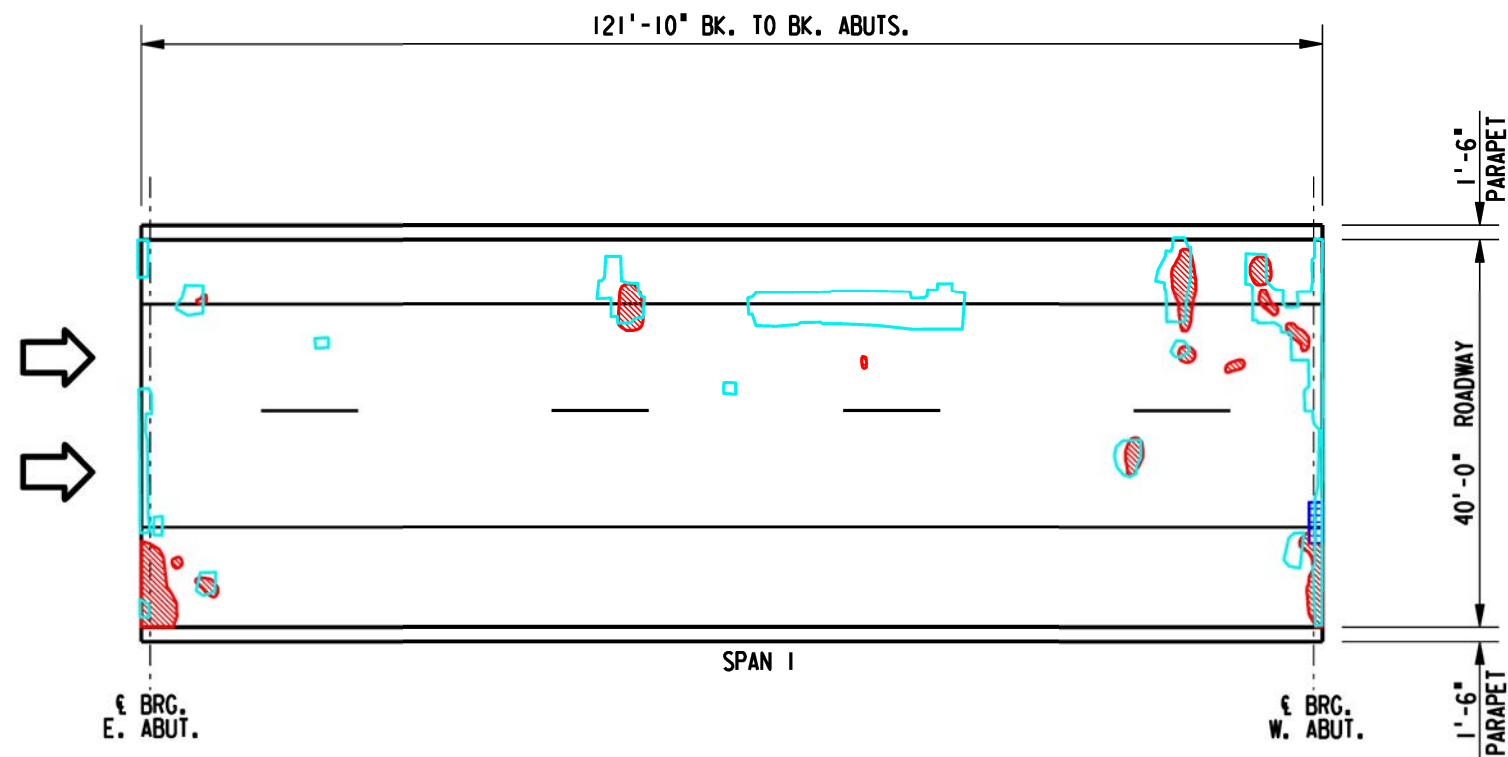
PLAN
B-5-222

DEFECT-REHAB COMPARISON		STRUCTURE NO. B-5-222	
ITEM	UNIT	QUANT.	%
TOTAL AREA	ft ²	4872	
TOTAL DEFECTS*	ft ²	92	1.9
TOTAL TYPE-1 REHAB	ft ²	239	4.9
DEFECTS/REHAB OVERLAP	ft ²	47	1.0
IR FALSE POSITIVES	ft ²	45	0.9
REHAB NOT DETECTED BY IR	ft ²	192	3.9

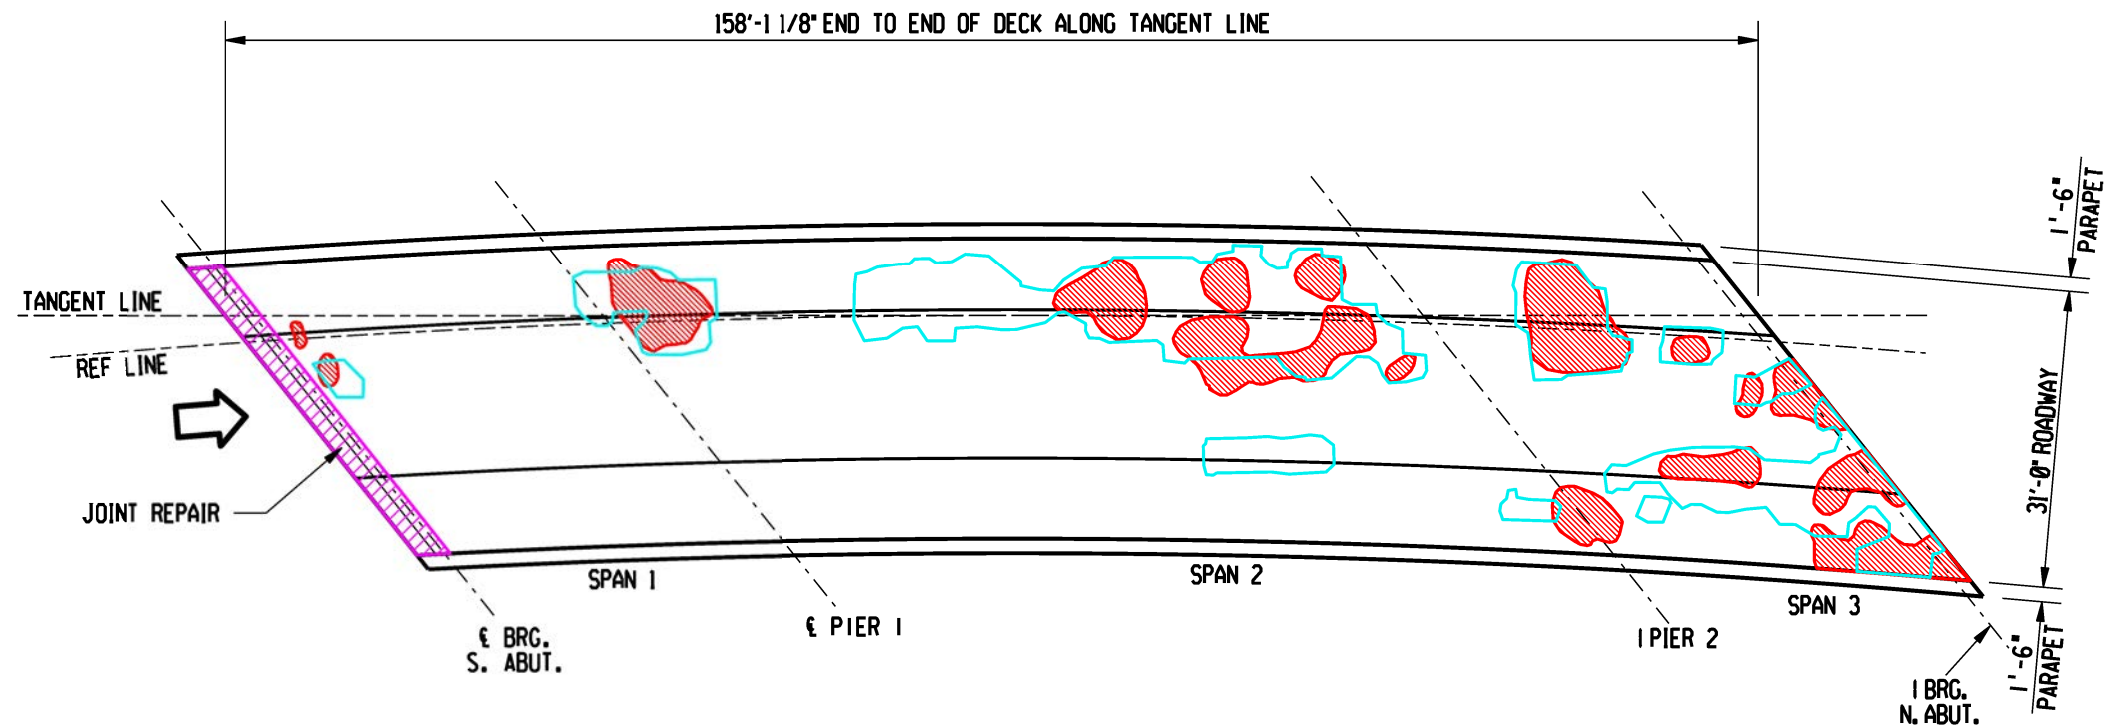
PLAN
B-5-223

DEFECT-REHAB COMPARISON		STRUCTURE NO. B-5-223	
ITEM	UNIT	QUANT.	%
TOTAL AREA	ft ²	4904	
TOTAL DEFECTS*	ft ²	541	11.0
TOTAL TYPE-1 REHAB	ft ²	1005	20.5
DEFECTS/REHAB OVERLAP	ft ²	423	8.6
IR FALSE POSITIVES	ft ²	118	2.4
REHAB NOT DETECTED BY IR	ft ²	582	11.9
