**SCHOOL OF  
CIVIL ENGINEERING  
OKLAHOMA STATE UNIVERSITY**

FATIGUE DAMAGE TO STEEL  
BRIDGE DIAPHRAGMS,

Report No. FHWA/OK 89(10)

December, 1989

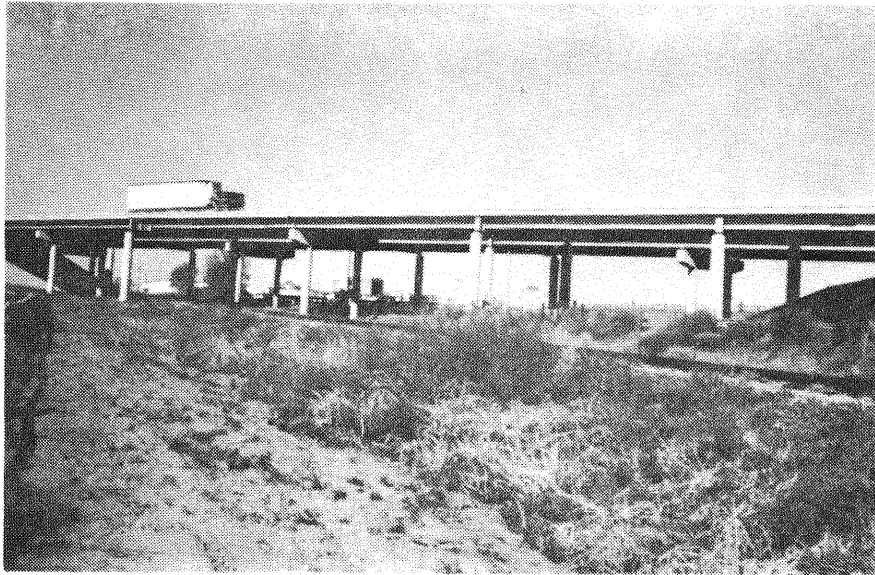
This research was conducted to identify the cause of diaphragm cracking in a steel girder highway bridge. The bridge, located on I-40 near Weatherford, Oklahoma, is shown in Figure 1. The bridge is about 20 years old and 60 of the 184 diaphragms in both the east and westbound spans are cracked, 5 of which have experienced a total section loss. A picture showing the position of several diaphragms on the bridge is presented in Figure 2, and two examples of fatigue damage are shown in Figure 3. In all but one case, cracks initiate at the lower flange and propagate up through the member. The one case where cracks were found in the upper cope is also the one case where cracks were found in diaphragms above pier caps. Locations of cracked diaphragms are indicated in Figure 4.

Figure 1. Bridge With Damaged Diaphragms,  
Structure No. 2004-1302SX

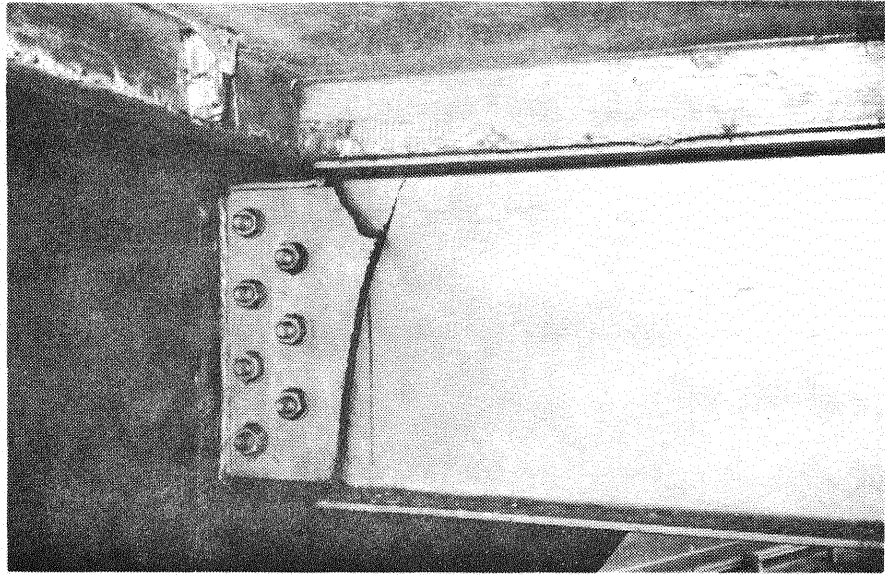
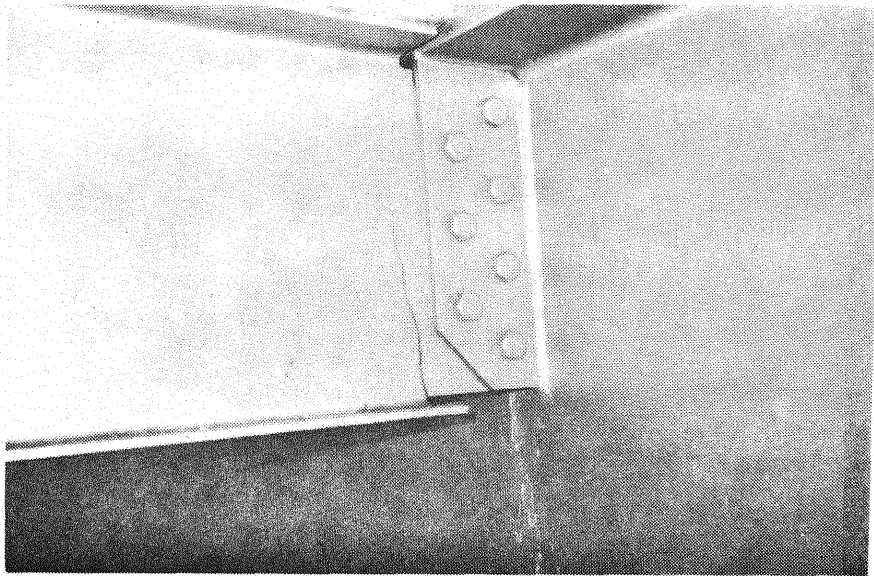
Figure 3. Examples of Cracked Diaphragms

The pattern of cracked diaphragms and the location of cracks in the diaphragms indicate that diaphragms at each transverse location between the piers are acting as continuous beams. In all but one case, the cracks originate in the bottom flange cope and grow up through the web. No cracks were found at connections to exterior girders. Taken as a whole, these observations indicate that the "continuous" diaphragms are being loaded by the differential deflections of the longitudinal girders.

It is recommended that for uncracked diaphragms and for diaphragms with cracks shorter than one inch, the bottom two bolts in the diaphragm-to-girder connection be removed. This recommendation is based on the effectiveness of this modification to increase fatigue life--even for diaphragms containing small cracks--and the relative ease with which this modification can be accomplished. Diaphragms containing cracks longer than one inch should be removed and replaced with diaphragms not coped at the bottom

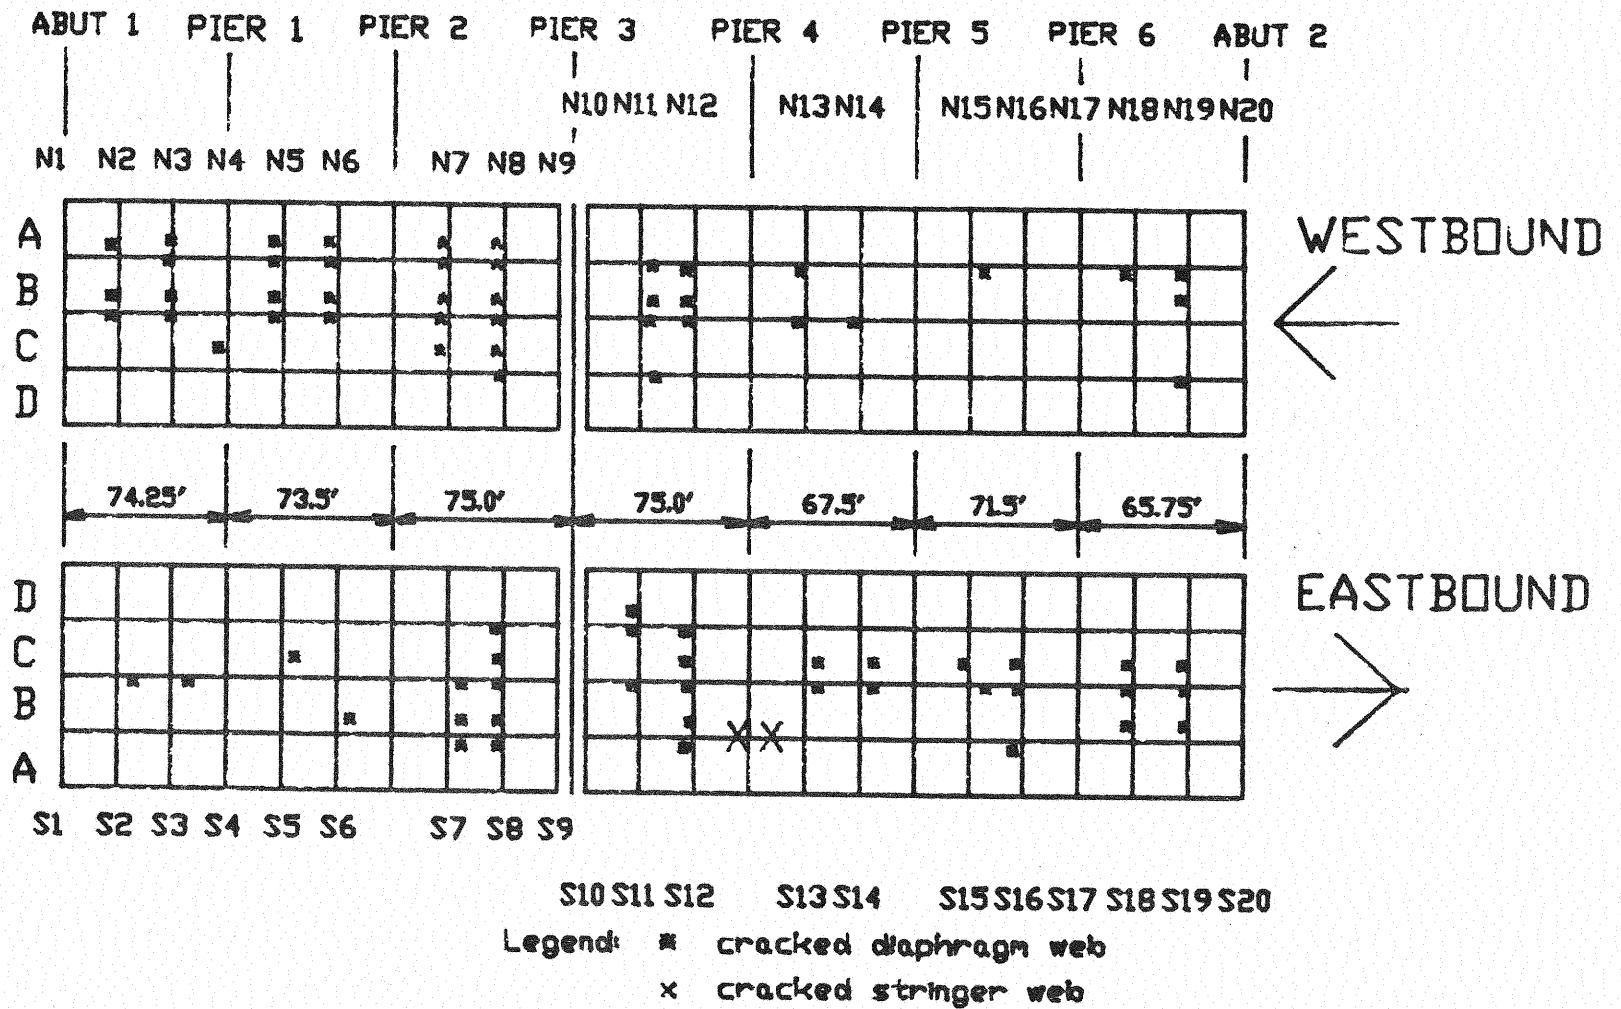
Figure 4. Plan View of Diaphragms and Stringers

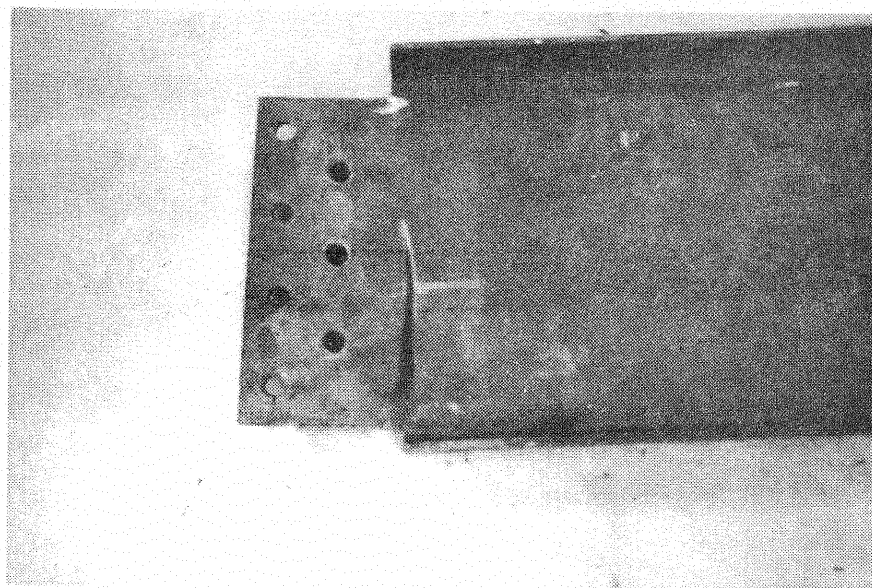
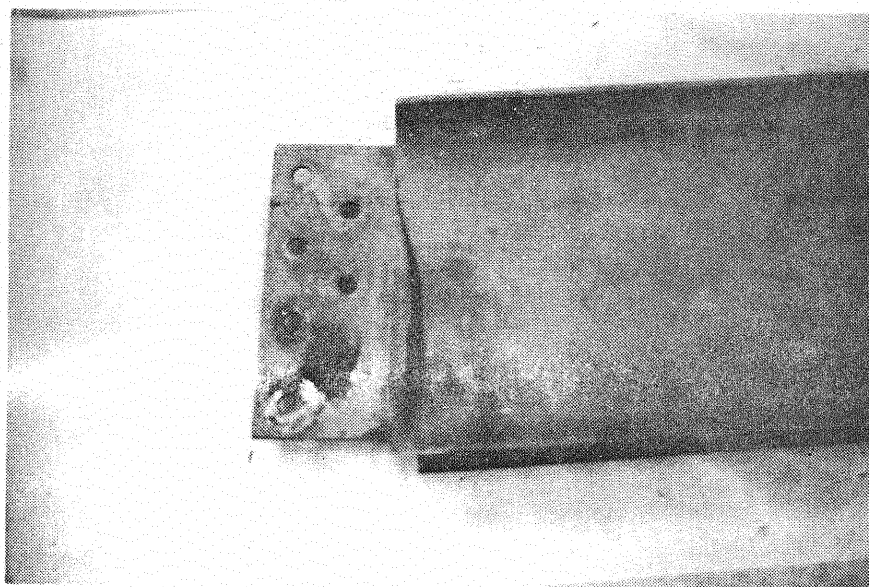
Failed specimens are shown in Figure 34. Specimens were considered to have failed when the crack had grown through half the web. It was found that very few cycles relative to the total number of cycles applied were necessary to propagate the crack from the web centerline through the upper half of the web. Stopping the tests when the cracks reached the web centerline was necessary to prevent the specimens from becoming so flexible that they would impact on the load frame during cycling. An important observation to be made from Figure 34 is that the crack shape is very similar to shapes observed on the bridge and that the crack plane is approximately perpendicular to the direction of the maximum principal tensile stress shown in Figure 31.

Figure 34. Typical Cracking Pattern in Laboratory Specimens

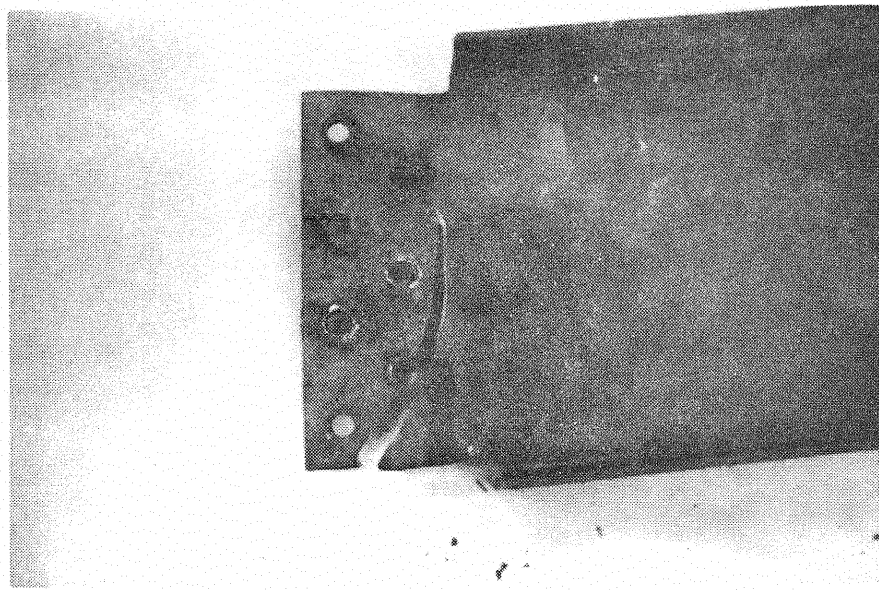
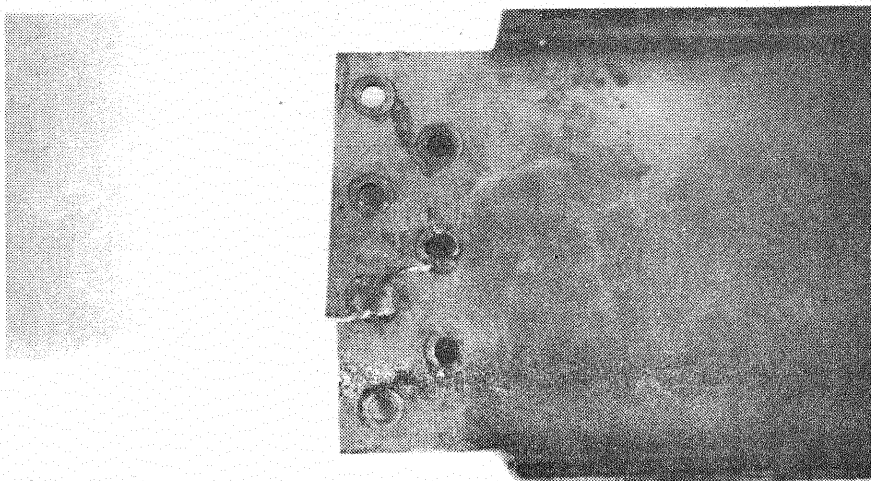
Failure in these specimens resulted from a crack originating in one of the lower bolt holes and growing out to the side or bottom of the diaphragm. Photographs of failed specimens are shown in Figure 38. The observed mode of failure may be partially the result of the loading system used in all the tests. Since the eccentricity at the diaphragm-to-column and diaphragm-to-actuator connections was fixed in the tests, removal of the bottom two bolts increased the eccentricity and therefore the moment on the connection. In the bridge, the moment is caused by differential deflections of the longitudinal girders, not by an eccentrically applied load. Removal of the lowest two bolts in the connections on the bridge may actually reduce the moment in the diaphragms by making them more flexible. The five remaining bolts will

Figure 38. Failure of Detail With Bolts Removed

Test results indicate that removing the bottom two bolts from the diaphragm-to-girder connection is an effective and reliable way of increasing diaphragm fatigue life. The method is effective even when small cracks are present in the diaphragm at the cope. Laboratory tests on this modification may be more severe than the detail would experience in actual service.

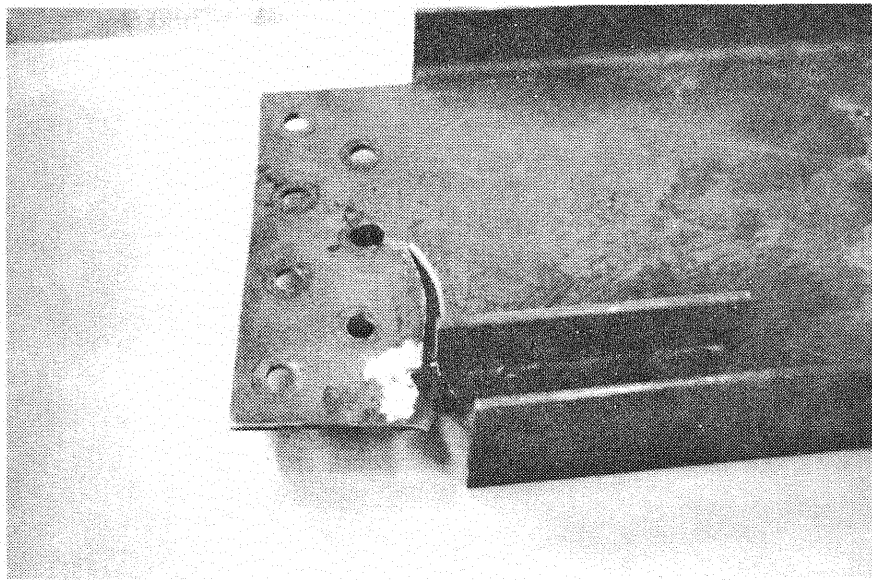
As can be seen in Table 3 and Figure 35, the modification did increase average specimen fatigue life, but there is a great deal of scatter in the data. In both tests, a short period of no growth after the modification was followed by propagation around the end of the auxiliary flange. A failed specimen is shown in Figure 39. The fact that the crack easily propagated around the auxiliary flange is an indication that the flange does not extend far enough ahead of the cope to be effective.

Figure 39. Failure of the Auxiliary Flange Detail
