Repair of Bridge Deck Fascias
OR22-002

Final Report

Michigan Department of Transportation

1. Report No. SPR-1730	2. Government Accession No. N/A	3. Recipient's Catalog No.	
4. Title and Subtitle Repair of Bridge Deck Fascias	5. Report Date 09/30/2023

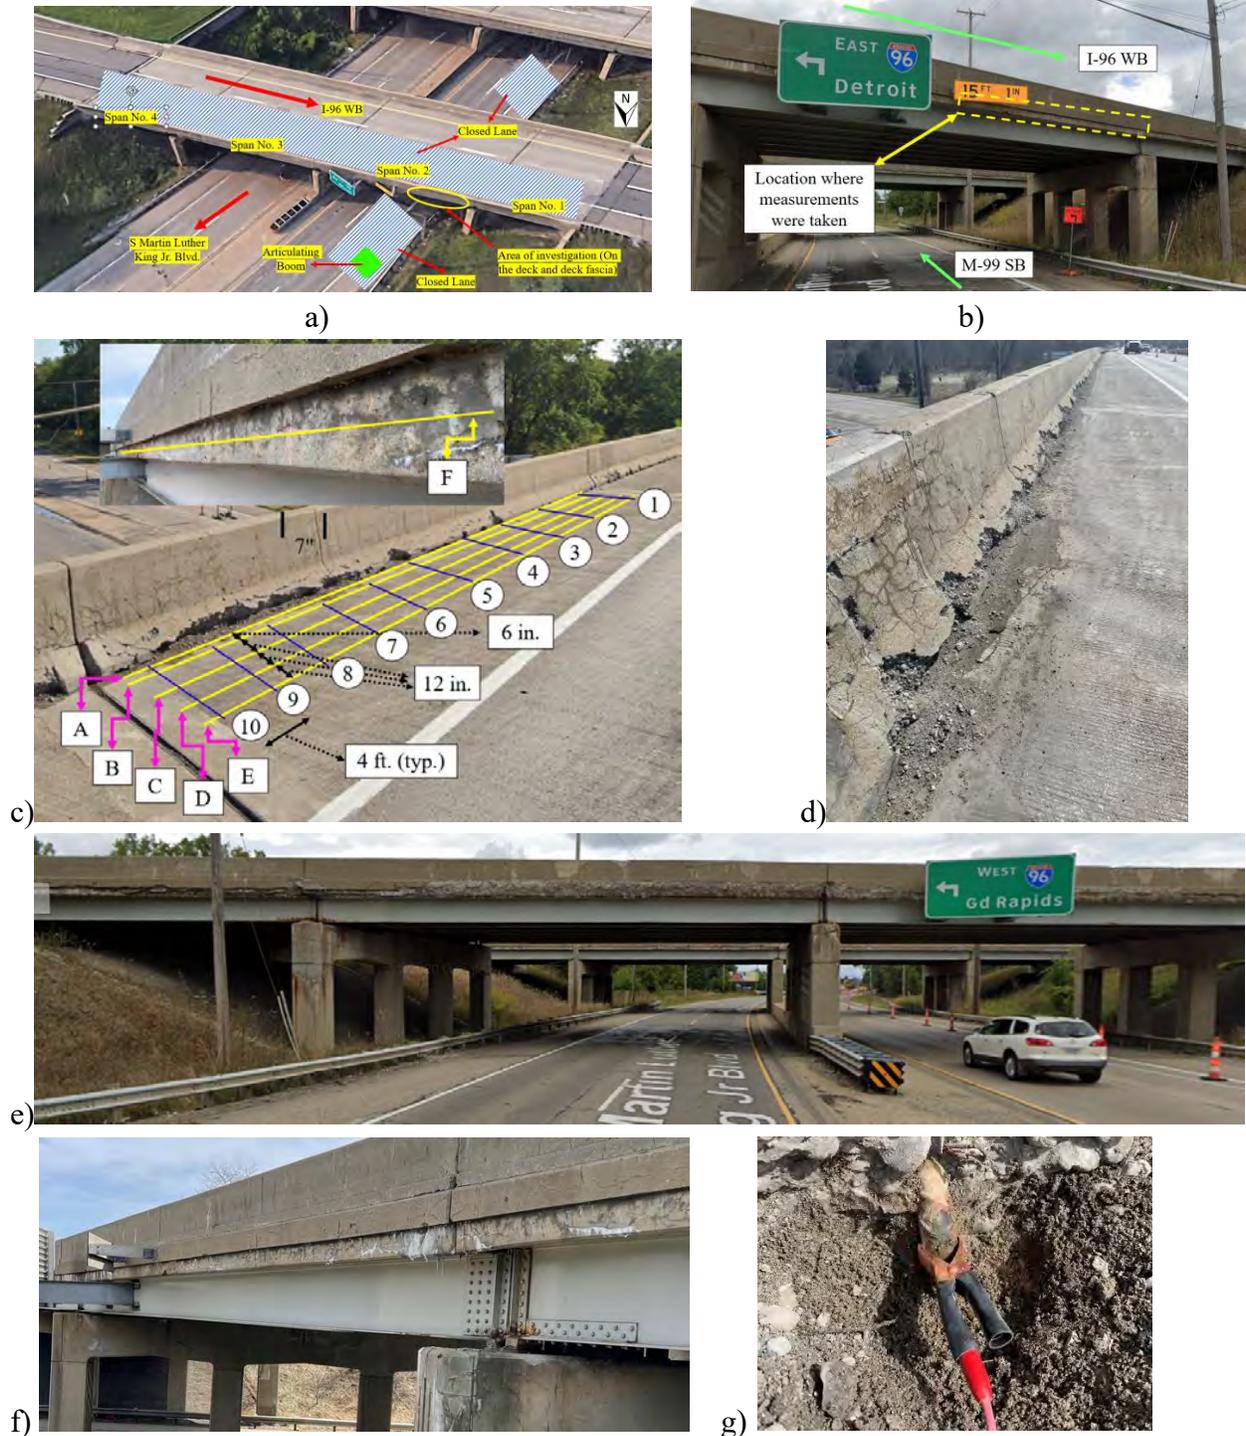
Fig. 3.5 a) Closed lanes on I-96 WB and M-99 to facilitate nondestructive testing on the deck surface and deck fascia, b-c) region where measurements were taken on the deck fascia and deck surface, respectively, d) severe barrier deterioration, e) deck fascia deterioration on I-96 EB, f) deck fascia deterioration on I-96 WB, g) connection of electrode to exposed steel in the barrier

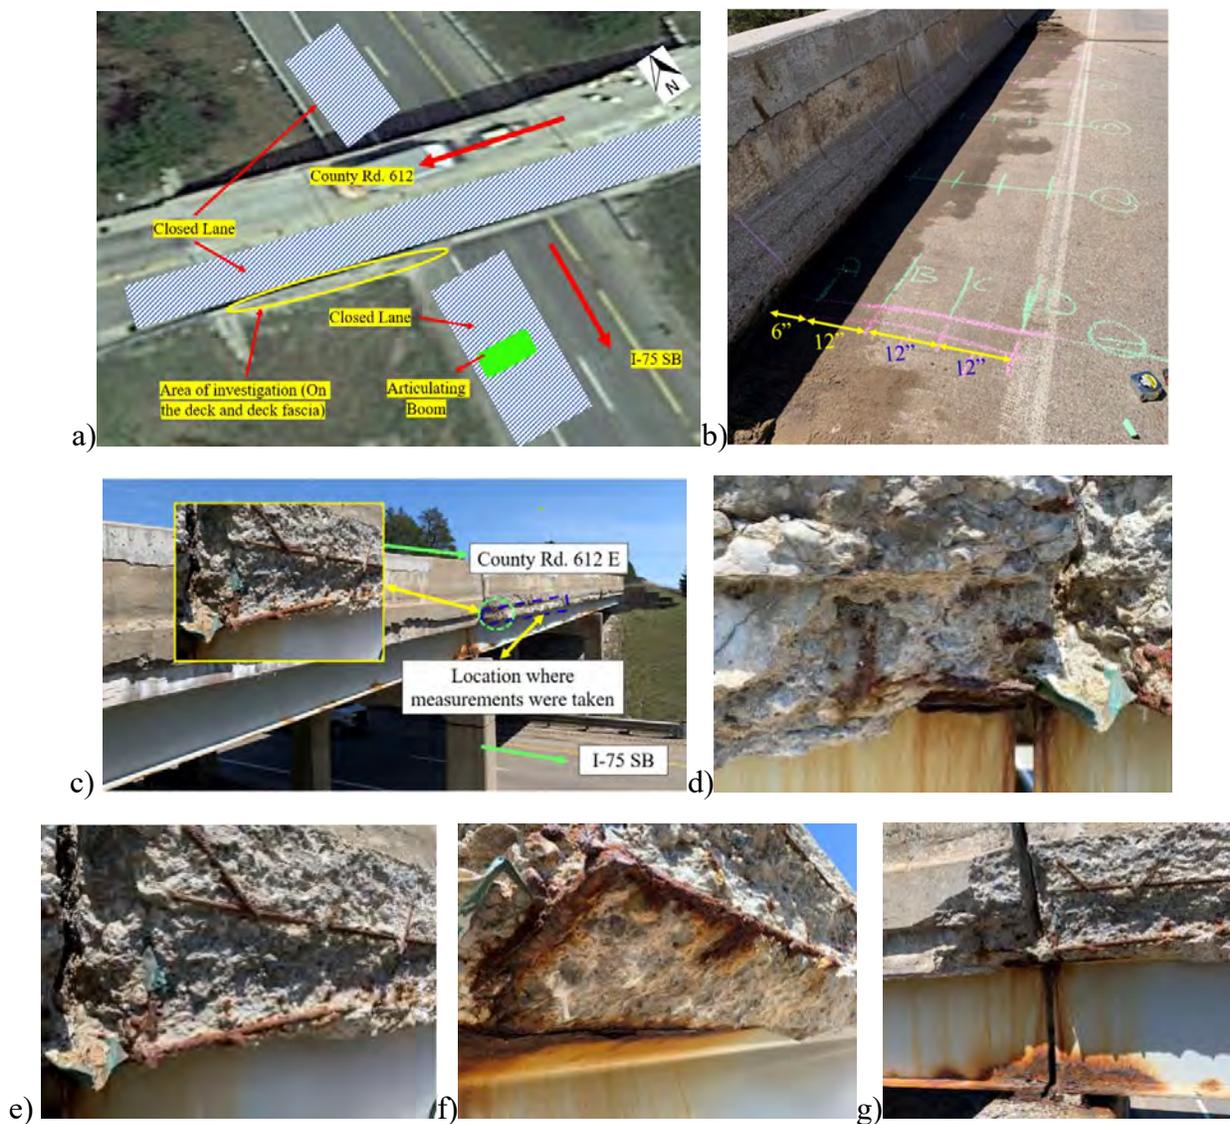
Fig. 3.6 a) Closed lanes and location of bucket truck, b) higher moisture content for the deck, c-g) deteriorated fascia

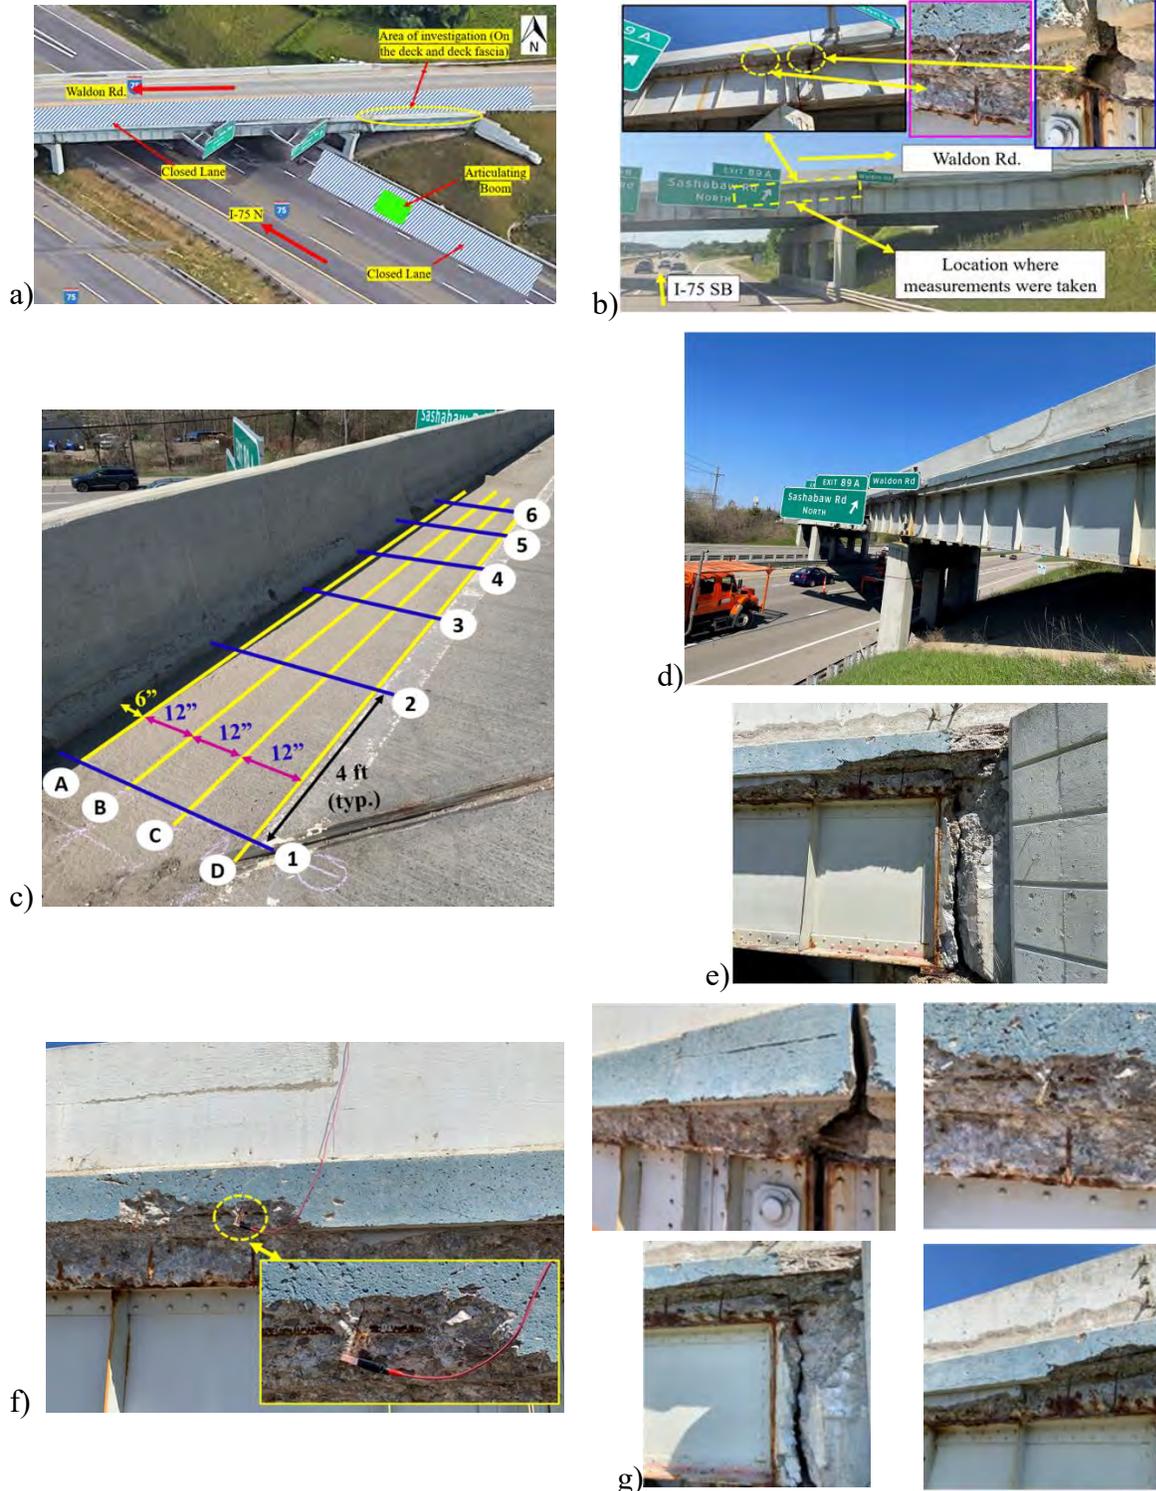
Fig. 3.7 Bridge on Waldon Road over I-75: a) closed lanes and location of bucket truck, b-c) location where measurements were taken and illustration of deteriorated deck fascia near the expansion joint, d-e) illustration of deteriorated deck fascia near the abutment, f) location where electrode was connected to existing bars for half-cell potential measurements, g) further illustration of deck fascia deterioration near the expansion joint and abutment

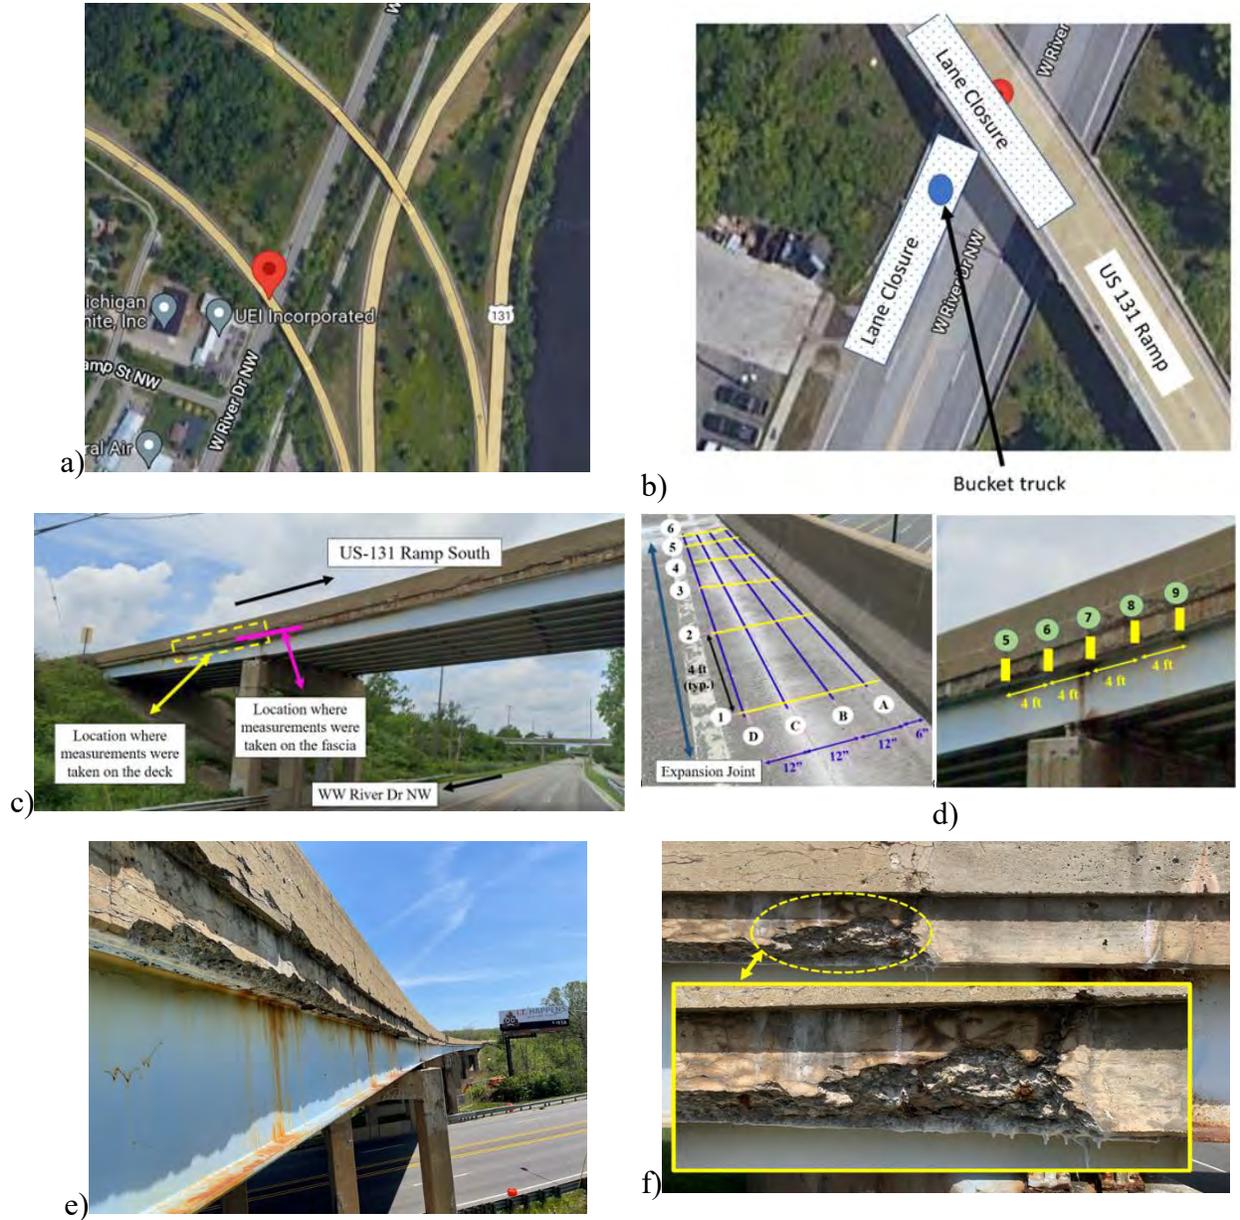
Fig. 3.8 Bridge on US 131 Ramp South over W River Drive NW: a) general location of the bridge, b) closed ramp and lanes and position of bucket truck, c-d) locations where measurements were taken on deck and fascia, e-f) deteriorated fascia

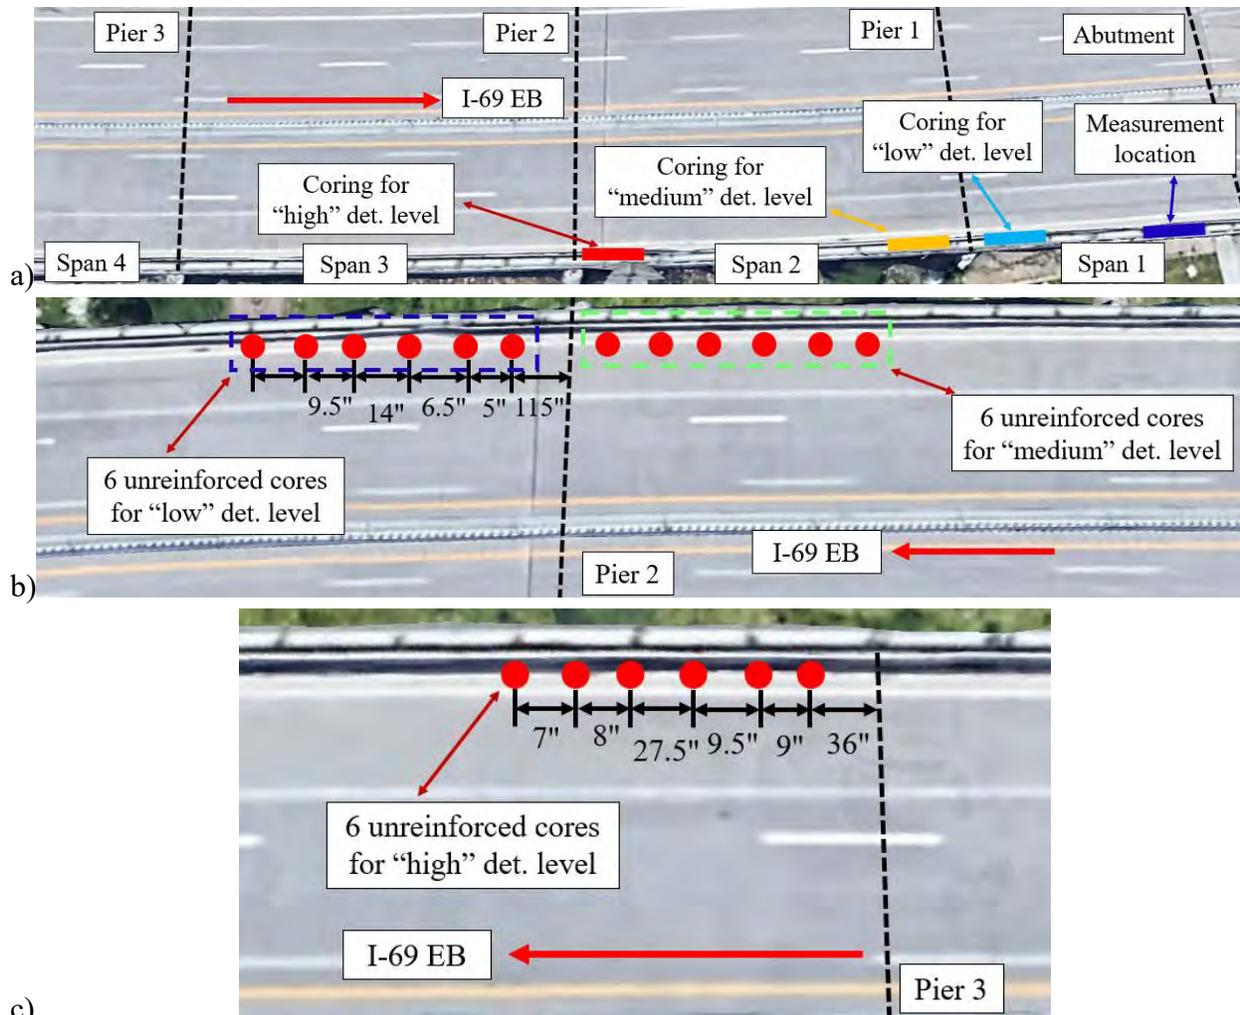
Fig. 3.16 a) Location of cores on the deck, b) detailed view of low and medium deterioration level coring; and c) detailed view of high deterioration level coring

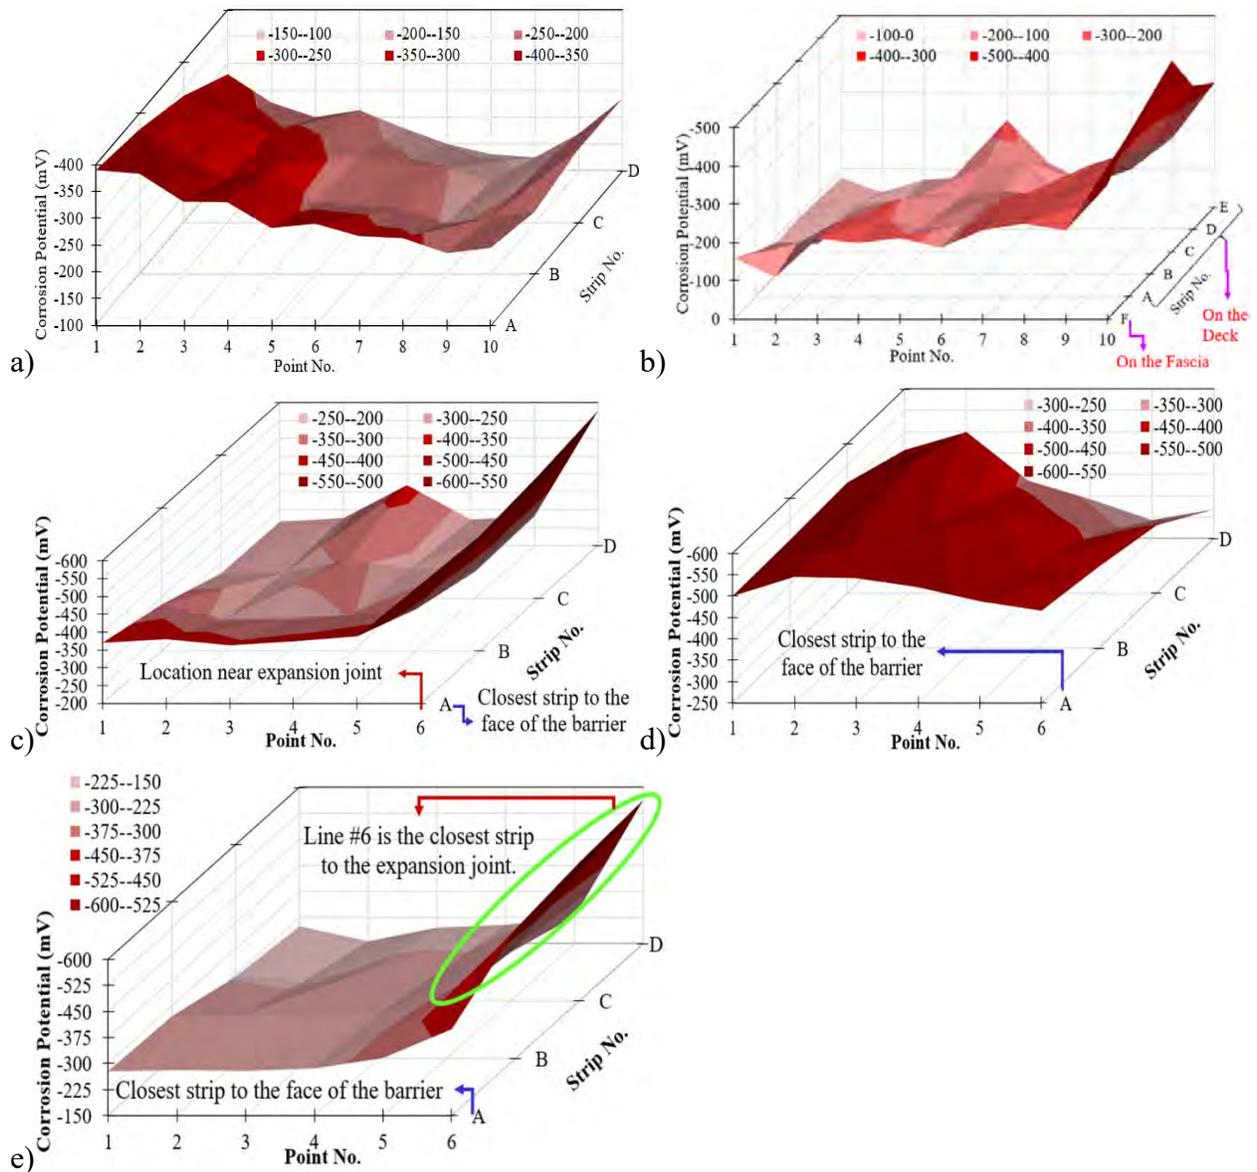
Fig. 3.31 Half-cell potentials for: a) the I-69 bridge over Fenton Road in Bay Region, b) the I-96 bridge over M-99 in University Region, c) County road over I-75, d) Waldon road over I-75, e) US 131 Ramp over W River Dr. HW

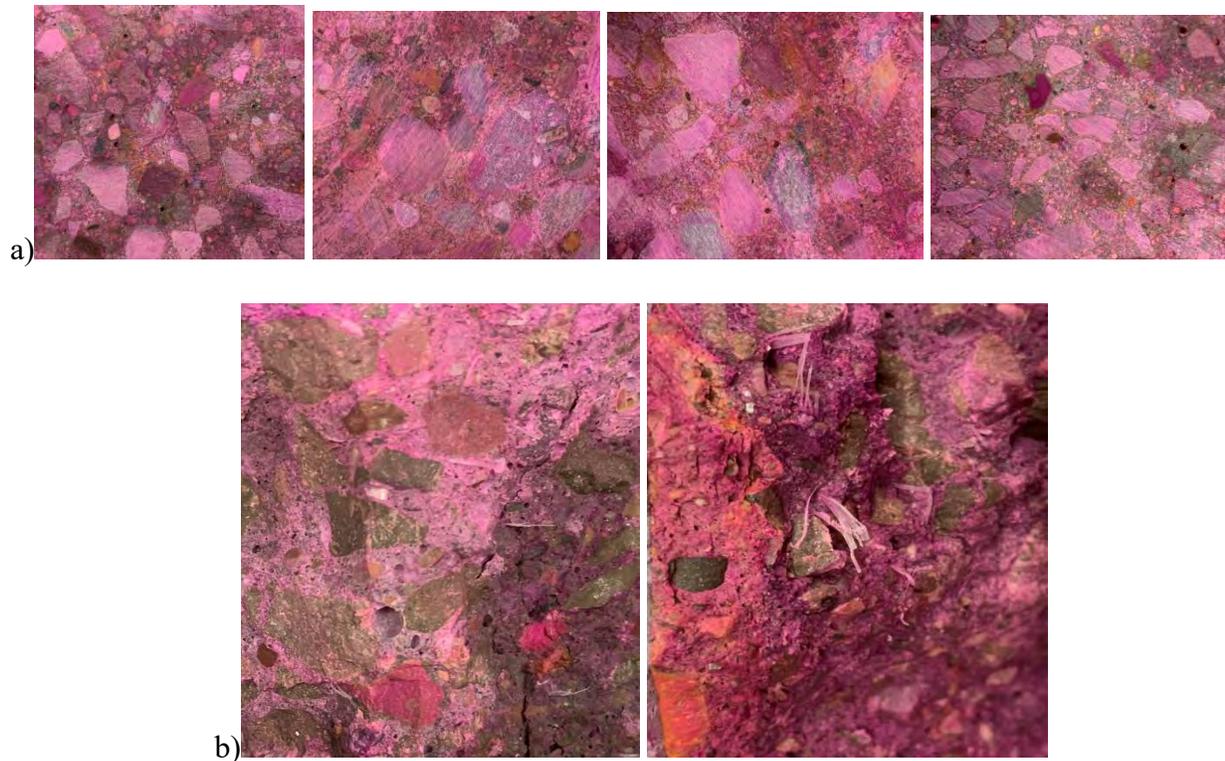
Fig. 3.33 ASR test results for the cores obtained from the bridge located in Bay Region on I-69 over Fenton Road: a) at the cross-section of the cores; b) along the height of the cores after compressive strength testing
