**THE EVALUATION
OF
NON-WOVEN FABRICS**

PETROMAT & MIRAFI

MAY, 1982

**Research and Development Division
Oklahoma Department of Transportation**

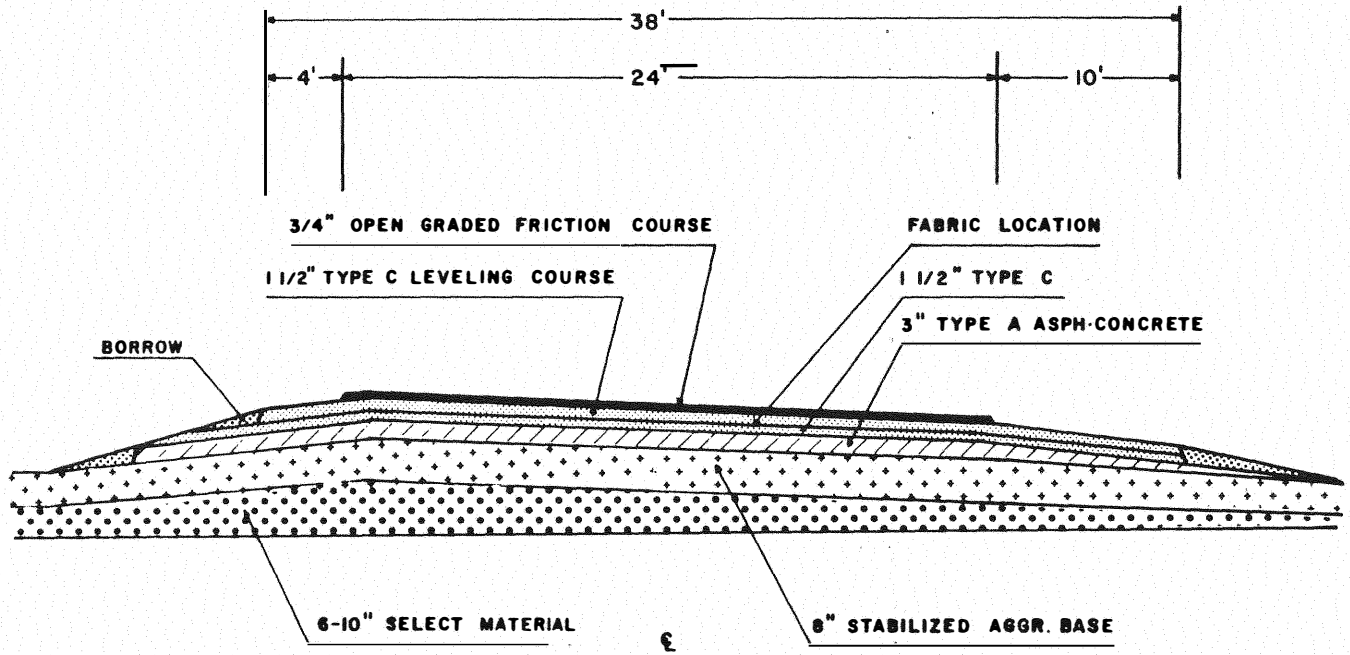
Figure 1. Typical Roadway Half Section

The highway selected for the Petromat and Mirafi fabric test was a badly cracked section of I-40 approximately 55 miles west of Oklahoma City, Oklahoma. This section was originally constructed under Project No. I-204(19) in 1958 and consisted of 6 to 10 in (152 to 254 mm) of select material, 8 in (203 mm) of stabilized aggregate base with 3 in (76 mm) of Type "A" asphaltic concrete and 1-1/2 in (38 mm) of Type "C" as the surface course. (See Figure 1.)

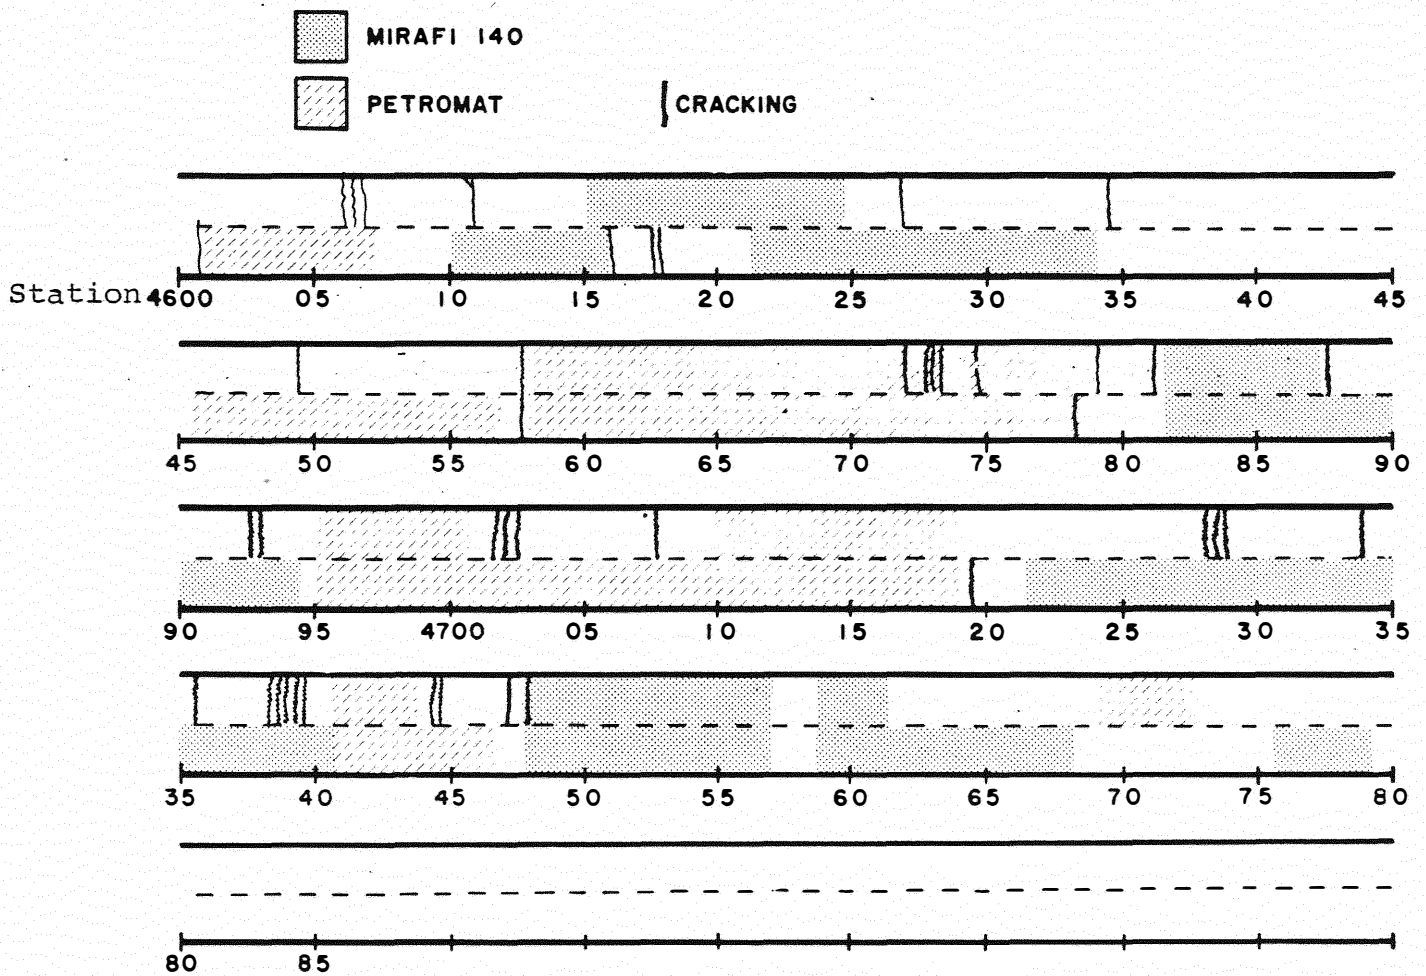
Figure 3. Transverse Cracks on Eastbound Section
30 Days after Construction

There were 42 transverse cracks within the project limits on the eastbound section (see Figure 3). Six of the cracks were located in Petromat between Stations 4672+00 and 4678+00. One crack was located in Mirafi (Station 4743+84) and one at the end of a Mirafi section at Station 4616+56. Only one crack ran the complete width of the road and it was in a control section. Most of the transverse

cracks began in the control sections opposite fabric sections and ran across the control section to the fabric edge. This occurred in control sections adjacent to both Petromat and Mirafi 140.

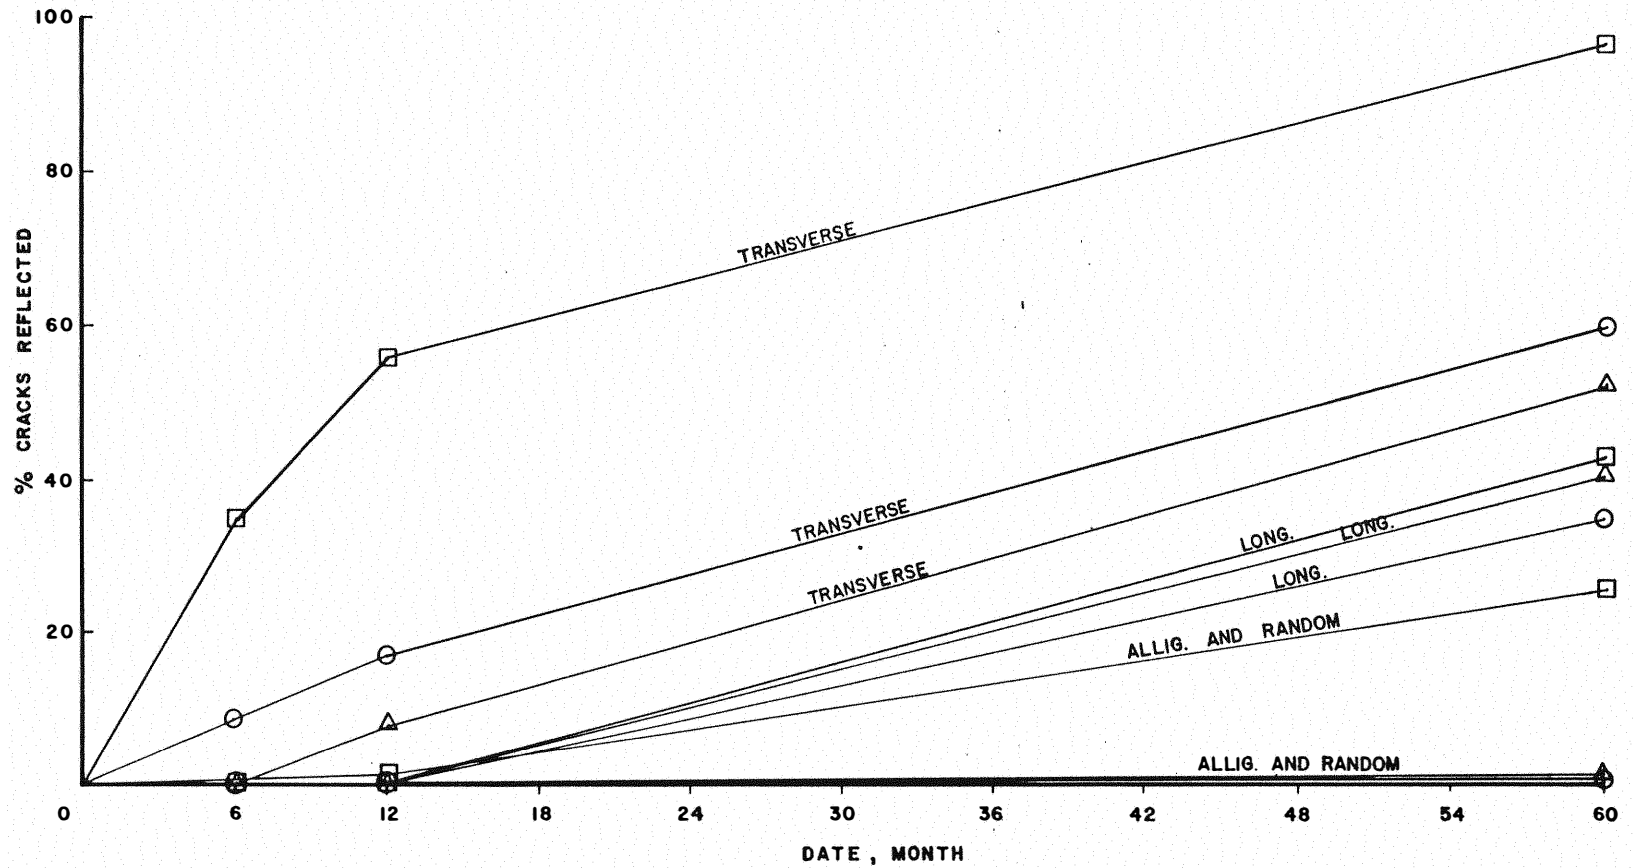
Figure 4. Crack Development for 1000 Foot Section

In the 1,000 ft. (305 m) Mirafi section, no cracks had reflected through in six months. Only 8 percent of transverse cracks had reflected through in one year. The longitudinal, random (block), and alligator cracks had not reflected through at the end of the year.

In the 1,000 ft. (305 m) Petromat section, 9 percent of the transverse cracks reflected through in six months with 17 percent of the cracks reflecting through at the end of the first year. Neither the longitudinal nor the alligator nor the random (large block) cracks had reflected through in the first year.

In the 1,000 ft (305 m) control sections, 35 percent of the transverse cracks had reflected through in six months and 56 percent of them had reflected through at the end of the year. There were no longitudinal cracks reflecting through in the first year. Only 0.2 percent of the random and alligator cracks had reflected through in six months and 8 percent at the end of the year. (See Figure 4.)
