USE OF FIBER-REINFORCED POLYMER COMPOSITES FOR BRIDGE REPAIRS IN MONTANA

FHWA/MT-26-001/10337

Final Report

Montana State University
Bozeman, Montana

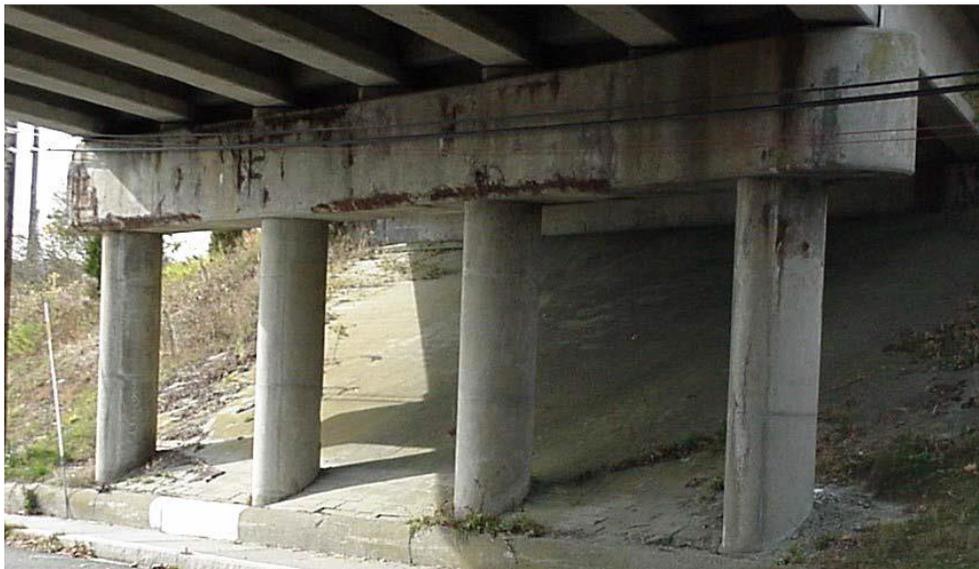
The Rhode Island Department of Transportation sponsored a program to repair the deteriorating RC pier cap of the Salt Pond Road bridge in South Kingstown, Rhode Island. The pier caps showed severe spalling and cracking, and the reinforcements were exposed at several locations [46] (Figure 37). The bridge is located near the ocean, and the constant exposure to contaminated water flowing over the pier caps was identified as the cause of the severe deterioration.

Figure 37: Deteriorated pier cap of Salt Pond Road Bridge [46]

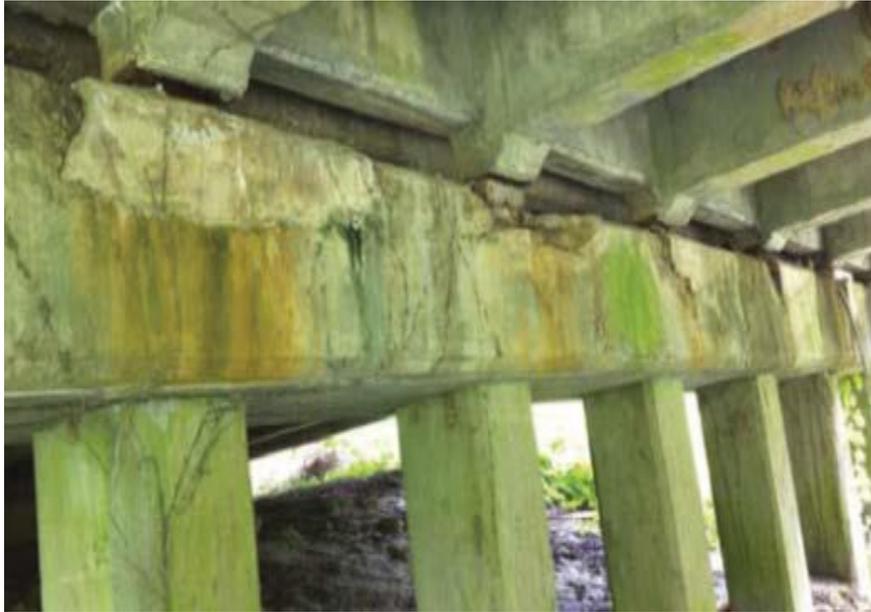
Figure 40: Delamination under the bearing plate of the Morganza Spillway bridge, Louisiana [47]

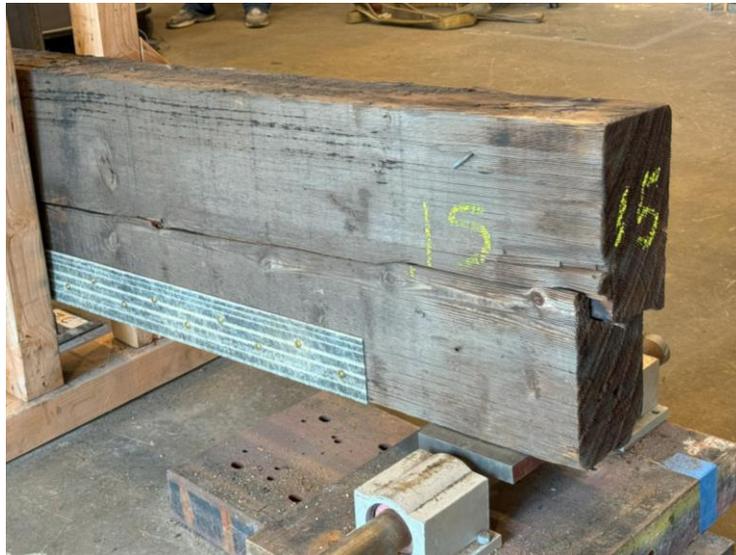
Shear splitting (as observed in Figure 48), result from horizontal shear stresses induced from loading. They run parallel to the top and bottom faces and initiate near the ends of the beam where the shear forces are the greatest. Like in tension failures, these failures often initiate at imperfections in the beam.

Figure 48: Example of a shear split failure

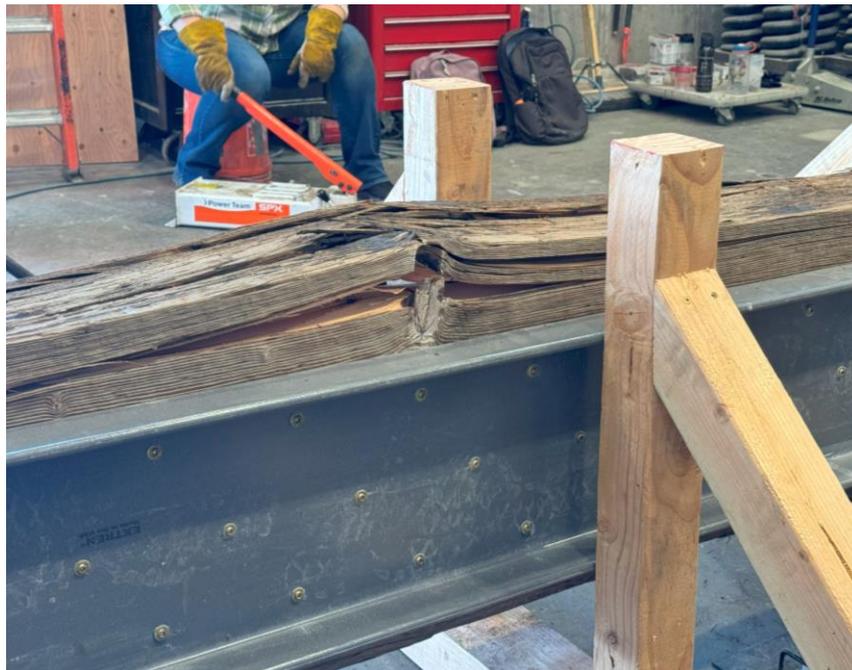
Another failure mechanism of timber beams is longitudinal (parallel to the grain) crushing of the wood in compression zones (as observed in Figure 49). In the beams in this research this occurred at the top mid-span of the beam where the positive moments were the highest.

Figure 49: Example of a compression crushing/cracking failure

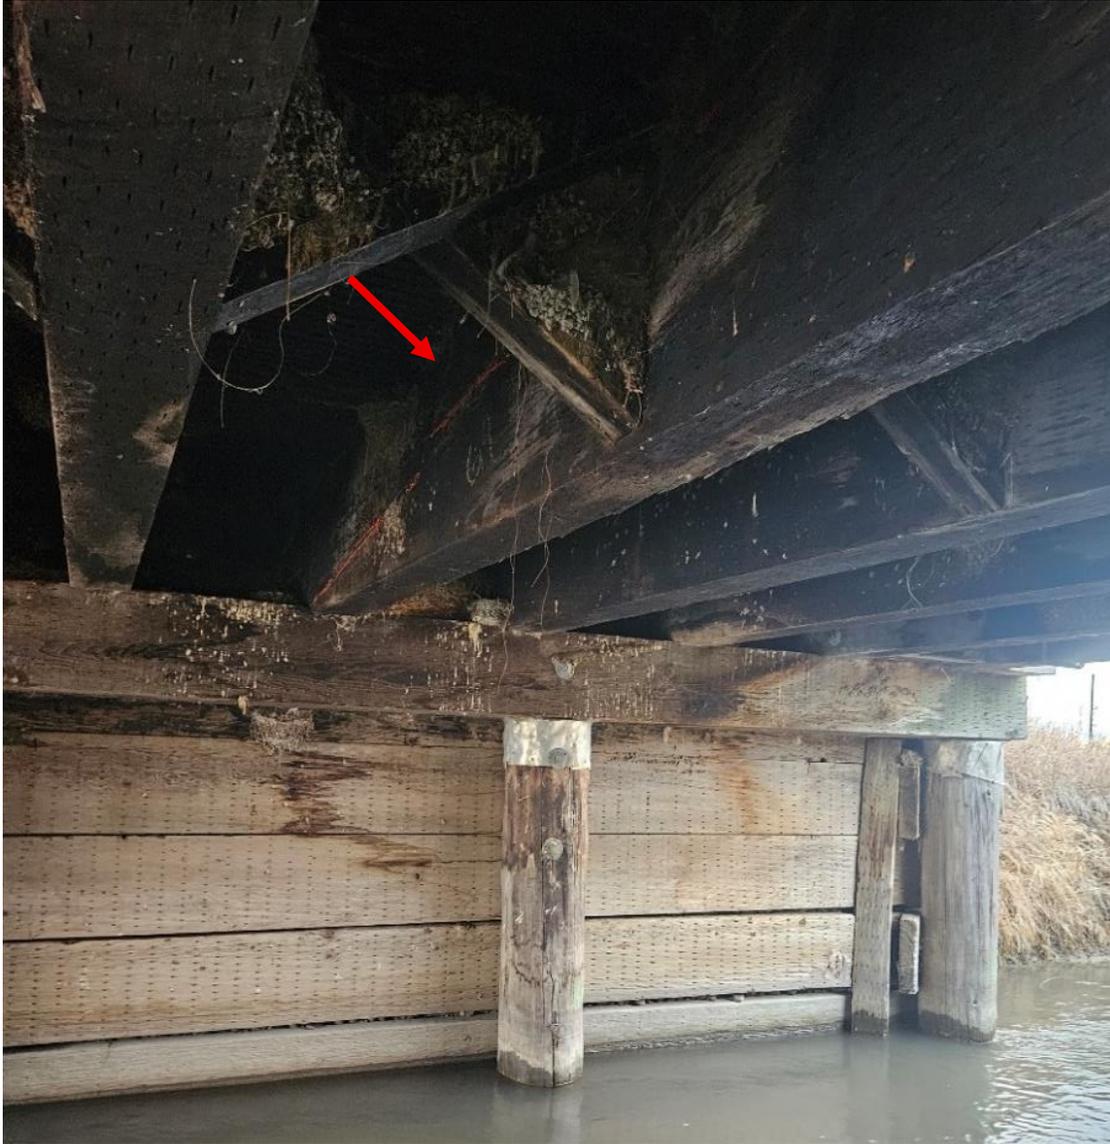
Figure 104: The broken girder G9 (red arrow) on Bridge #06581

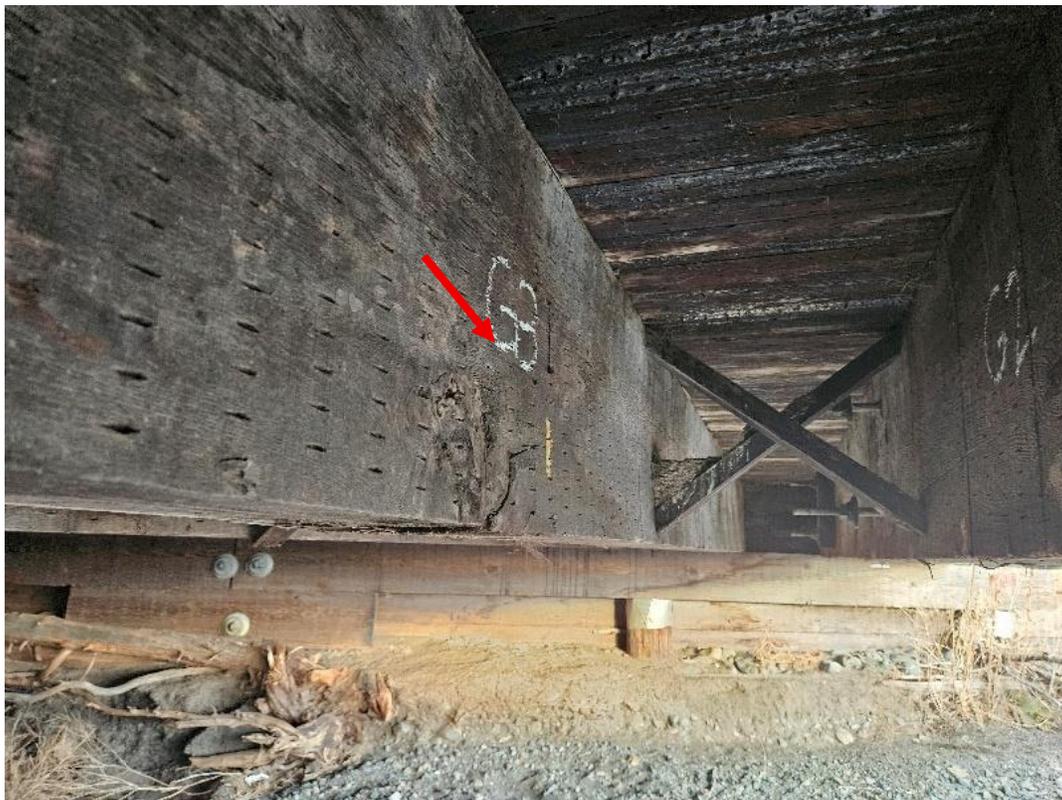
Figure 106: Cracked girder G3 (red arrow) on Bridge #06583

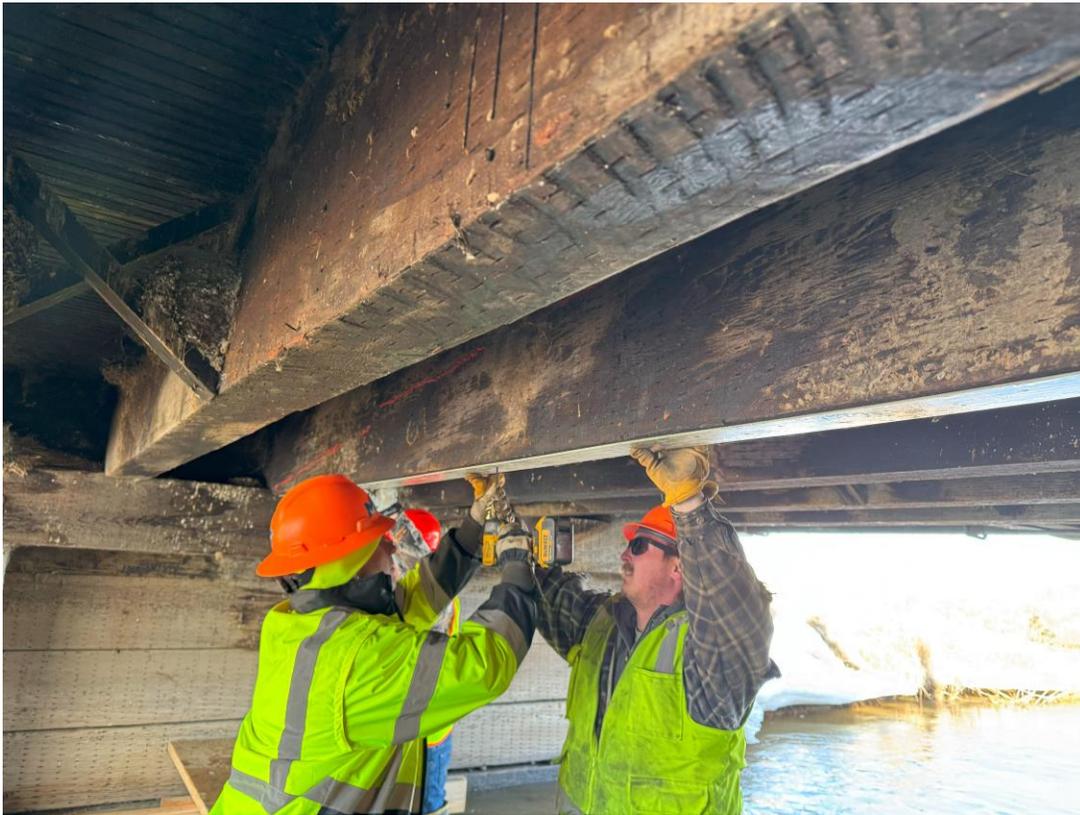
Figure 118: Attaching bottom strip on girder G9, Bridge #06581

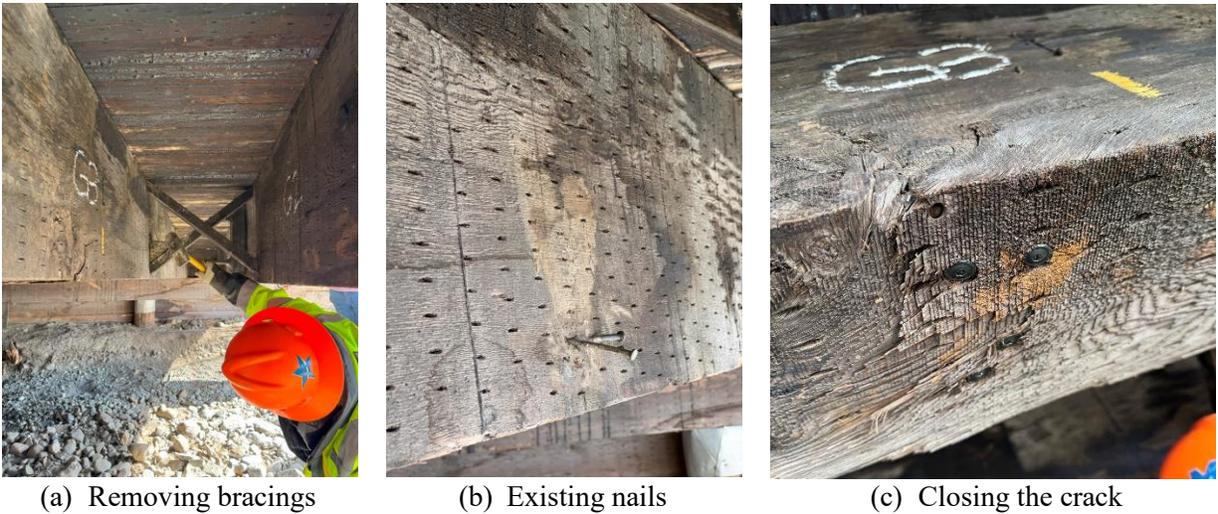
Figure 121: Surface preparation of girder G3 on Bridge #06581

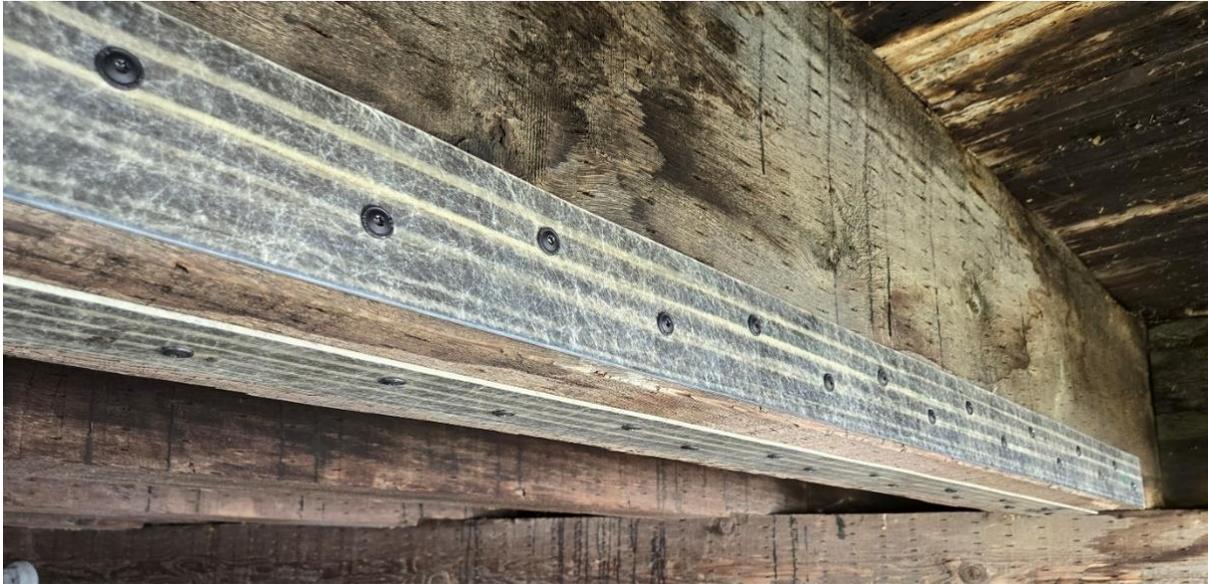
Figure 125: Repaired girder G3 on bridge #06583
