# Evaluation of Wind-Loading on Airport Signs

DOT/FAA/AR-TN00/32

*technical note*

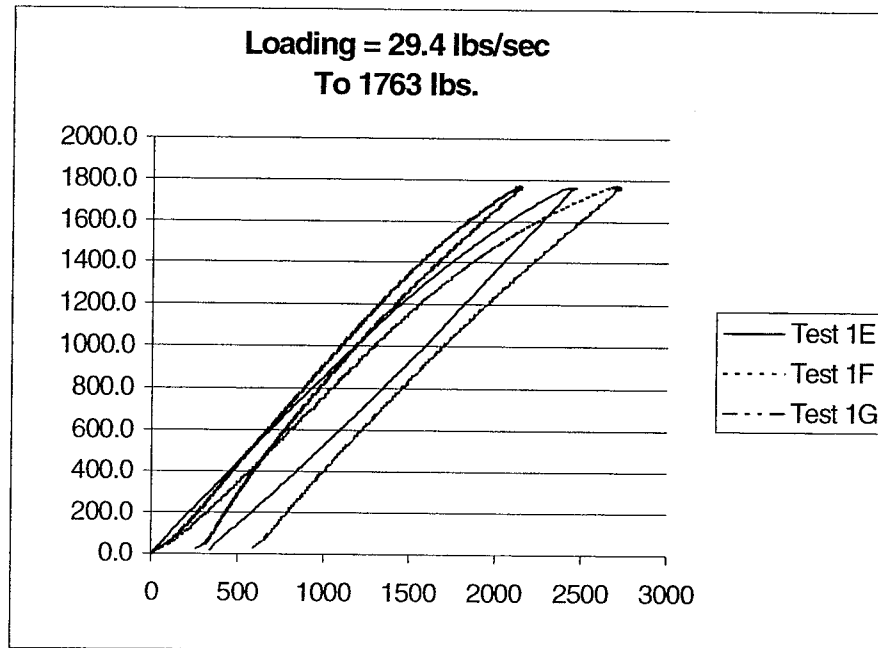
FIGURE 5. MTS COUPLING (STANDARD RATE) LOADING TO 0.9 psi

The MTS test data indicated that the couplings remained, for the most part, elastic through loads of approximately 1800 lb. (slightly greater than 0.9 psi) although there was some indication that 0.9 psi (minimum design load) was at the very fringe of the elastic limit of some of the couplings.

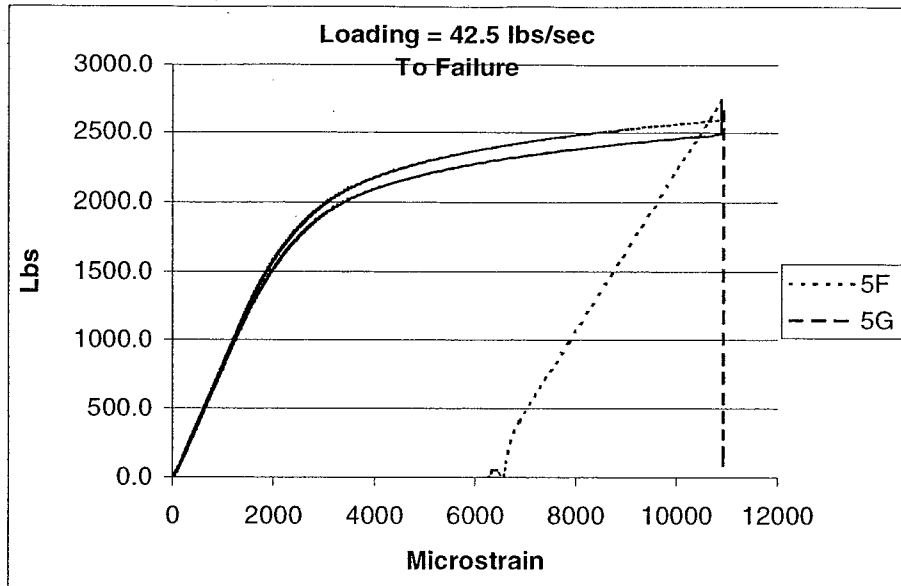
FIGURE 7. MTS LOADING TO 1.3 psi (OR FAILURE)

The MTS test data also indicated that the couplings failed with loads of more than the maximum design load (2600 lb. or 1.3 psi) on the sign face. The results of the tests also demonstrated that the elastic limit and failure point of the couplings are independent of the rate of loading. Sample results for the standard and highest load rates are illustrated in figures 5 through 8.

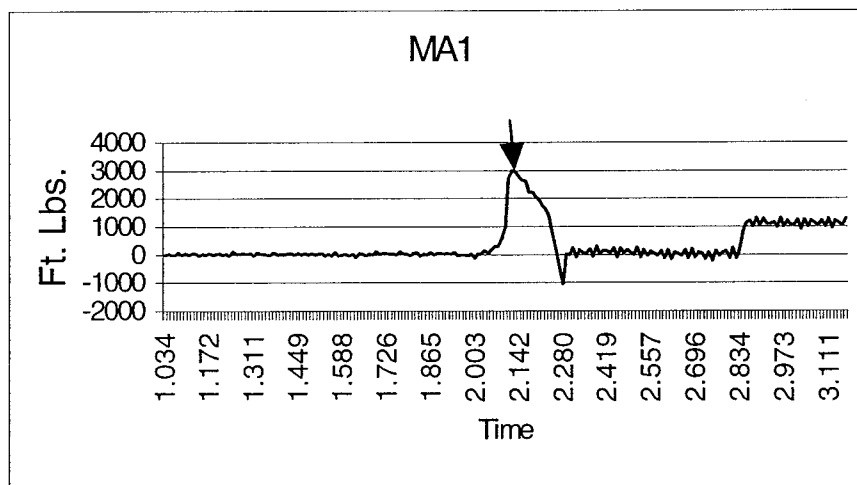
FIGURE 11. FRANGIBLE COUPLING 1, MA1

The measured moments at MA1 and MA2 differed in magnitude by 20% indicating that there was some bending (twisting) about the horizontal plane. The values for MA1 and MA2 in figures 11 through 18 were zeroed (MA2 values are absolute) for comparison.

The data also showed that the sign failed at the frangible point (couplings) under a load of only approximately 0.62 psi; which is less than the minimum frangibility requirements of the Advisory Circular. Moreover, the failure appeared to occur within the elastic limits of the laboratory tested couplings. It should be noted that the loading was applied to the sign over a time frame of less than 0.05 second, almost 200 times faster than in the laboratory tests. Although the measured wind speed was only 14.95 and 19.43 mph respectively, the data are considered to be unreliable since it was measured with a mechanical device that is not capable of providing accurate measurements over such a short period of time.

Further investigation of events prior to the total failure of the frangible couplings showed loads that exceeded the elastic limits of the couplings, causing permanent deformation of the couplings and actual failure (cracking) of the couplings well before the sign broke completely free of the couplings.
