# **Modification of Visual Approach Slope Indicator Baffles at Pearson Field Airpark, Vancouver, WA**

June 2007

DOT/FAA/AR-TN07/12

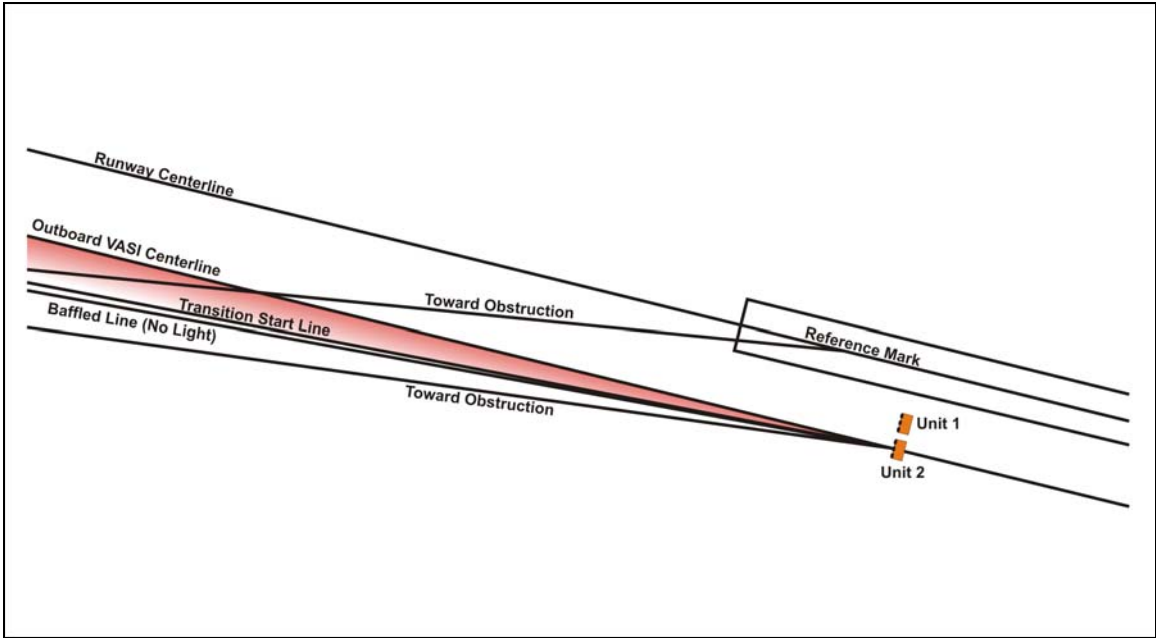
Figure 1. Diagram of VASI Unit Closer to Runway 8 Threshold

In a preliminary meeting with the FAA Portland SSC, the Visual Guidance Team discussed the September 2005 effort to baffle the VASI system. The survey conducted during this effort showed that the obstruction was  $8^{\circ} 19' 57''$  left of the extended runway centerline of the approach end of runway 8. This measurement is shown as the angle between the runway centerline and the toward obstruction line, as shown in figure 1.

Reference Lines	Angular Measurements in Figure 1	Angular Measurements in Figure 2
Transition Start Line	3° 30' 00"	1° 57' 20"
Baffled Line	4° 00' 00"	2° 14' 00"
Toward Obstruction Line	6° 00' 00"	5° 19' 20"

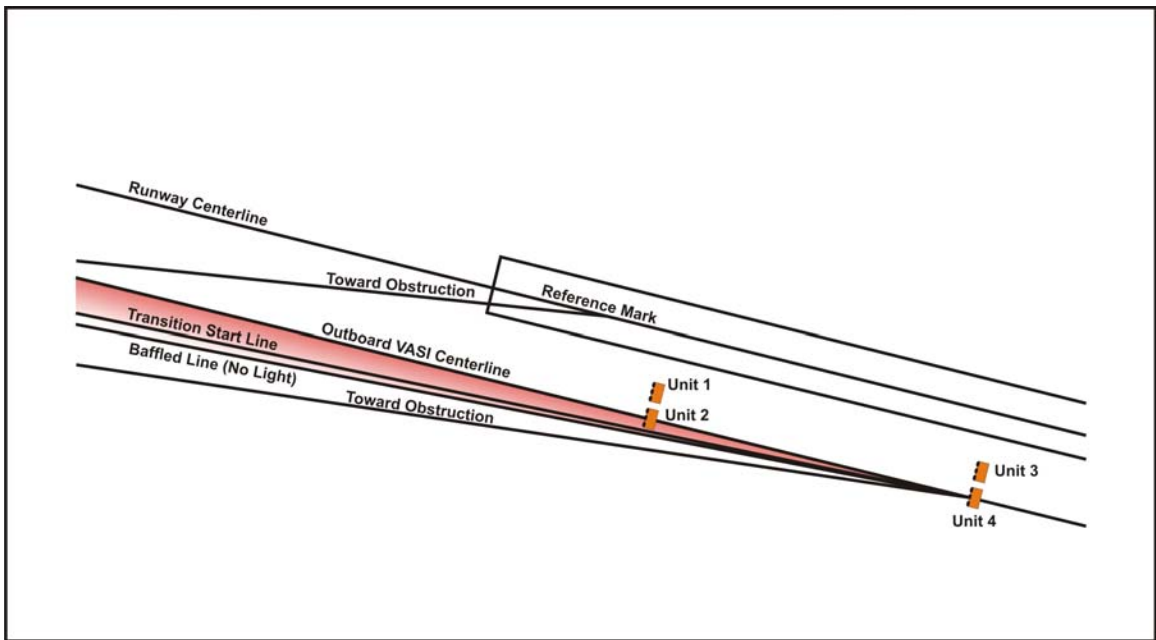
Figure 2. Diagram of VASI Unit Farther From Runway 8 Threshold

New measurements were needed prior to developing a plan for installing the baffles in the VASI units. These measurements were essential to give the Visual Guidance Team an accurate sense of the angles between the VASI unit on the outboard side of the runway and the bridge obstruction. The angles formed between the VASI centerline, the desired transition start line, the baffled line, and the toward obstruction line, are illustrated in figures 1 and 2. The values for these angles are given in table 1.

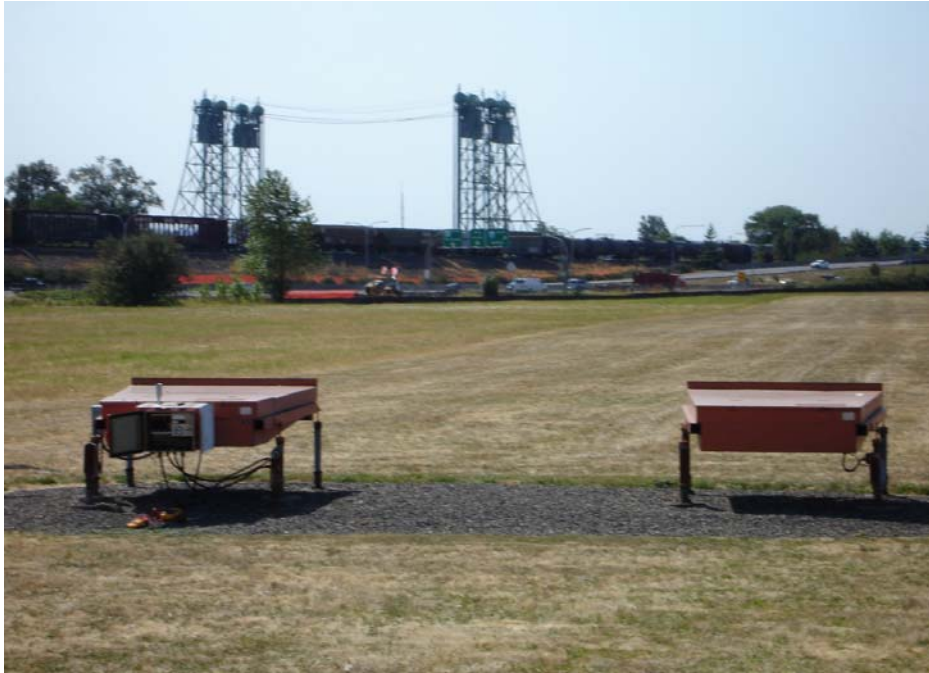
In the situation at Pearson's runway 8 VASI system, portions of the on glide path signal intersected with the northern-most vertical supports of the Interstate I-5 bridge connecting OR and WA over the Columbia River (see figure B-1 in appendix B). The FAA Flight Inspection Operations Group failed the VASI system on July 12, 2005, citing the potentially dangerous situation that the VASI signal created by overlapping the bridge obstruction. At that point, the VASI units were placed out of service. It is interesting to note that the VASI at VUO had been baffled many years ago, but over the last 25 years since the units were installed, the units became misaligned.

Figure B-1. Interstate I-5 Bridge Forming Obstruction

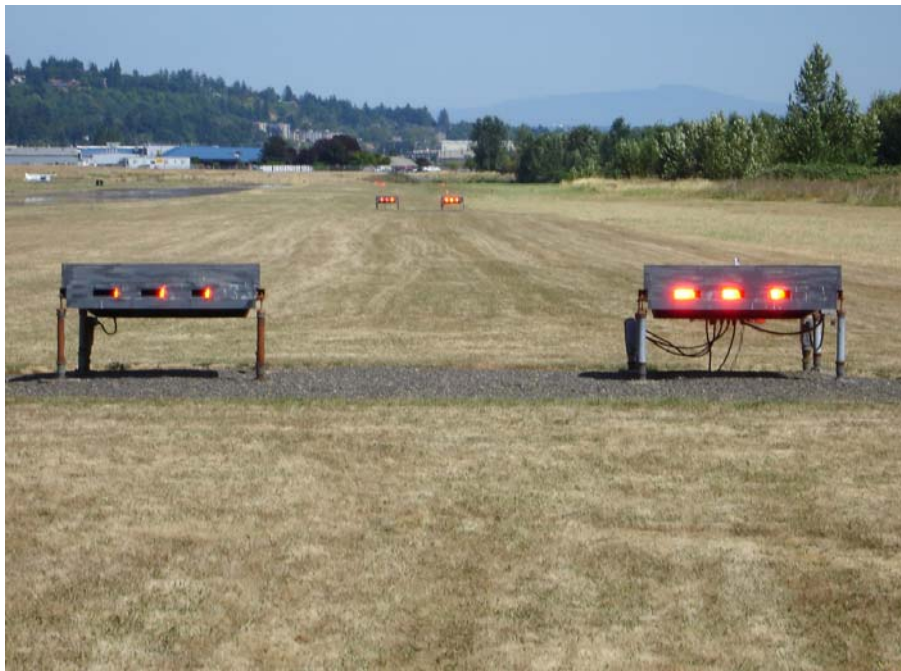
offset distances between the baffles varied with each unit. Furthermore, the inner baffles were attached using rivets to the sectional supports of the ceiling of the boxes, and were left in a hanging position without any support on the bottom. The inner baffles were constructed of 1/16-in.-thick aluminum. Over time, this type of material does have a tendency to warp and twist, and can contribute to the problem with the light being visible beyond the obstruction. It was determined, however, that the twisting and nonsymmetrical positioning of the baffles was not the cause of the problem at Pearson.

Figure B-2. The VASI Units Before Modification

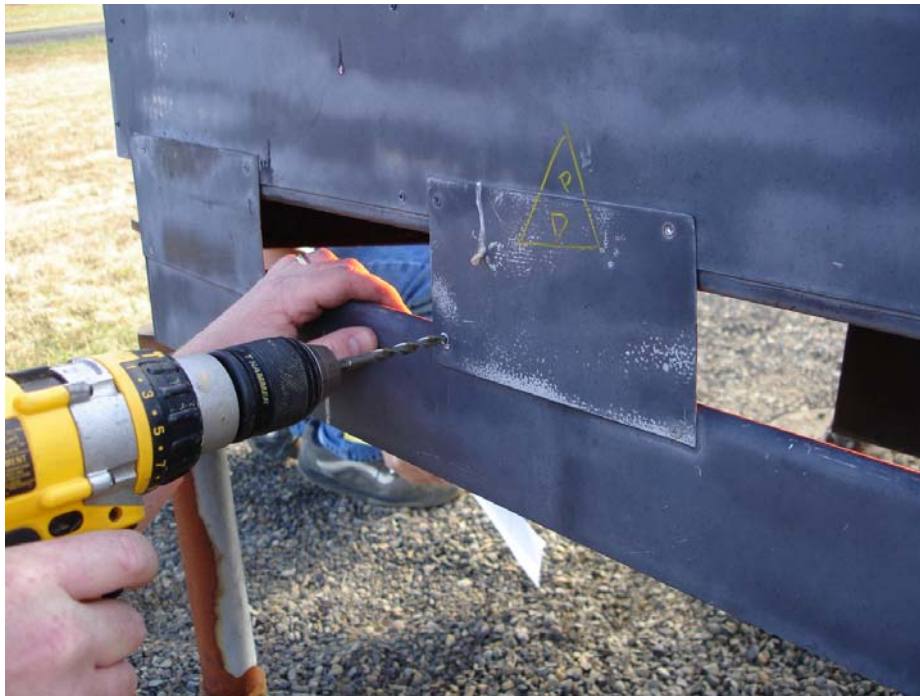
Figure B-4. Removing Rivets From Older Outer Baffles

Initial measurements were taken of the previously installed baffles in each of the four VASI units, which are shown in figures A-1 through A-4 in appendix A. These measurements were taken for two purposes: (1) to provide information on the dimensions of the previously installed baffles and provide information on any nonsymmetrical dimensions that may be contributing to the problem at Pearson and (2) to provide the Visual Guidance Team with backup data that would allow the Team to return the system to its original configuration, if necessary. After the measurements were recorded, the outer baffles were removed (see figure B-4 in appendix B) and reattached with a temporary adhesive material in such a way that they could be easily moved to the left or right or used to extend the edges of the baffles if they were not long enough.

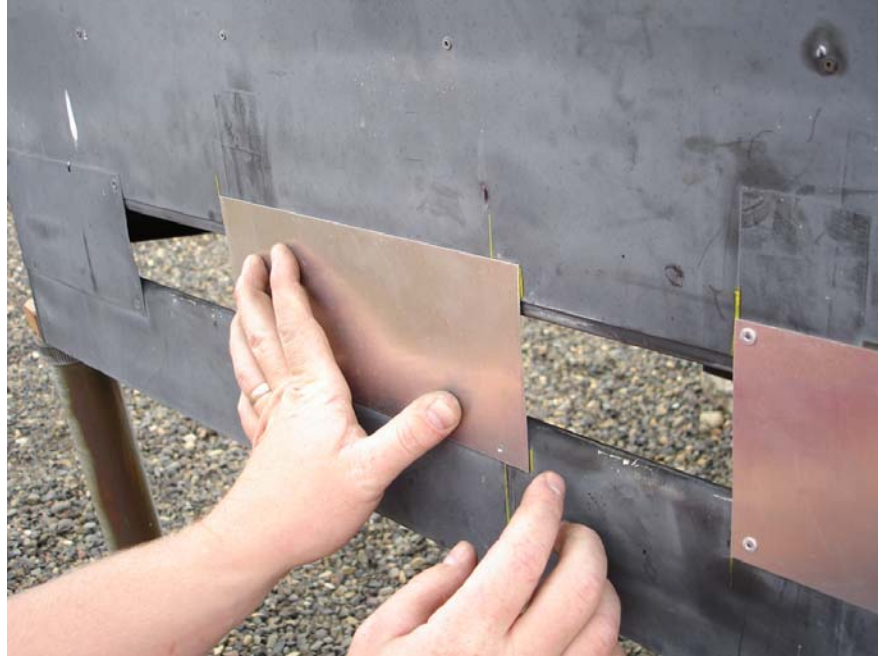
Figure B-5. Riveting Permanent Modifications

On the following day, Team members returned to the VASI site to make the temporary modifications to the VASI units permanent. The final locations of the baffles were marked, and permanent sheet metal strips were installed (see figure B-5 in appendix B). All temporary material was removed, leaving the new baffles secured in their proper locations. After the baffles were installed, another series of daytime approaches were made to verify that the permanent baffles performed the same as the temporary baffles. This final evaluation ensured that no mistakes were made in the transition from temporary to permanent modifications. After the conclusion of final flight evaluations, a coat of nonreflective black paint was applied to the front of each VASI unit, thus completing the modification process (see figure B-9 in appendix B).

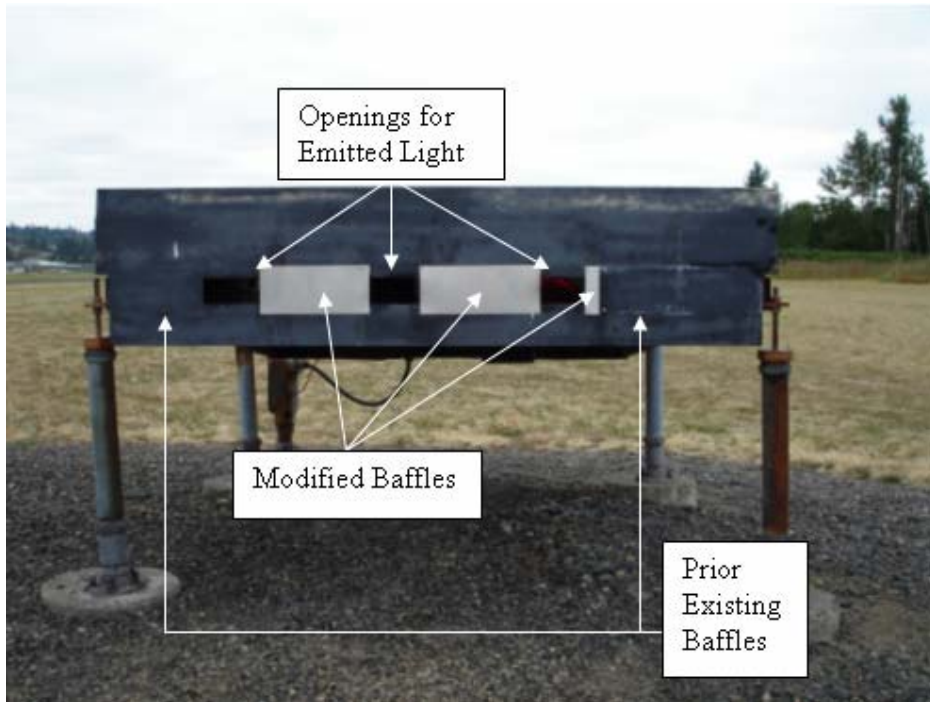
Figure B-6. Front View of a Modified VASI Unit

The outer baffles of a VASI unit are designed to restrict the angle of light laterally across the final approach area, and can be adjusted by increasing or decreasing the overall horizontal width of each outer baffle (see figure B-6 in appendix B). These outer baffles are also made of aluminum, and are approximately 6 in. high (enough to cover the 4-in. opening in the front of the VASI unit), and vary in width depending on their purpose. In the situation at Pearson, it was determined that the horizontal lengths of the outer baffles were the only elements of the system that needed modification to restrict the lateral coverage of the VASI signal.

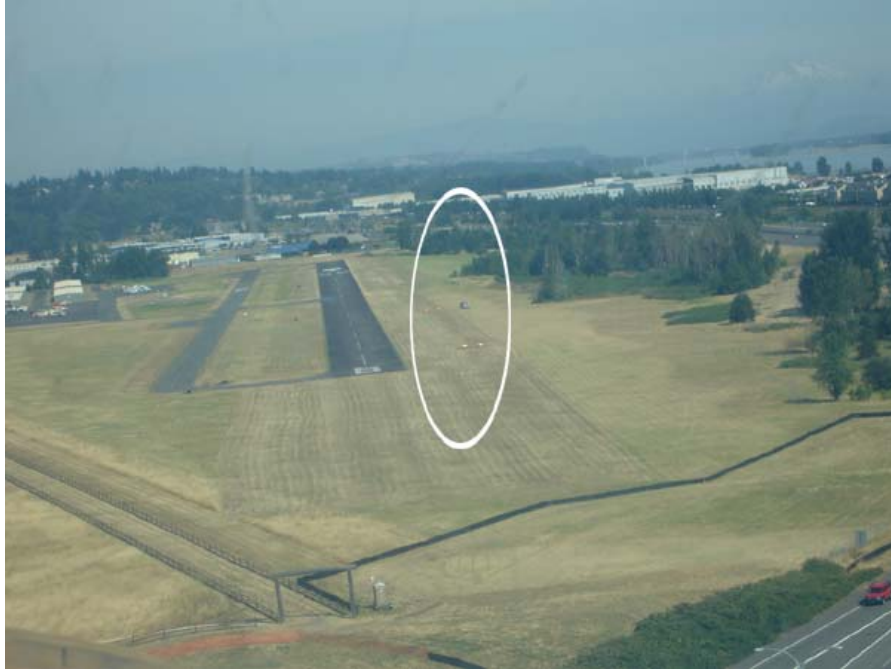
After the units were satisfactorily baffled, a Cessna 172 was used to conduct airborne flight evaluations of the VASI units. A series of approaches to runway 8 were flown from about 6 mi out, over the Columbia River, along the right-most limits of the usable VASI signal. The flight evaluations revealed that the baffle modifications made to the VASI units were successfully blocking light along the baffled line path. Visible light from the units was detected at distances greater than 3 nautical miles along the runway centerline. During each approach, the pilot flew the aircraft towards the VASI units, wavering left and right of the baffled lines, to evaluate the point at which the VASI signal was visible (see figure B-7 in appendix B) and not visible (see figure B-8 in appendix B).

Figure B-7. Flight Evaluation Left of Baffled Line—VASI Signal Visible

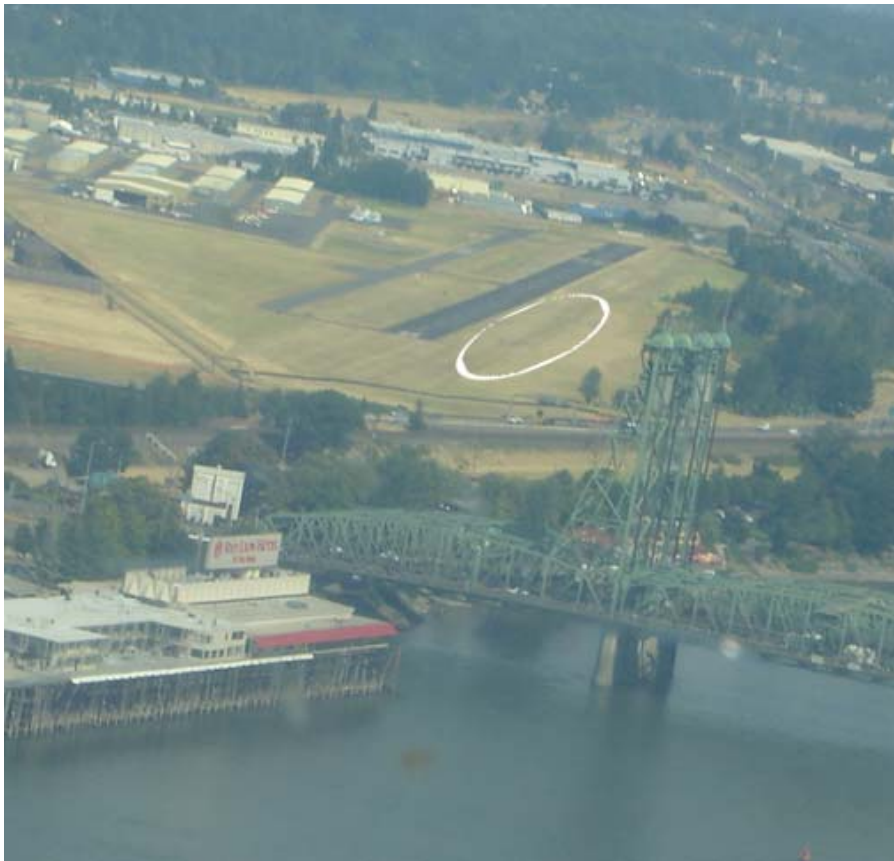
Figure B-8. Flight Evaluation Right of Baffled Line—VASI Signal not Visible

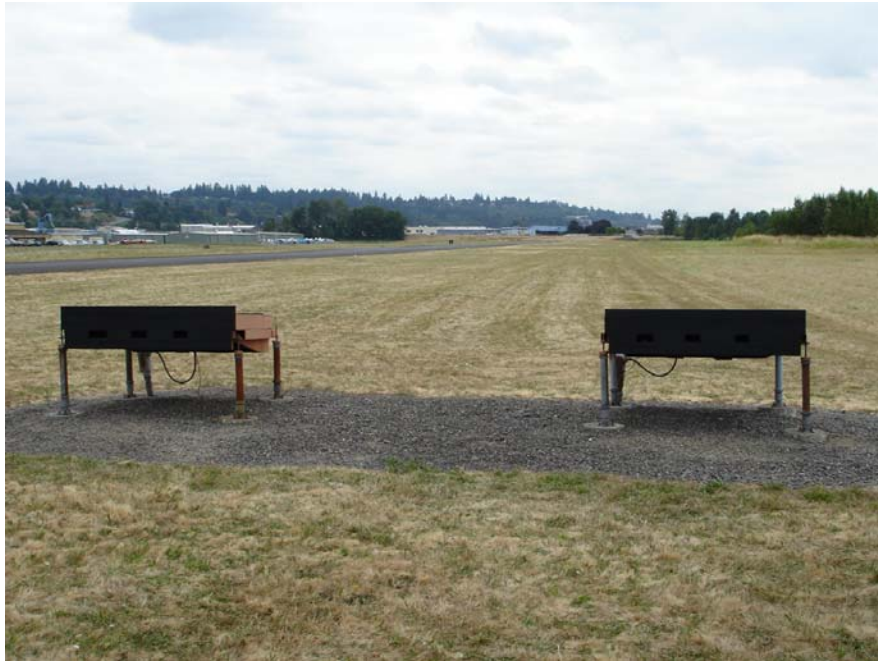
Figure B-9. Final Results of Modification Process
