Effects of Concentrated Hydrochloric Acid Spills on Aircraft Aluminum Skin

July 1998

DOT/FAA/AR-TN97/108

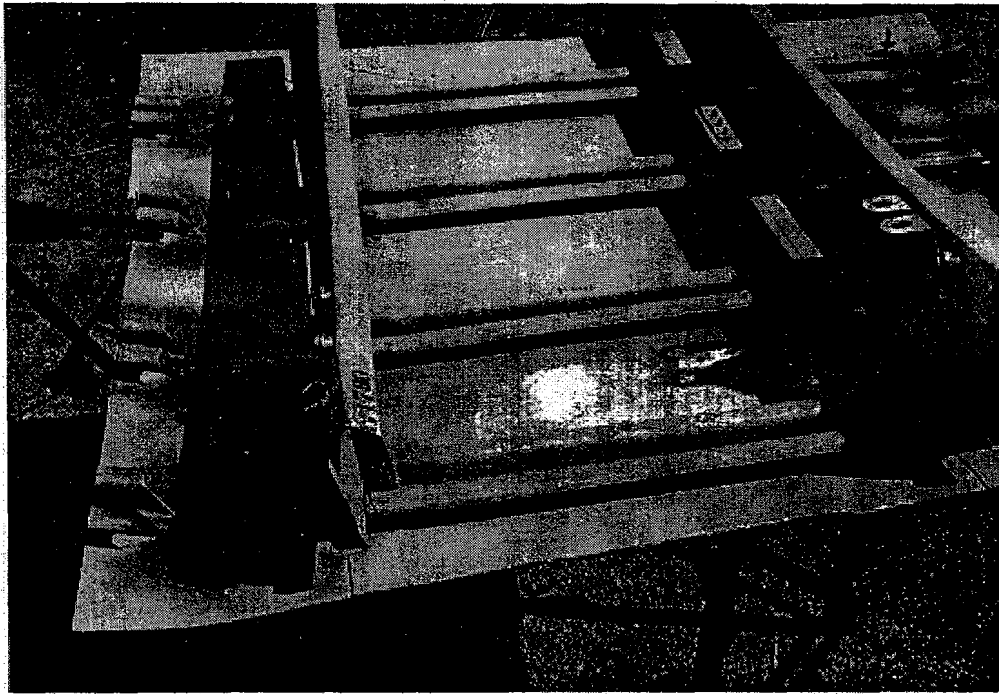
The first test was the largest, a 3- by 3-foot section with a 1-liter acid spill (figures 1 and 2). The edges of the skin were bent upwards to contain the acid. In the process of bending the skin and cutting notches in the ribs to allow the bending of the frame, scrapes and breaks in the surface coating of the aluminum skin were produced. There was no treatment of the marred surfaces in this test. The acid contacted not only the interior skin surface but also the bulkhead plates and fittings and the ribs and attaching grommets.

FIGURE 1. TEST ARTICLE FOR TEST 1: 3- BY 3-FOOT SIDEWALL OF A BOEING 747

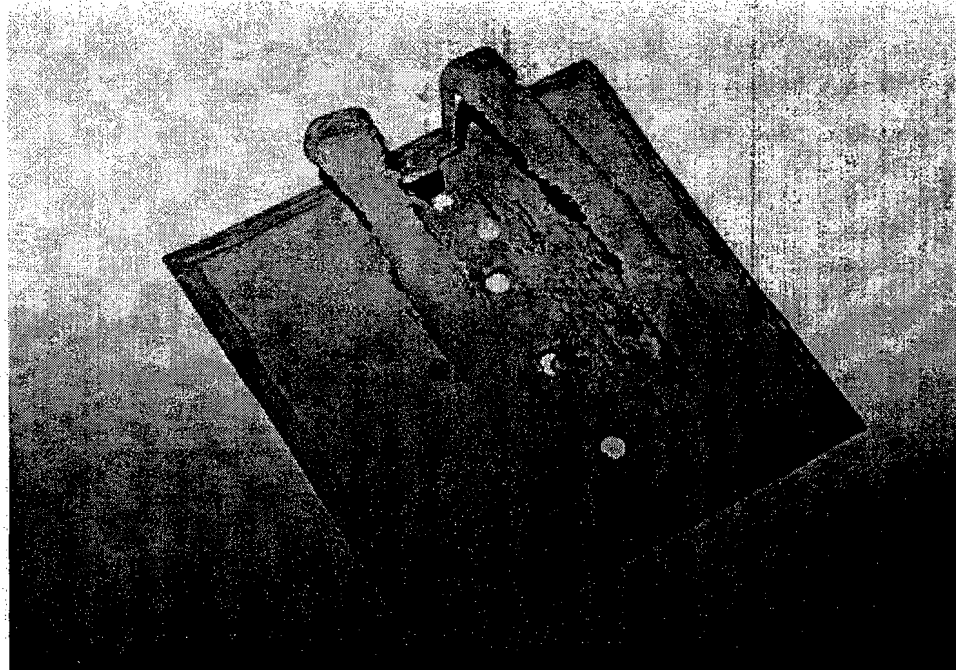
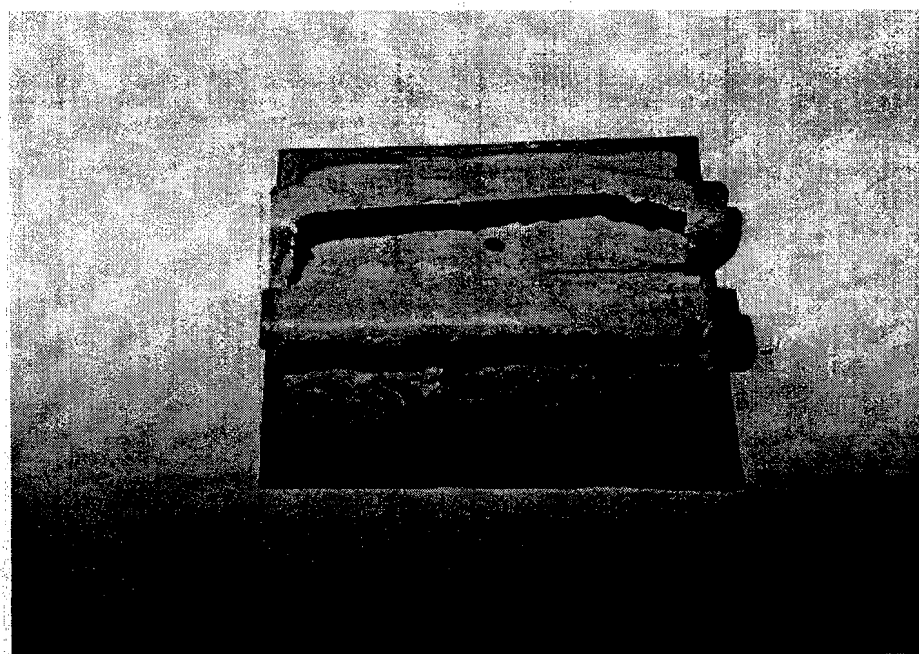
FIGURE 3. TEST ARTICLE FOR TEST 2 AFTER REMOVAL FROM PYREX PAN CONTAINING 1 LITER OF CONCENTRATED HYDROCHLORIC ACID, TWO VIEWS

A 6- by 6-inch section of the skin, including the frame material, was placed in a Pyrex pan with the outside surface of the skin face down. All cut edges of the test sample were covered with epoxy paint. One liter of concentrated HCl was spilled into the Pyrex pan. The depth of acid was 1 1/4 inches. Periodically the section of skin was lifted out of the solution with metal tongs to visually evaluate the damage as a function of exposure time. The test specimen was rinsed with tap water at the conclusion of the test and photographed (figure 3).

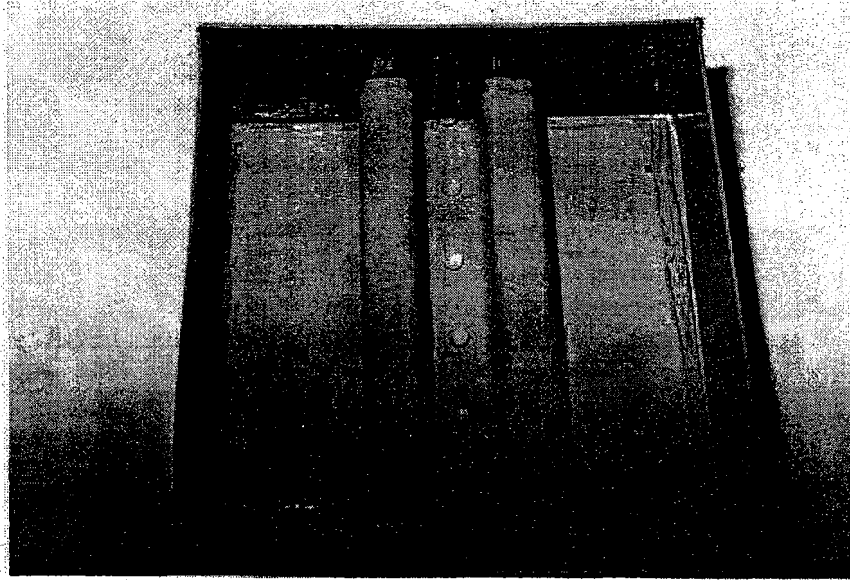
FIGURE 4. TEST ARTICLE FOR TEST 3 PRIOR TO ACID SPILL

A 7- by 7-inch section of aluminum skin was used as the base of a box (figures 4, 5, and 6). All cut edges of the test sample were covered with epoxy paint. The test specimen was caulked to the bottom of a shallow aluminum box with silicone caulk. The bottom of the box was cut out to be slightly smaller than the test specimen resulting in a high-contact surface of the silicone caulk with both surfaces. An epoxy coated metal lid was caulked in place over the aluminum box. The lid contained two Teflon swagelok bulkhead unions. The box was pressurized with nitrogen from 0 to 2.5 psi.

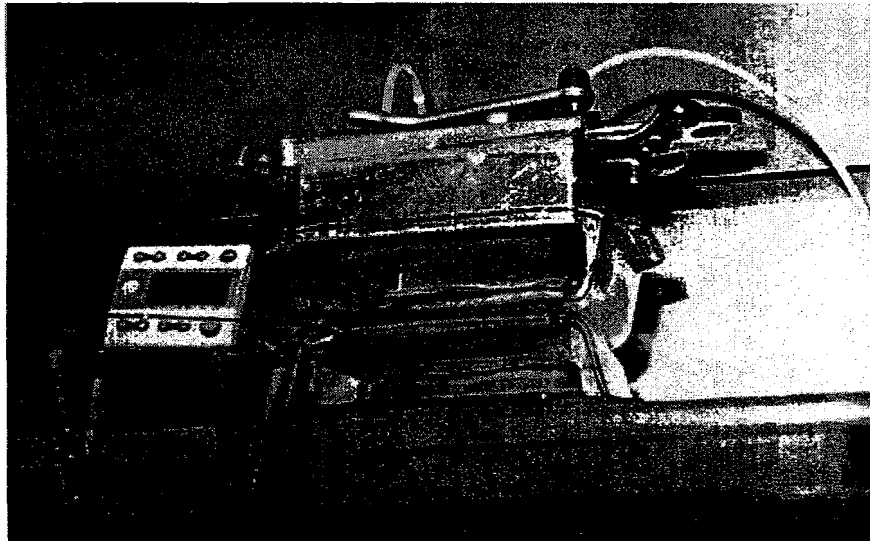
FIGURE 5. TEST 3 IN PROGRESS WITH A 1-LITER SPILL OF CONCENTRATED HYDROCHLORIC ACID

A 2.5 psi box pressure simulates the ΔP_{skin} at 15,000 feet altitude. A small ΔP may result in the blowout of the white exterior epoxy paint on the bottom of the box when the rivets fail, giving a visual indication of failure. However, the silicone lid seal failed early into the test and pressure fell to ambient.

One liter of concentrated HCl was poured into the test box through a funnel placed in the swagelok fitting. The depth of acid was 1 1/4 inches. The box was maintained initially at 2.5 psi with a nitrogen purge. The purge flow ranged from 0.2 to 2 liters per minute. The intent of the purge was to prevent the buildup of dangerous hydrogen gas, a decomposition product of the reaction of HCl and aluminum. Box pressure was maintained with a needle valve plumbed downstream of the box.

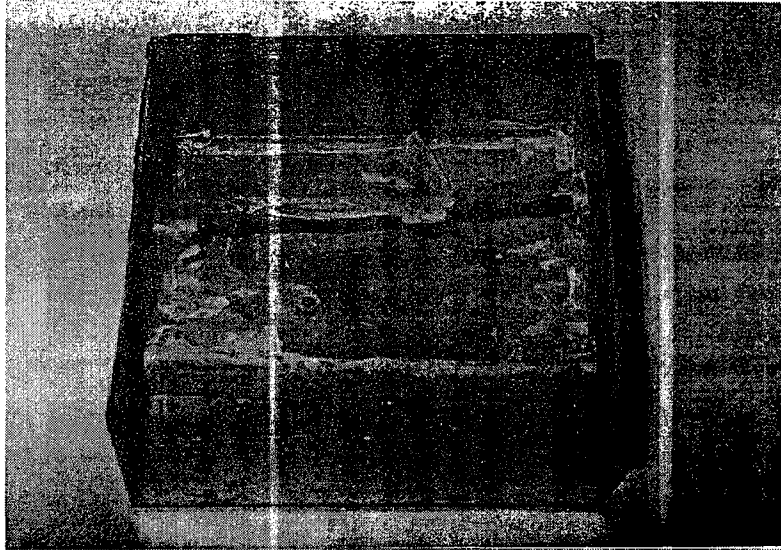
FIGURE 6. TEST ARTICLE FOR TEST 3 AFTER A 90-MINUTE CONTACT WITH SPILLED CONCENTRATED HYDROCHLORIC ACID. TOP OF TEST CONTAINER REMOVED.

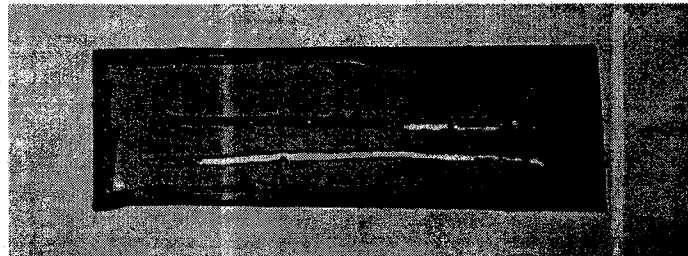
FIGURE 7. TEST ARTICLE FOR TEST 4. SCRATCHED B-747 SKIN AFTER REMOVAL FROM PYREX PAN CONTAINING 1 LITER OF CONCENTRATED HYDROCHLORIC ACID.

4	One scratched strip of aluminum skin, 2" x 6 3/4" in a 7" x 7" Pyrex pan	At scratches	60-90	Acid created hole through the aluminum skin along the scratch. The white exterior epoxy paint was wrinkled, but the seal remained intact.	7
