**Experimental Feature Evaluation
 December 2022**

Experimental Feature:	Sprayroq – SprayWall Polyurethane Applied Culvert Lining
Location:	Missoula District, Mineral County, Interstate 90, RP 59.0, Nemote Creek
MDT Project Name:	I-90 Nemote Creek Culvert
MDT Project Number:	IM 90-1(205)59
Experimental Project Number:	MT-13-14
Principle Investigator:	Chad DeAustin, Experimental Project Manager (ExPM)
Construction Date:	February 2017
Date of Inspections:	April 2017, April 2018, March 2020, September 2021, July 2022

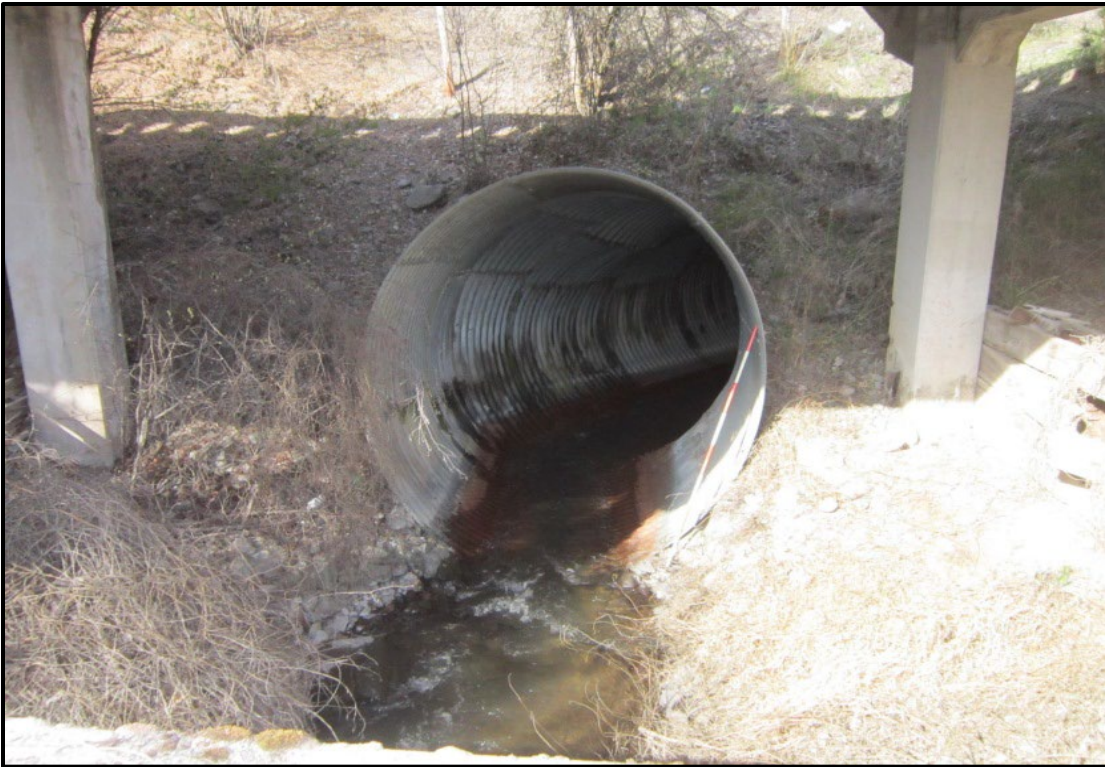
↑ Upstream culvert inlet view, east end.

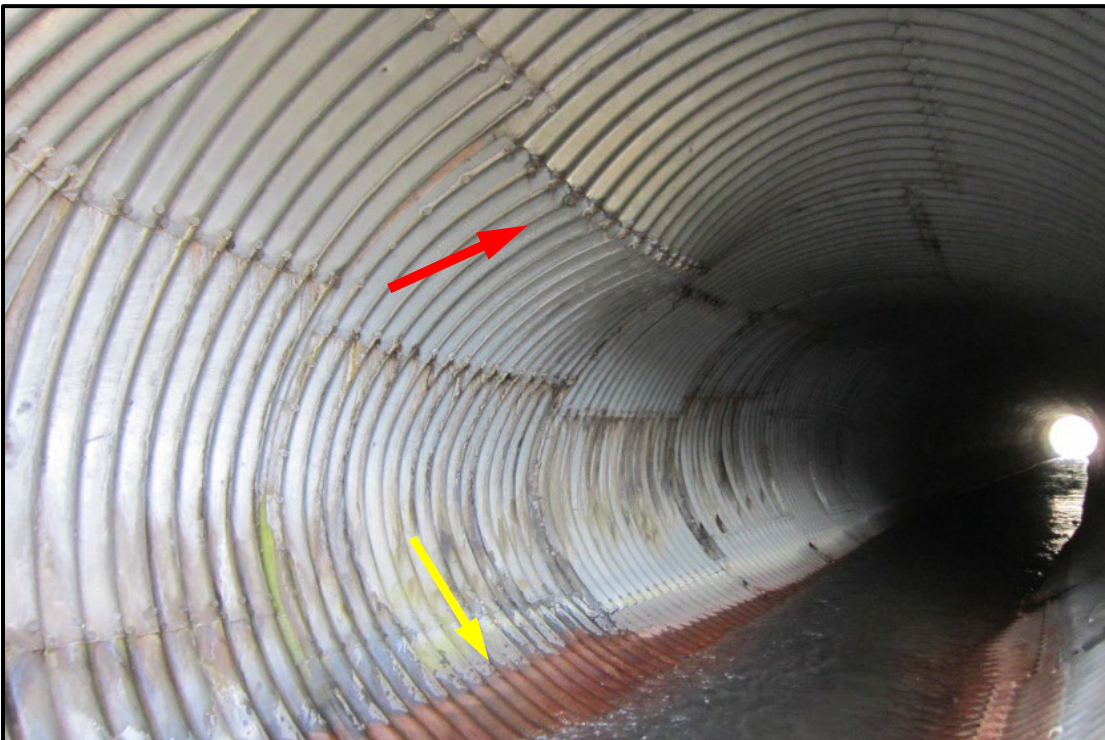
↑ Representative image of the observed sagging in the top panels of the steel plate arch culvert. Deflection estimated at six inches inspected in 2014 (red). Corrosion also apparent at the base of the culvert (yellow).

During project development, Sprayroq representatives inspected the culvert and provided SprayWall application recommendations based on repairing the deflection of the culvert. After discussions with the contractor, it was decided to not repair the deflection. Sprayroq engineers recalculated the application of the SprayWall for the new site parameters.

The original calculation, with the ovality of 9%, was an application rate of 412 mil thickness. With the change in parameters, a new ovality was used of 19.2% resulting in a new mil thickness of 555. For safety purposes, Sprayroq recommended 750 mils for the deflection and area within two feet then tapering to the original design thickness over the remaining area.

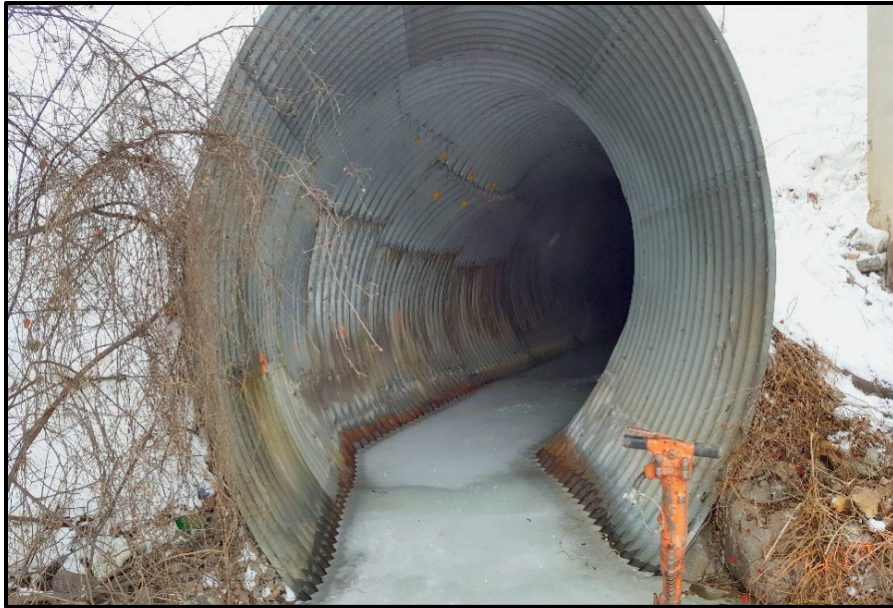
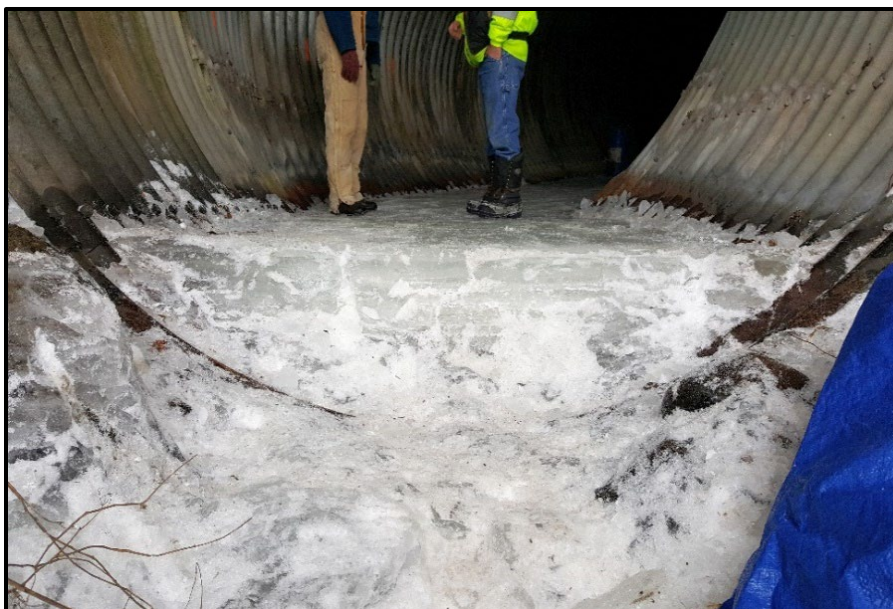
↑↓ The contractor elected to perform the work during the coldest month of winter when the stream was fully frozen. With the intent to remove the ice, then to dry the culvert with high heat to allow the preparation work required prior to the SprayWall application. Shown are representative images of the progress of removing ice from the culvert. Jackhammers, shovels, and picks were used to break up nearly two feet thick ice.

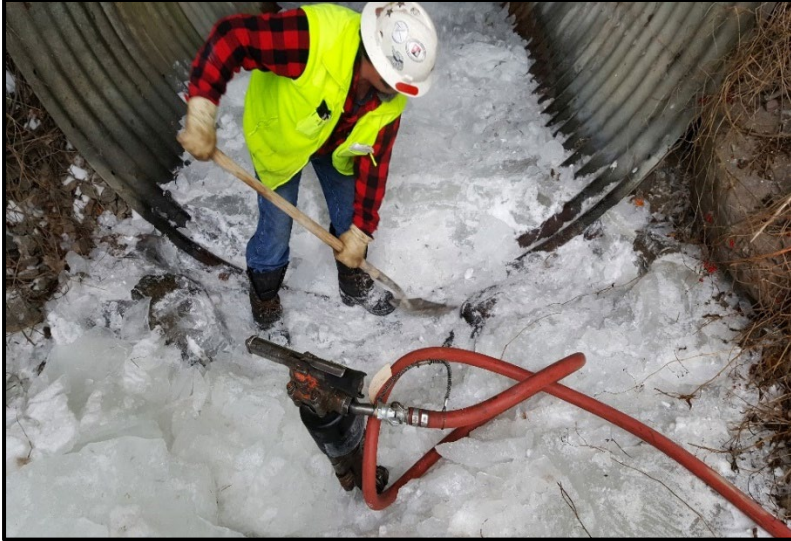
↩️ More images of ice removal.

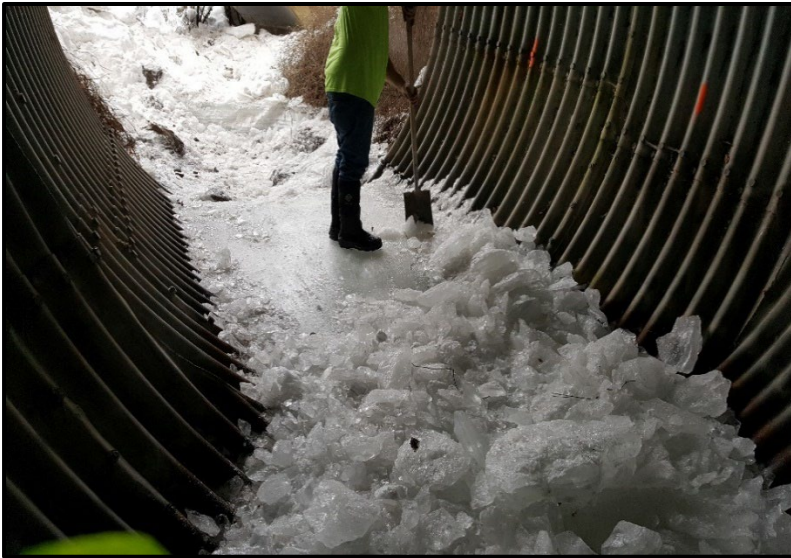
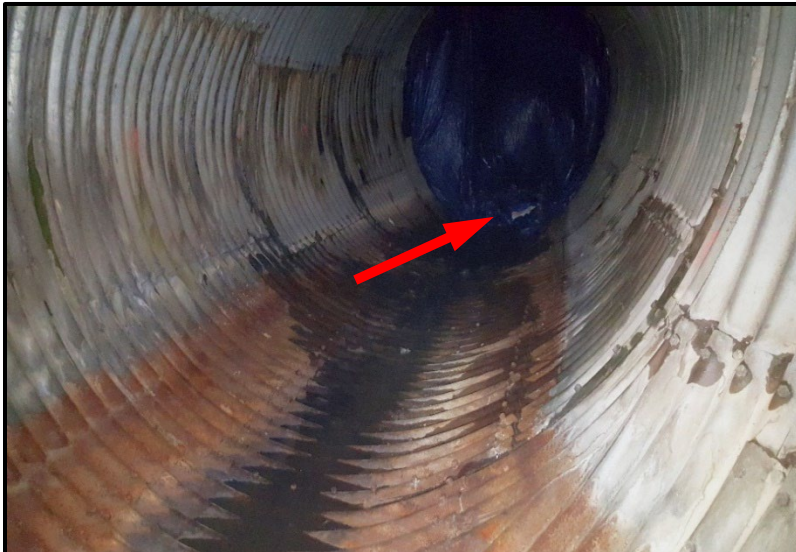
↩️ Ice removal complete and culvert is now ready for preparation phase. The red arrow highlights the placement of tarp with sandbags beyond the rehab area to block air flow and water from entering the clean and dry section of pipe.

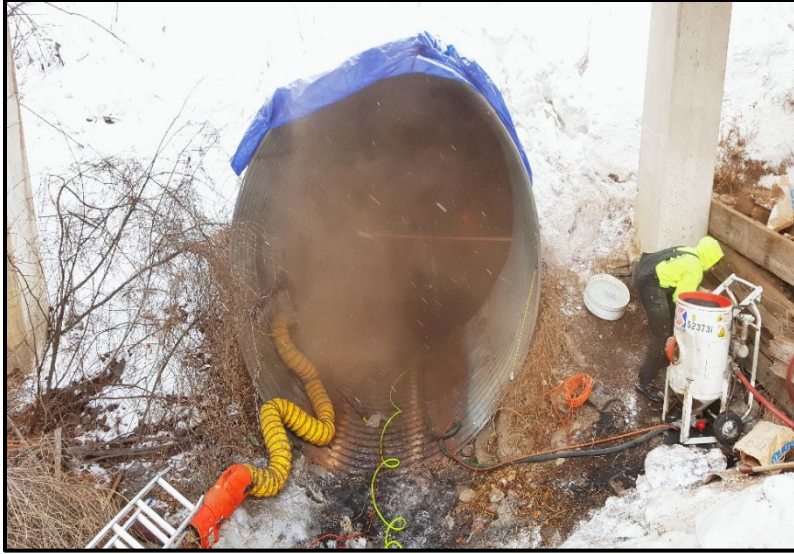
↙ The base of the culvert where corrosion took place is sand blasted (Kleen Blast Abrasives) to bare metal and vacuumed clean.

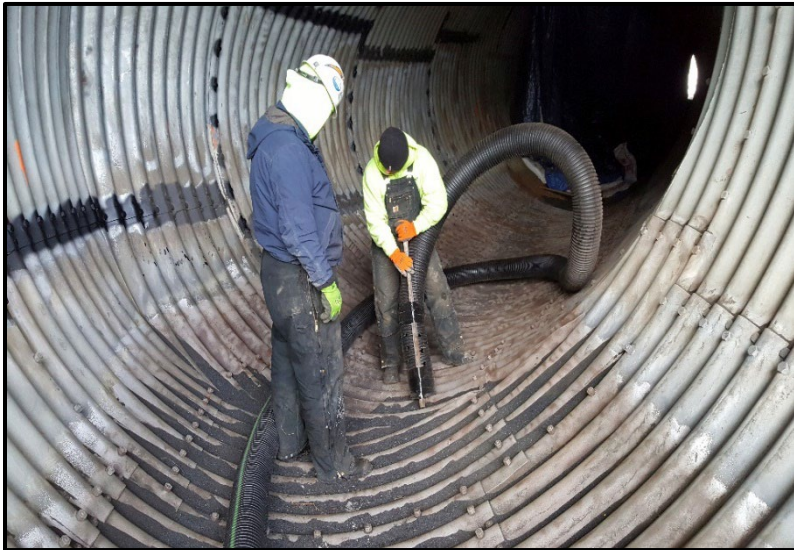
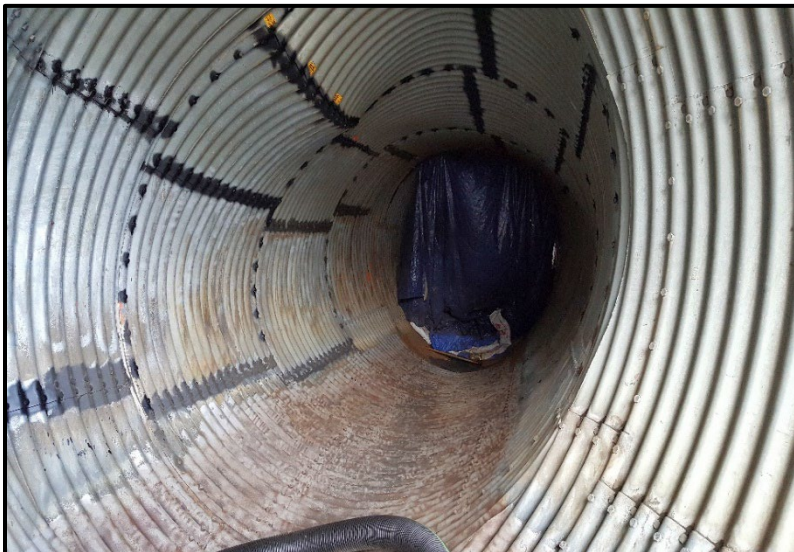
↙ The culvert interior after sand blasting.

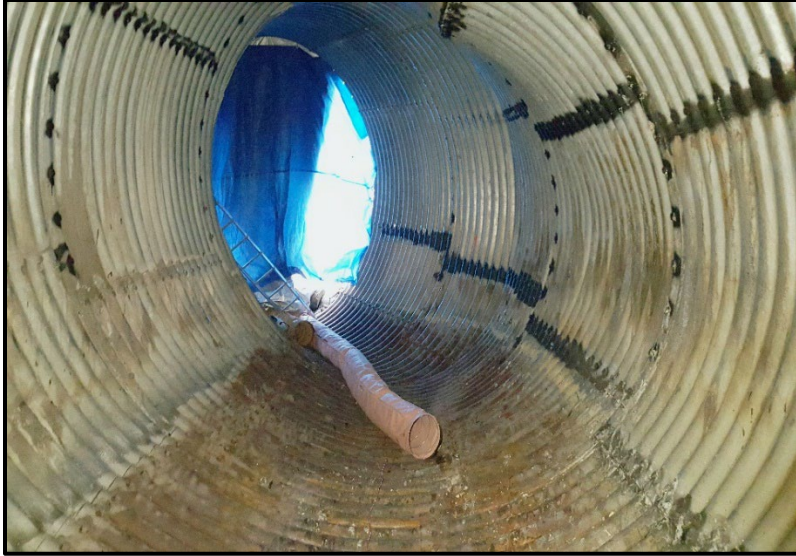
← Warm air is circulated within the prepared section of culvert. Ambient air and surface temperature must be above 60 degrees for adequate adhesion of the polyurethane coating.

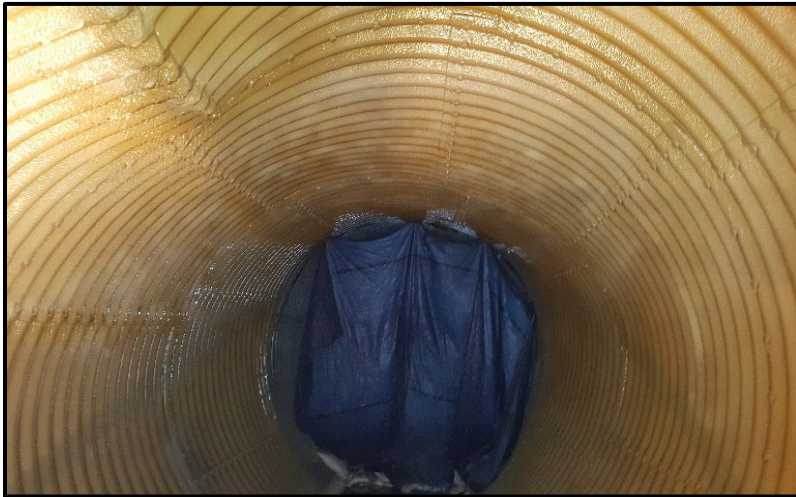
← View of SprayWall coating near end of rehab section after full cure. As a rule, SprayWall begins to gel in about 8 seconds, with a tack-free condition after 2 minutes. Within 60 minutes, the initial cure is complete, and the structure can accept flow, while complete curing continues over the next 72 hours based on ambient temperature.
