**Experimental Feature Final Report
 December 2022**

Experimental Feature:	Tencate-MIRIFI MPV400 Polypropylene Nonwoven Geotextile
Location:	Great Falls District, Cascade County, City of Great Falls, U-5201 Smelter Ave. NW – 5 th St NW to 1 st St NW
MDT Project Name:	Smelter Ave – 1 st to 5 th St NW
MDT Project Number:	UPP 5201(24)
Experimental Project Number:	MT-17-03
Principle Investigator:	Chad DeAustin, Experimental Project Manager (ExPM)
Construction Date:	August 2017
Date of Inspections:	April 2018, April 2019, April 2020, September 2021, May 2022

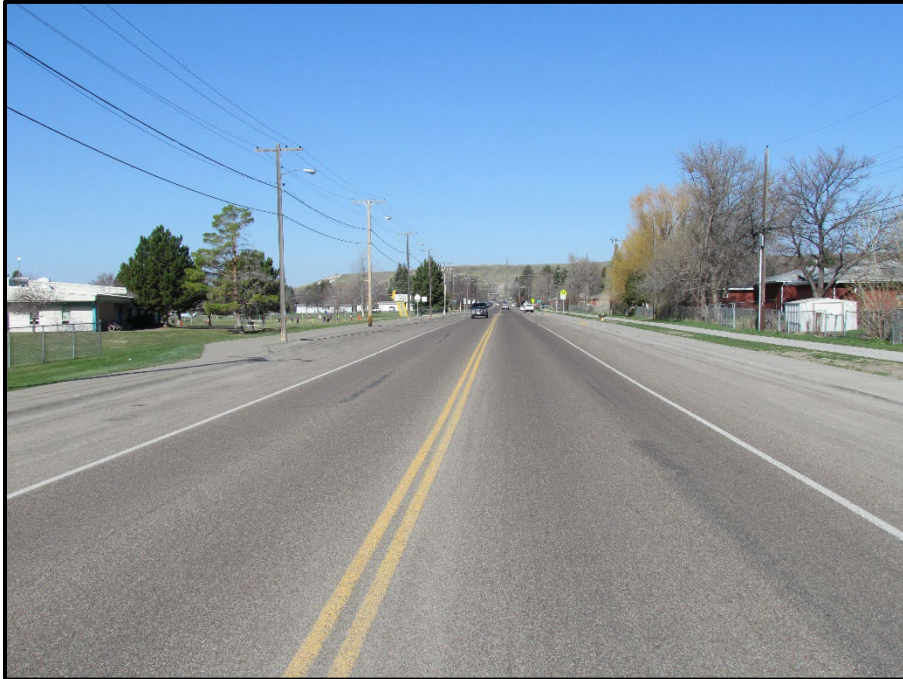
← East end of project;
view west.

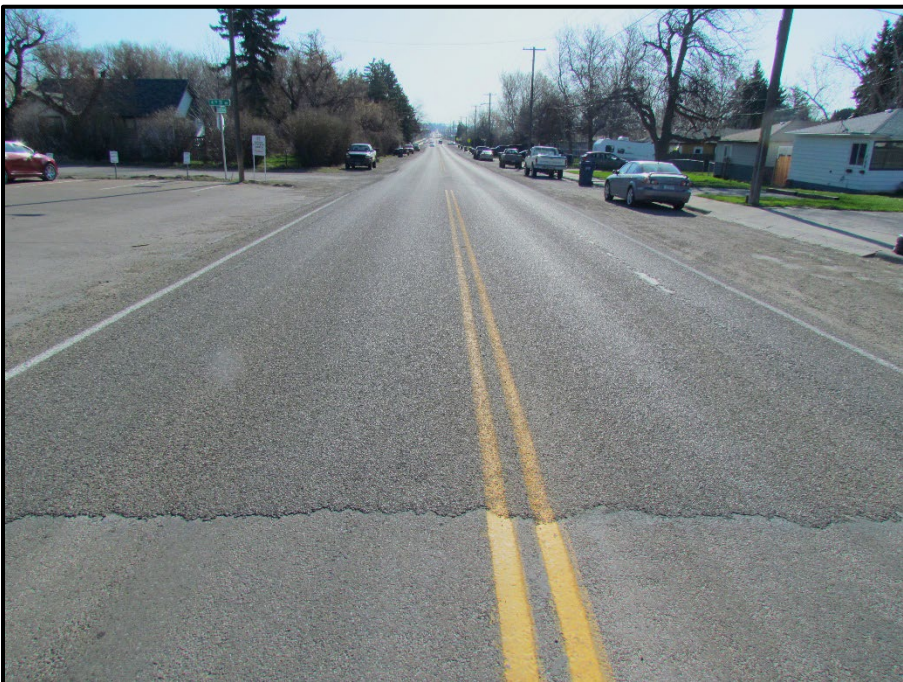
← West end of project;
view east.

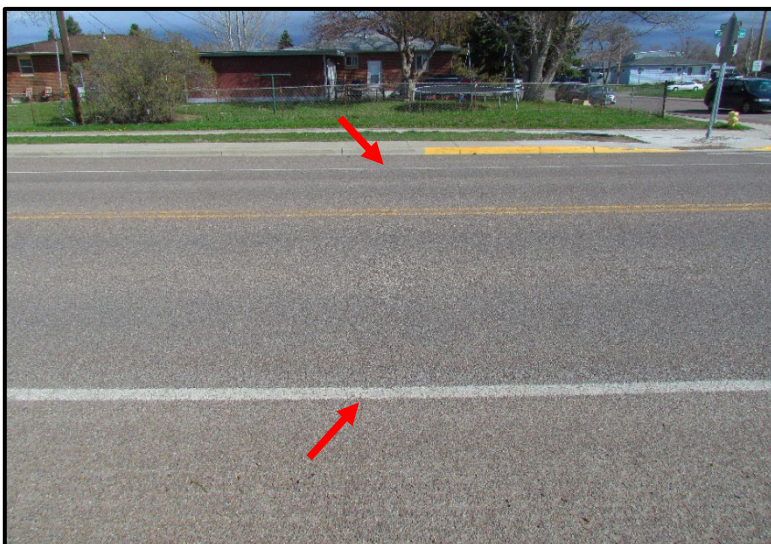
← Although difficult to see in this image; one low-severity longitudinal crack has appeared on the project near Riverview Blvd intersection (red arrows).

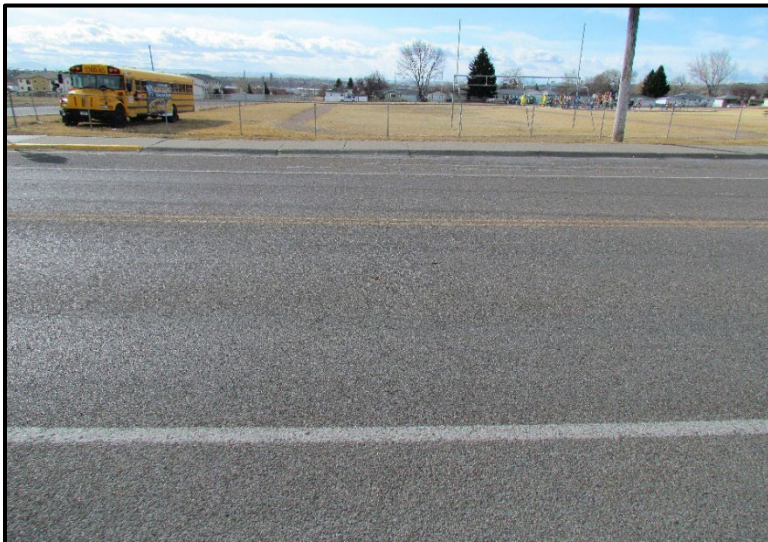
← Transverse view of pavement.
