PRESSURE RELIEF AND OTHER JOINT REHABILITATION TECHNIQUES

FINAL REPORT

February, 1987

7. Author(s) K. D. Smith, M. B. Snyder, M. I. Darter, M. J. Reiter, K. T. Hall	8. Performing Organization Report No.	
9. Performing Organization Name and Address ERES Consultants, Inc. P. O. Box 1003 Champaign, IL 61820	10. Work Unit No. (TRAIS)	11. Contract or Grant No. DTFH61-83-C-00111

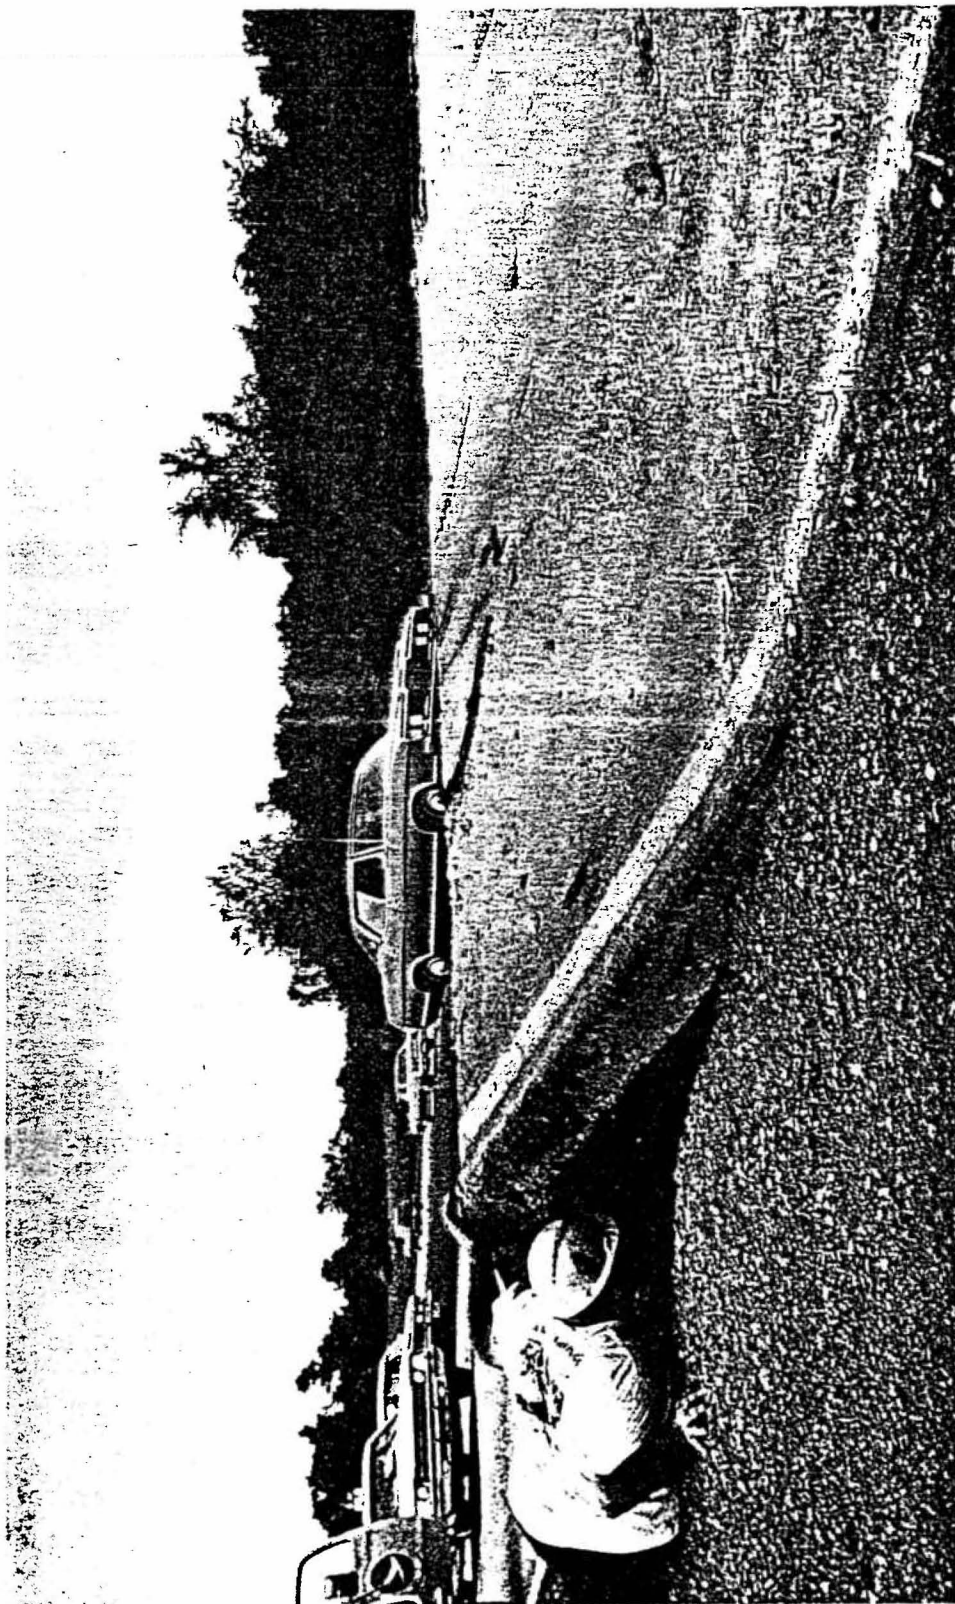
Figure 1. Blowup on Ohio 21, Summit County, 1975.
(Photograph, Akron Beacon Journal)

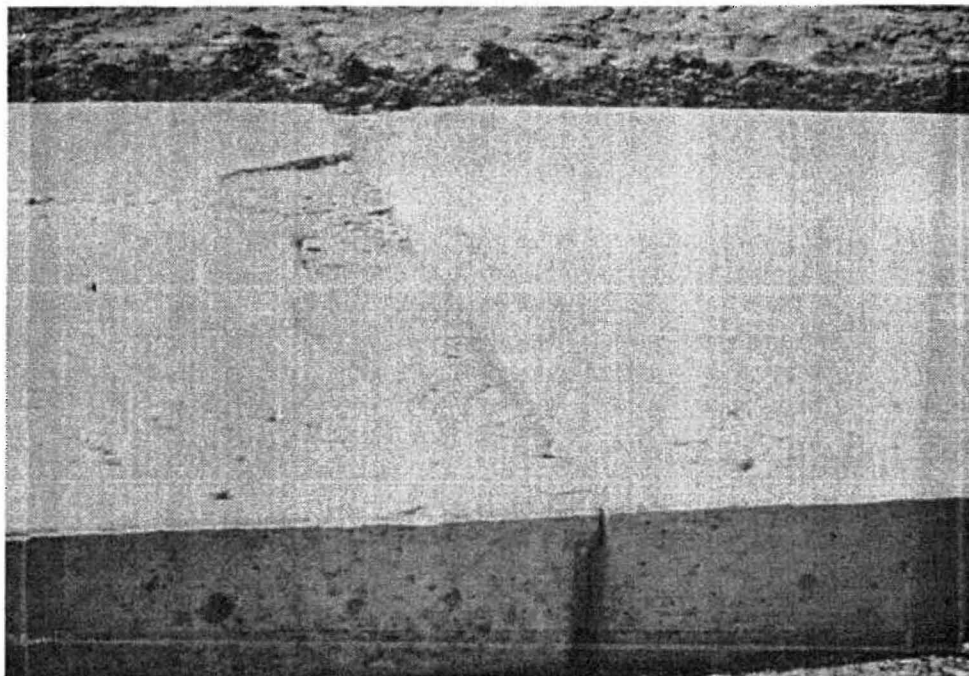
Figure 3. Photo of Pressure-Induced Spalls.

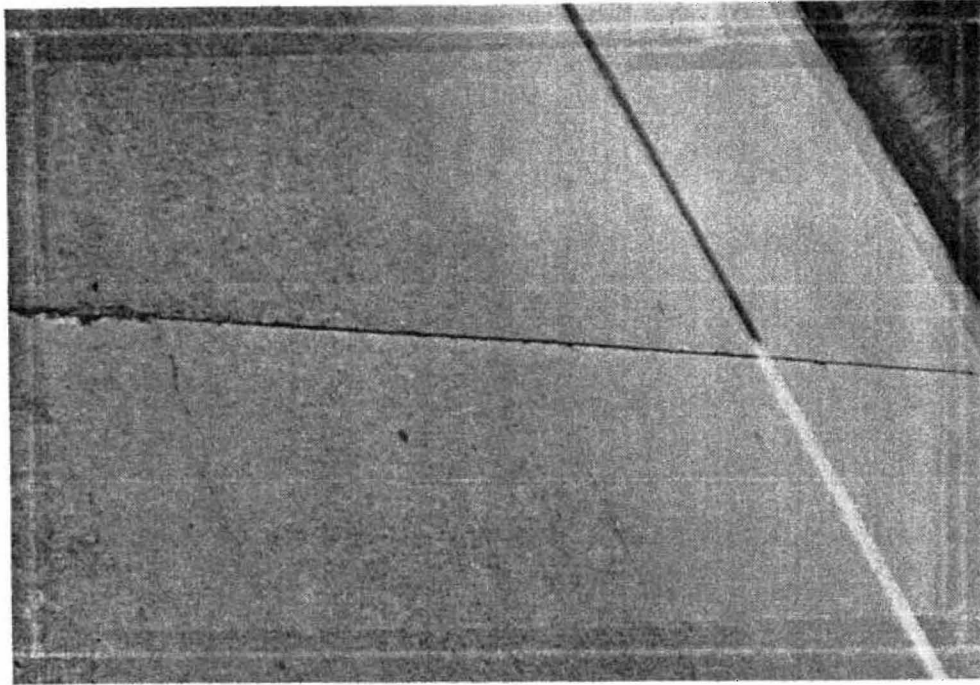
Figure 4. Photo of Spalls Caused by Differential Vertical Movement.

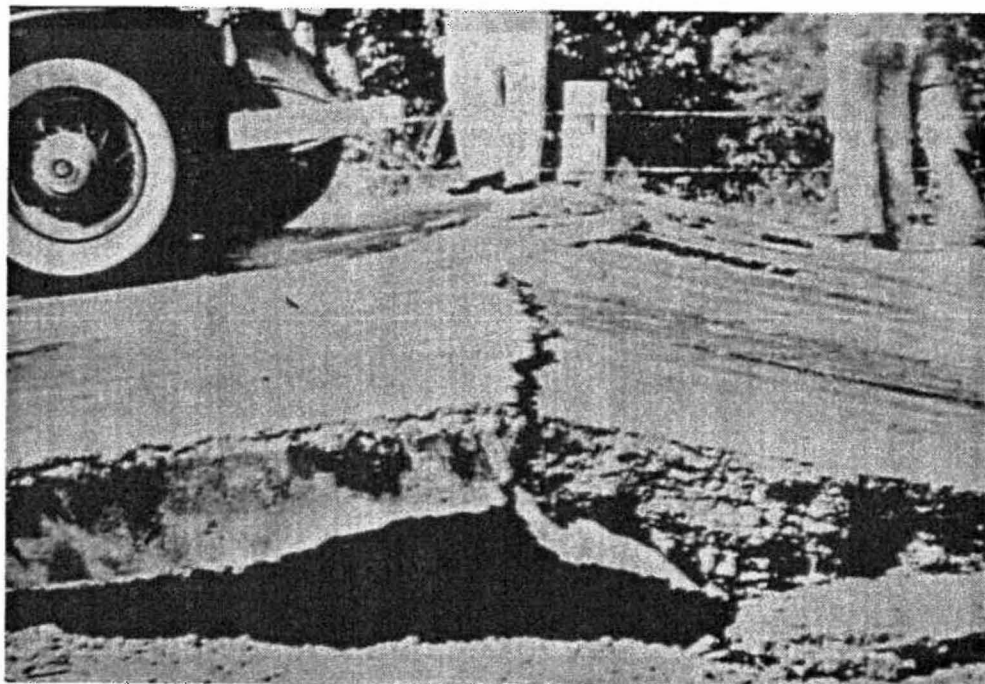
Figure 5. Photo of Blowup (Localized Vertical Movement).

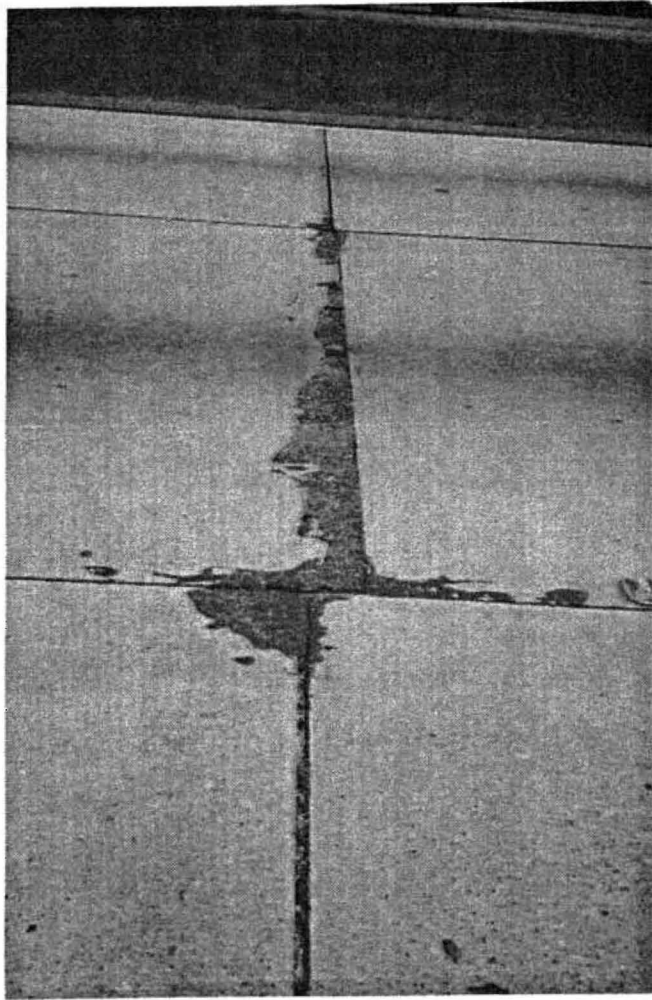
Pressure damage may continue after relief joints have been installed. The New York DOT has documented projects where the longitudinal joint ties have sheared as the traffic lanes moved independently (see Figure 7).

Figure 7. Photo of Traffic Lane Movement After Placement of Relief Joints.

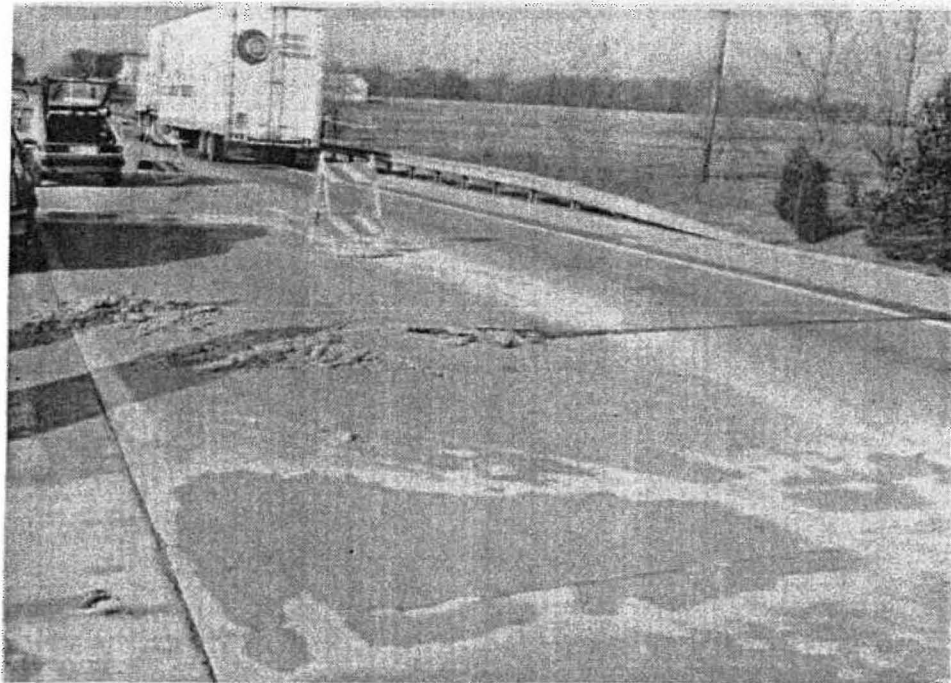
Figure 25. Blowup in Inner Lane Due to Relief Joint Placed in Outer Lane (Courtesy of Kentucky Department of Highways).

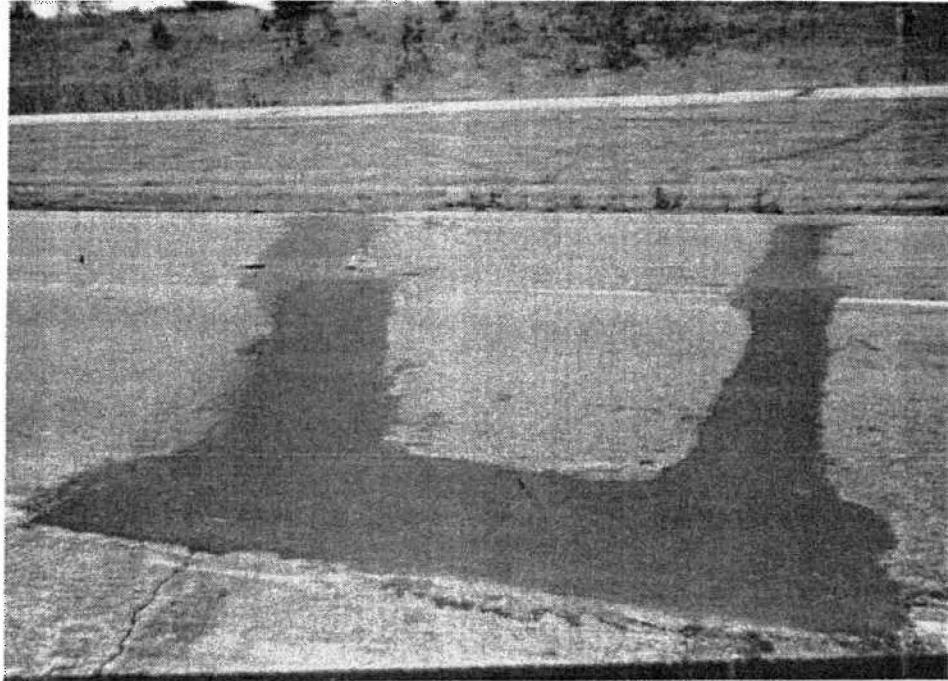
The pressure relief joints seem inappropriate for this project because there were no signs of pressure buildup problems and the installation of the full-depth repairs at every joint should have alleviated any built-up pressure.

Figure 26. Photo of AC Repairs Above Pressure Relief Joint and Regular Contraction Joint on OH071210.

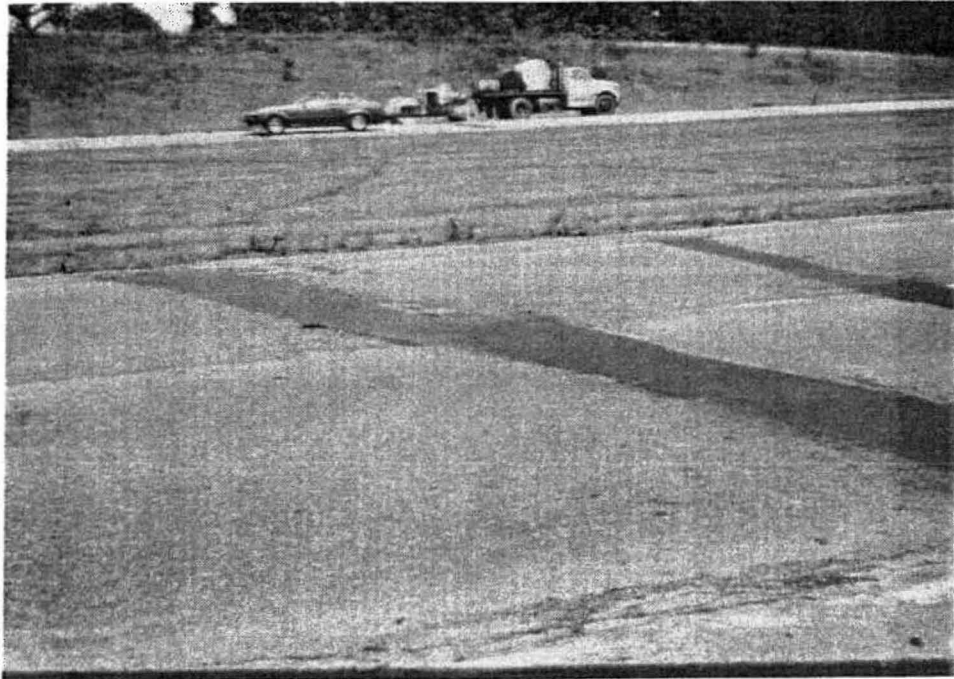
Figure 27. Photo of Skewed Pressure Relief Joint on OH071210
(Same Relief Joint as Shown in Figure 26).

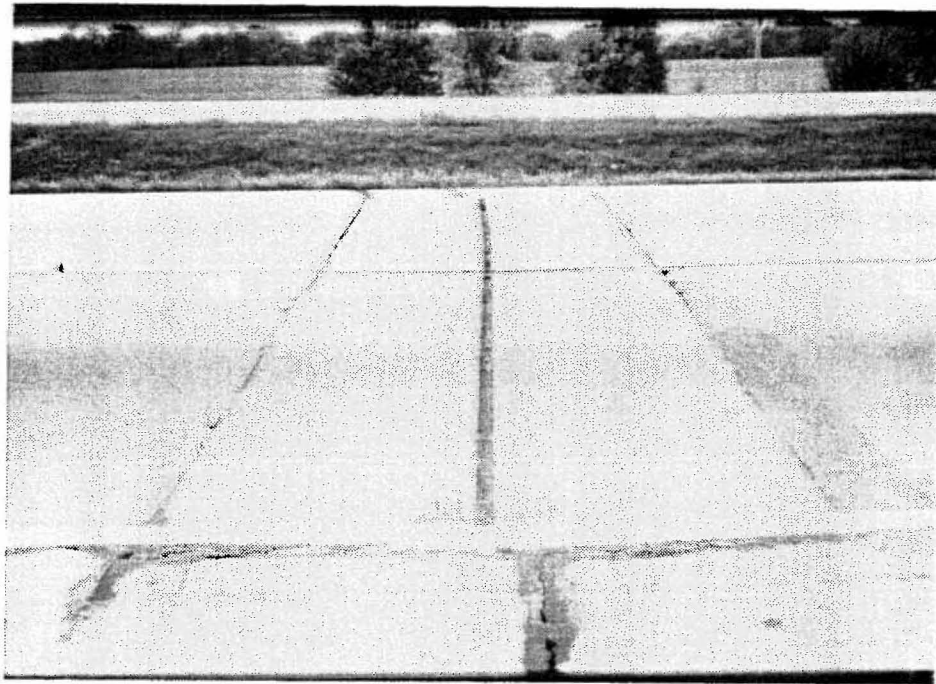
The "heavy-duty" pressure relief joints installed in 1975 have performed well in that they have withstood 10 years and approximately 10 million 18-kip [80-kN] ESALs without exhibiting excessive faulting or

Figure 28. Photo of Pressure Relief Joint Constructed on IL055252 (Sample Unit 1, Station 4+50).

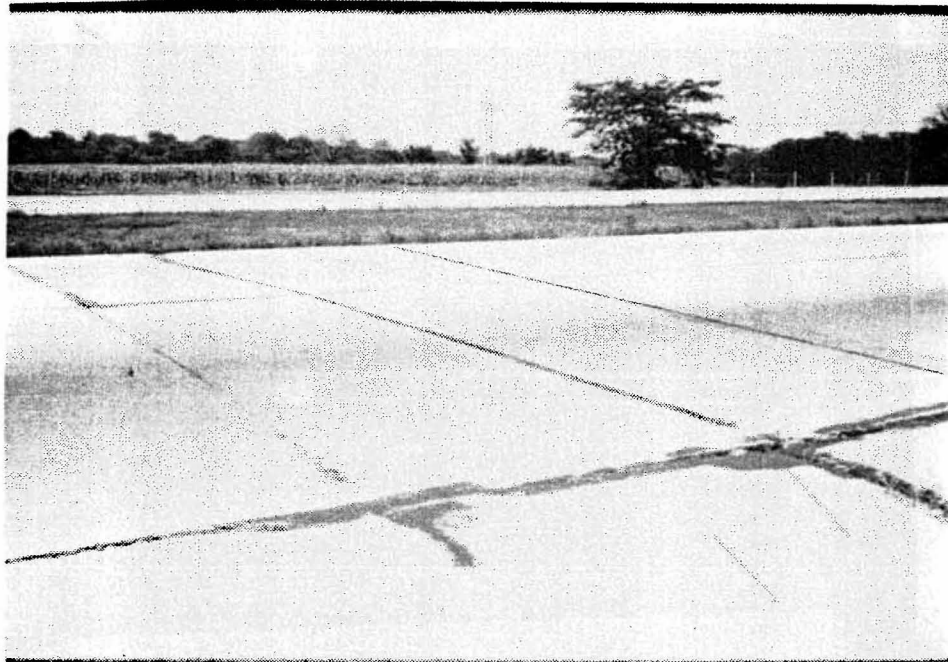
Figure 29. Photo of Pressure Relief Joint Constructed on IL055252 (Sample Unit 2, Station 2+00).

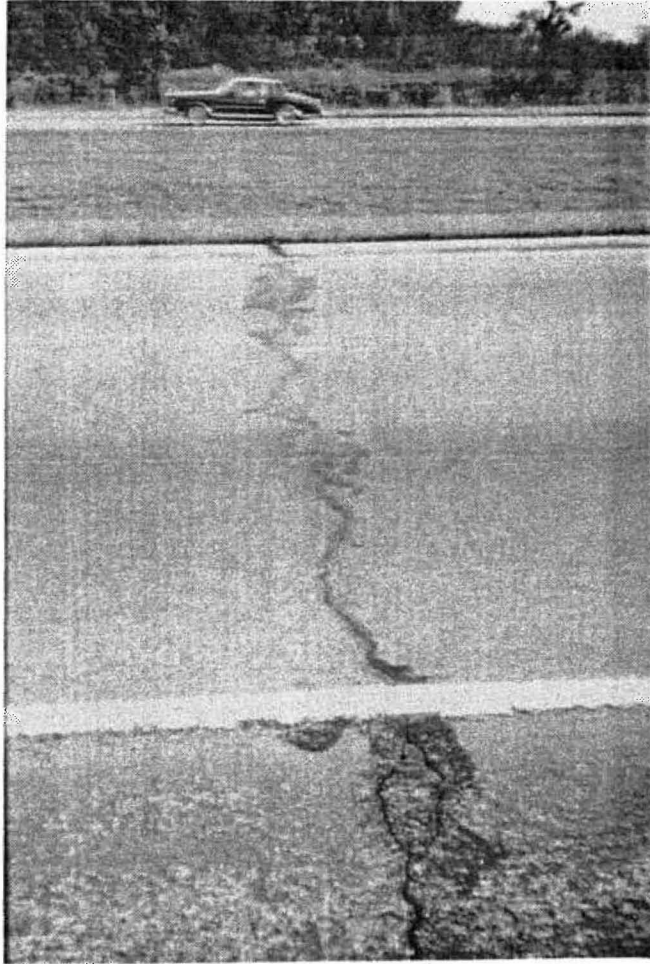
Figure 31. Photo of Sealed Crack Over Pressure Relief Joint on OH070066.

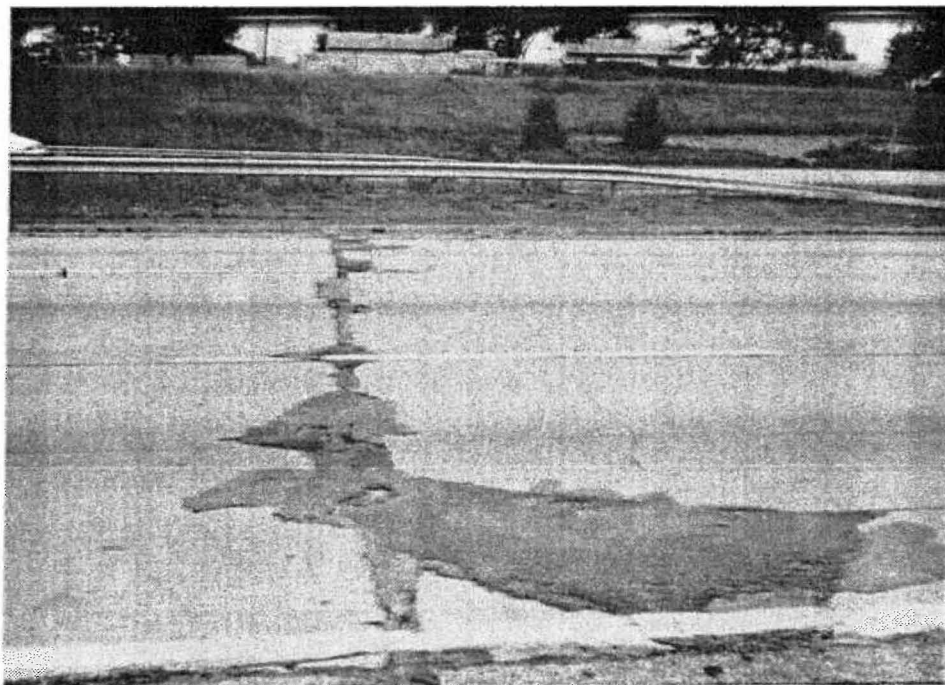
The pressure relief joints are exhibiting medium-severity joint and corner spalling and transverse cracks adjacent to the pressure relief joints have deteriorated from tight, nonworking cracks (typical of a CRC pavement) to spalled, working cracks (see Figures 32 and 33). Punchouts were more frequently located near the pressure relief joints.

Figure 32. Photo of Pressure Relief Joint on OH270029.

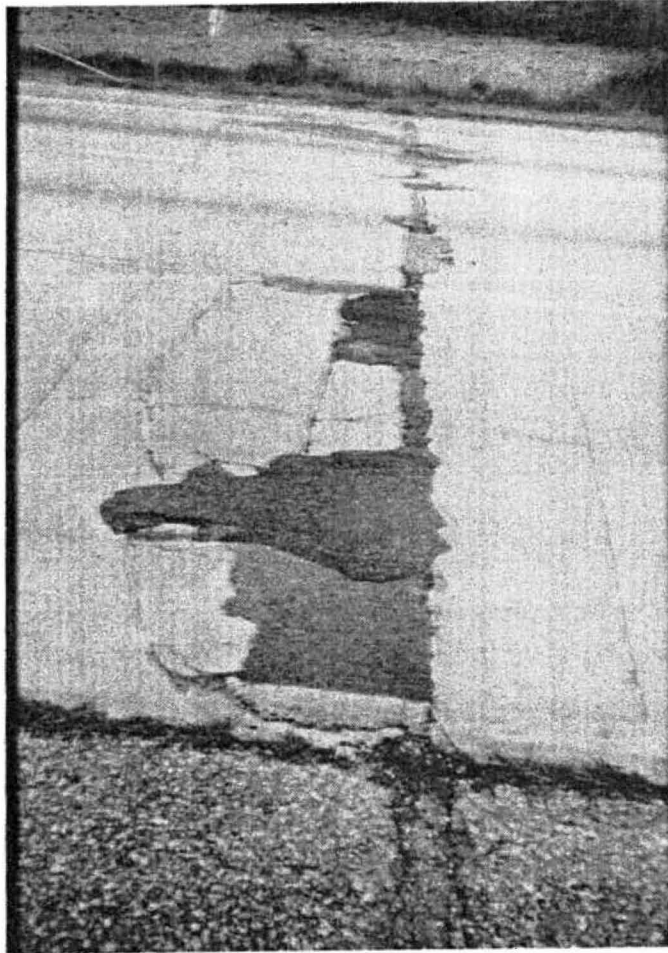
Figure 33 . Photo of Pressure Relief Joint on OH270029
(Same Relief Joint as in Figure 32).

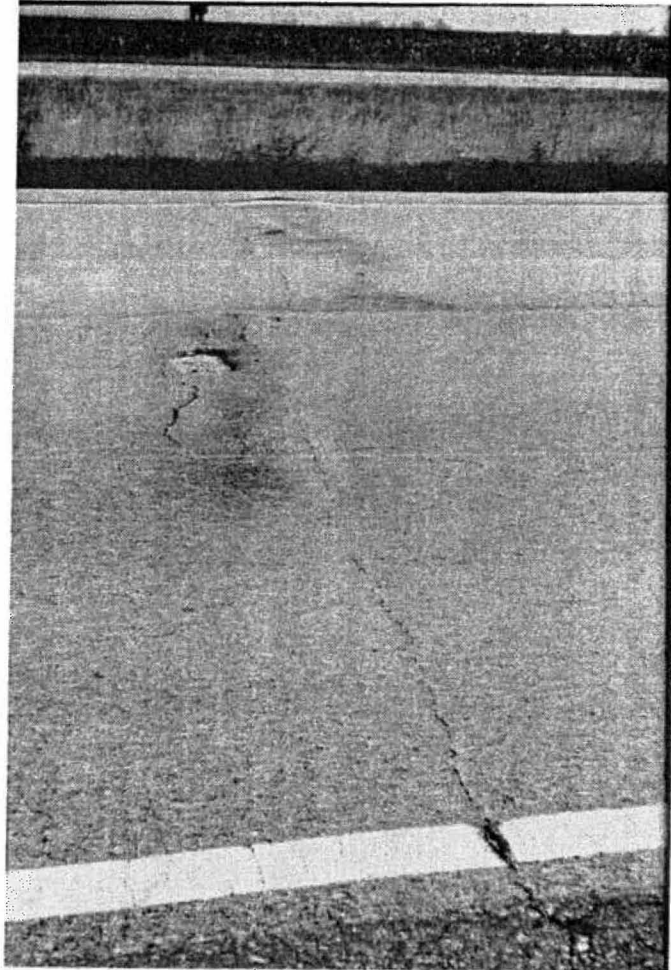
The pressure relief joints placed on this project are inappropriate because there are no signs that pressure buildup problems existed. Furthermore, the interruption of the continuous reinforcement can be

Figure 36. Photo of AC Overlay Above Pressure Relief Joint in Sample Unit 1 (Station 1+84) of IL072067.

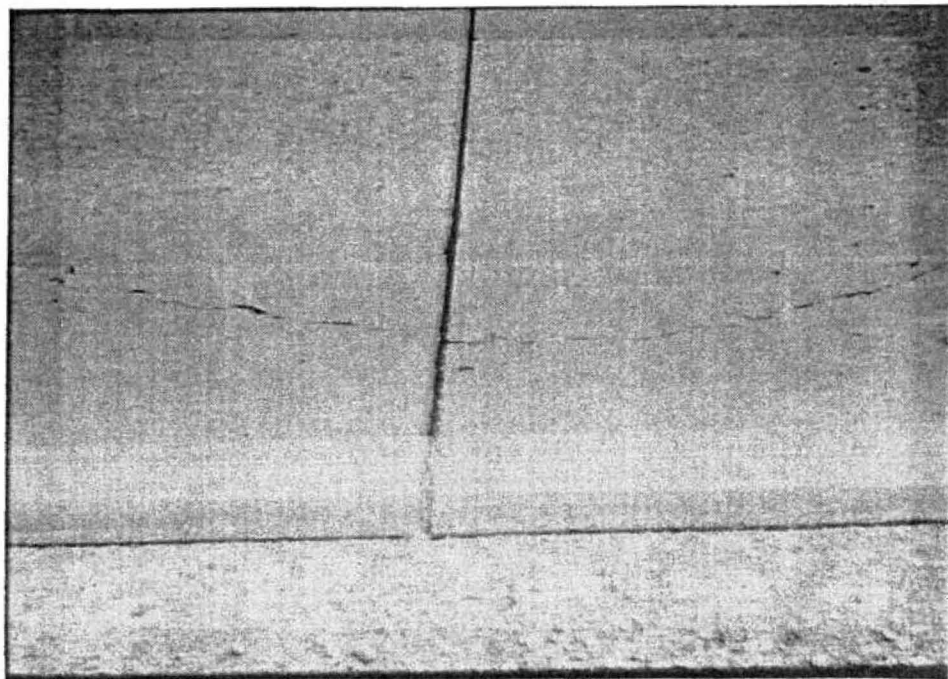
The pressure relief joints installed in 1980 were inappropriate for this project. They were placed to relieve pressure and prevent blowups and other pressure-related damage. However, since no pressure damage had previously occurred and the pavement has short joint spacing, it is doubtful that the a potential for pressure damage existed. It is unclear whether compressive stresses were building (e.g., did the observed longitudinal compression cracks form before or after 1980?) and, if so, whether the installation of pressure relief joints was the best approach to address the problem.

Figure 38. Photo of Regular Contraction Joint with Longitudinal Compression Cracks on IA030156.

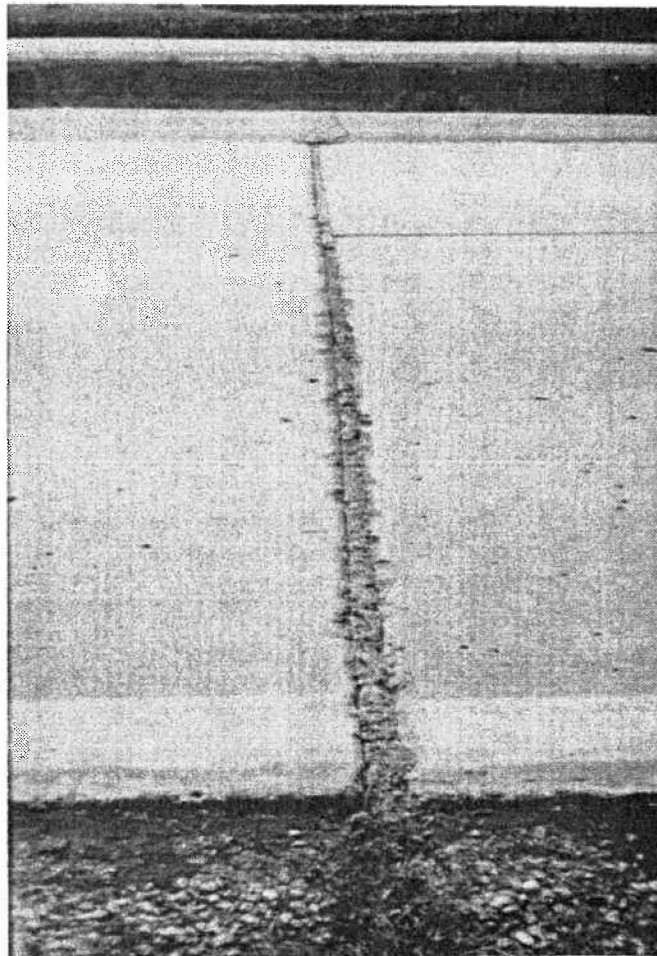
The pressure relief joints (excluding those located near bridges) have closed to an average width of 0.84 in [21 mm] and have faulted an average of 0.23 in [5.7 mm]. The filler is frequently absent and the joints are full of incompressibles (see Figures 41 and 42). Several of the relief

Figure 41. Photo of Pressure Relief Joint
Filled with Incompressibles on IA035086.

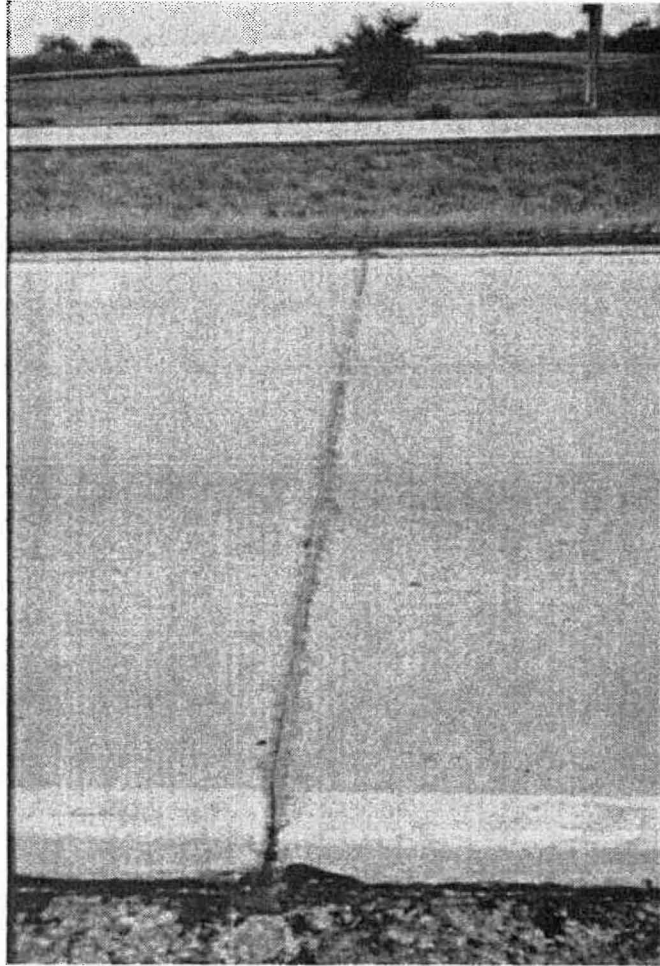
Figure 42. Photo of Pressure Relief Joint with Filler Intact on IA035086.

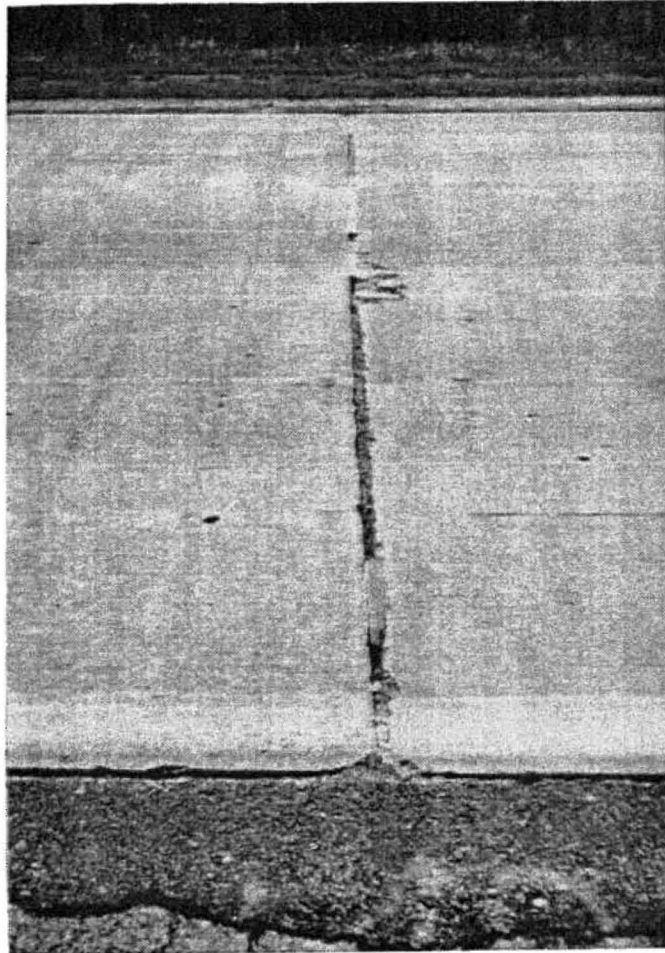
Figure 43. Photo of Pressure Joint on IL055102
with Medium- to High-Severity Spalling.

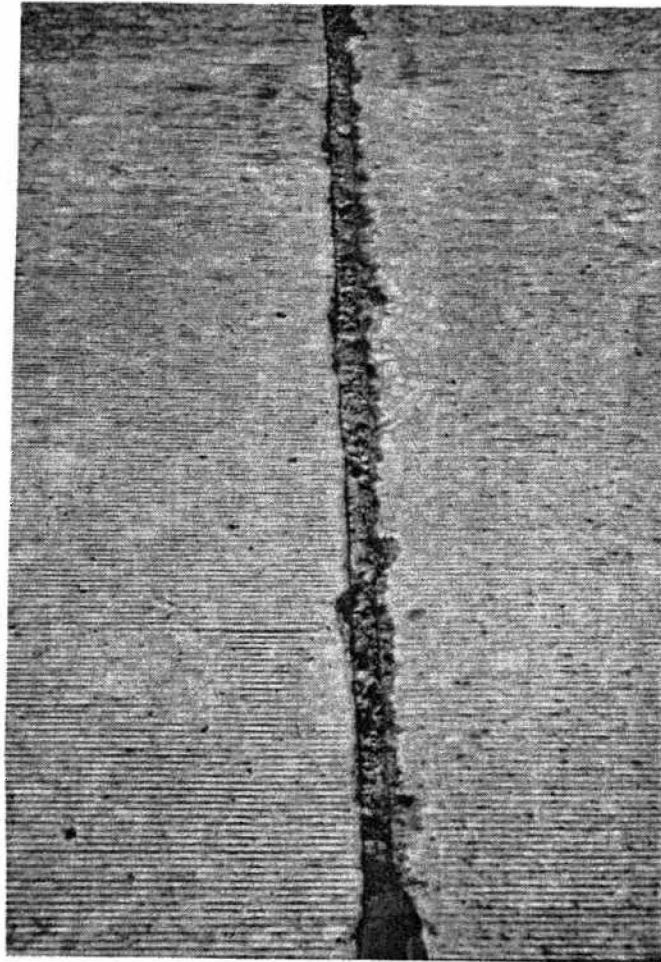
Figure 44. Photo of Pressure Relief Joint Filled with Incompressibles on IL055102.

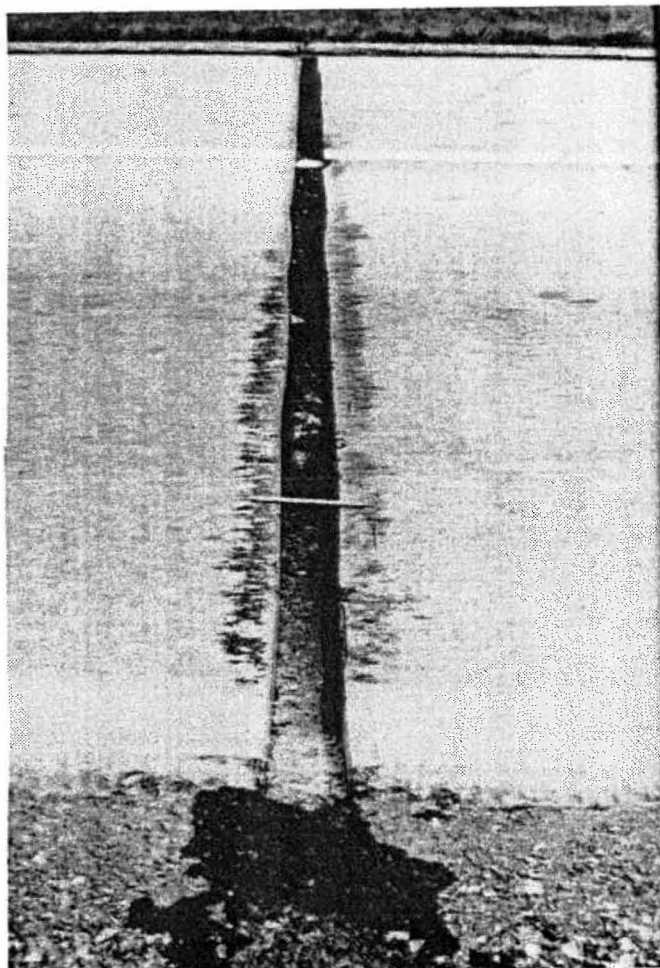
Figure 46. Photo of Pressure Relief Joint Filled with AC in Sample Unit 2 (Station 7+30) of IL080105.

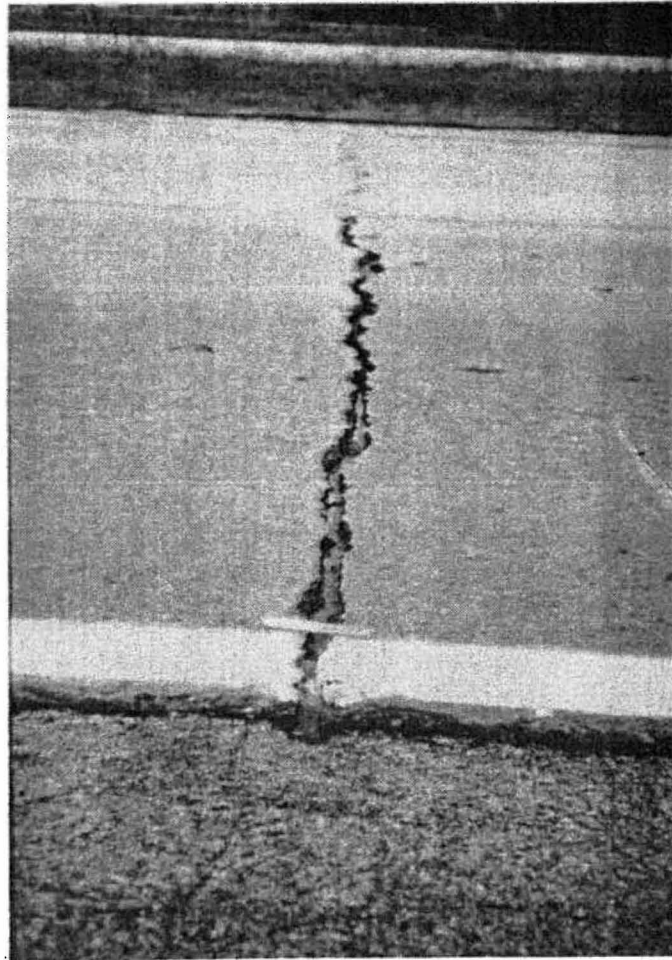
Figure 49. Photo of High-Severity Crack in Sample Unit 3
(Station 9+60) on MI127.

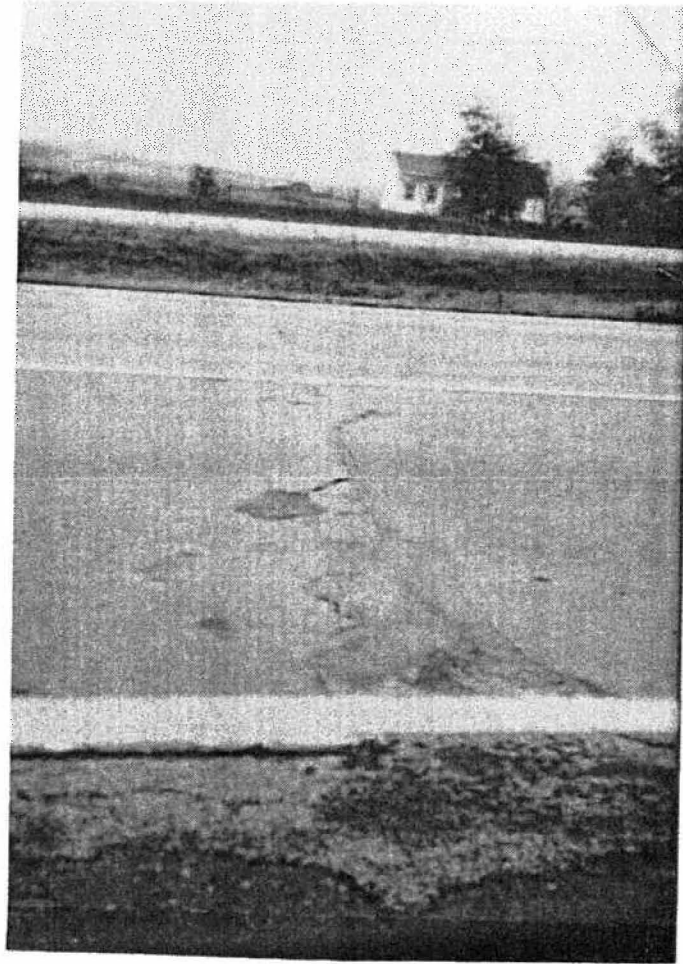
Figure 50. Photo of Regular Contraction Joint in Sample Unit 5
(Station 4+06) on MI127.

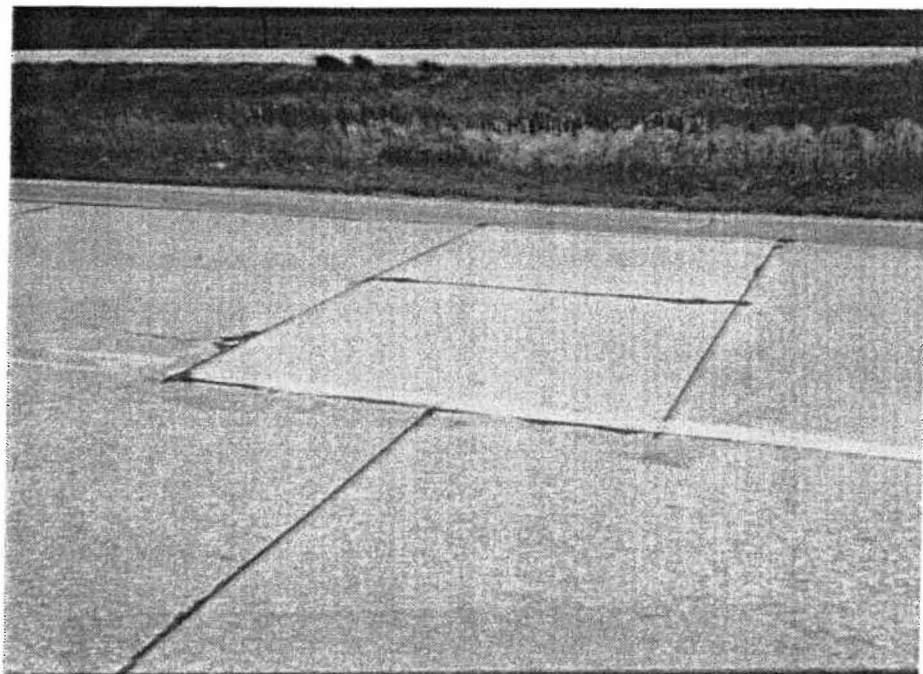
Figure 82. Photo of Full-Depth Repair on NE080404.

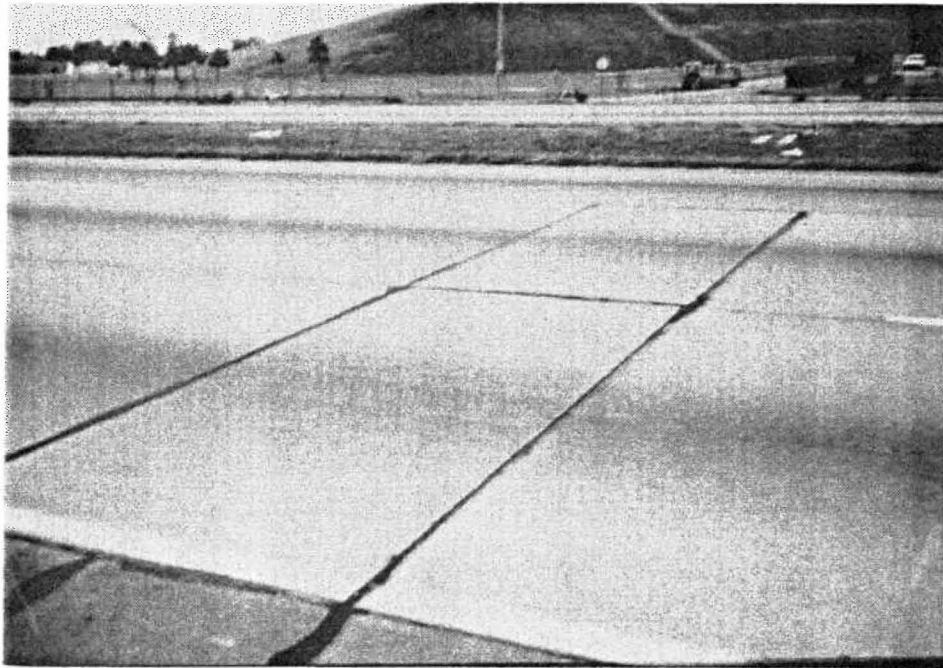
Figure 86. Photo of Typical Full-Depth Repair on VA044000.

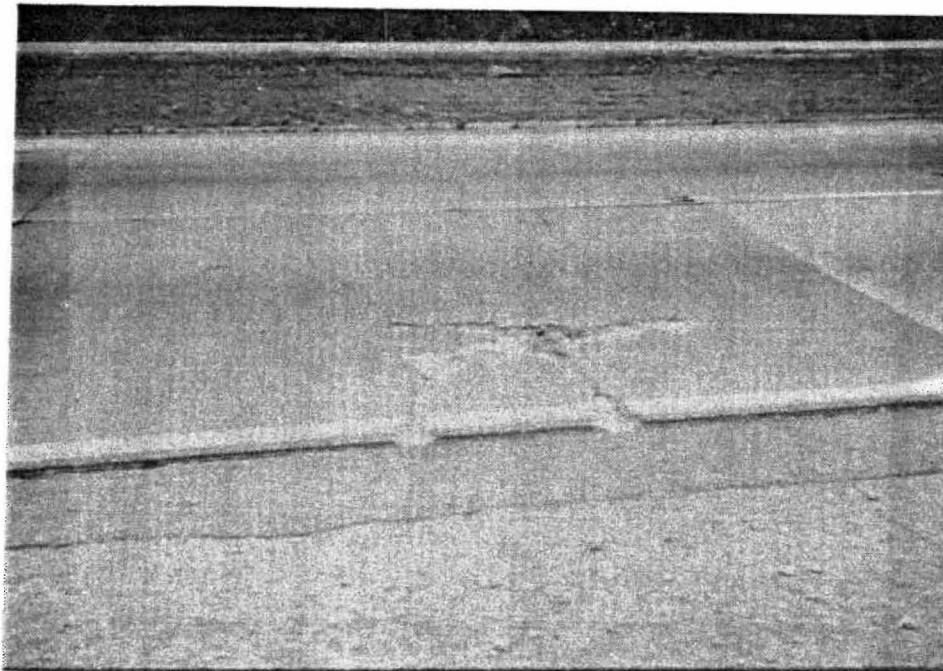
Figure 92. Photo of 1982 Full-Depth Repair with Slab Cracking and Spalling on WV070002.

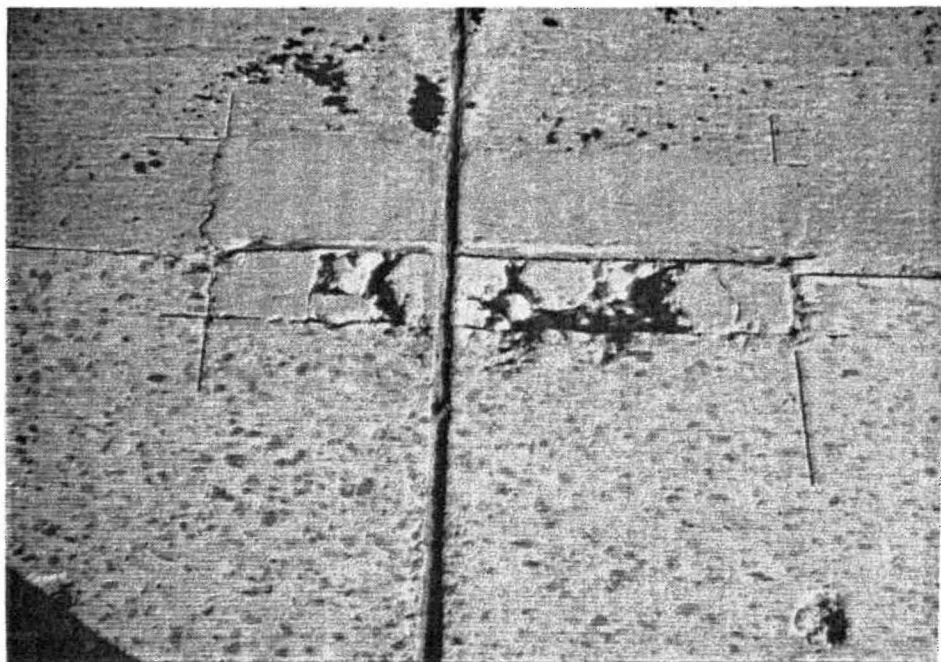
Figure 94. Photo of Partial-Depth Repair on LA010151.

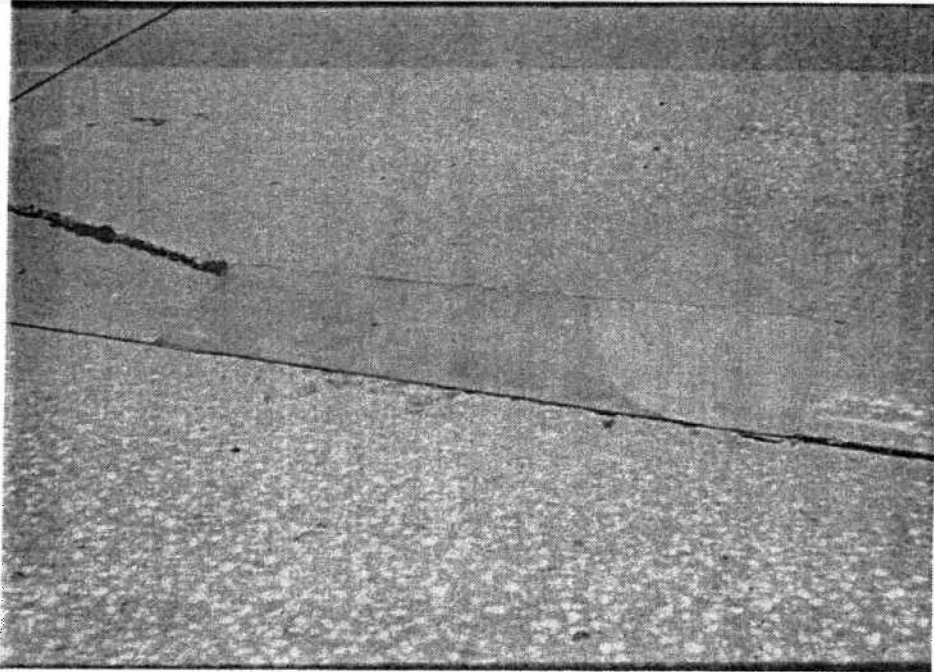
Figure 96. Photo of Partial-Depth Repair at Working Crack on NE080404.

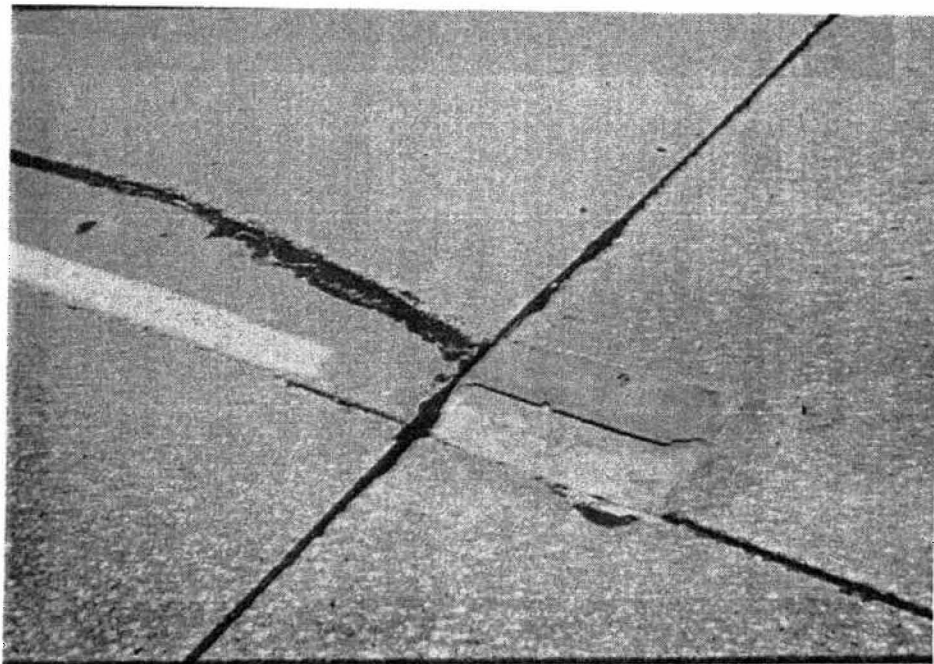
Figure 97. Photo of Material Loss of Partial-Depth Repair on NE080404.

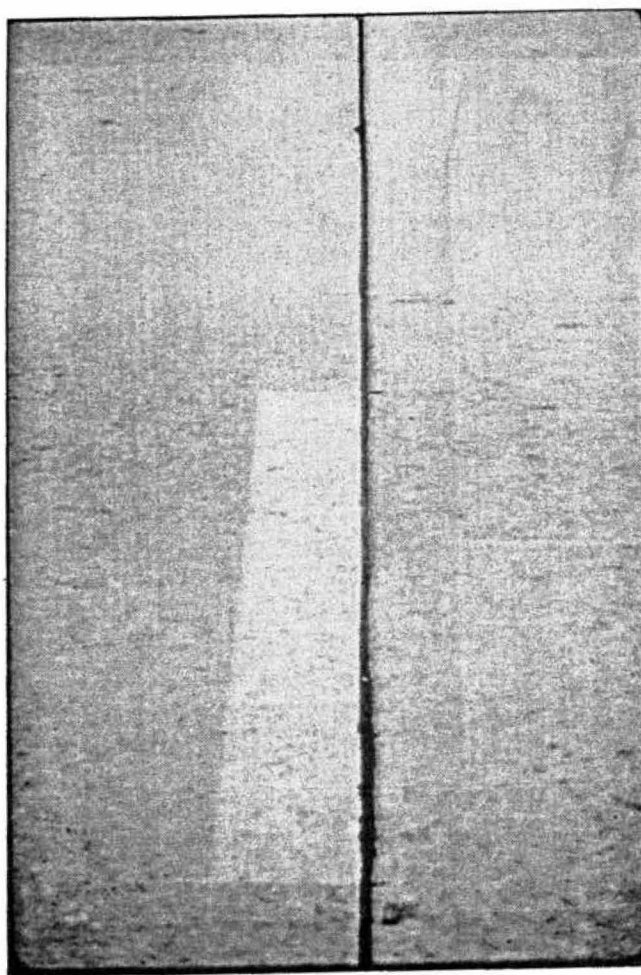
Figure 98. Photo of Partial-Depth Repair on VA095000.
