DOT/FAA/CT-82-118

Crash Injury Protection In Survivable Air Transport Accidents-U.S. Civil Aircraft Experience From 1970 To 1978

March 1983

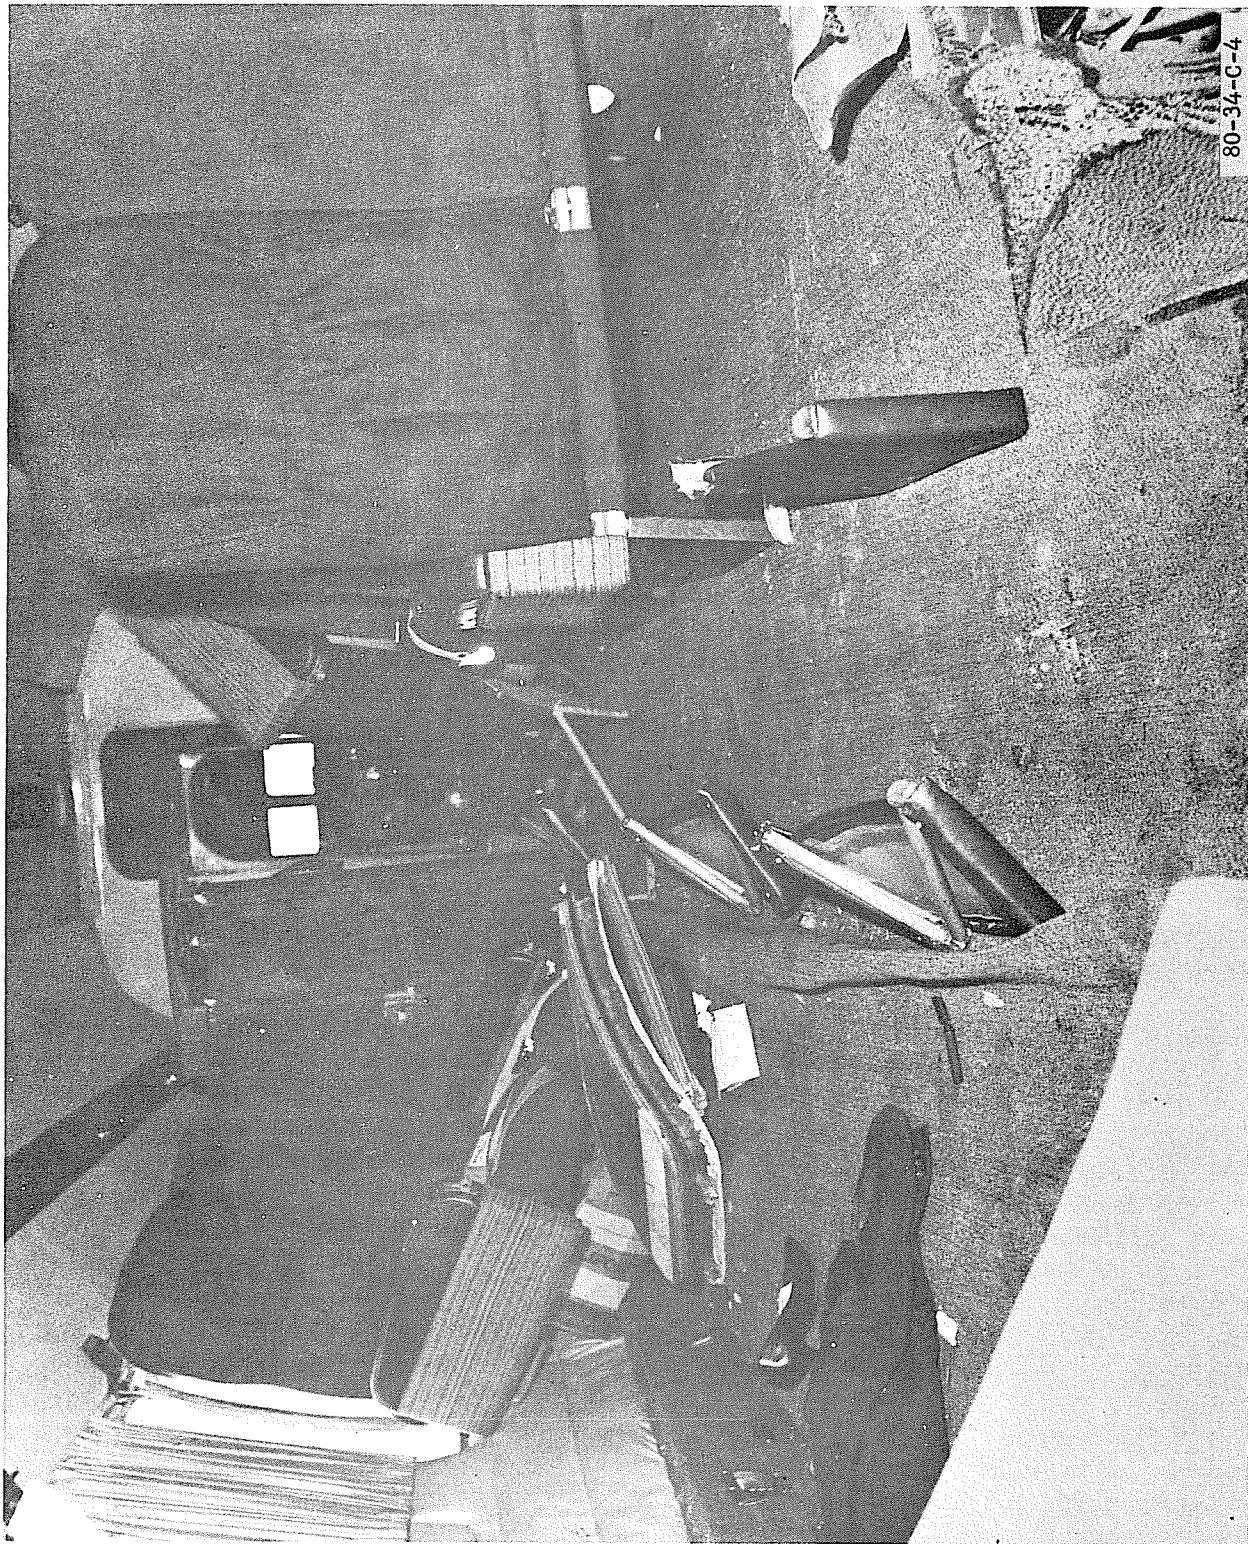
FIGURE C-4. N40412 SEAT FAILURES

Pax Seat Performance. Passenger seat failures were numerous and of all categories seat attachment leg failures, seat position locking failures, seat leg failures, etc. (figure C-4). It was estimated that about one-third of the passenger seats were broken and detached from the floor. Because the seats were not numbered,

their exact location in the fuselage cabin, prior to impact, could not be established; however, the side of the aircraft from which they originated was determined. All seats subject to failure forces were loaded downward and to the right.

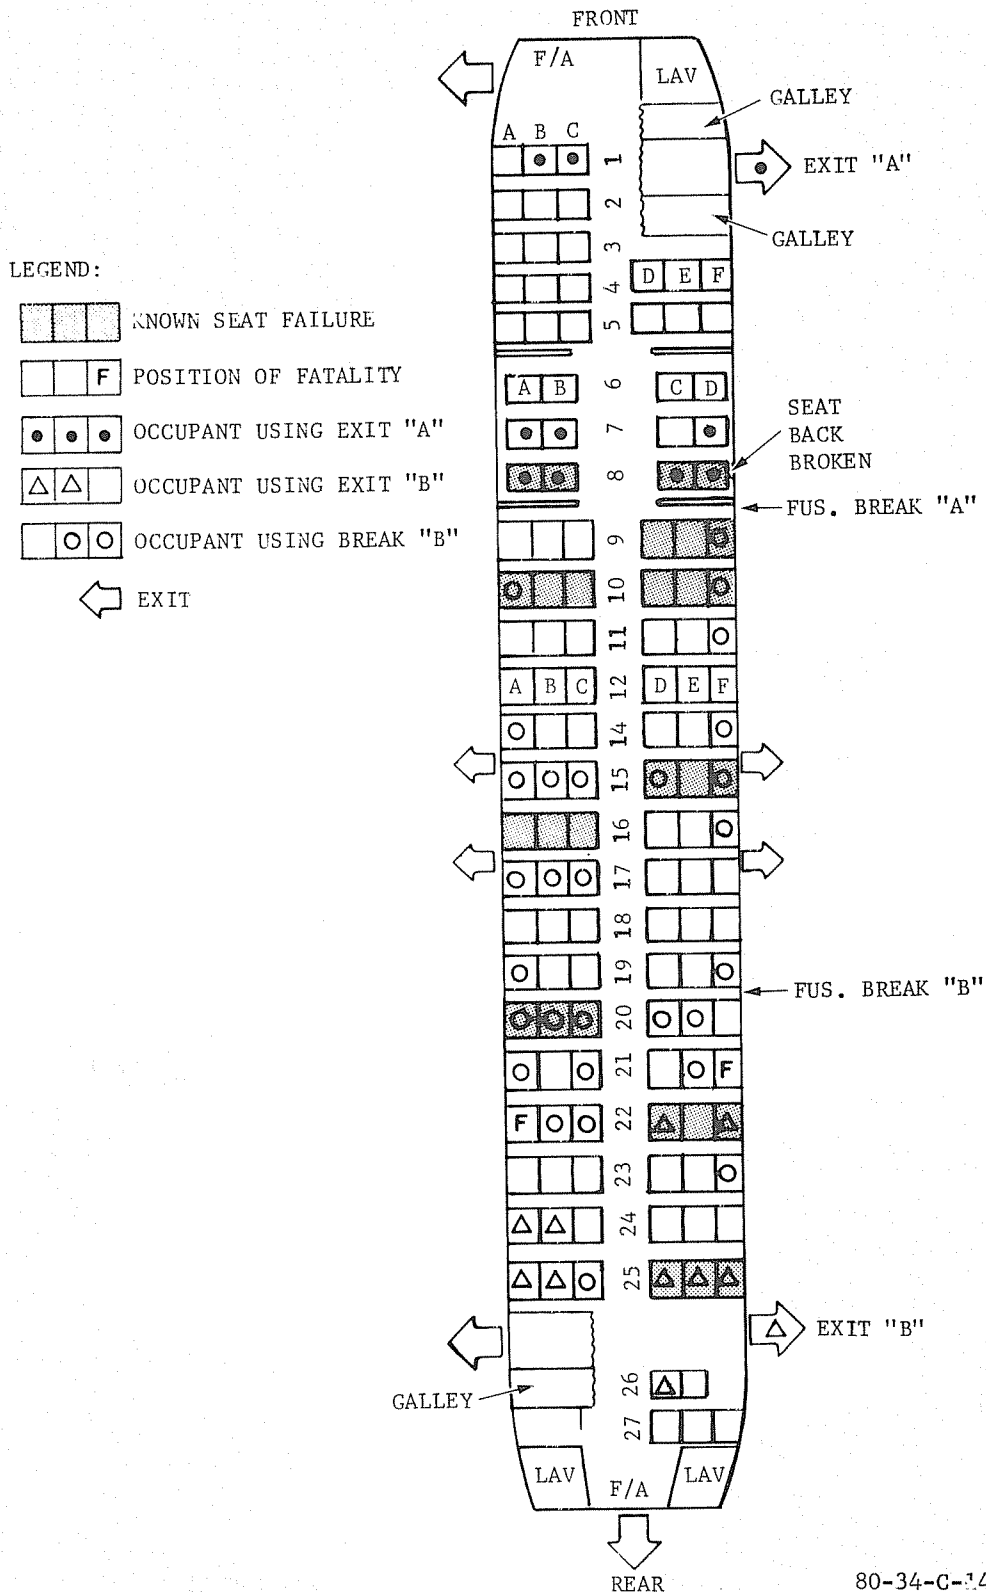
FIGURE C-14. SCHEMATIC VIEW OF N8790R ILLUSTRATING FUSELAGE BREAKS, SEAT FAILURES, AND OCCUPANT EVACUATION ROUTES

Pax Seat Performance. There were 10 reported passenger seat unit failures (figure C-14). Passenger accounts and the examination of the seat found in the wreckage area indicate there were lateral failures that occurred as a result of the sideward impact forces generated when the aircraft came to rest against the hill. The impact angle in relation to the longitudinal axis of the aircraft was in excess of 30°.

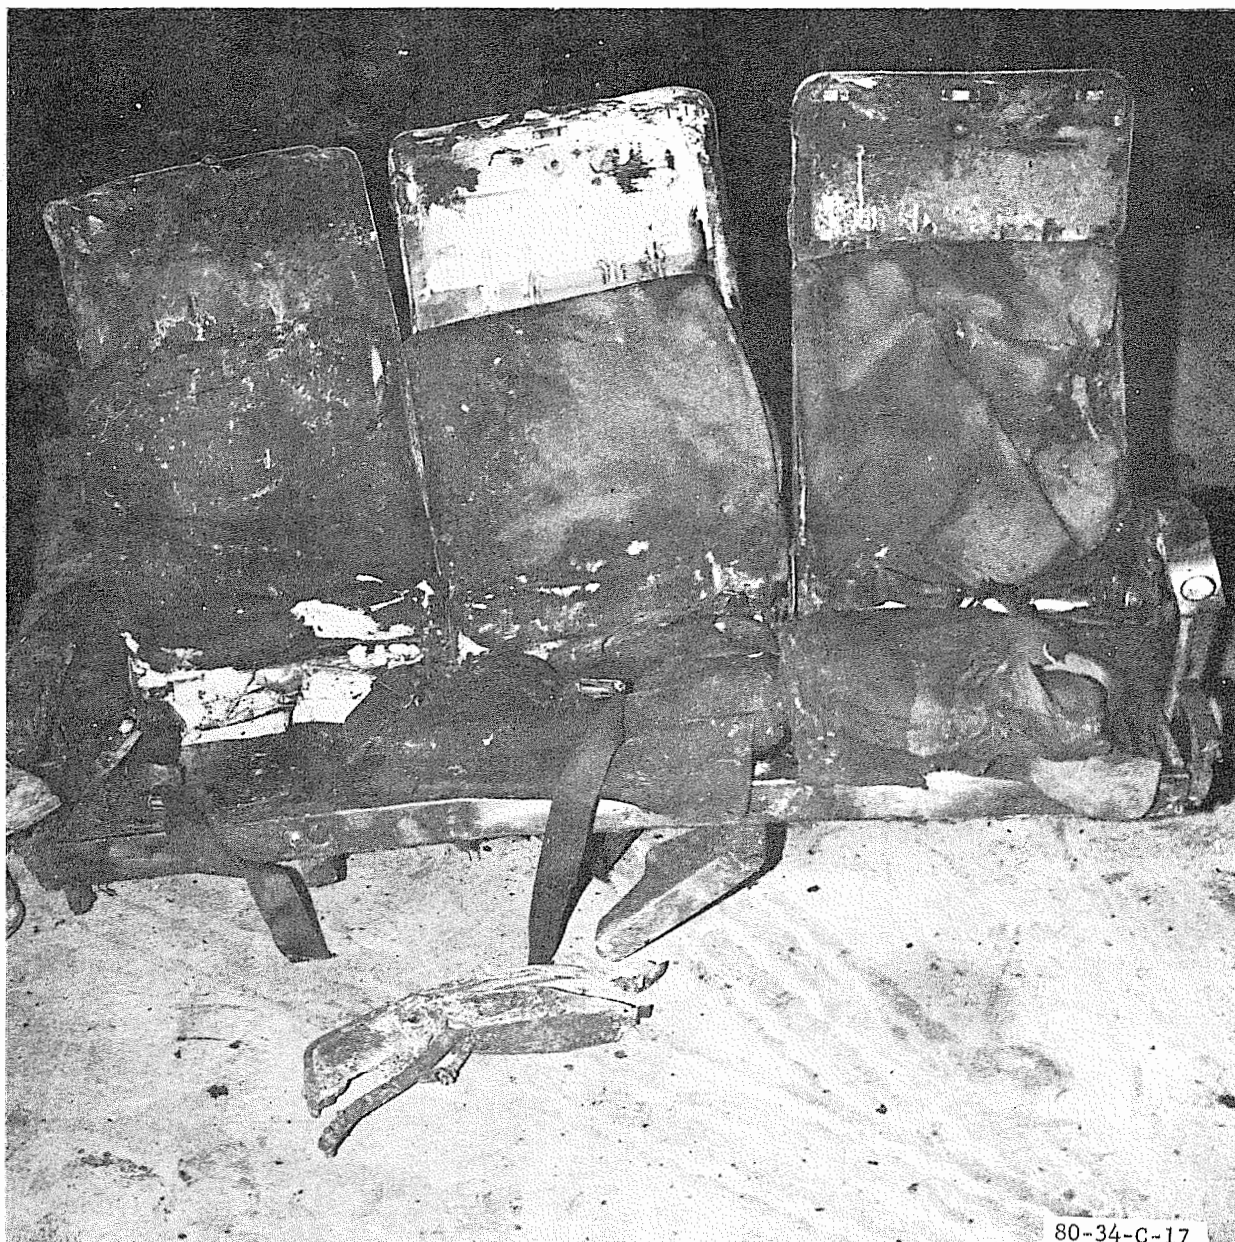
FIGURE C-18. N9031U SEAT DEFORMATION AND FIRE DAMAGE

Pax Seat Performance. The passenger survivors were seated in rows 8 through 12 and 16 and 17. With the exception of two passengers who could not remember, all survivors stated that their seatbelts remained intact and most reported bruises to attest to this fact. Survivors on the right side of row 8, 10, and 11 had difficulty releasing their respective seatbelts because their seats, though intact, had come partially loose and were leaning forward, consequently semisuspending the occupants by their seatbelts. There was no floor in front of seat 8F, so the occupant had to step on a cable to relieve pressure before his seatbelt buckle would release. No first class seats were recovered intact. All seats received some degree of fire damage. Typical seat damage and track deformation are illustrated in figures C-18 and C-19.

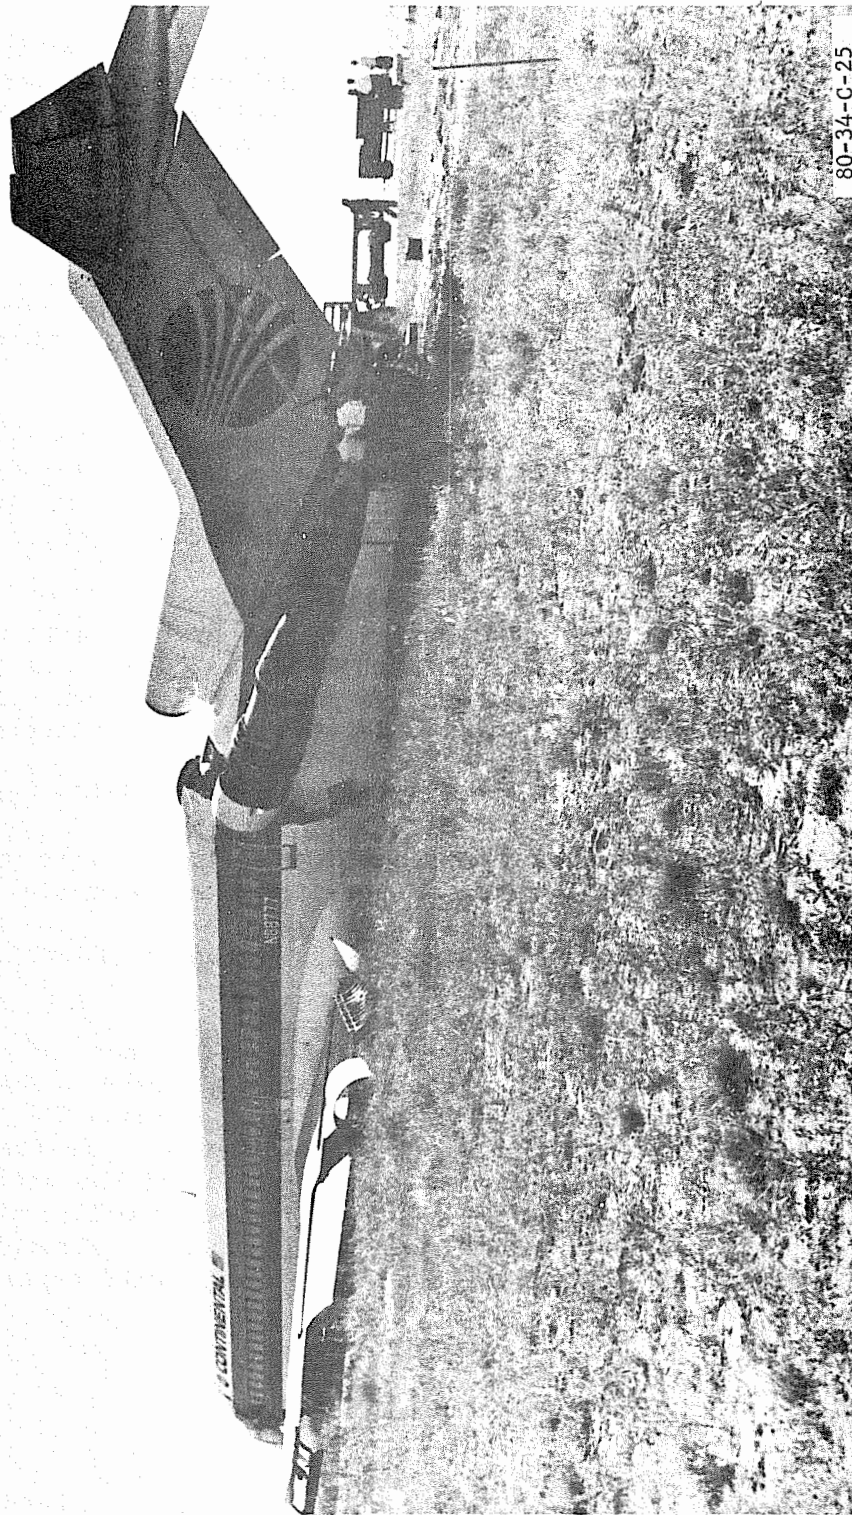
FIGURE C-26. N8877 FUSELAGE BREAK

Airframe Deformation/Crash Loads. The aircraft fuselage split at approximately FS 279 on the right side and just aft of the production joint at approximately FS 390 on the left side. This portion of the fuselage structure from FS 178 aft to FS 360

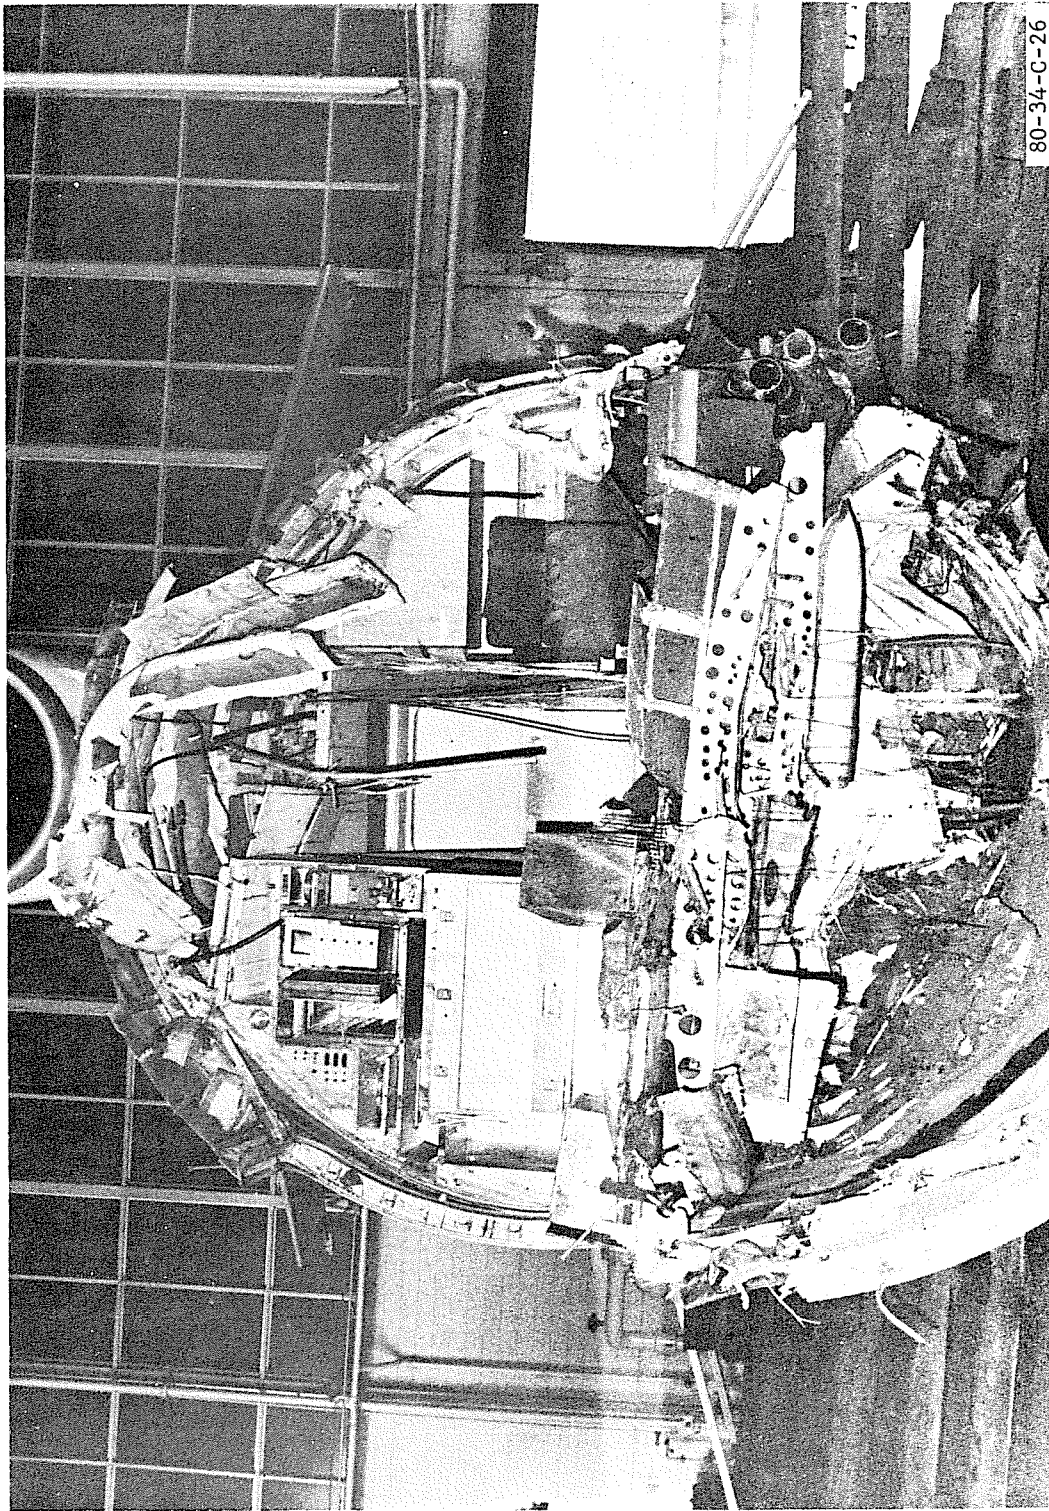
FIGURE C-27. N88777 CROSS SECTION AFT PORTION ILLUSTRATING FLOOR DEFORMATION

sustained severe ground impact damage in a generally aft direction. The fuselage was also split open from the crown area to the external lower portion of the fuselage near FS 390. Numerous wrinkles were in evidence. The cabin floor section in the immediate area of FS 380 had buckled and caved in at the coat closet front attachment joints. The cabin floor tracks were fractured at a point about 14 inches aft of the coat closet rear attachment points. The forward galley remained intact and attached to the floor structure. However, this section of the cabin floor had collapsed toward the center aisle. The floor beams from FS 360 to FS 460 were severely damaged. The fuselage was also separated at about FS 1050 on the right side around to FS 1100 on the left side (figure C-26). The floor beams at FS 950 were fractured (figure C-27).

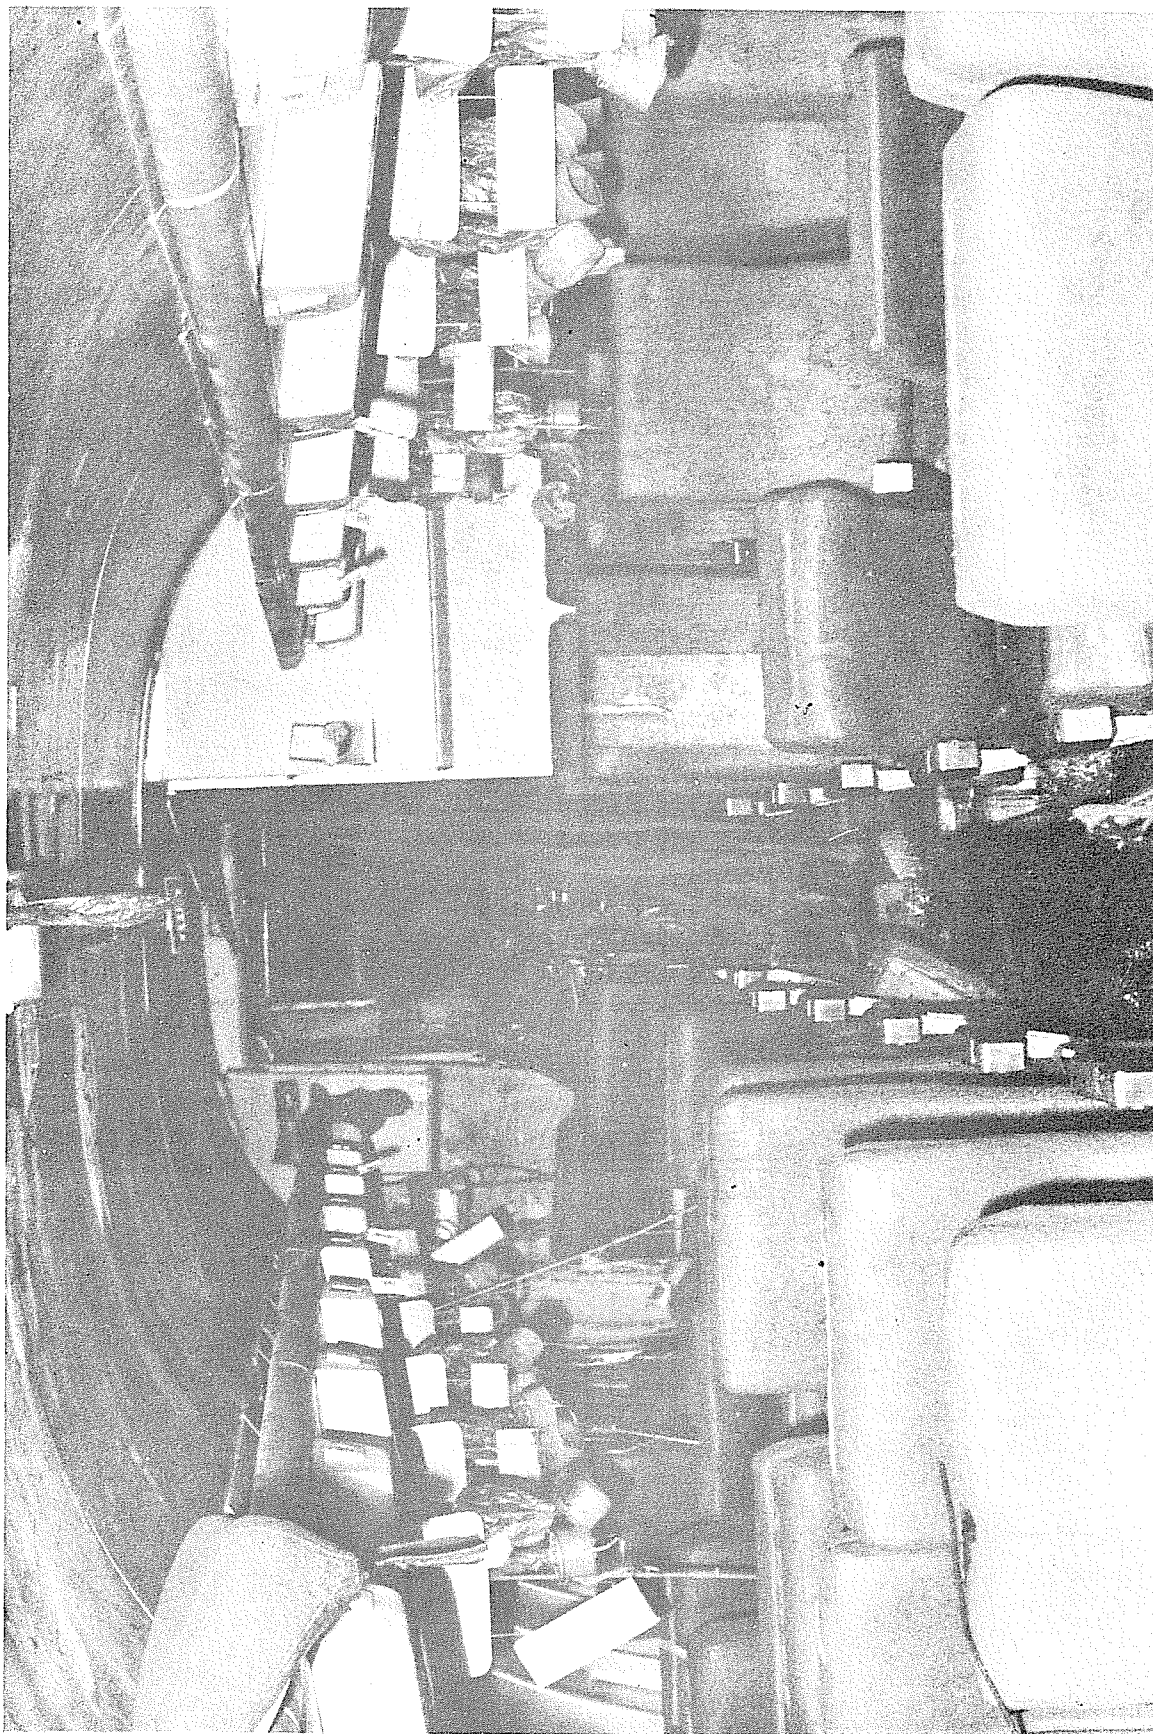
FIGURE C-43. N4744NA INTERIOR CABIN VIEW AFTER ACCIDENT

Miscellaneous Cabin Interior Performance. The cockpit entry door separated inward but did not impede egress from the cabin. The left forward clothes closet in the passenger cabin became dislodged, shifted forward, and according to the crew, delayed the opening of the forward passenger door. A floor access panel (about 33 by 15 inches) in the first class cabin aisle between the forward passenger and galley door came loose on impact. All galleys remained secured. Except for several lightweight trim panels and a ceiling panel in the rear of the cabin, all overhead storage racks and ceiling panels remained secured (figure C-43).

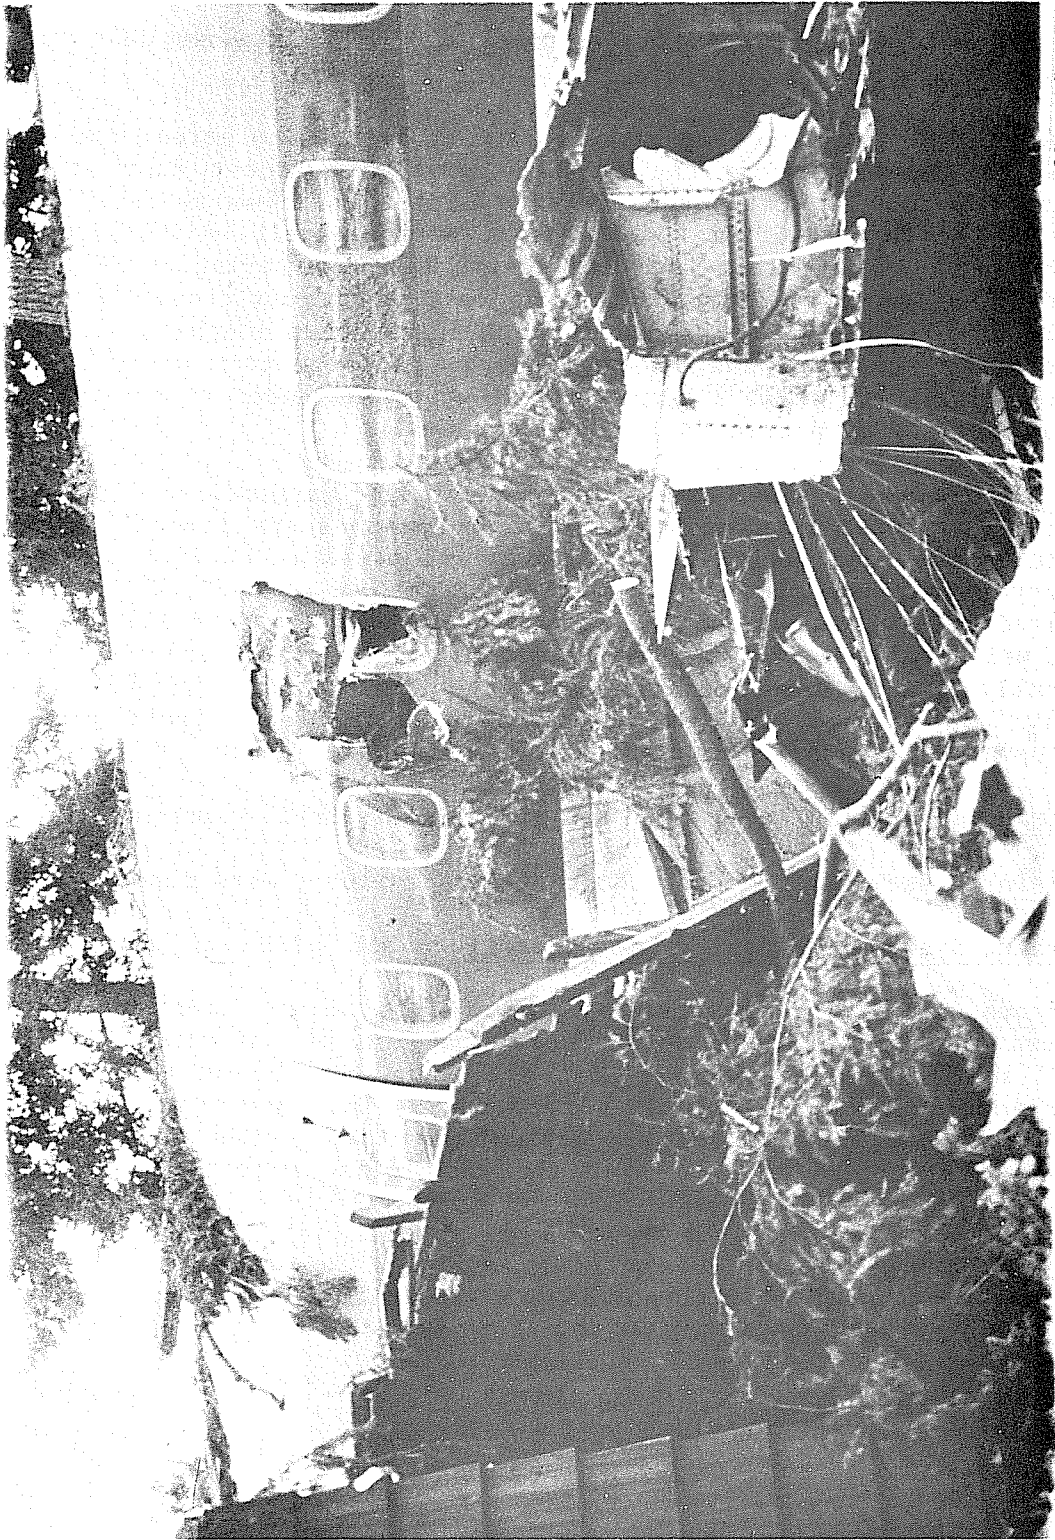
FIGURE C-45. N8082U FUSELAGE DAMAGE

Airframe Deformation/Crash Loads. The fuselage from FS 200 forward received severe and extensive impact damage in a generally rearward direction. Fuselage skin and associated stringers from a point just below the cabin window on the left side of the fuselage at FS 280 forward to FS 200 had been torn away. Also, on the left side of the fuselage, the window at FS 250 was in position but was smashed; the fuselage skin and associated support structure on the lower and underside of the aircraft from FS 200 aft to about FS 300 was torn and crushed. There was also a 2-by 2-foot depression between the cabin windows (at FS 834 and FS 879) and extensive tearing and crushing type damage (from FS 960 aft to FS 1040). The structure was
